Process REPORT (hereinafter called the "Report")

ALL INSPECT
All Building & Termite Inspections

Inspection Date: 19/01/2016

Property Address: 875 Sample Drive Sample 4300

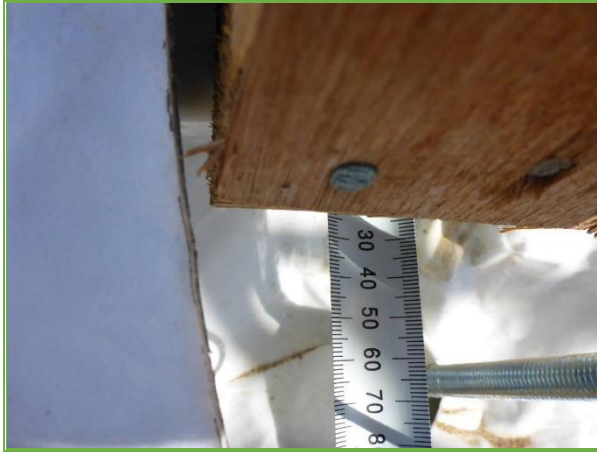
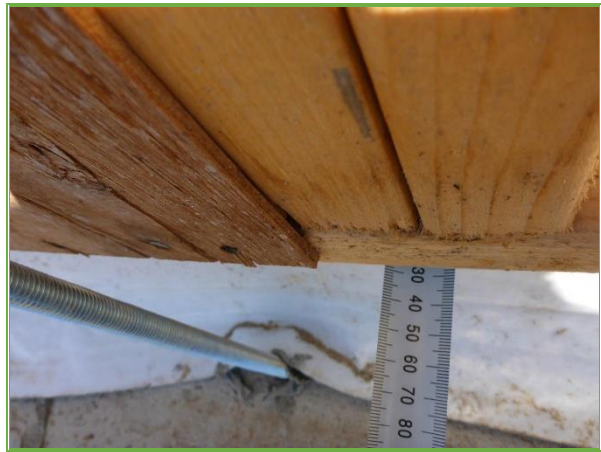
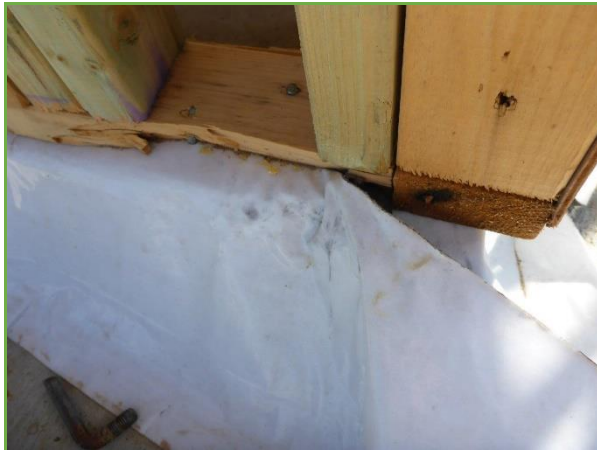
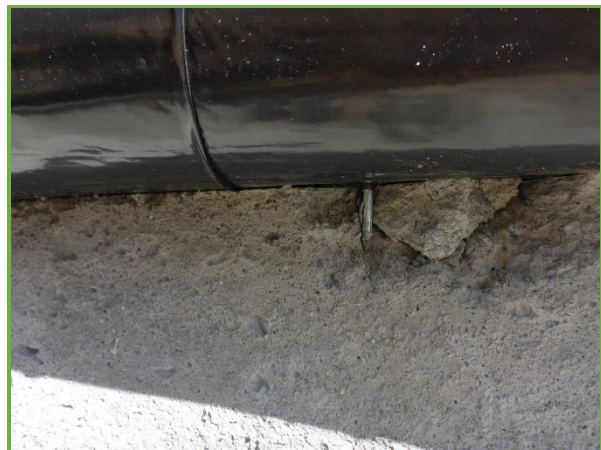
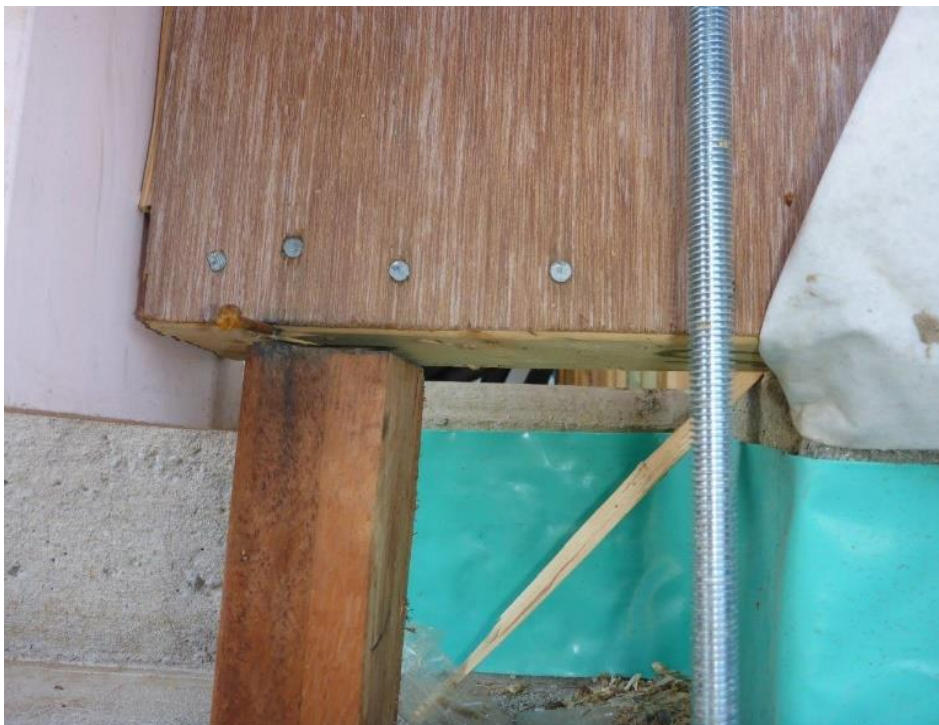
The frame overhang is more than the allowance and needs to be supported in a manner that complies with As 1684.2, clause 6.3.3, and the BCA 15mm for a 90mm frame, and fixings have broken the edges the Standards & Tolerances allowance reference to the 4.11

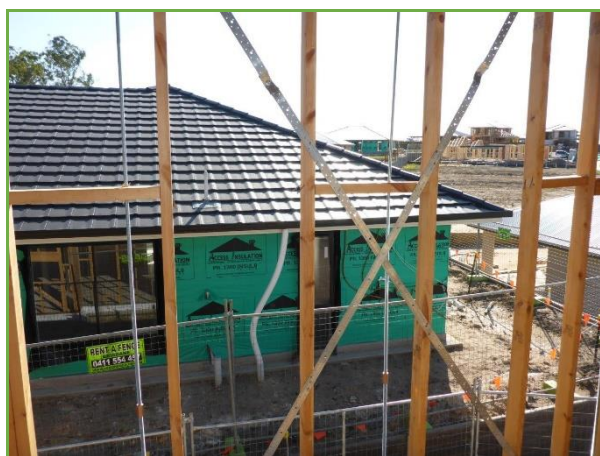
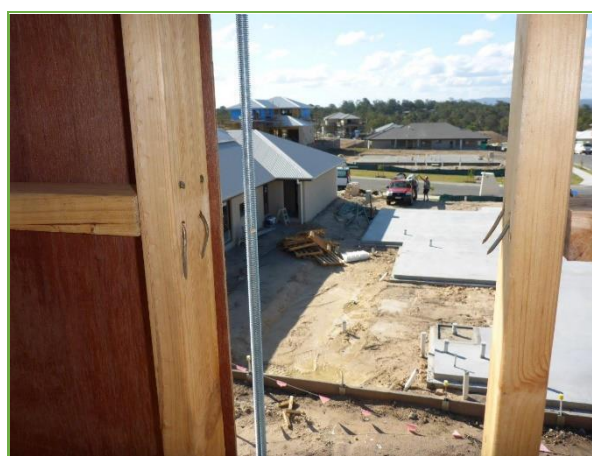
There are several noggings that need to be installed or in parts reinstalled.

I refer the builder to AS 1684.2, clause 6.2.1.5 which calls for all noggings to be installed at no greater than 1350 mm from top or bottom plate and no greater than 1350 centres.

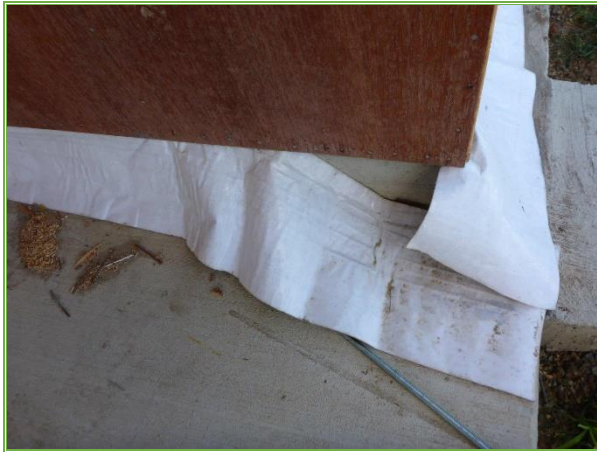
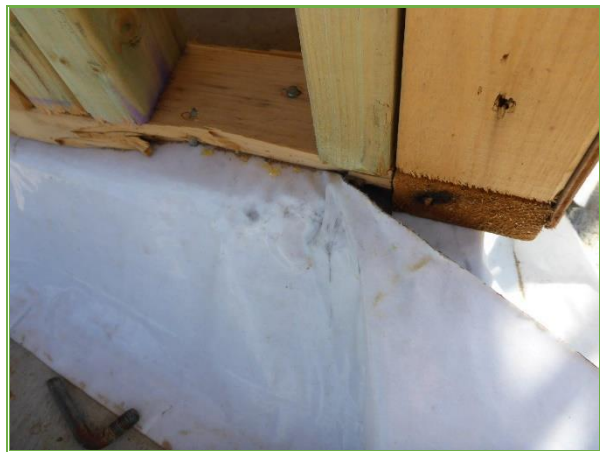
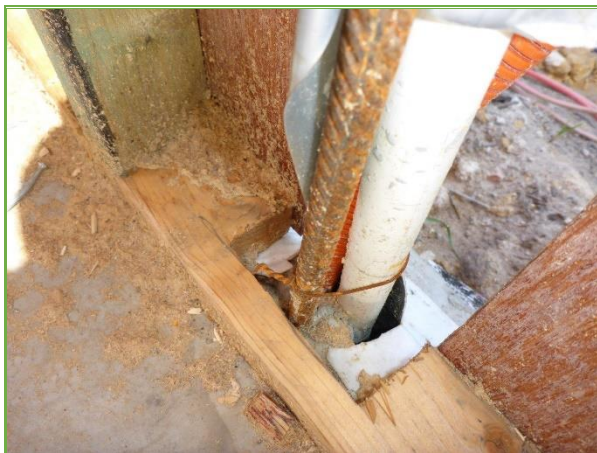
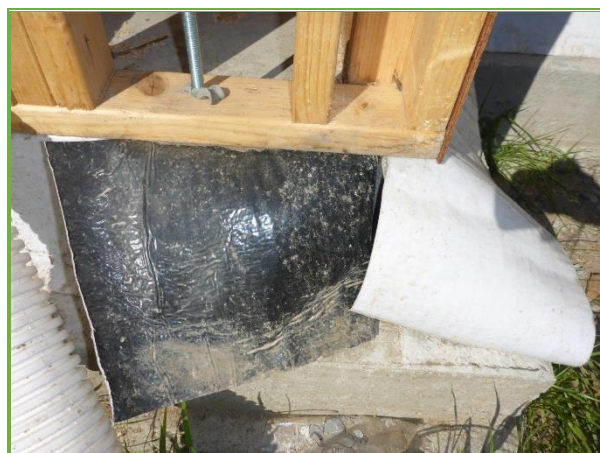
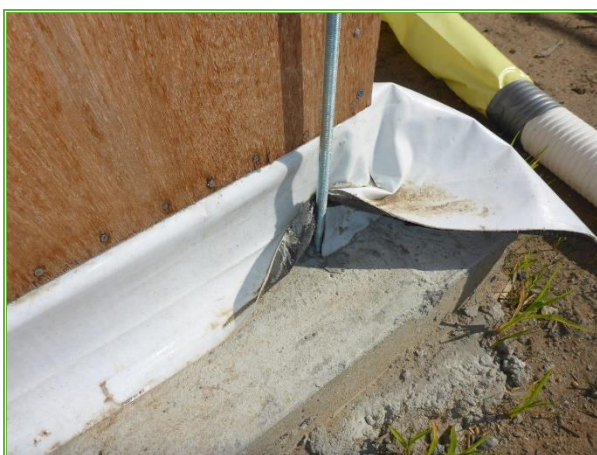
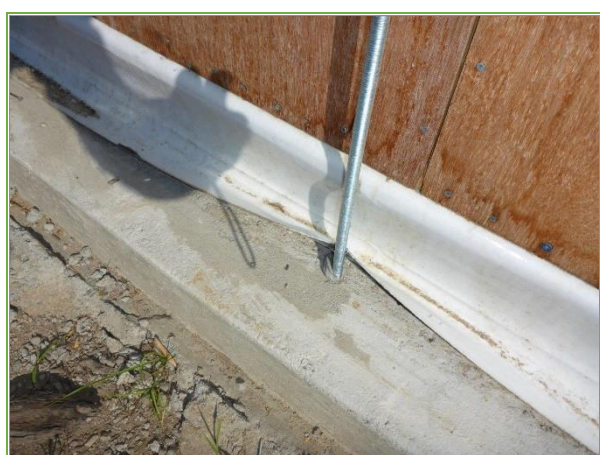
It was noted at the time of inspection that the **Plasmite Termite Blanket** system appears to be incomplete as the barrier in some areas is not under the frame. The tie down rods that have been install to the outside of the frame have push the termite barrier back to the rebait and doesn't comply with AS 3660.1 2000 and the manufacturers instructions and Deemed-to-Satisfy Provisions are an optional means of achieving compliance with the mandatory Performance Requirements. this will need to be reworked and completed before continuing reference for builder.

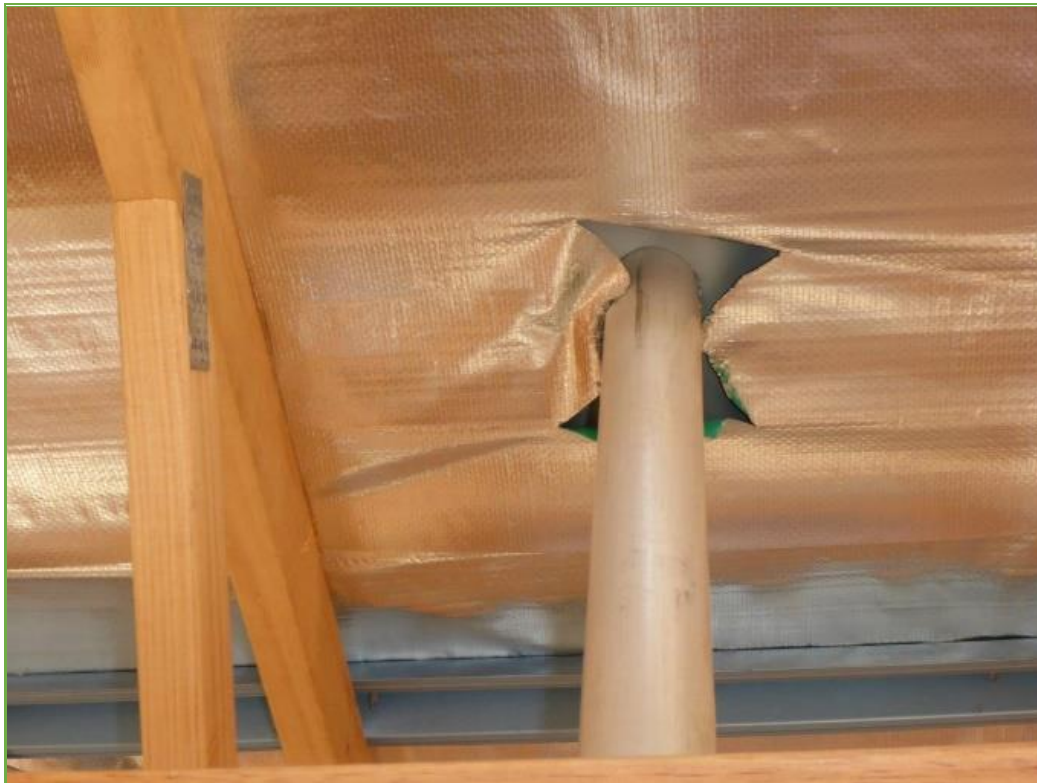
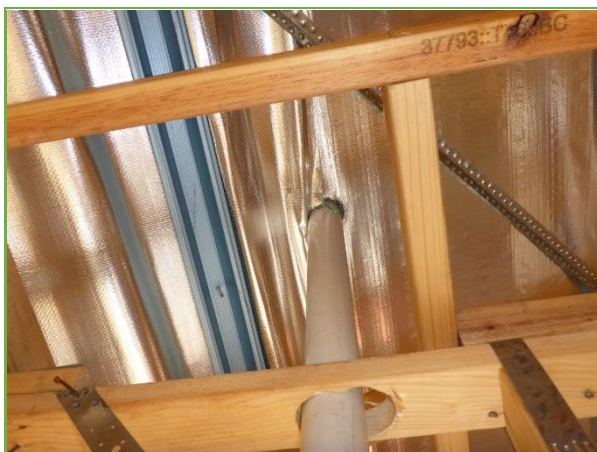
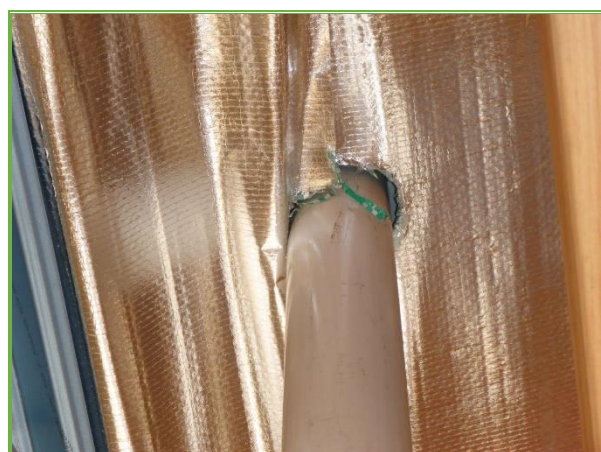
It was noted at the time of inspection that there is holes in the roof sarking, thus allowing the transfer of water moisture to the frame roof void, any moisture running down the Roof will now exit into the void. This will in itself cause additional defects at a later stage. This needs to be complete otherwise considerable rework will have to take place to ensure that the builder comply with requirements of the BCA and Australian standards AS 4200-1994. All holes will need to be patched to comply with Energy efficiency requirements "Pliable Building Membranes and Underlay's" part 2 states: The only tapes that can be used on sisalation are AS 4254 compliant. Please note that any coloured tapes used on the foil side of the sisalation are defective. The tapes used to this side of the sisalation must be designed for installation on a foil surface and hence AS 4254 compliant. Ensuring full coverage of the frame in wall or roof sisalation. Ensuring that penetrations through the sarking by services have been taped to provide a weather tight seal.

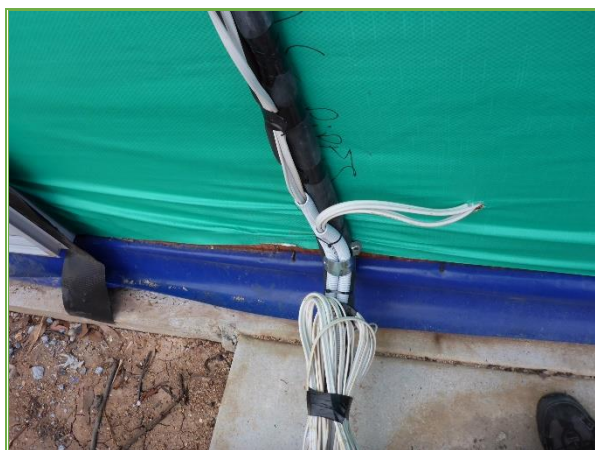
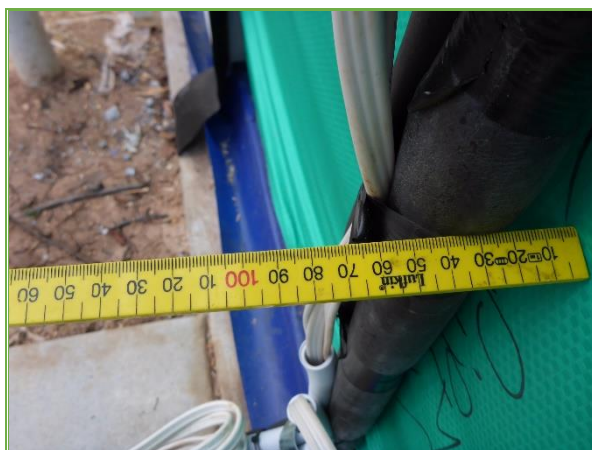
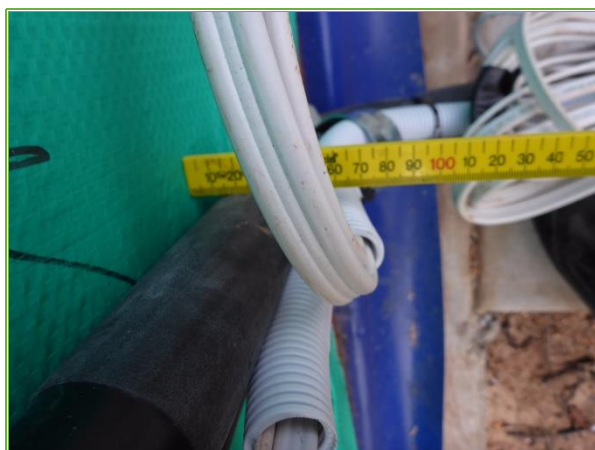
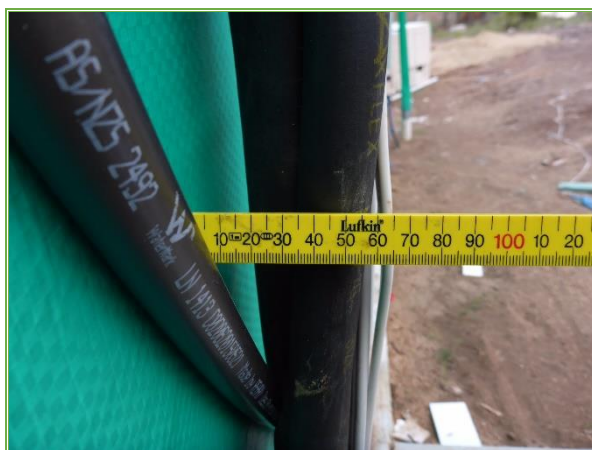
Where it is: Frame

What it is: A/C pipes cavity breach

Results: It was noted at the time of inspection that the air condition pipes installed to the cavity area of the dwelling will breach the minimums set down in the bricking Standard.

As such I refer the plumber and the builder to part 9.2. This part clearly states that a cavity must be a minimum of 25mm. Given that the plumbing pipes in the wall are 40mm to 60mm the builder would need a 70 mm+- cavity to make this work.

I noted from the installed slab that the builder's intentions are to install the cavity at about 25 to 35 mm.

Given this configuration, the installation of A/C pipes on site will bridge the cavity.

The plumber will need to return to site and rework all of the external installation prior to brick installation.

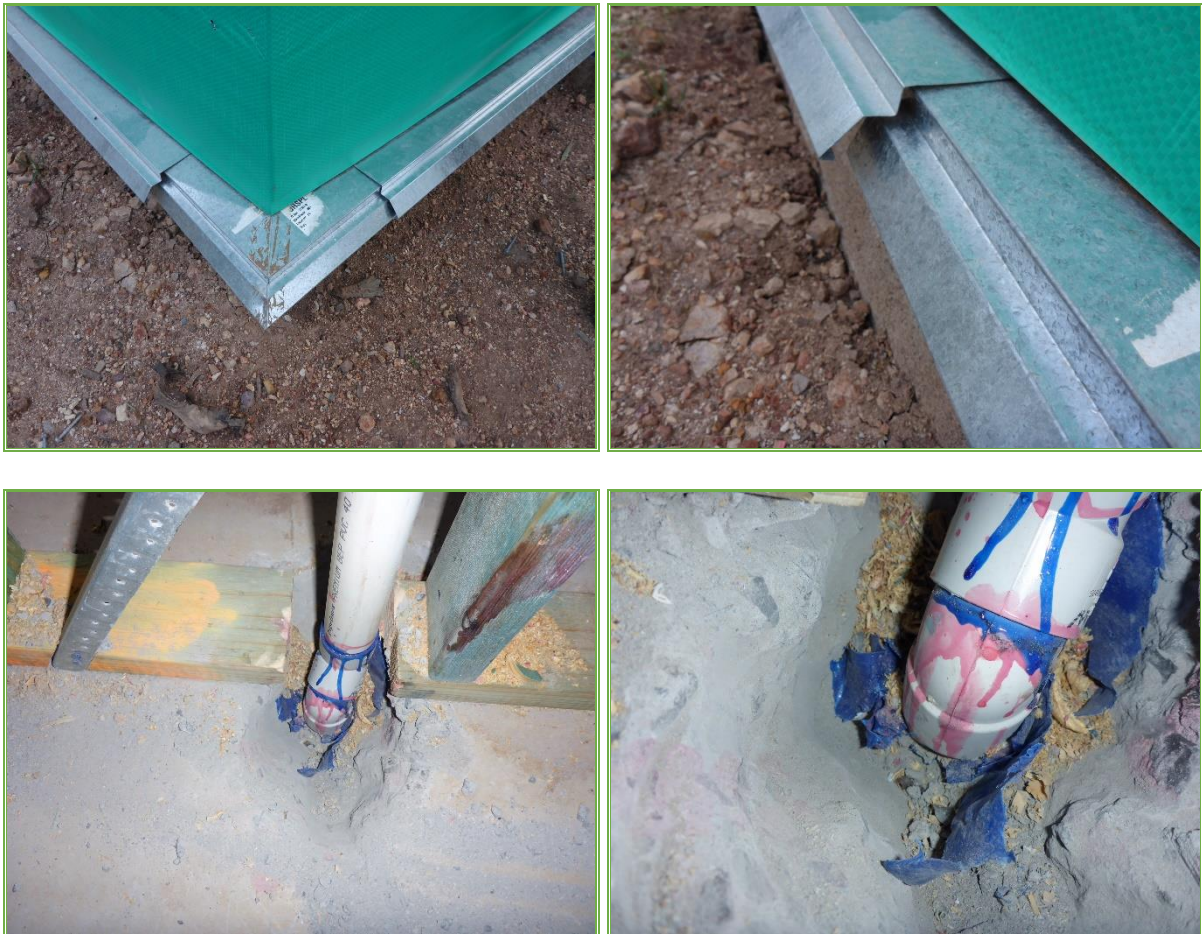
Where it is: External

What it is: Ant capping defective and termite film damage.

Results: The ant capping to the dwelling breaches AS 3660.1 inserted below 5.5.2. The film is damage. Deemed-to-satisfy requirements. This will need to be reworked and a form 16 produced before continuing.

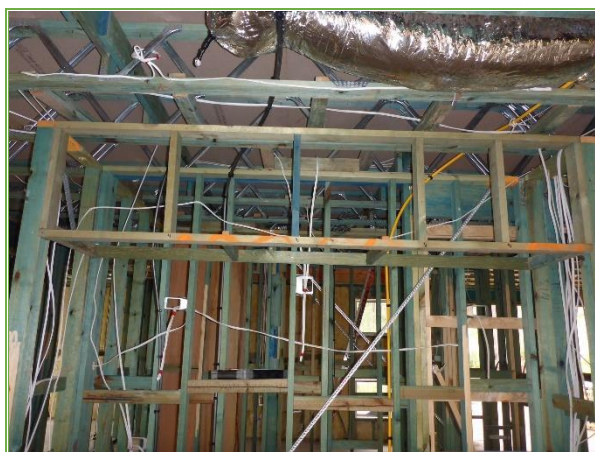
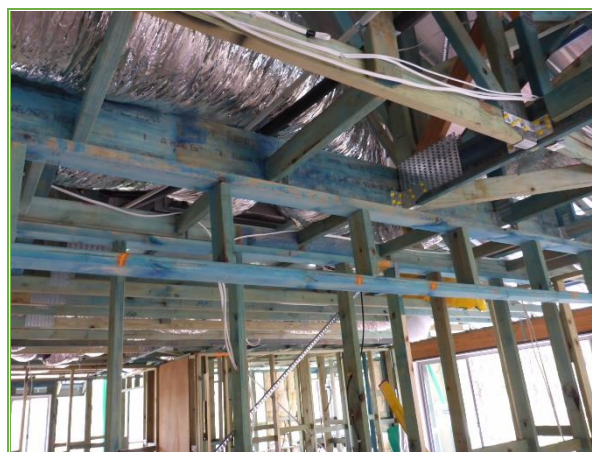
Where it is: Kitchen Bulk Head and other areas

What it is: lintel Missing

Results: Incomplete Lintel missing

AS 1684.2-2010 states that when openings in NON-LOADBEARING WALLS over 1800mm occur, both internal and external, a lintel shall be installed and the size of the lintel will be determined by table 23, based on the top plate.

All openings over 1800mm will need to be fitted with lintels to comply with the code.

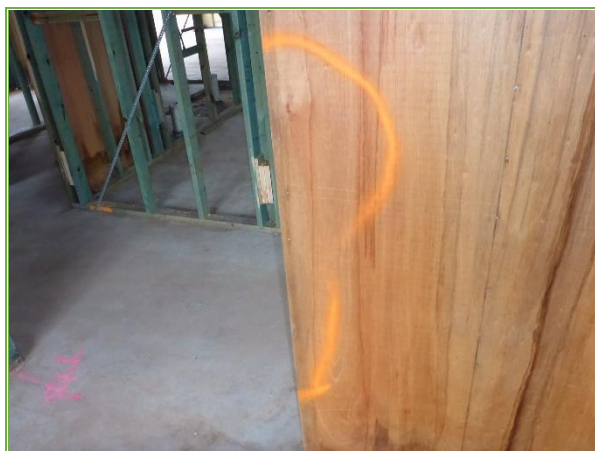
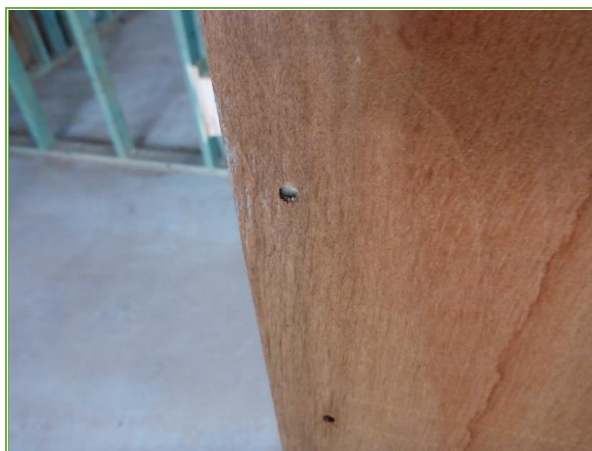
Where it is: Numerous Areas

What it is: Bracing over shot

Results: The timber sheet bracing installation is a vital structural member in the overall build of the dwelling. It stops the house from moving when racking forces, such as wind, are applied to a dwelling. The installation of the timber sheet bracing on this house is defective for several reasons. The nails have been over installed or punched through a number of boards.

The outer sheet edge must be secured at a maximum of 150 centres. This dwellings installation fails that requirement. The central studs must all be nailed off at 300 mm centres maximum.

I refer the builder to AS 1684.2, table 8.18 on page 143. The requirements stated above are clearly defined and must be rectified prior to moving forward with the dwelling.

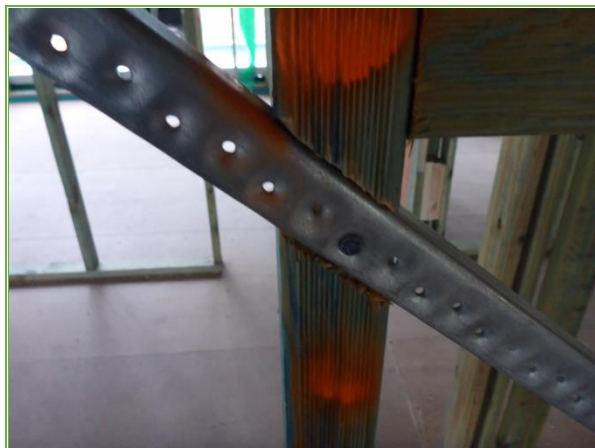
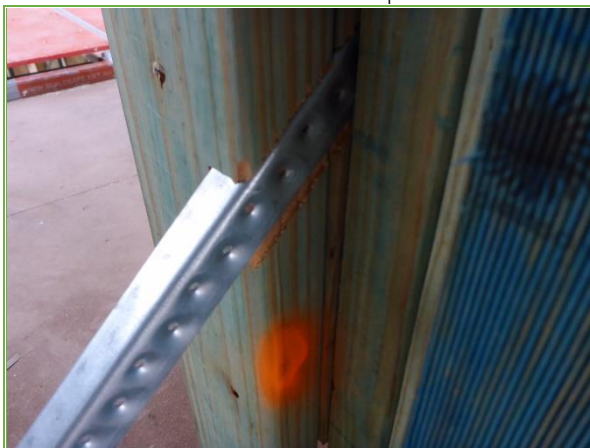
Where it is: Areas

What it is: Missing nails

Results: The steel bracing to the dwelling have not been installed with a minimum of two nails to each stud to the marked up areas only. Most areas are compliant.

I refer the builder to AS 1684.2, page 143, table 8.18 that clearly mandates the requirement of a minimum of two nails to each connection.

The additional nailing is required to ensure compliance.

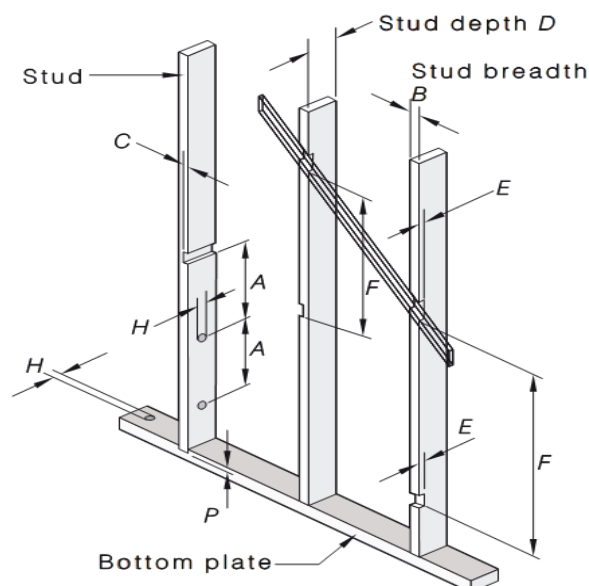
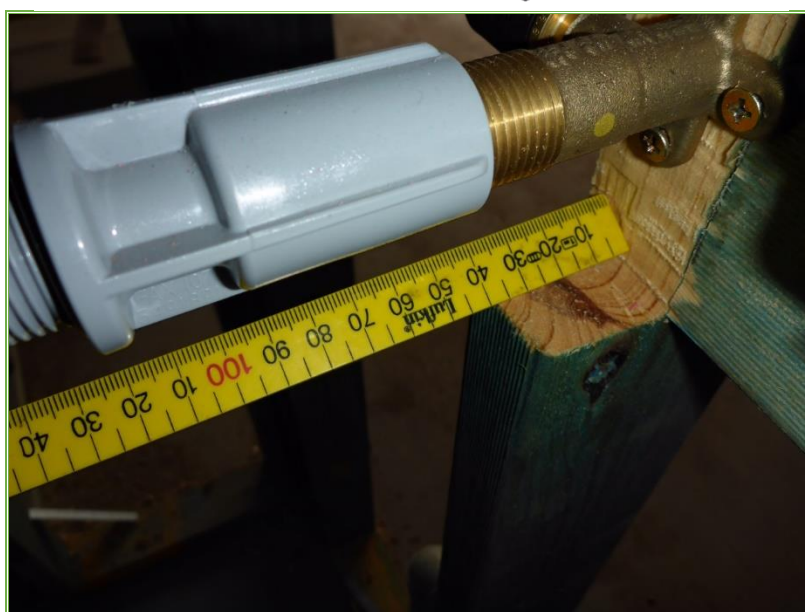
Where it is: Areas

What it is: Over Notching

Results: AS 1684.2, AS 3500.1 and AS 3500.4, notching into a stud must be restricted to 20 mm. See Table 6.1, section (e) below. Some of the plumbing water outlets has been installed via notching the studs depth by 30 mm or greater. This needs to be rectified by installing a supporting timber to the stud where the notch has taken place. I refer the builder to the inserted below.

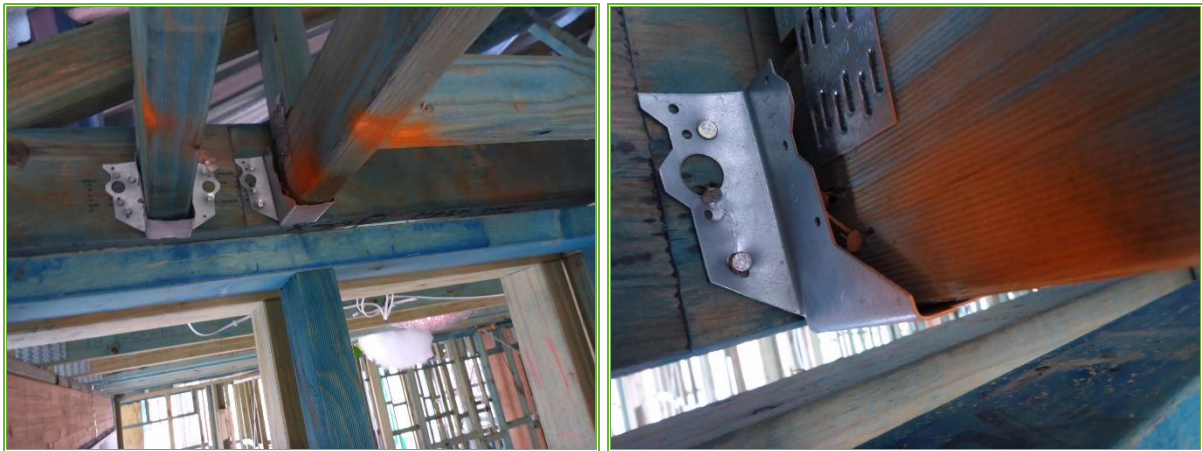
Where it is: Trusses

What it is: Missing nails to joist hangers

Results: Some of the nails are missing to the joist hangers, this is a vital part of the tie down. This will need to be re-worked to comply with AS4440 & AS1684.
