This is a visual only Building Inspection & Report carried out in accordance with AS4349.0

Handover REPORT (hereinafter called the "Report")

Inspection Date: 10/11/2015

Property Address: 41 sample Circuit Sample QLD 4164

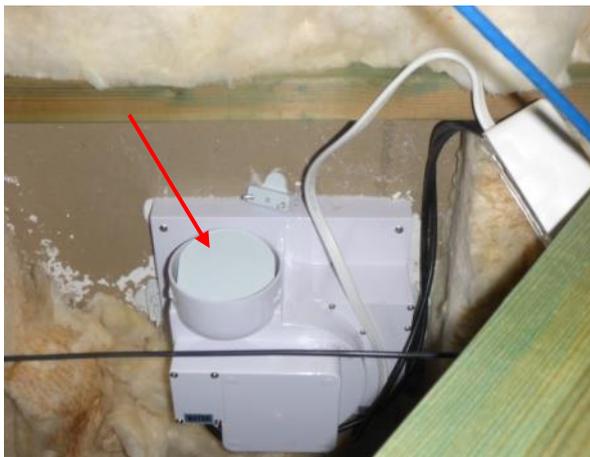
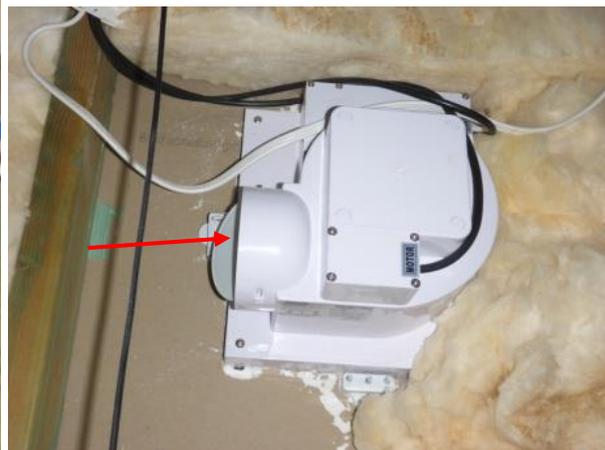
Where it is: Internal Ensuite

What it is: Mechanical Ventilation needs to be ducted or vented.

Results: There is no ducting or venting from the mechanical ventilation this will need to be rectified before handover. I refer the Builder to the B.C.A section 3.8.5.2 sub section (c) outlines the requirements of a builder in relation to ventilation of a sanitary compartment. The sanitary compartment on this dwelling needs to be mechanically vented, via a ducting system, to the external of the building. This item needs to be rectified. 3.8.5.2 Ventilation Requirements: ventilation must be provide to a habitable room, sanitary compartment, bathroom, shower room, laundry and any other room occupied by a person for any purpose by any of the following means: (a) Permanent openings, windows, doors or other devices which can be opened.

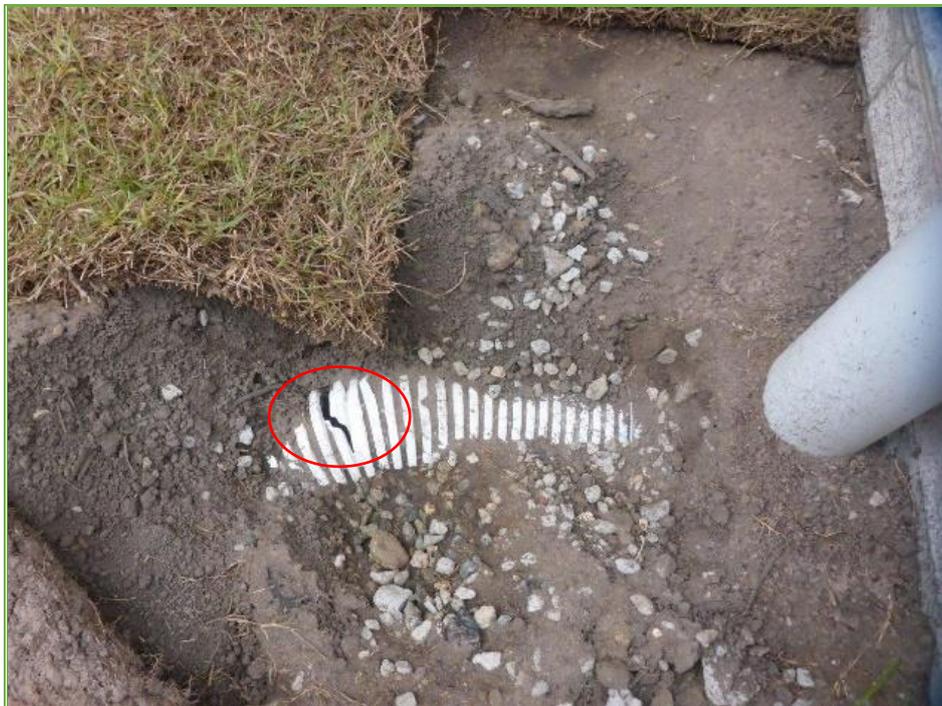
Where it is: External

What it is: Stormwater pipes damage and – not deep enough.

Results: It appears that some of the stormwater drainage is not deep enough and damaged, this will need reworking before handover.

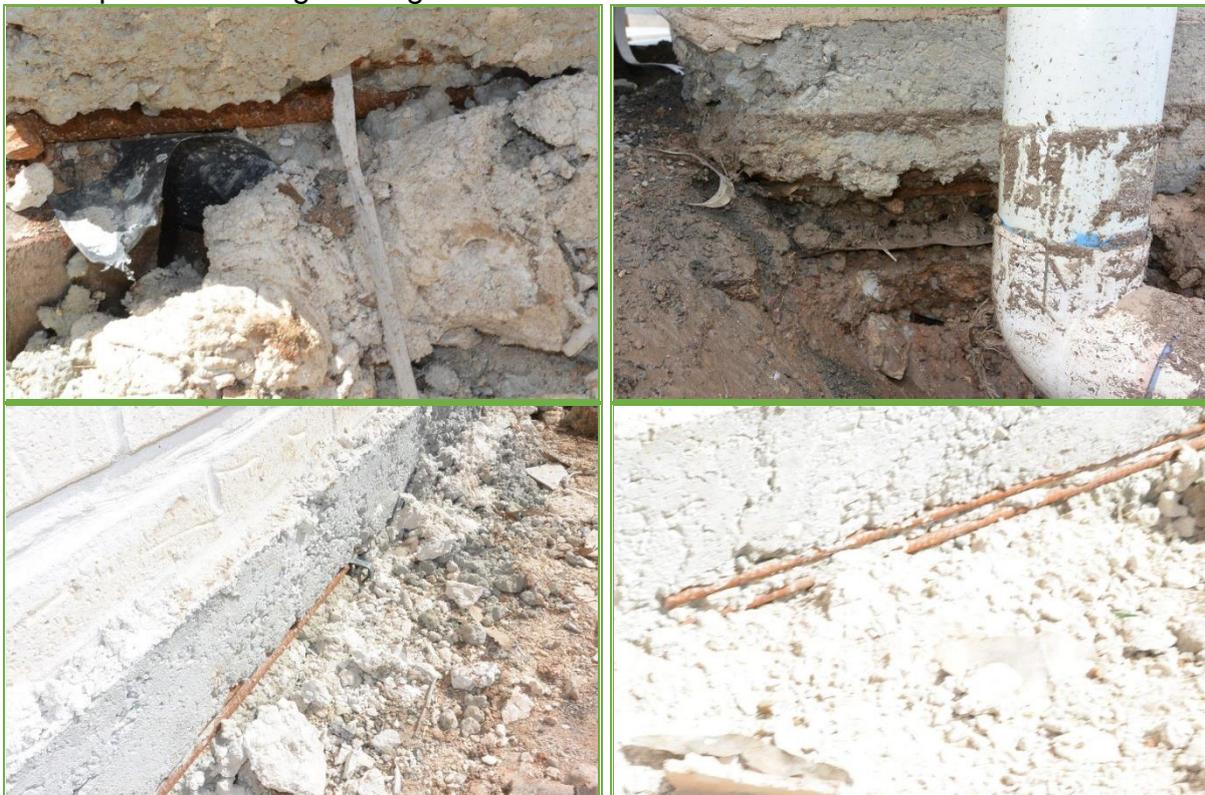
Where it is: Slab

What it is: There are large areas of open concrete voids to the slab edge. These areas are now showing the exposed reinforcement bars and that the slab has not been mechanically all compacted in areas as per the requirements of AS 2870. It is clear that the steel was not installed with the minimum concrete coverage area as per the mandated requirements of the BCA. I refer all to part 3.2.3.2. and AS 2870, part 6.4.7 and Part C6.1 that calls for the vibration in the 4th paragraph of that clause.

- Seek engineering process and design for rectification of this defect **form 15**.
- Send the engineer to the site surveyor for approval **form 16**.
- Have the site Engineer witness the repair of the slab to ensure that the builder has carried out the works in accordance with the process's and rectification statements in the engineering documentation.
- Satisfy the defect has not been hidden by placing soil over the edge-beam of the slab.
- Copies of the engineering documentation sent to our client.

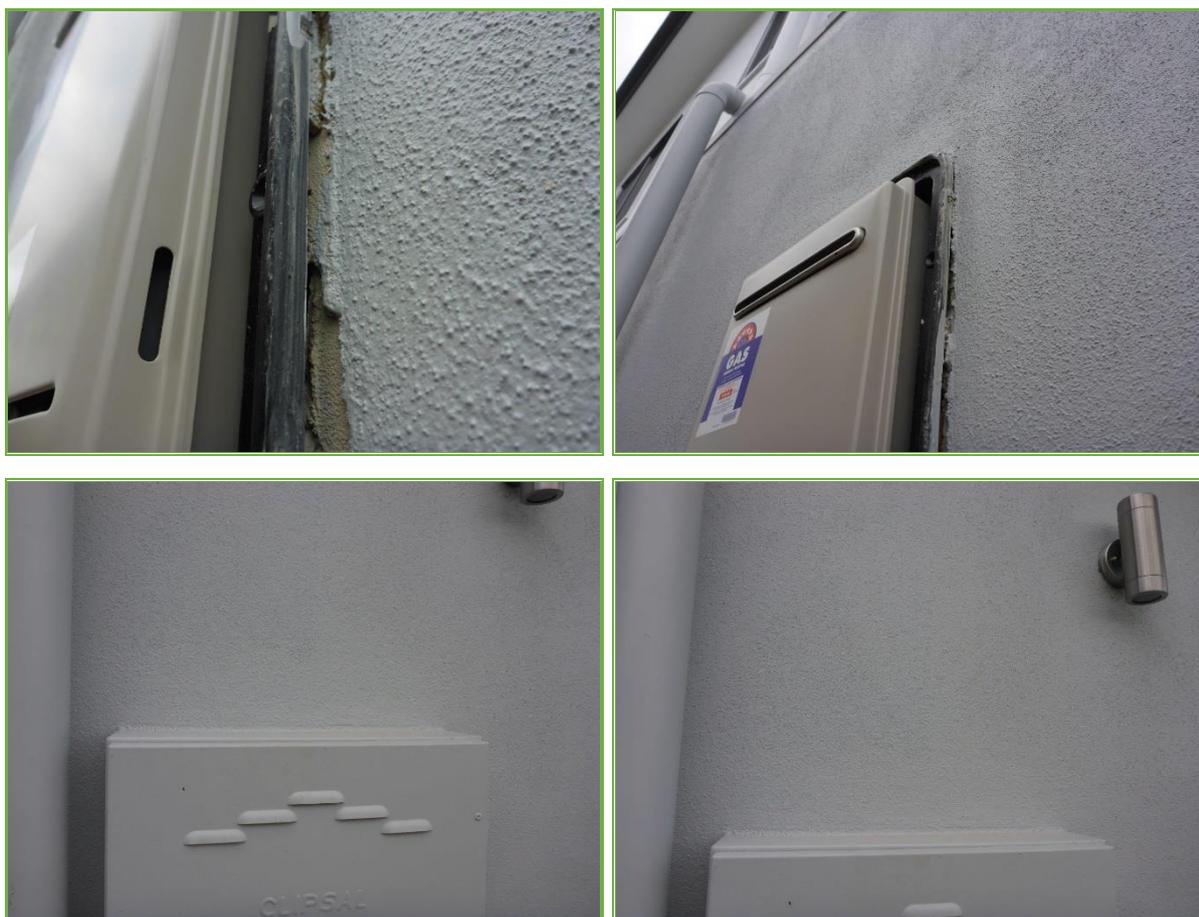
Where it is: External Meter Box & Hot Water System

What it is: No Head flashings and wide gaps.

Results: It was noted at the time the inspection that I was unable to detect the head flashings above the meter box and gas hot water system. Either expose the DPC flashings above the meter box and hot water system or install them. I refer the builder to the BCA, page 220, part 3.3.4.7, under the heading of *Location of flashings*. At the time of inspection, it was noted that there are gaps in the render near the hot-water system that need to be closed off. The gaps either require caulking or depending on the opening, an infill installed. The infill will need to be coloured the same as the render. Any caulking must also match the exterior colour. this to be rework before Handover.

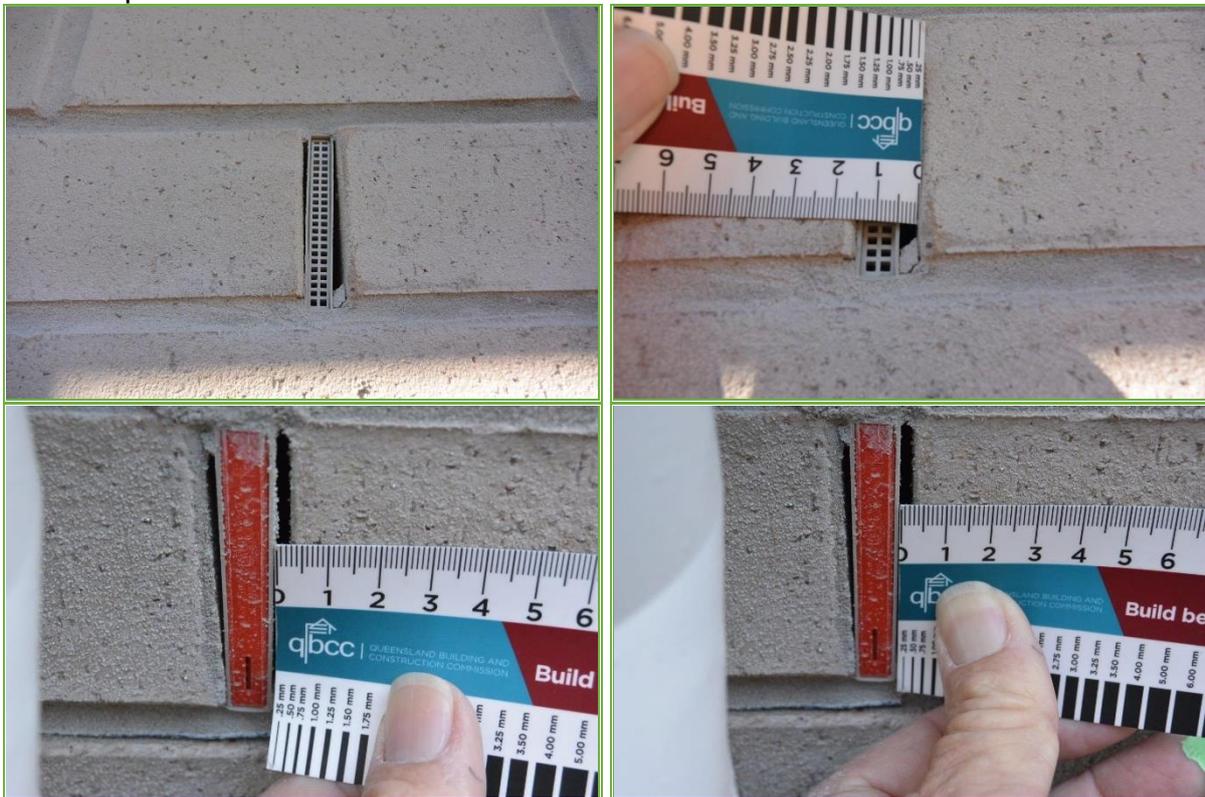
Where it is: External

What it is: The dwelling has a Fire Attack Rating of 12.5. Must comply with AS3959

Results: At the time of inspection there was number of defects that do not comply with the rating of 12.5 Fire attack. The BAL was introduced to stop ember attack to dwellings rated at 12.5 needs to be rectified before handover. As per AS3959

1. Weep holes not to BAL 12.5

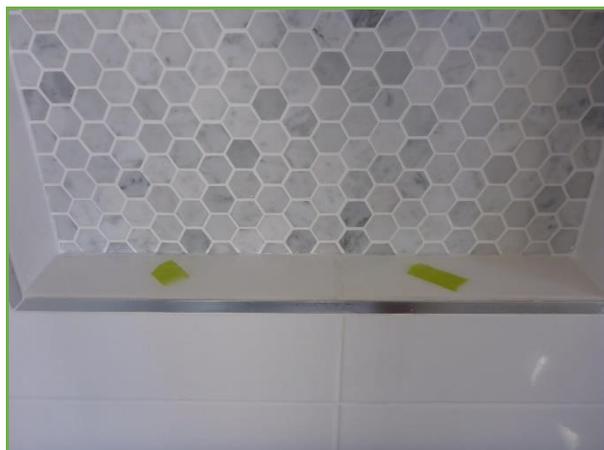
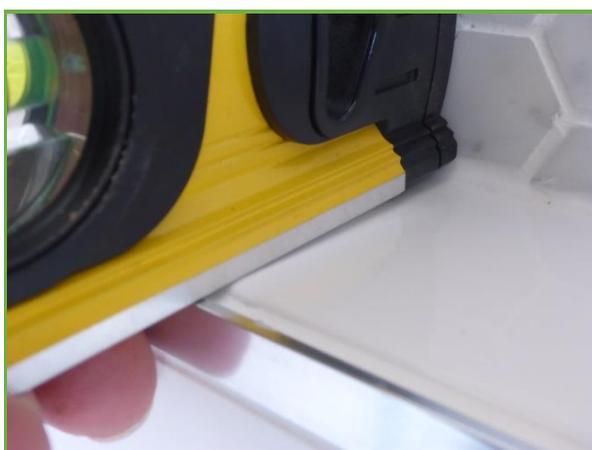
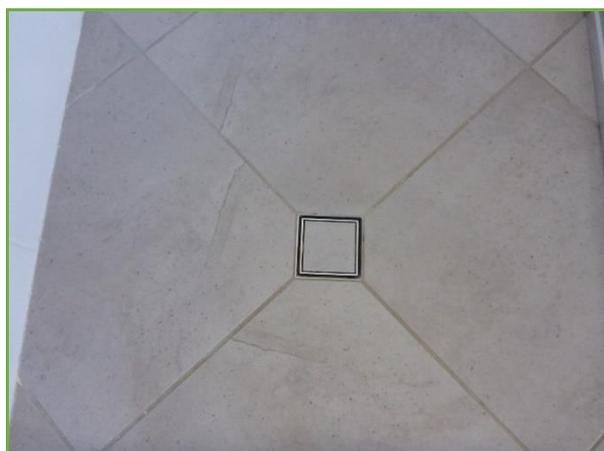
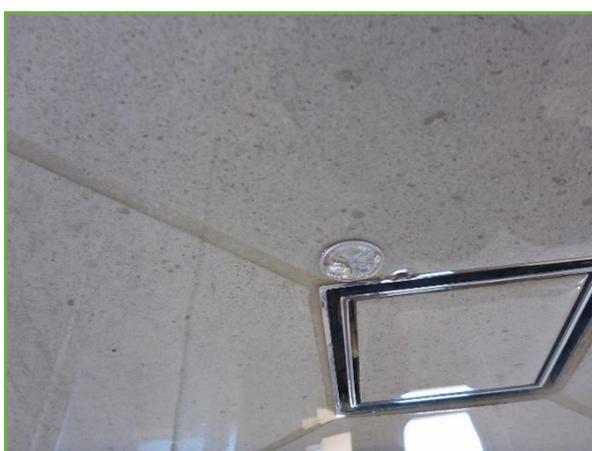
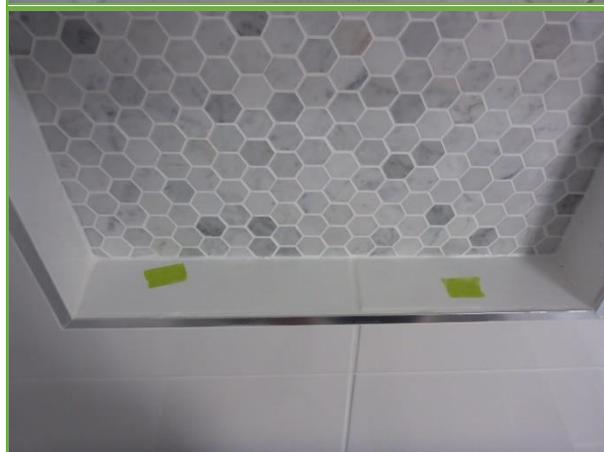
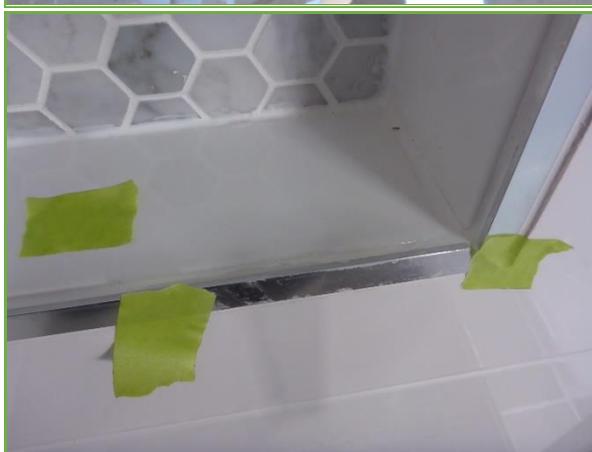
Results: It was noted at the time of inspection after testing the shower, the nook and base appears to be holding water and there are tiles that are level and have some back fall to the wall and waste is too high, this is preventing the water from draining to the floor waste, this will need to be reworked to the minimum standard set out as per, I refer the Builder to, 103 AS 3958.1-2007 Appendix D FALLS IN FLOOR FINISHES D1 General.

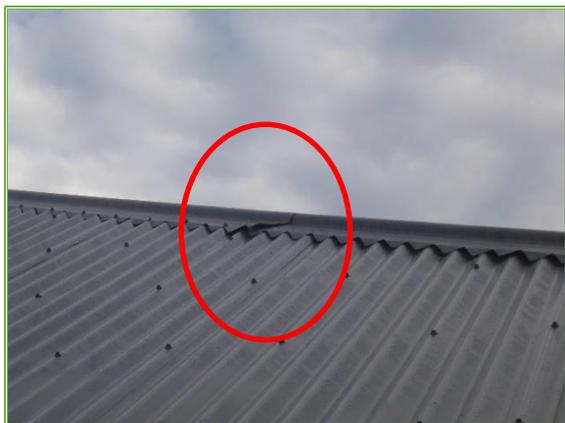
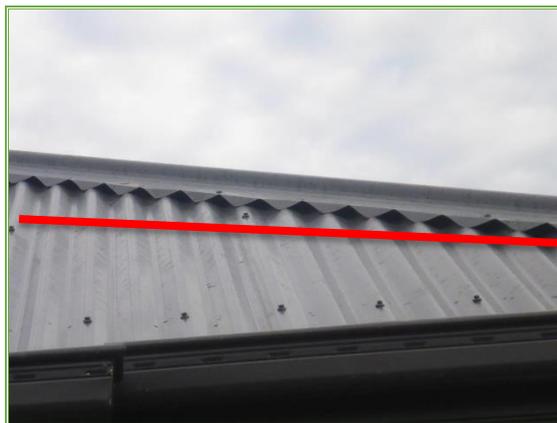
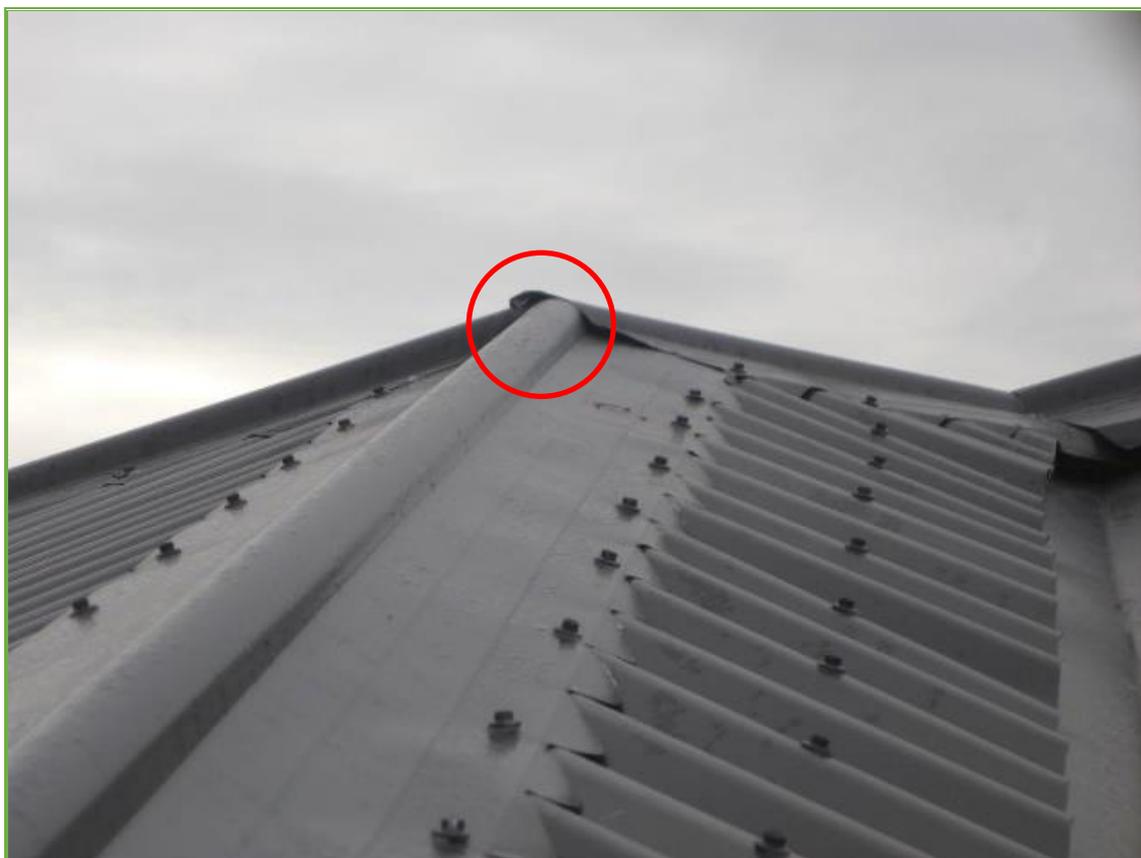
Where it is: External Roof

What it is: Ridge Capping

Results: It was noted that the ridge capping has been poorly installed and is defective. All needs to comply with BCA and HB39 Roofing Standards Australia and in the Domestic Building Contract Act 2000 part 4 warranties section 44, the contractor will carry out the work in an appropriate and skillful way with reasonable care and skill. All needs to be rectified before Handover.

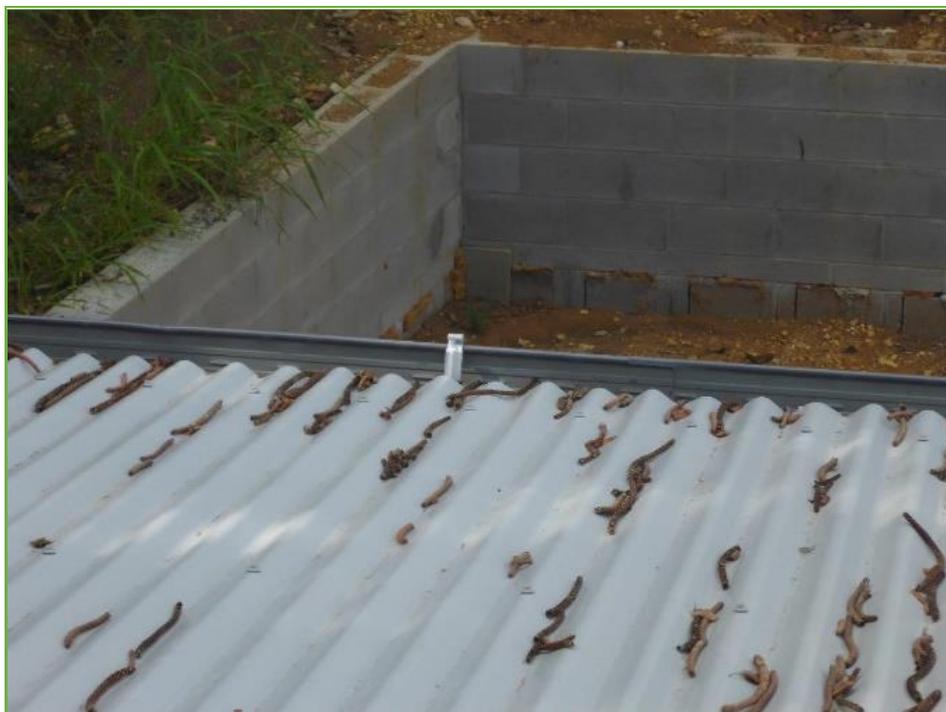
Where it is: External Front and side

What it is: Guttering holding water and bent/bowed and not fitted to the brackets.

Results: The Colourbond gutter to the dwelling is defective and is holding water which needs to be reworked. The gutter is bowed to the side of the dwelling; this will need to be replaced as the manufacture did not make the guttering bow out of shape.

All must be made as new prior to handover and fit for purpose.

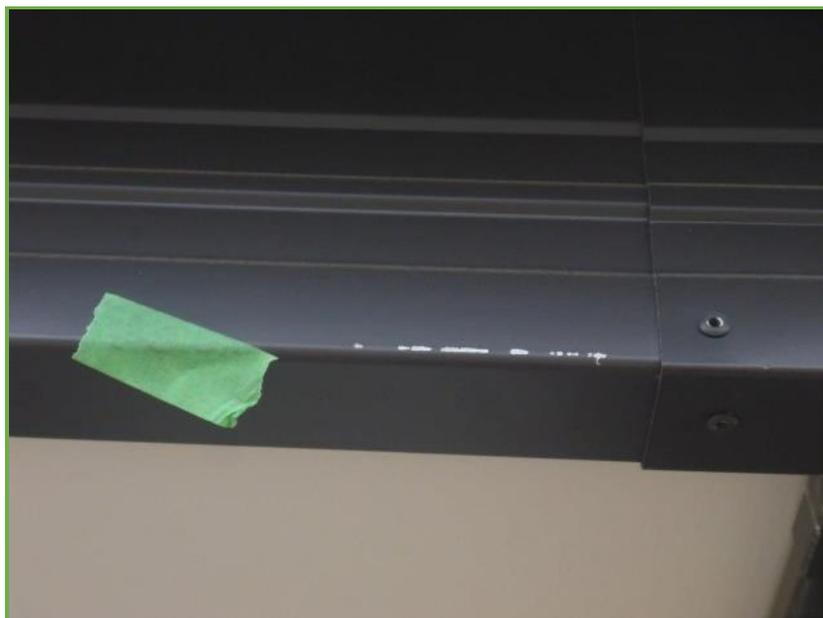
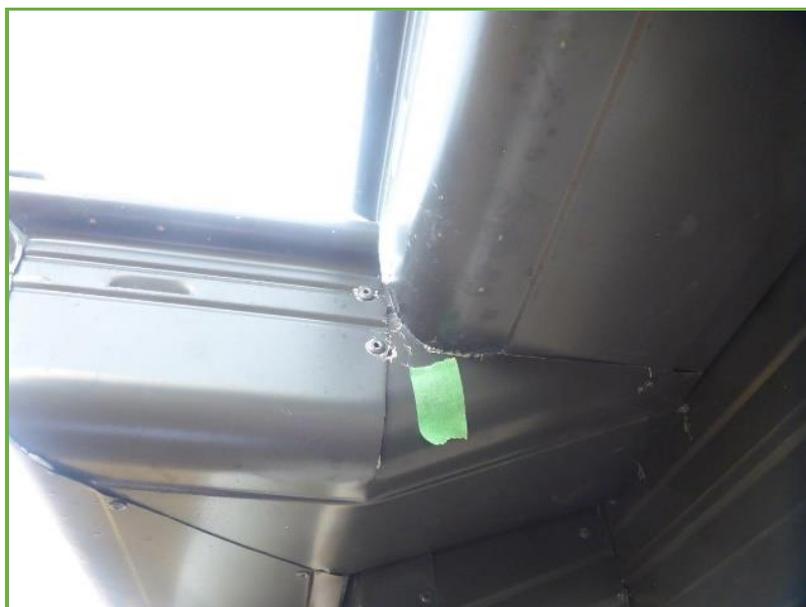
Where it is: External

What it is: Fascia and Gutter

Results: The colourbond fascia and gutter to the dwelling has been damaged during construction. There are areas that have been scratched; All must be made as new prior to handover. Please note that the supplier web site on the care and maintenance of gutters clearly states that touch up paint is not to be used when rectifying these types of defects. BlueScope Steel does not recommend the use of touch up paints on COLORBOND® steel. The manufacturing process that gives COLORBOND® steel its colour and gloss retention properties means that the surface weathers differently to air drying paint. After weathering, the areas which have been touched up will look different and can leave a blotchy look. Damaged areas will need to be replaced.

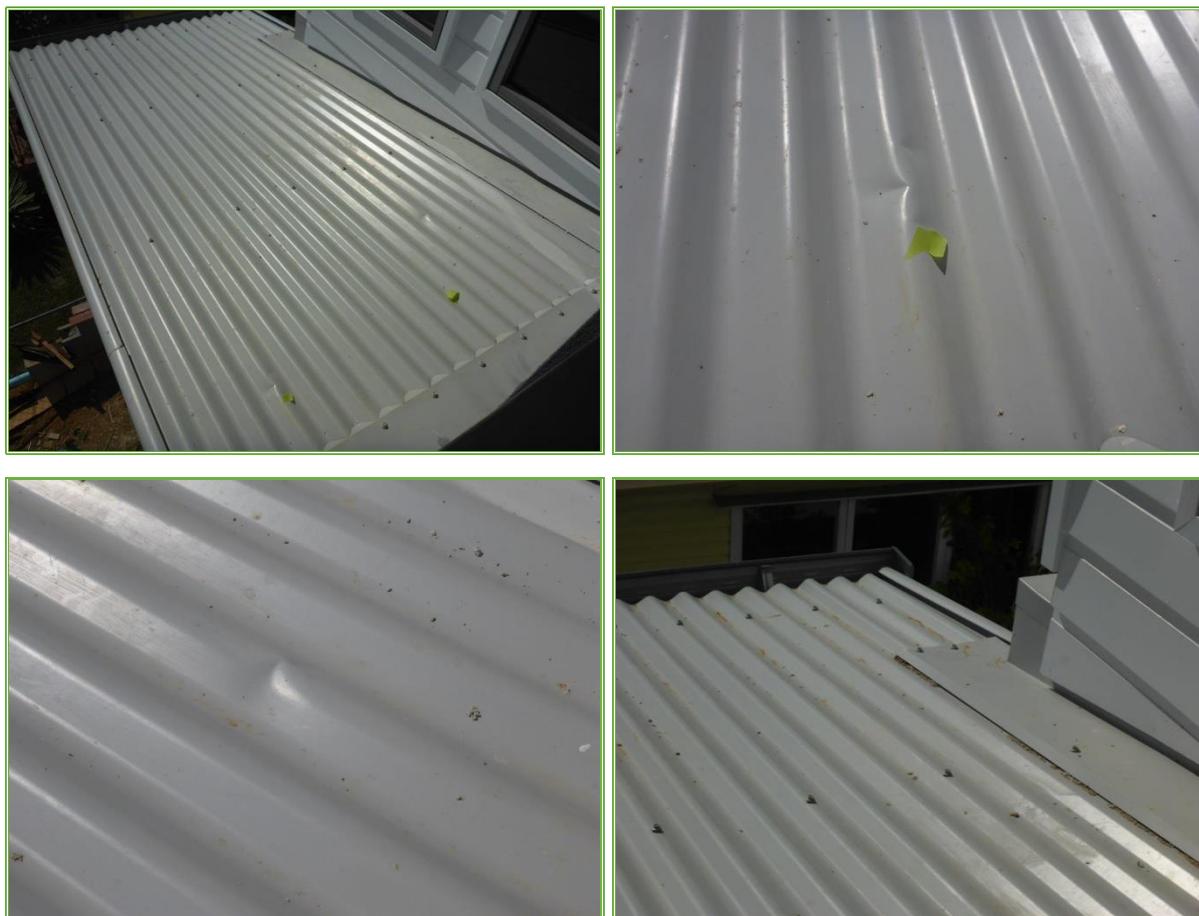
Where it is: Roof and Guttering

What it is: Dents and marks

Results: Roofs are defective if they are dented or mark in the first 12 months of completion, this will need to be replaced under the Builders Warranty. I refer the Builder to Below to QBCC Standards and Tolerances.

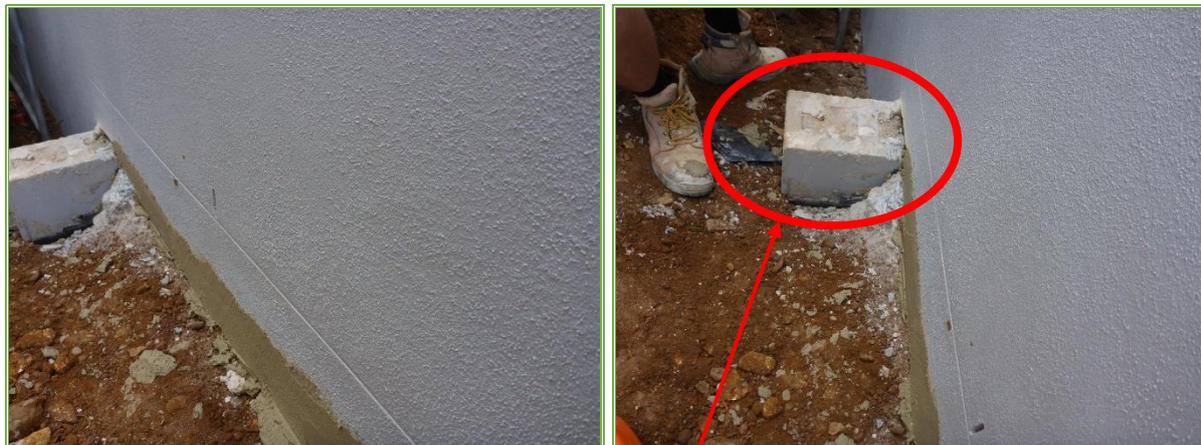
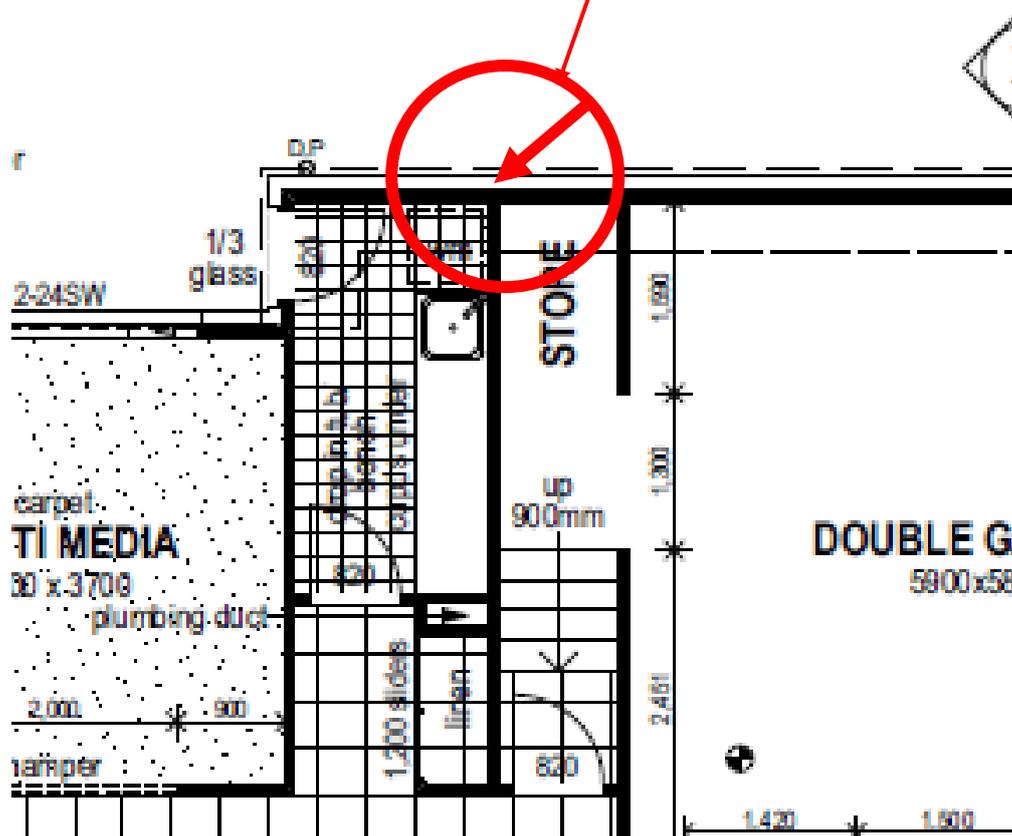
Where it is: Back Garage Block Wall

What it is: Blockwork not as per plan

Results: It was noted at the time of inspection that garage wall block work is too long not as per plan and elevation (2) almost a full block sticking out passed the finish external wall and encroaching on the boundary and becoming an obstacle. This will need to be rework to comply with the plans.

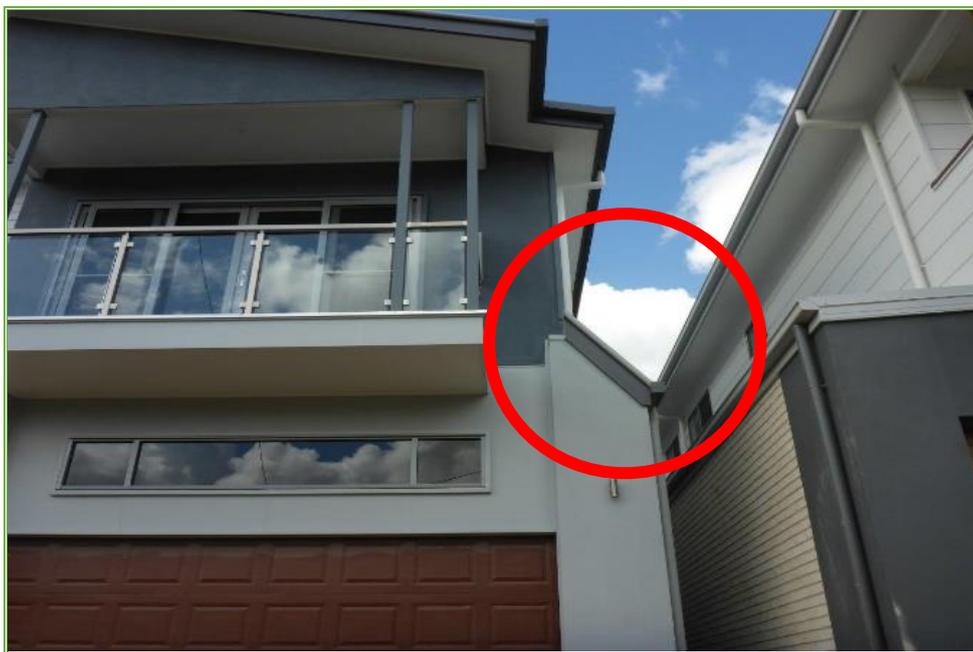
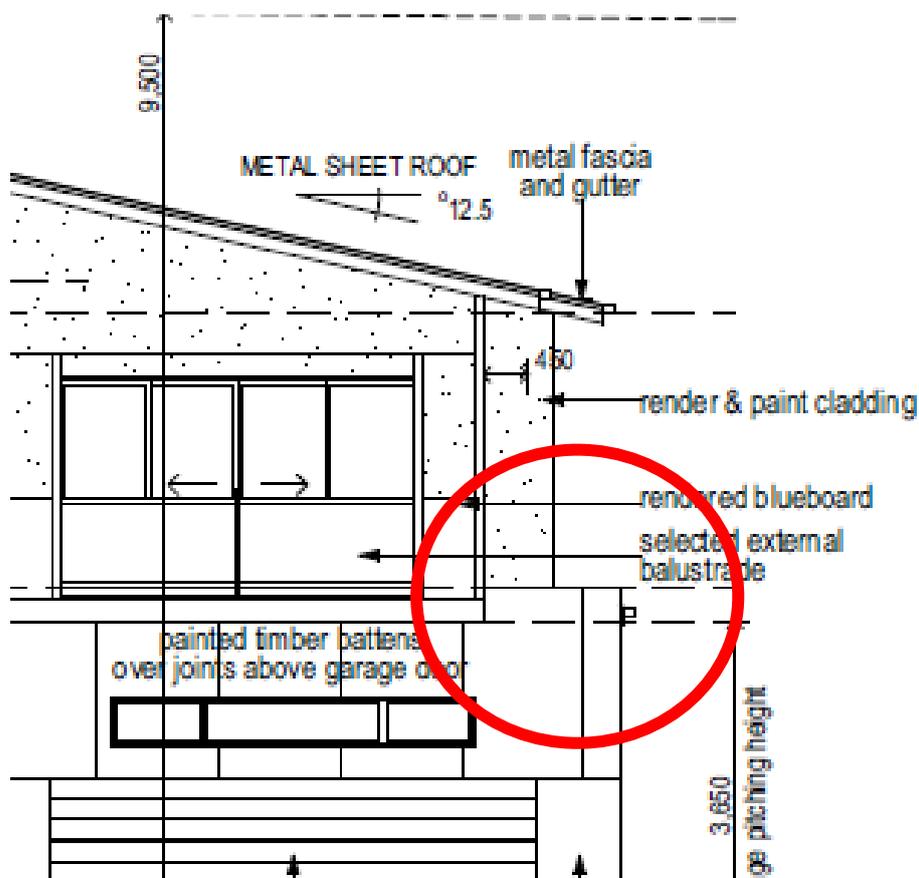
Where it is: Front Elevation

What it is: Building not as per plan

Results: It was noted at the time of inspection that front elevation (1) the roof fascia is incorrect, there is no parapet, not as per plans. This will need to be rework to comply with the plans.

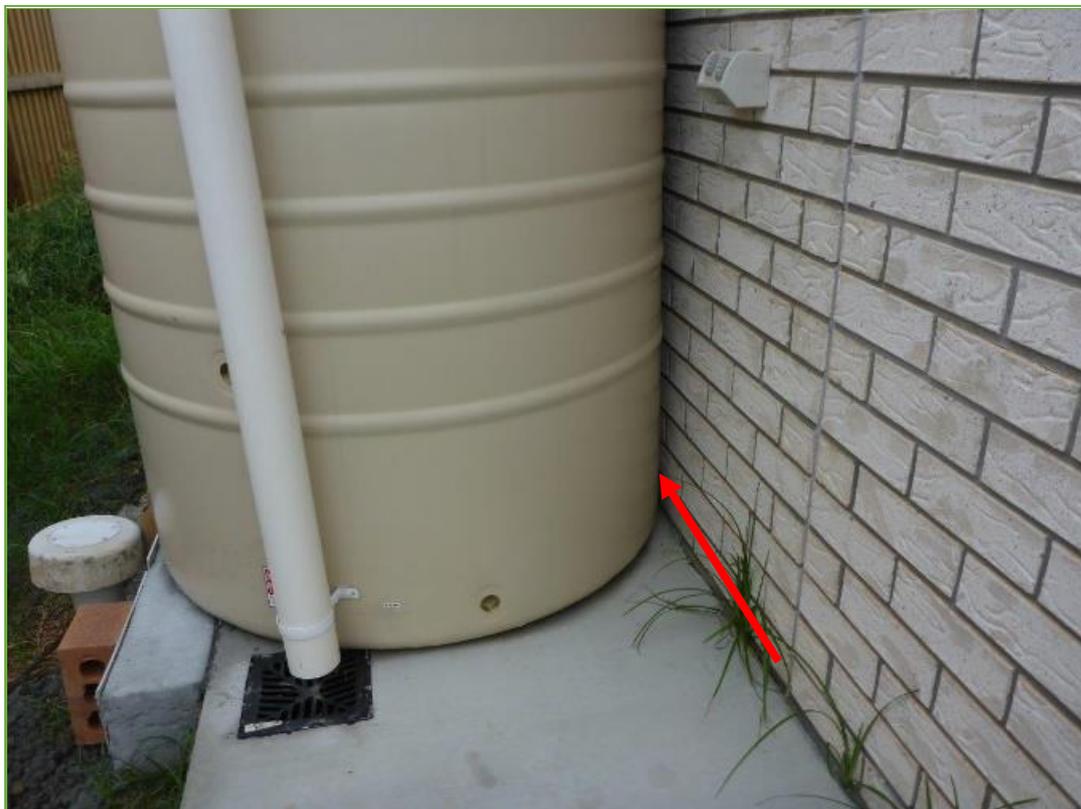
Results: It was noted that the rain water tank is hard against the brickwork and has created Bridging and Breaching of termite management, this will need to be rework to comply with insert below
DEEMED TO SATISFY REQUIREMENTS AS 3660.1:2014

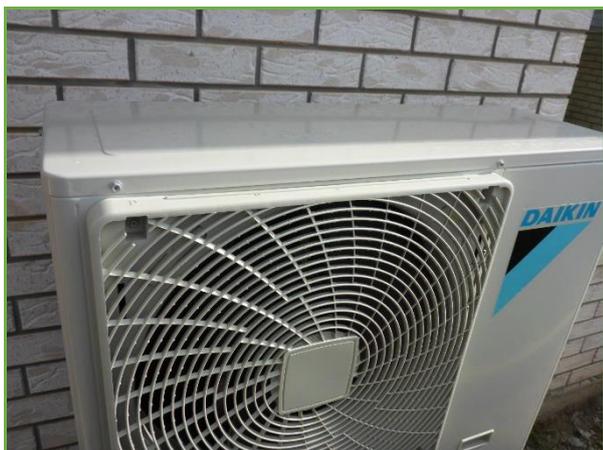
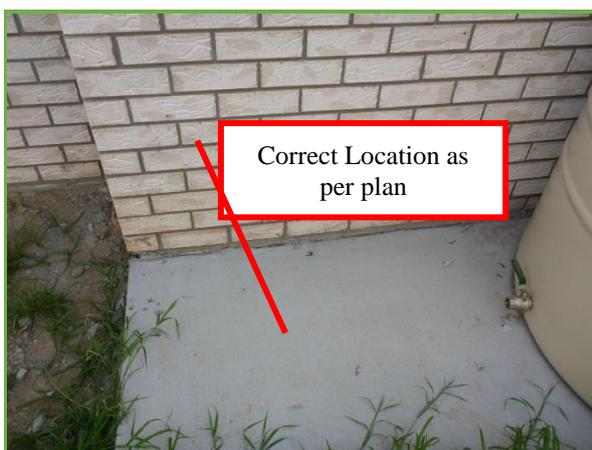
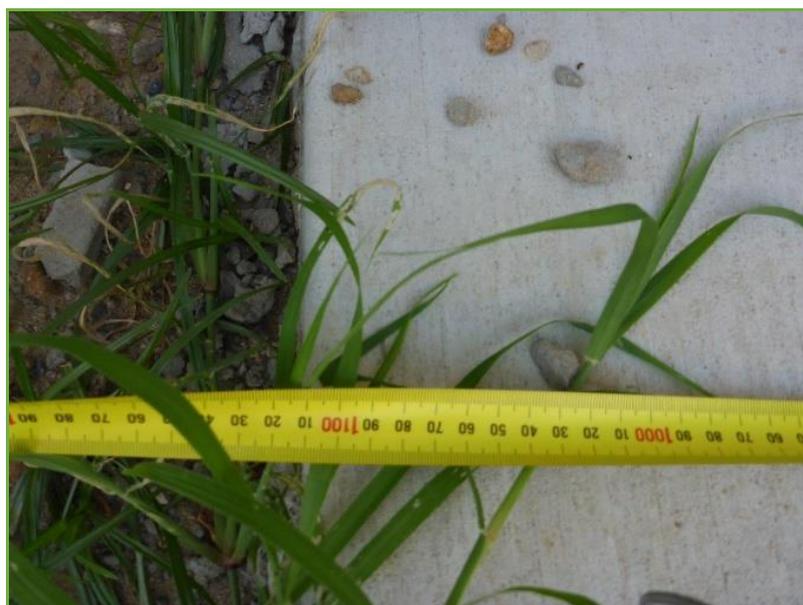
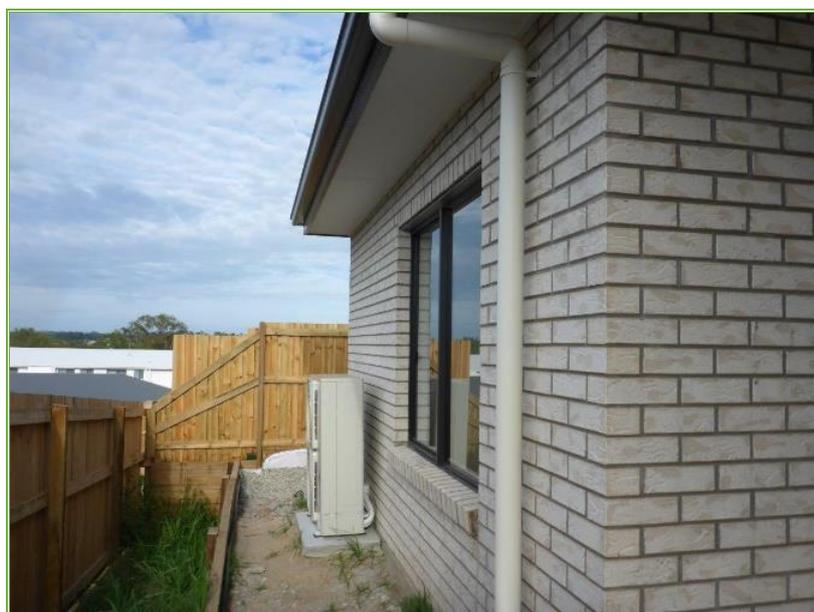
Where it is: External

What it is: Air-conditioning not in the correct area as per plan.

Results: It appears that the system has been installed incorrect location and hinders access and is a potentially safety hazard. It should be installed so it does not interfere with the normal operation of any access with any other aspects of the normal operation of a building: Where it does not cause a nuisance or injury to person. This is clearly a nuisance and is potentially a safety hazard and it clearly interferes with the normal access pathway.

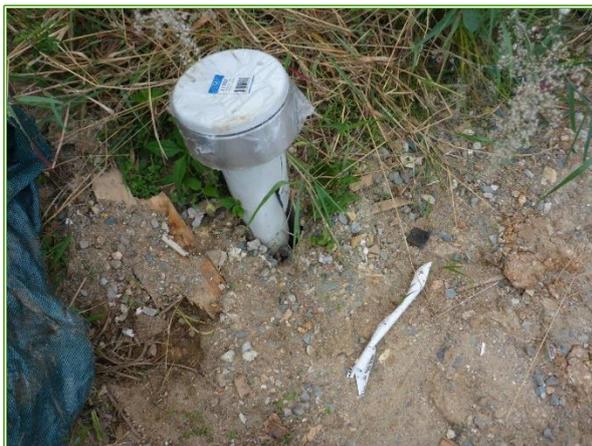
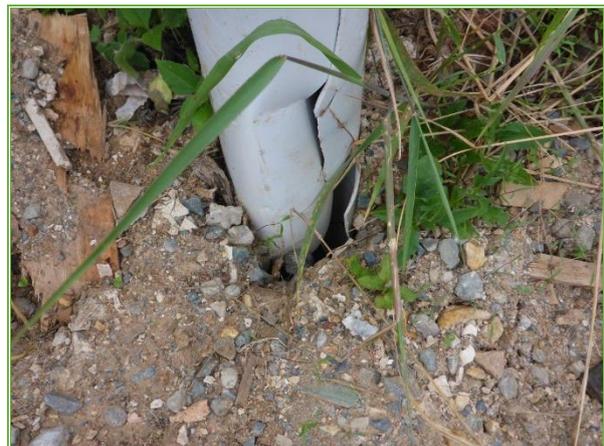
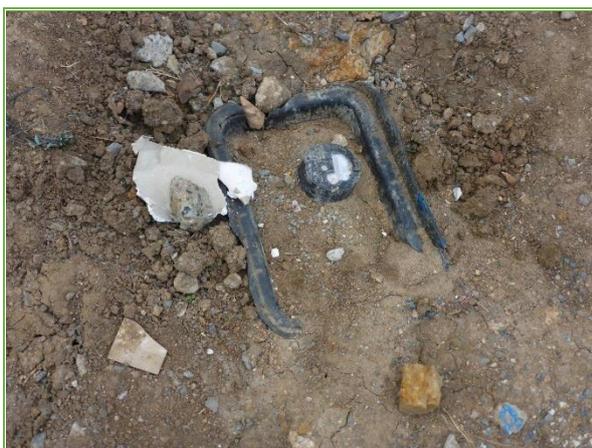
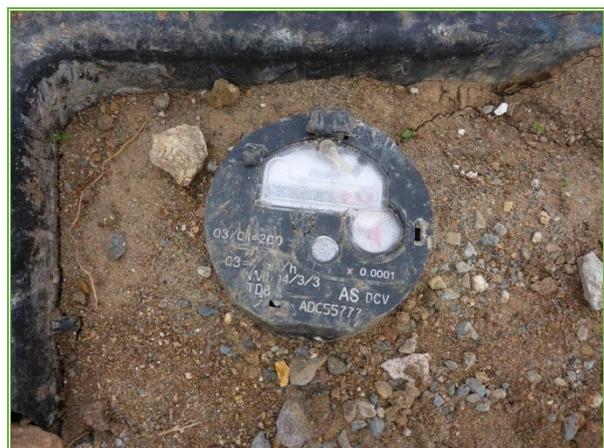
Where it is: External Plumbing to

What it is: Damage IO pipe and Water Meter Box.

Results: At the time of the inspection the pipe and the water meter box was damaged, this will need to be re-place before handover. I refer the builder to Standards & Tolerances 2016

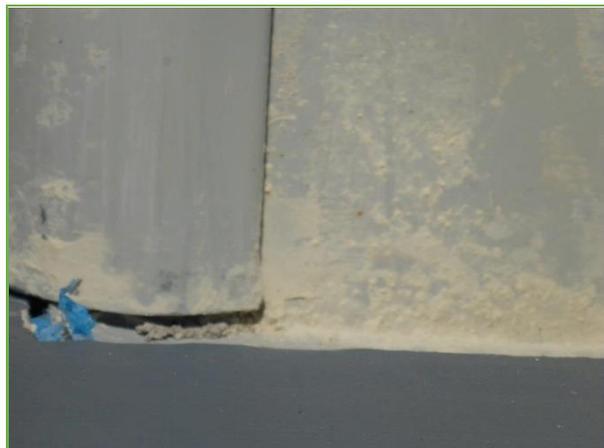
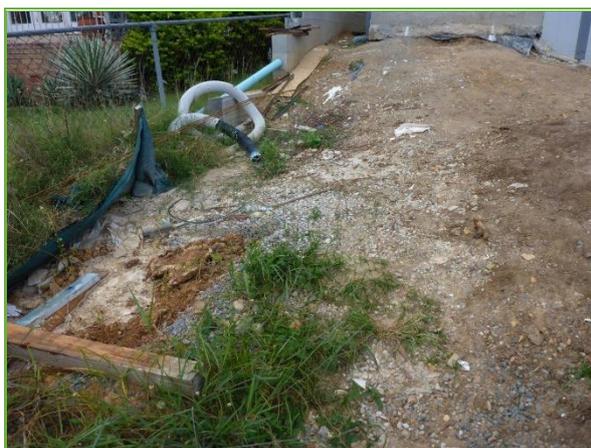
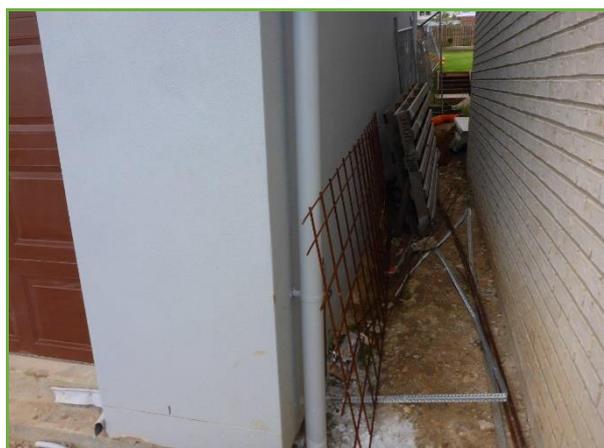
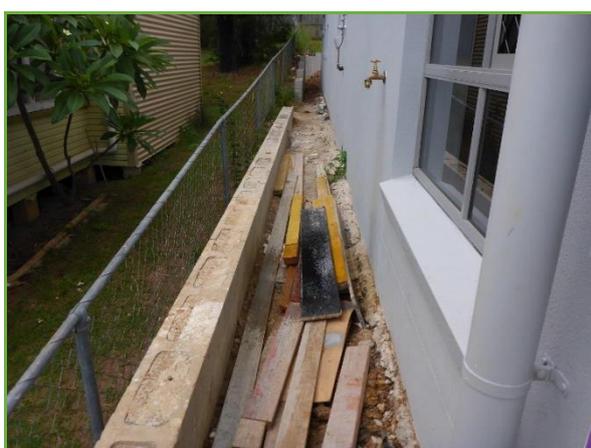
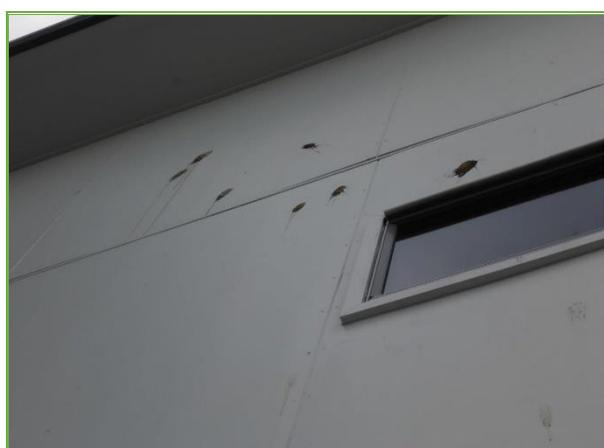
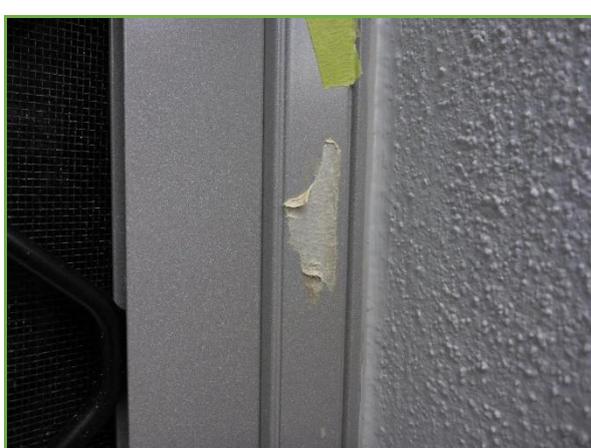
Where it is: External

What it is: Cleaning Defect

Results: General cleaning site and building needs to be cleaned to be brought up to the minimum Standard. It was noted that there is still an amount of builder's waste on the site. All builders waste must be removed. A good test of what makes up builder's waste is if the builder brought it to site and it has been discarded, and then the builder needs to remove it from site. Owners are entitled to expect that the building site and works are clean and tidy on completion. Where handover is delayed for any reason the owner must expect that dust may have settled on interior exposed surfaces. Building sites are defective if, upon handover, they are not clear of building debris. Building works are defective where windows are not clean, marks on bricks, walls and roofs are not clean off.

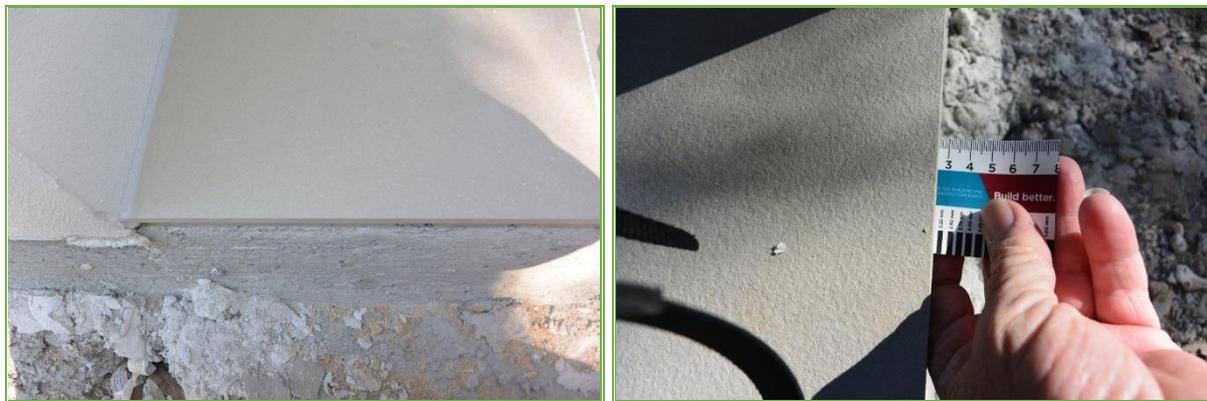
Where it is: External Back Patio Area

What it is: Tiles are not supported in a proper workmanlike manner

Results: As per AS 3958.1, all tiling installed must be supported. I noted that porch tiling has an over lipping of about 25mm. That is 25mm of unsupported tile hanging over the edge. This will need to be re-worked under the Builders Warranty.

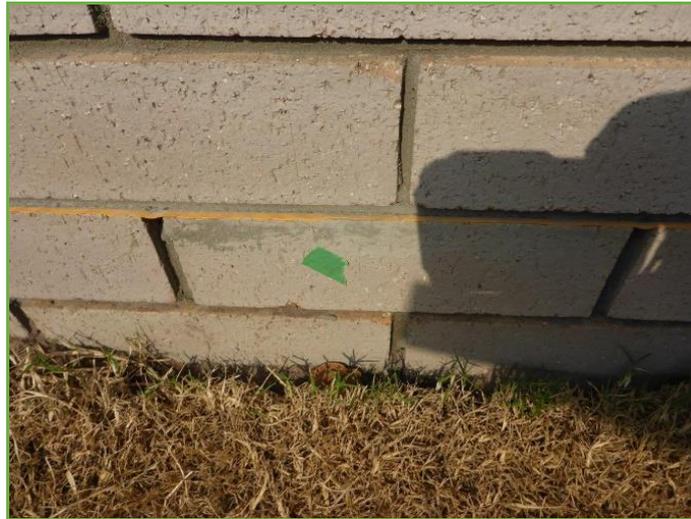
Where it is: External Back

What it is: Mortar splashes and marks on brickwork.

Results: It was noted at the time of inspection that there were mortar splashes to the external wall, all need to be fully cleaned to a level that removes all mortar waste and other waste, that can be seen from a normal viewing position.

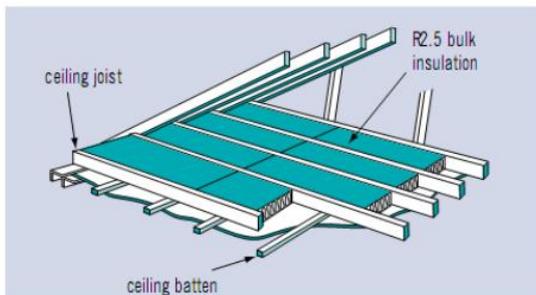
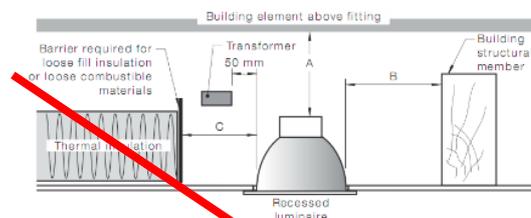
Where it is: Roof Void

What it is: Insulation is defective.

Results: Other trades appear to have removed batts from their work areas with little regard for the information inserted below. Note that batts must be installed up to the 50 mm area around protected down lights. The insulation needs to be reworked so as to be installed in a manner that complies with AS 3999 with all areas covered and the batts flush to the top of the plaster. The inserted diagrams demonstrate the minimums that must be achieved. These diagrams are basic and easily to adhered too. Installing insulation Installation guidelines. It is vital that insolation is installed with careful attention to detail, as incorrect or inappropriate installation will significantly decrease performance. For instance, failure to but all ends and edges of batts to give a snug fit could result in 5% of the ceiling area not been covered, losing up to 50% of the potential insulation benefits.

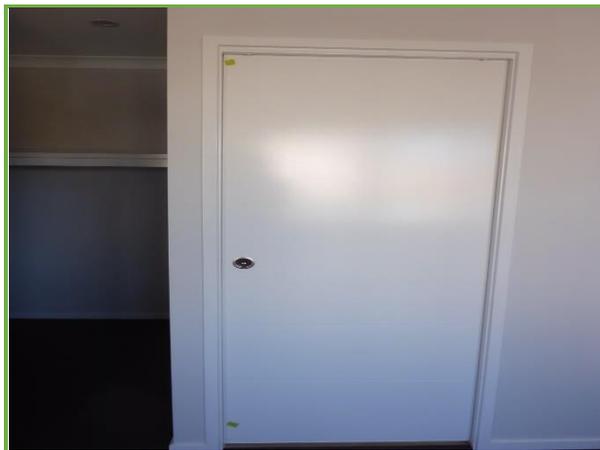
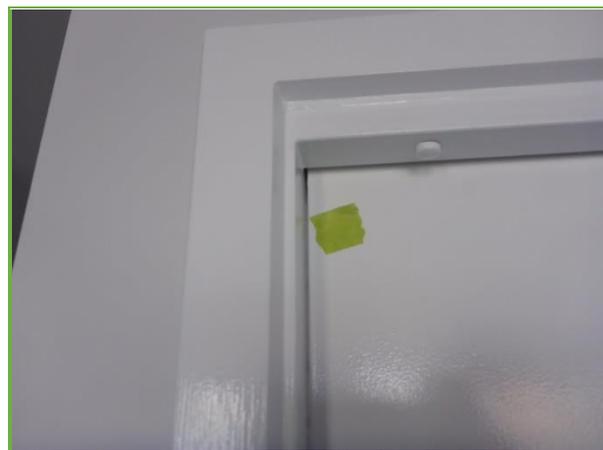
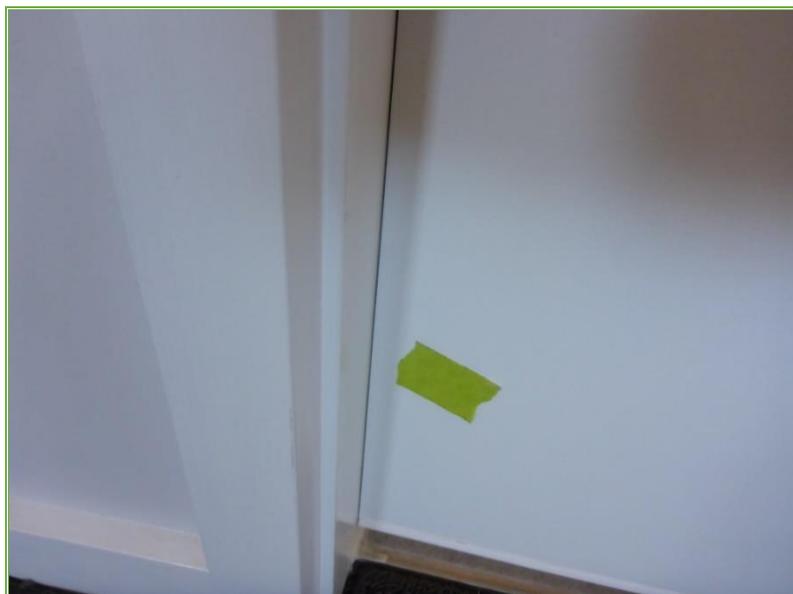
Results: It was noted at the time of inspection that the door margins are uneven. This will need to be reworked before handover, I refer the builder to the insert below,
