This is a visual only Building Inspection & Report carried out in accordance with AS4349.0

Handover REPORT (hereinafter called the "Report")

Inspection Date: 10/11/2015

Property Address: 41 sample Circuit Sample QLD 4164

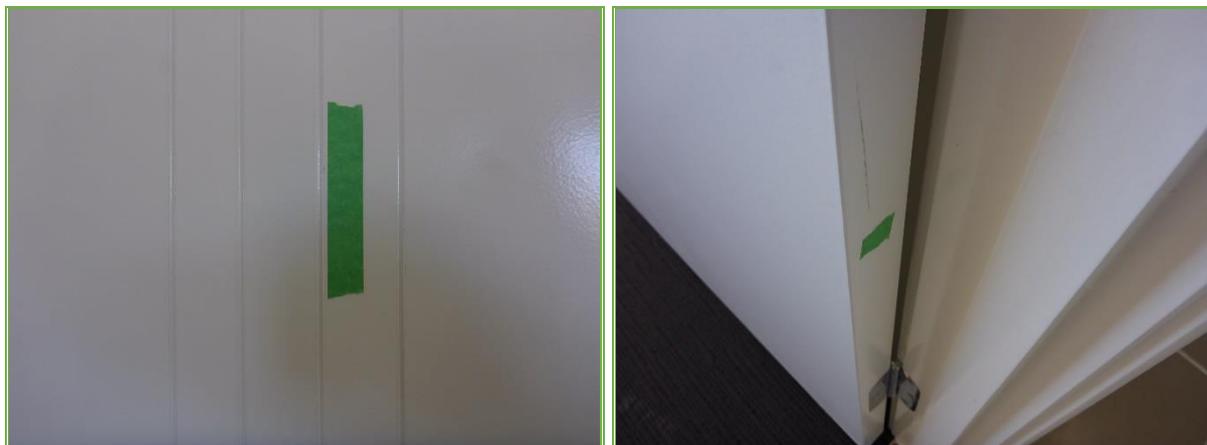
Where it is: Internal Doors

What it is: Door Staved Painting

Results: It was noted at the time of inspection the most of the internal doors appeared to be staved of paint coverage, all will need to be reworked before Hanover.

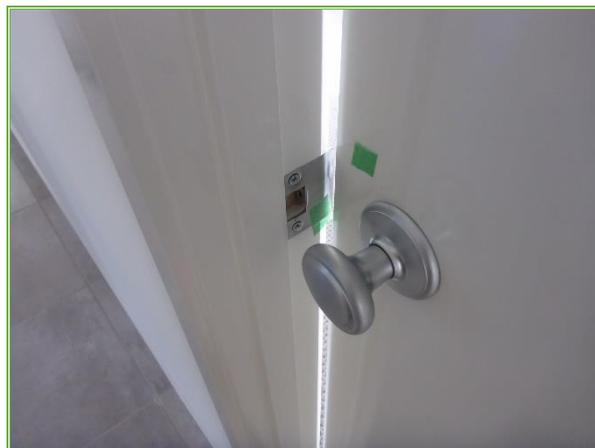
1 Bedroom 2 door not locking

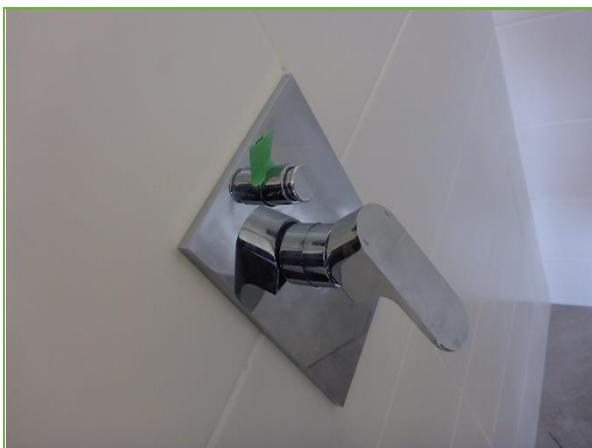
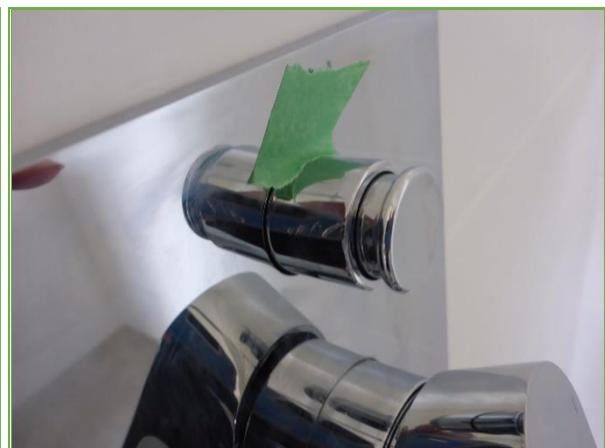
2 Ensuite shower flick-mixer damaged

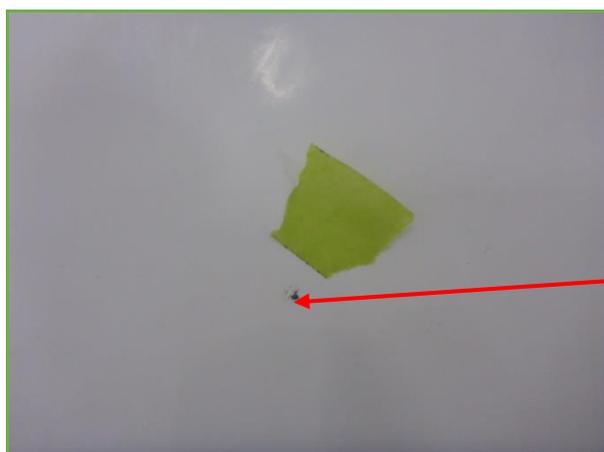
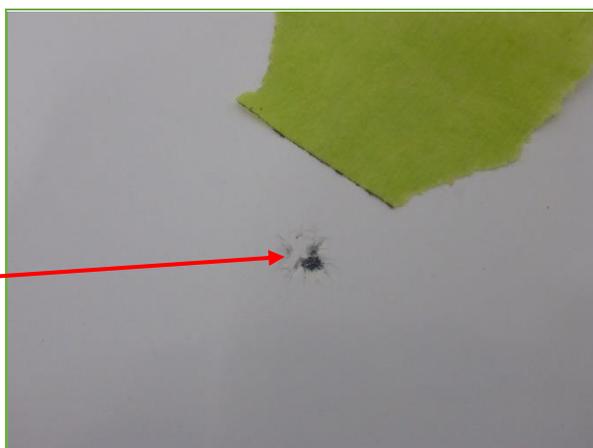
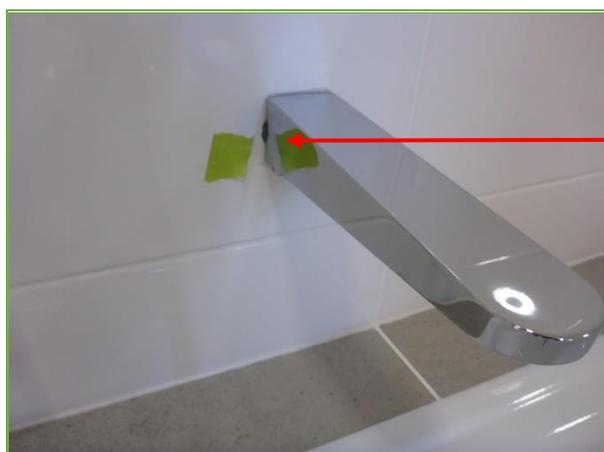
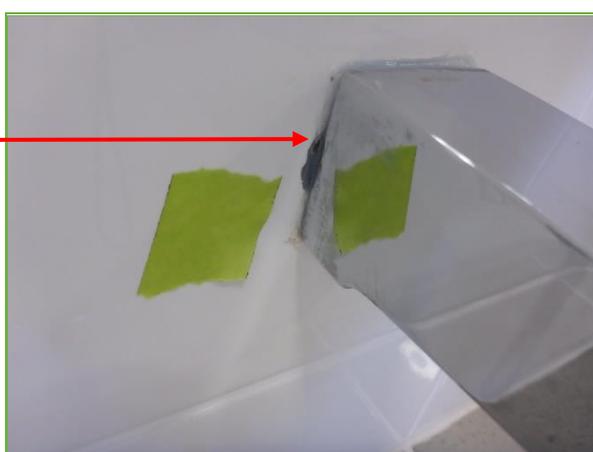
4. Bathroom Chipped Bath and overcut tile around the spout.

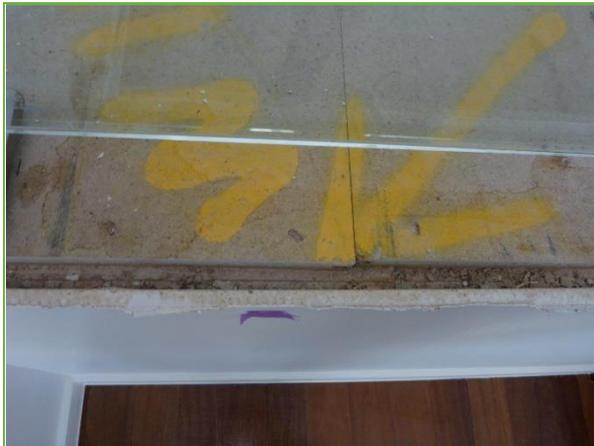
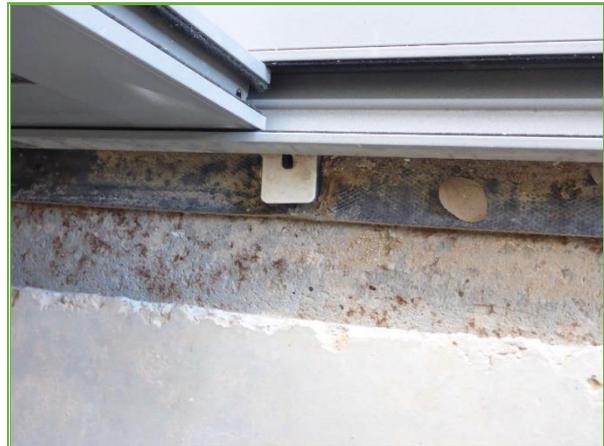
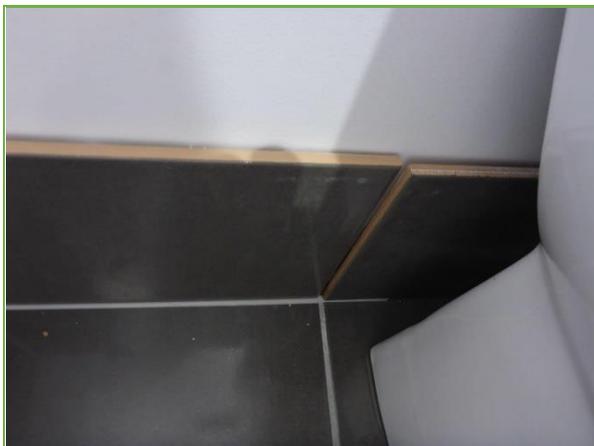
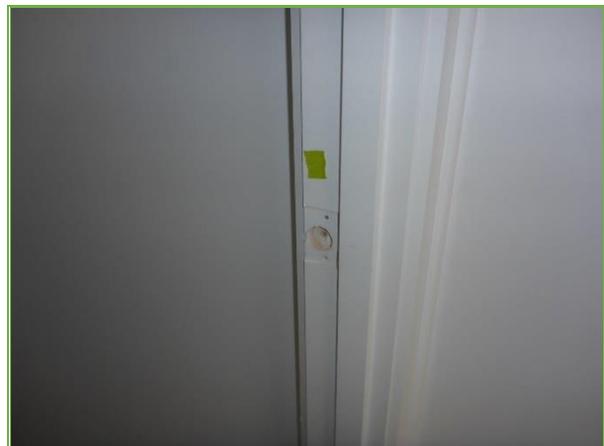
Results: At the time of inspection it was noted that the building is not ready for practical completion or handover as there is numerous incompletd works. These incomplete works will need to be finished before this is deemed ready for pracitical completiion or handover as per contract. The Domestic Building Contracts Act May 2015. It is clearly not suitable for habitation.

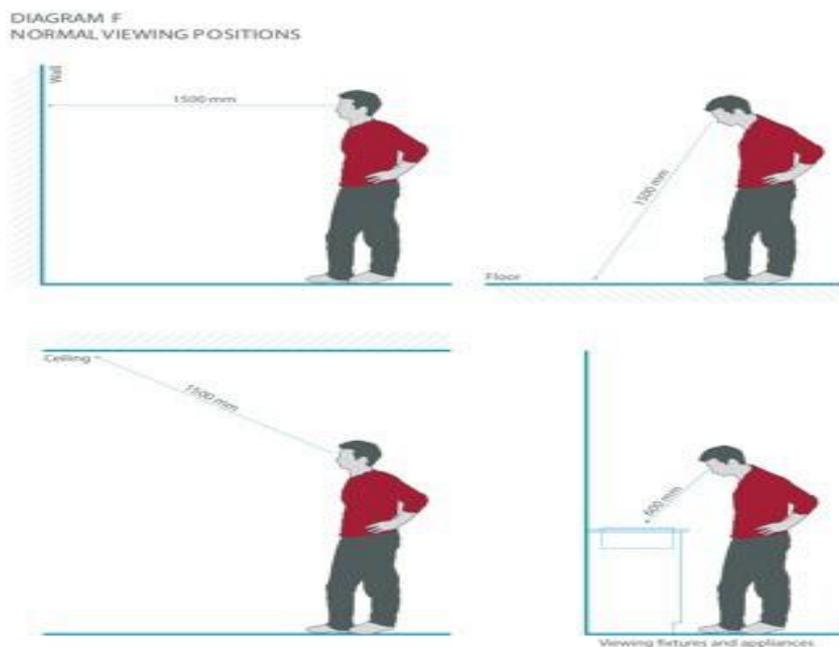
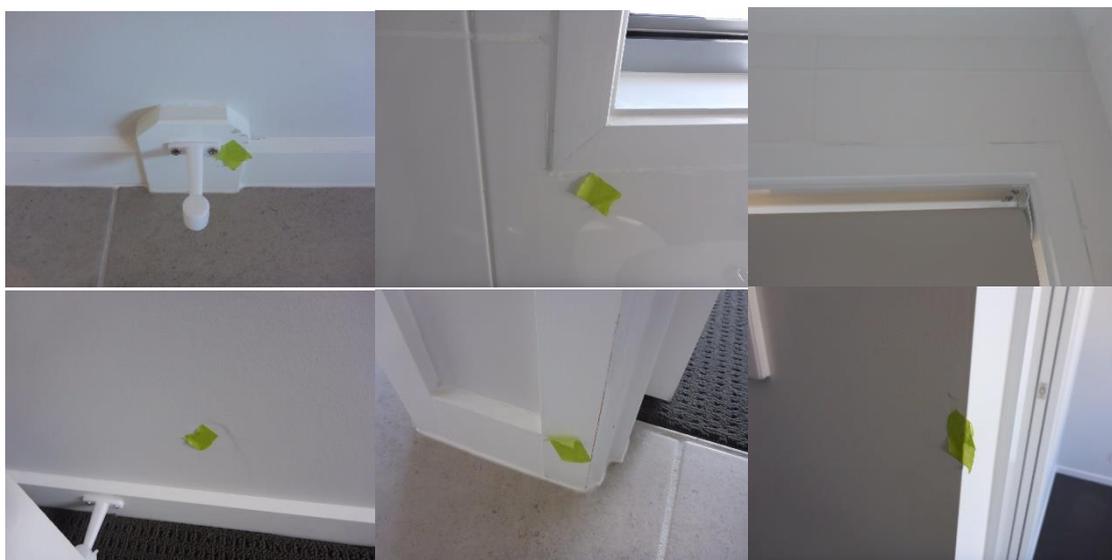
Where it is: All Areas

What it is: Touch-ups required

Results: Touch-ups required, general paint defects as marked, but not all. The surfaces are to be inspected in "Non-Critical" light. In other words, in light that is defused. One of those reference notes is AS 2589-2007. Clause 3.1.5 inserted below indicates that critical lighting can be used on Gloss or Semi-Gloss. All surfaces are to be inspected under non-critical light only is incorrect. Gloss may be inspected in critical light, however the intent is to only defect items that are clearly discernible.

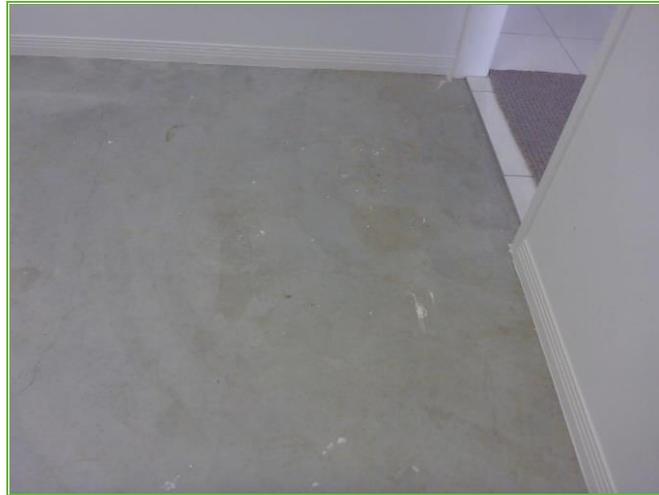
Where it is: Garage

What it is: Cleaning defect.

Results: It was noted that there are marks on the garage floors. Owners are entitled to expect that the works are clean and tidy on completion. It was new when it was poured, so has to new at handover. Building works are defective where floors are not swept, mopped or vacuumed and are not cleaned ready for use.

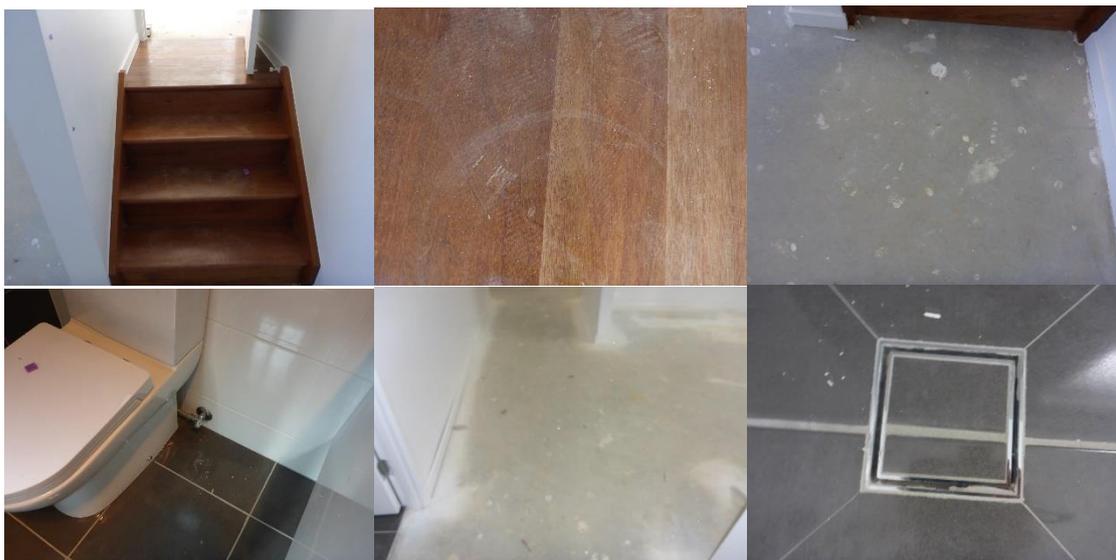
Where it is: Internal

What it is: Cleaning Defect

Results: Owners are entitled to expect that the building site and works are clean and tidy on completion. Where handover is delayed for any reason the owner must expect that dust may have settled on interior exposed surfaces. Building sites are defective if, upon handover, they are not clear of building debris. Building works are defective where windows are not clean, floors are not swept, mopped or vacuumed as appropriate, tiles, sinks, basins, troughs, baths, etc. are not cleaned and shelving, drawers and cupboards ready for use.
