This is a visual only Building Inspection & Report **Defect REPORT** (hereinafter called the "Report")

Report Number 12663B

Inspection Date: 24/09/2018

Property Address: Sample street

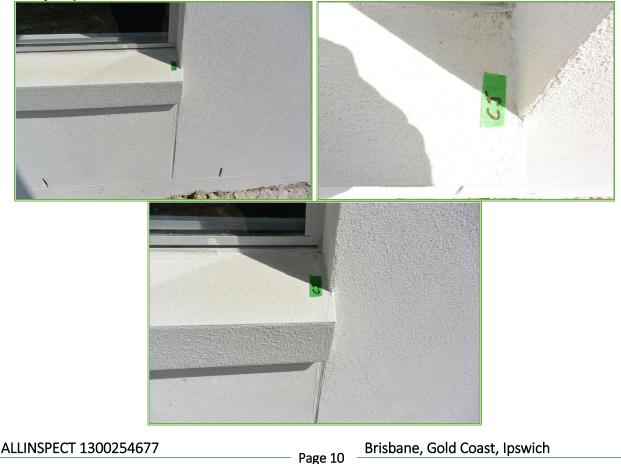
What it is: It was noted that the Articulation or Control Joints in the dwelling have noncompressive material (mortar) still in the joints and have been cover over. The AJ's must be stripped, cleaned of all non-compressive material and then sealed, they must go all the way through the window. We refer the builder to AS 4773.2, page 32, section 7.1, and the BCA. Failure to remove the hardened mortar will result in brick and mortar cracking if the dwelling needs to expand by its full measure. If the AJ's (CJ's) are blocked, the movement must dissipate elsewhere. Hence cracking occurs.

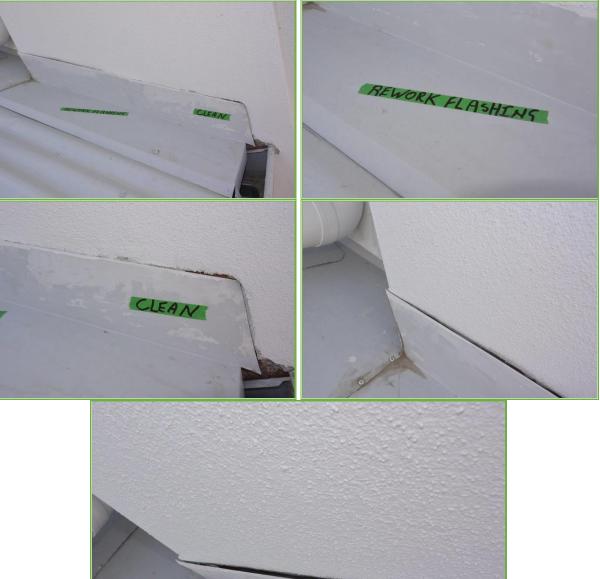
Where it is: External Roof

What it is: Substandard installation of the flashing with gaps which will allow water ingress, mortar smears. This will need to be rectified. This is conditions conducive to structural damage. **QBCC Standards & Tolerances 6.1 Flashings and accessories**

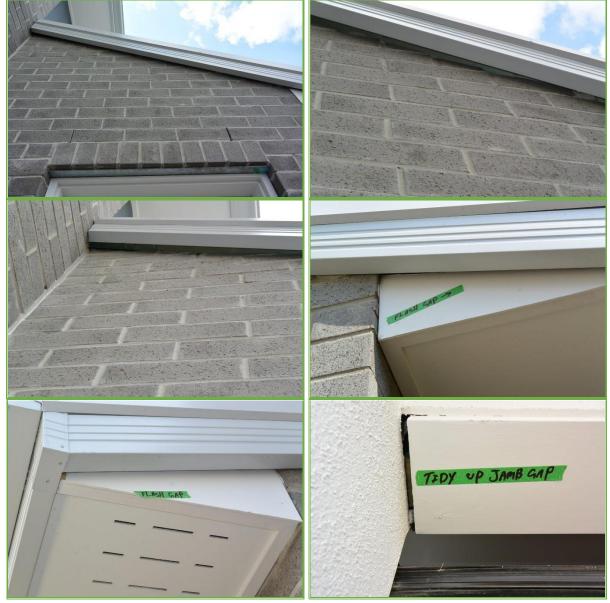
What it is: Some areas have huge gaps that require flashing/ sealing as the timber is exposed. This will need to be rectified, not at all in an appropriate, skilful way or with reasonable care and skill. This is conditions conducive to structural damage.

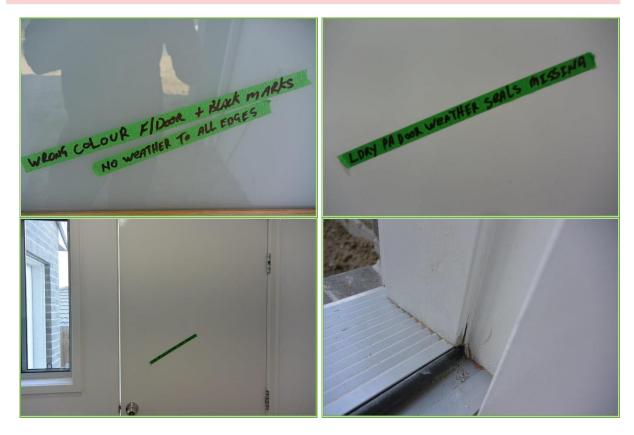
Where it is: Front Door, Laundry PA Door, Garage Door

What it is: The doors have not been weather proofed and the weather seal have been pulled off and the seal groove has been gaped in some places. now allowed water to ingress into the building. This is very substandard workmanship all will need to be reworked to comply with below.

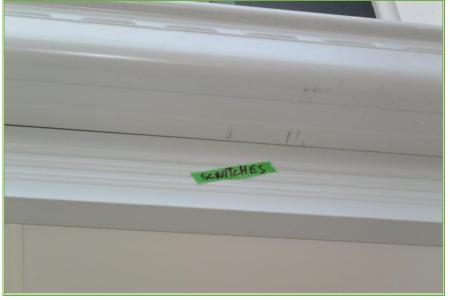
1. At the time of inspection, the roof sheets and guttering has dents and marks. Roofs and Guttering are defective if they are dented or mark in the first 12 months of completion, this will need to be rectified. We refer the Builder to Below

• Gutter is scratched during the carrying out of building works this will need to be rectified to present as new.

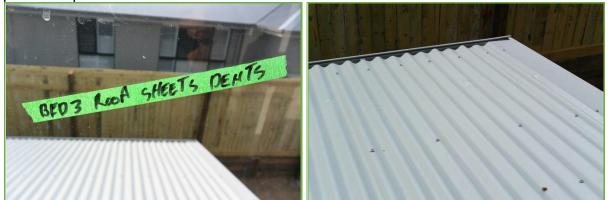
• Bedroom 3 roof sheets dents during the carrying out of building works this will need to be replaced to present as new.

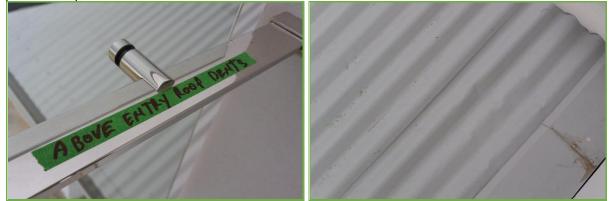
• Above entry roof sheets dents during the carrying out of building works this will need to be replaced to present as new.

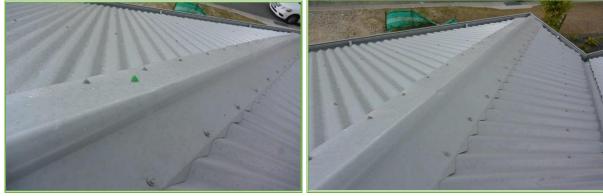
• Ridge capping has been damaged during the carrying out of building works this will need to be replaced to present as new.

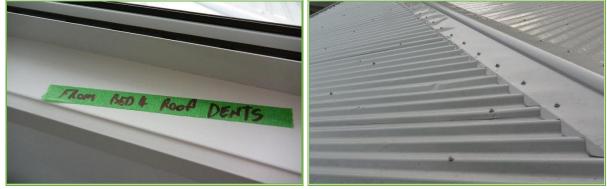
Bedroom 4 roof sheets dents during the carrying out of building works this will need to be replaced to present as new.

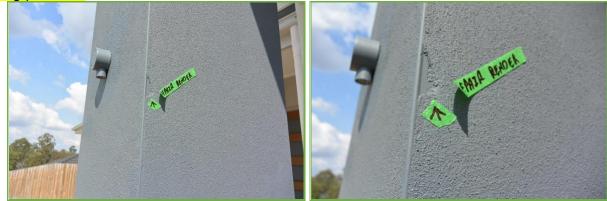
2. Damage to the render on the front column, this will need rework as per **QBCC Tolerance & Standards 9.00 PLASTERING, RENDERING AND PLASTERBOARD** Within the first 12 months after completion of the work, obvious spot rust marks, due to the composition of the material and other blemishes, are defects if they are visible from a normal viewing position.

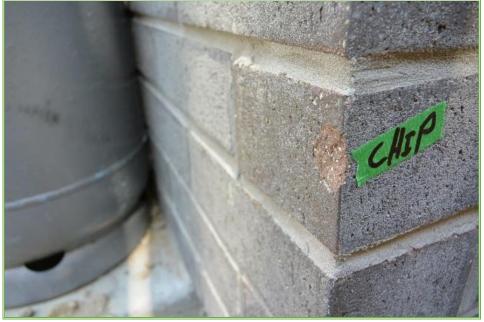
3. Chip bricks as marked caused during the carrying out of building works they were new when laid must be new at handover no chips or damage.

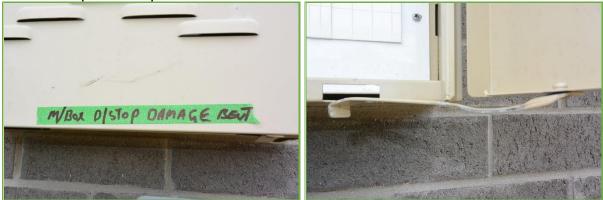
4. Meter box door stop is damaged caused during the carrying out of building works this will need to be replaced to present as new.

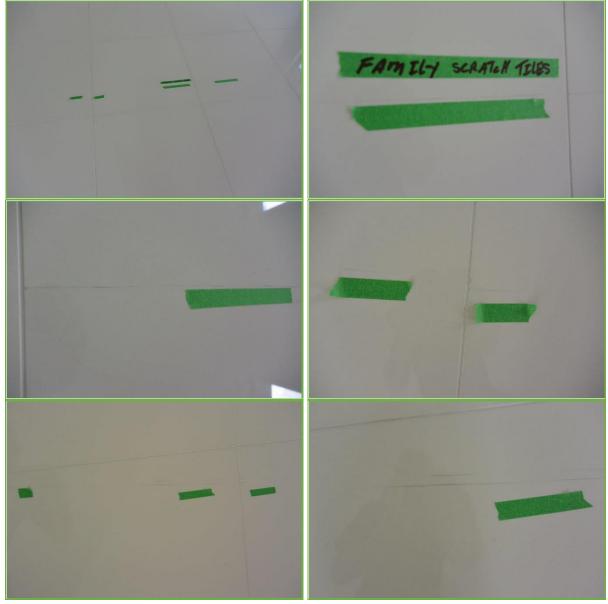
5. The family room has scratched tiles caused during the carrying out of building work. They were new when laid must present as new (No scratches, marks, chips)

QBCC Standards & Tolerances 2016 11.4 Cracked, pitted, chipped, scratched, loose tiles Within 12 months of completion of the work tiles are defective if they are cracked, pitted, chipped, scratched, or loose unless such cracking, pitting, chipping or scratching has been caused by actions or inactions of the owner or others outside of the contractor's control. Within 6 years and 3 months from the completion of the work, cracked, pitted, chipped, scratched or loose tiles are defective if they allow water penetration into the building, or comprises the health and safety of those who use the building.

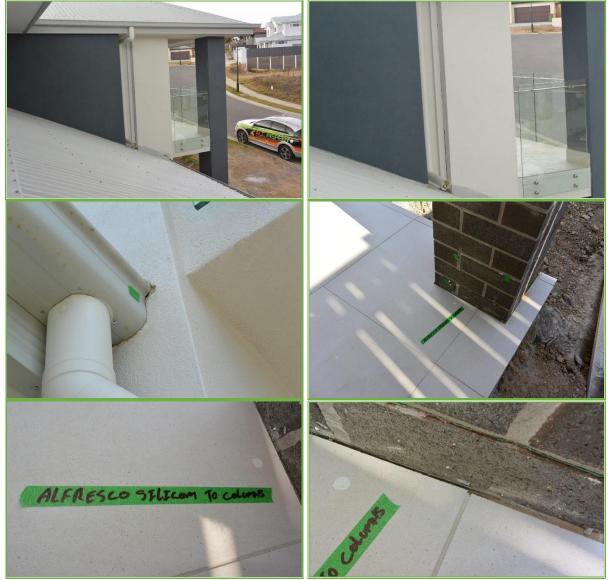
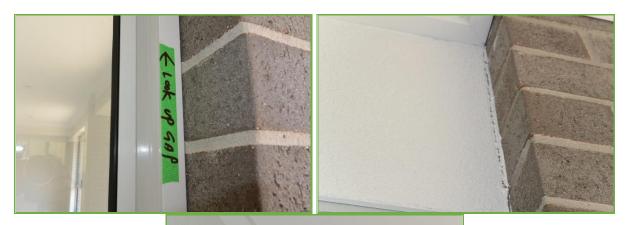
- (a) in an appropriate and skilful way; and
- (b) with reasonable care and skill.
 - 1. There are many external areas with excessive gaps that will need to be sealed/silicone as this can cause water and pest ingress as marked all will need to be sealed and completed to reach practical completion.

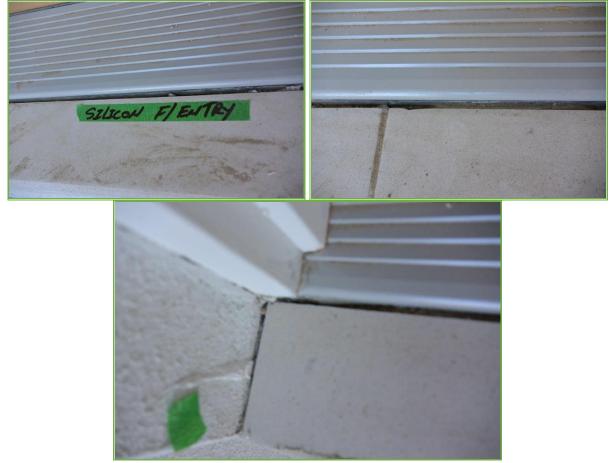
• External front entry large gaps need to be sealed, substandard finish, this will need to be rectified not in an appropriate, skilful way or with reasonable care and skill,

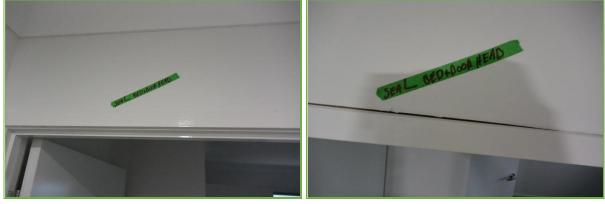
Bedroom head gaps need to be sealed, substandard finish, this will need to be rectified not in an appropriate, skilful way or with reasonable care and skill,

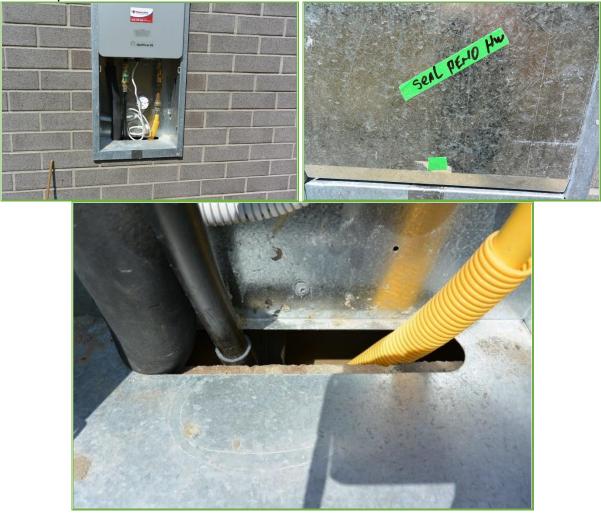
2. It was noted at the time of inspection, that there are gaps around Gas HWS pipe fittings, these will need to be filled and sealed.

Within the first 12 months after completion of the work, plumbing holes are defective if they are not properly grouted as appropriate, or in the case of cabinet work, fitted through neat minimum size penetrations, or fitted with tight fitting cover plates or collars with penetrations kept to the smallest size practicable.

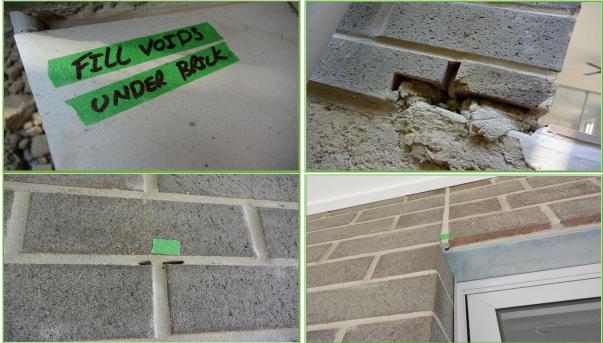
4. External wall mortar blow outs and voids many areas this will need to be rectified not in an appropriate, skilful way or with reasonable care and skill,

Within 12 months from date of completion of the work, voids and holes in mortar in masonry walls, excepting weepholes and vents, are defects if they are visible from a normal viewing position.

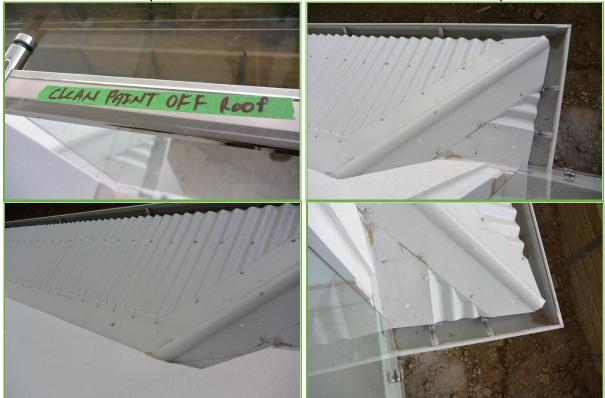
• Clean excessive paint off roof sheets, all needs to be cleaned and present as new.

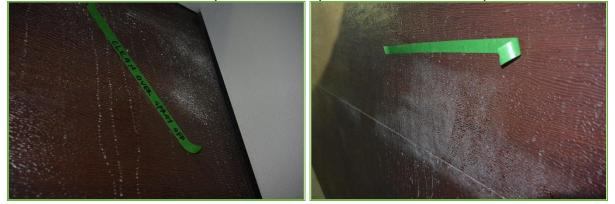
• Garage panel lift door excessive paint all needs to be cleaned off if paint cannot be removed it needs to be replaced come up with a resolution and present as new.

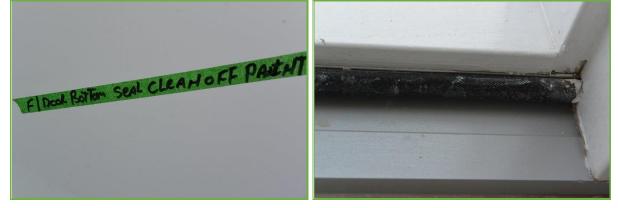
• Front door bottom seal excessive paint all needs to be cleaned off if paint cannot be removed it needs to be replaced and present as new.

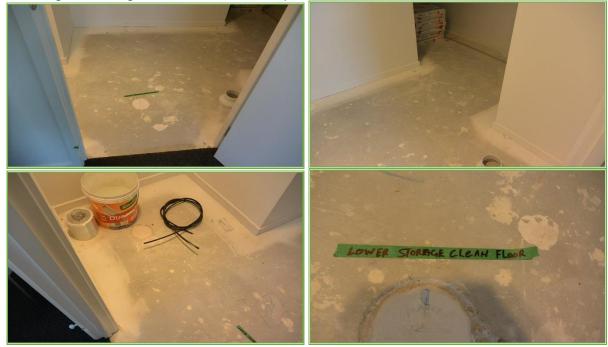
Downstairs storage room excessive paint on slab floor this will have to cleaned so it can be suitable for applied finishes, not in an appropriate, skilful way or with reasonable care and skill. If it cannot be clean the builder will have to come up with a resolution to fix it.

Within the first 12 months after completion of the work, the finish to a concrete slab is defective if it is not suitable for the documented applied finishes such as tiles, polished concrete, carpet or sheet flooring, including set downs where required.

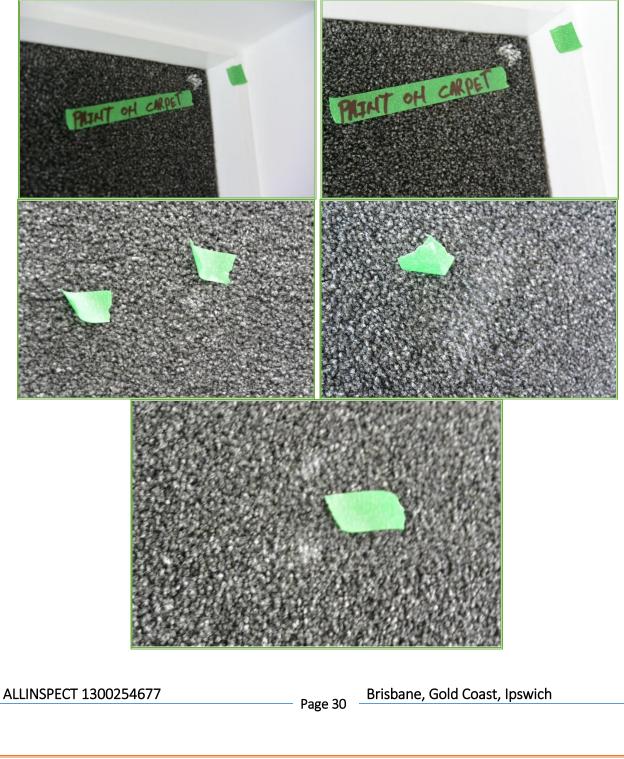
Carpet in many areas as marked has excessive paint all needs to be cleaned off if paint cannot be removed it needs to be replaced and present as new.

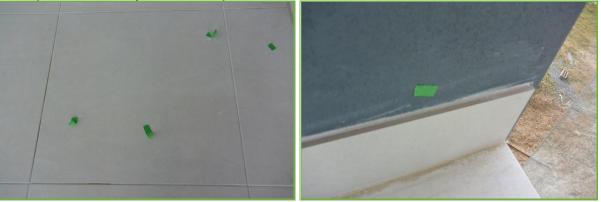
Upstairs balcony excessive paint smears

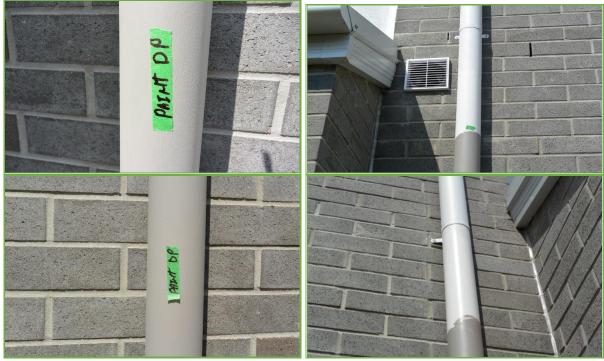
6. The stormwater pipes have not been fully painted, this needs to be rectified and completed before practical completion.

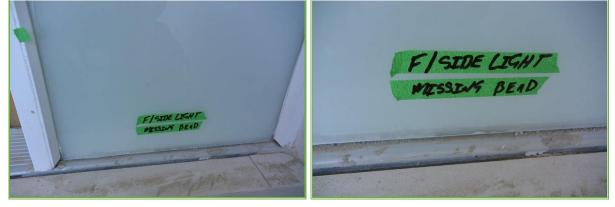
7. External front glass panel missing beading, substandard finish this will need to be rectified not in an appropriate, skilful way or with reasonable care and skill,

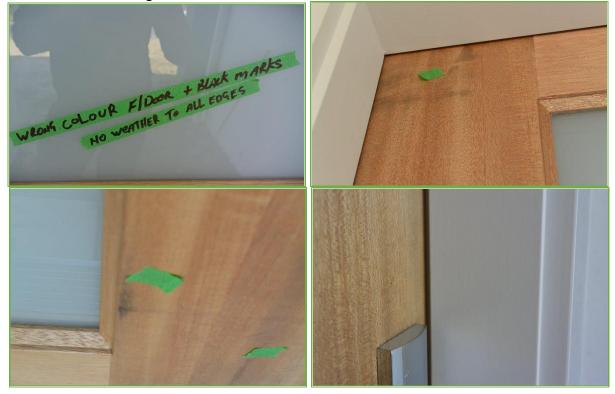
- 8. Many doors have been substandard installation with not aligned, marks, missing screws, mechanical damage, splitting timber, damaged caused during the carrying out of building works. They will all need to be rectified and present as new.
- Front door wrong colour and has black marks this will need to be rectified

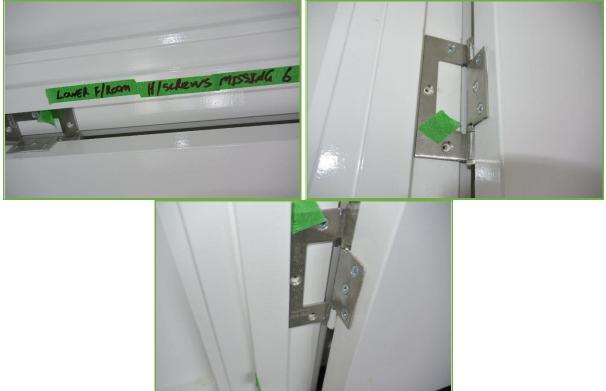
• Front room door downstairs 6 screws missing very substandard installation, not in an appropriate, skilful way or with reasonable care and skill.

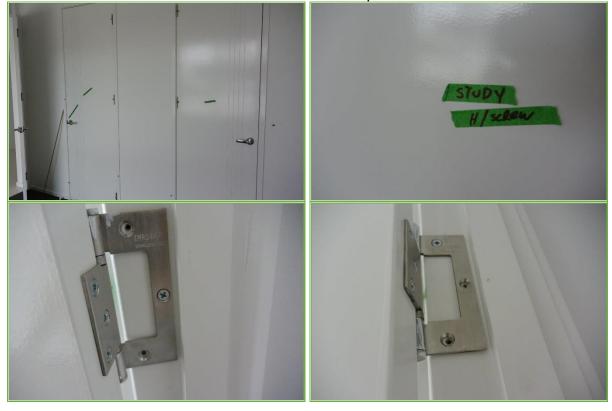
• Study door screws missing and it has been damaged during the carrying out of building works very substandard installation, not in an appropriate, skilful way or with reasonable care and skill this will need to be replaced.

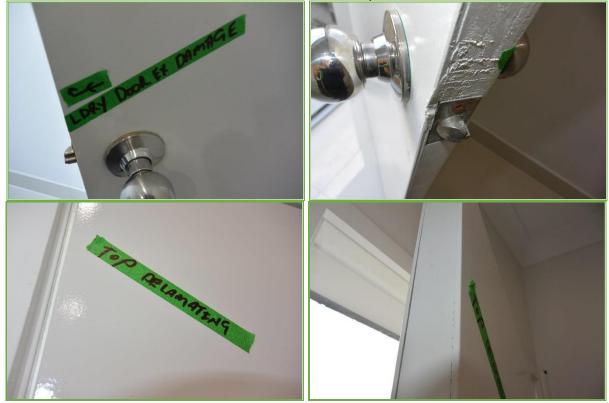
• Laundry door has been damaged and is delamintaing during the carrying out of building works very substandard installation, not in an appropriate, skilful way or with reasonable care and skill this will need to be replaced.

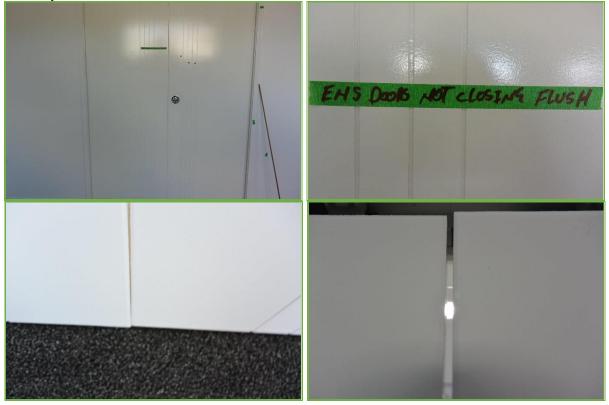
• Ensuite door not closing flush, substandard installation, not in an appropriate, skilful way or with reasonable care and skill this will need to be reworked.

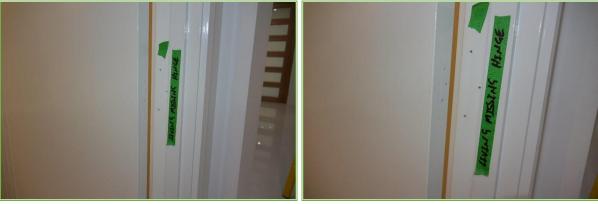
• Living room door and frame substandard installation missing hinge not installed, not in an appropriate, skilful way or with reasonable care and skill this will need to be reworked.

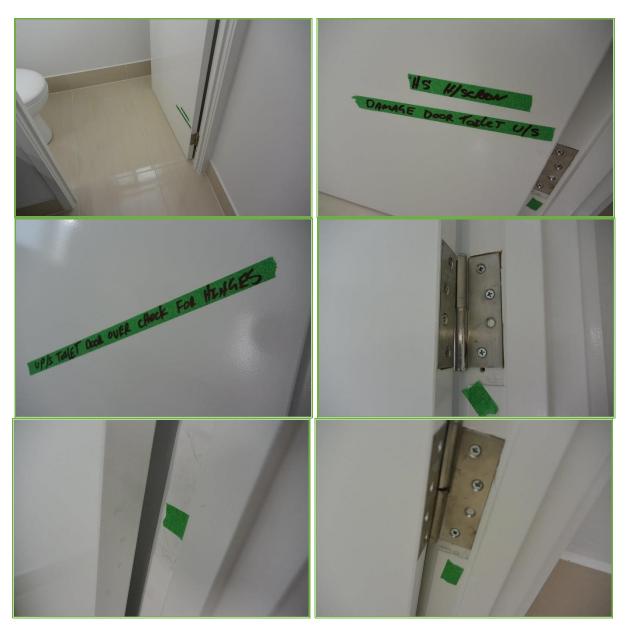
• Upstairs Toilet door and frame substandard installation has been damaged, over cut for hinges mechanical damage, not in an appropriate, skilful way or with reasonable care and skill this will need to be replaced.

QBCC Standards & Tolerances 12.4 Mechanical damage and natural defects in surfaces. Within the first 12 months after completion of the work, holes and any other unfilled depressions in painted or stained timber such as surface defects caused by mechanical damage, natural characteristics such as gum pockets or surface splits are defects if they can be seen from a normal viewing position.

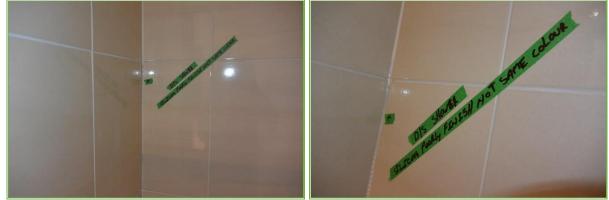
9. Downstairs shower silicone very substandard not the same colour, not in an appropriate, skilful way or with reasonable care and skill.

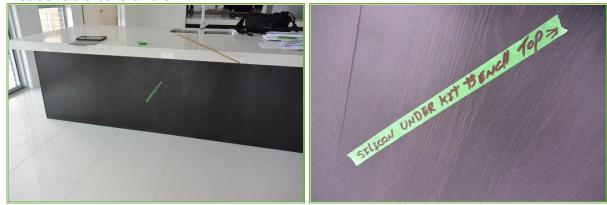
10. Kitchen under bench missing silicone, not in an appropriate, skilful way or with reasonable care and skill.

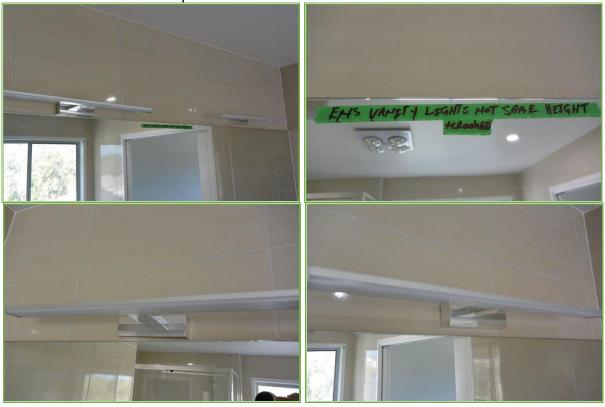
12. Ensuite vanity lights very substandard installation with not been aligned, croocked, not uniformed finished seen from a normal veiwing point, not in an appropriate, skilful way or with reasonable care and skill. This will need reworking to bring it up to a suitable standard that is accecptable.

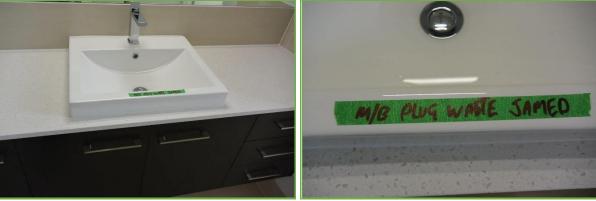
13. Main bathroom plug is jamb substandard installation, not in an appropriate, skilful way or with reasonable care and skill. This will need reworking to bring it up to a suitable standard that is fit for purpose and working.

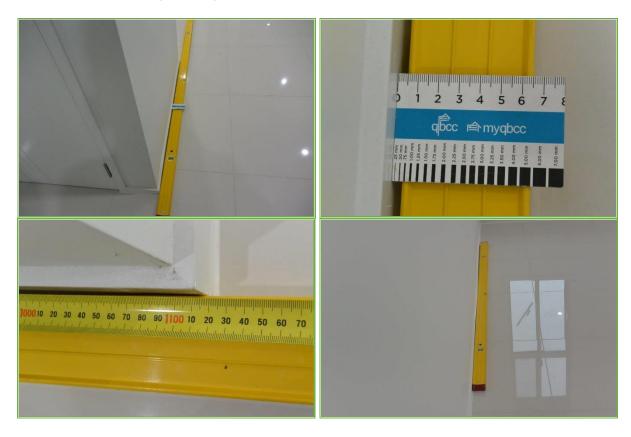
14. Walls exceed the allowable allowance, this will need to be reworked before handover. We refer the builder to the insert below.

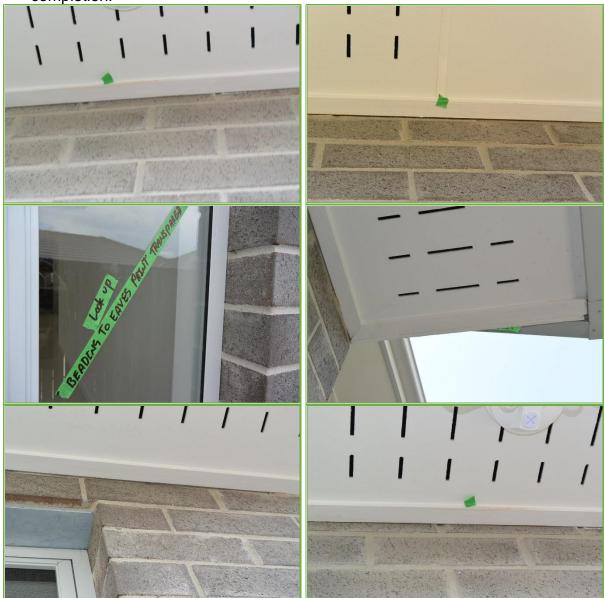
Beading is starved of paint this will all need to be repainted before practical completion.

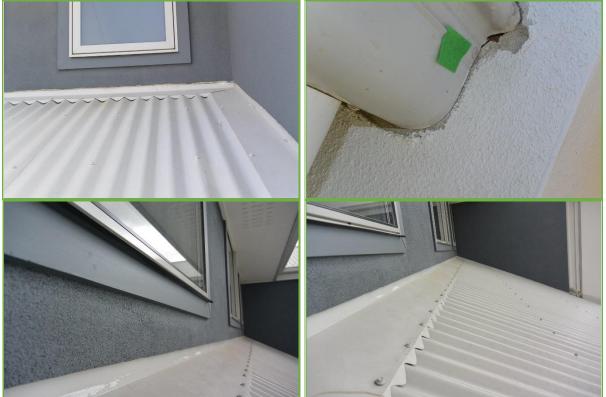
Poor finished to external areas that can be seen from a normal viewing point all will need to be repainted and tidied up this very poor workmanship.

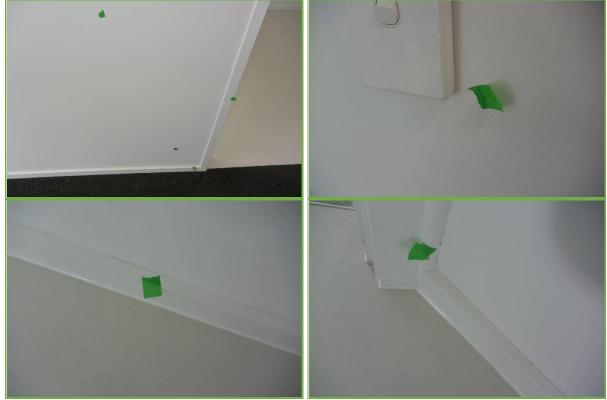
• Internal many areas require re-painting as marked

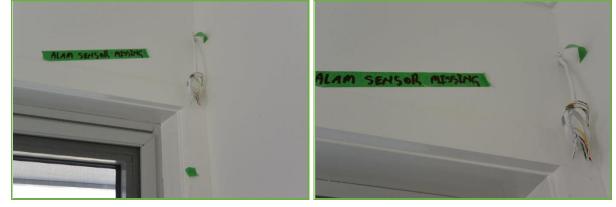
16. Alarm sensor still needs to be installed and completed before practical completion.

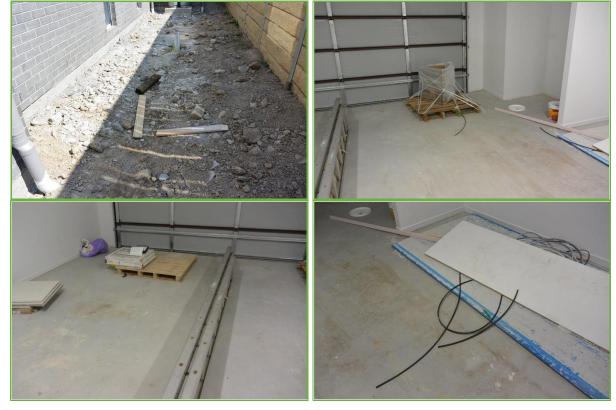
Builders waste to be removed

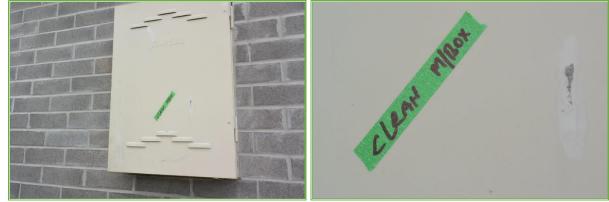
Clean meter box
