## **Pre-Purchase REPORT** (hereinafter called the "Report")

**ALL INSPECT**  
All Building & Termite Inspections

**Inspection Date: 4/02/2016**

**Property Address: A15 Sample St Upper sample 4122**

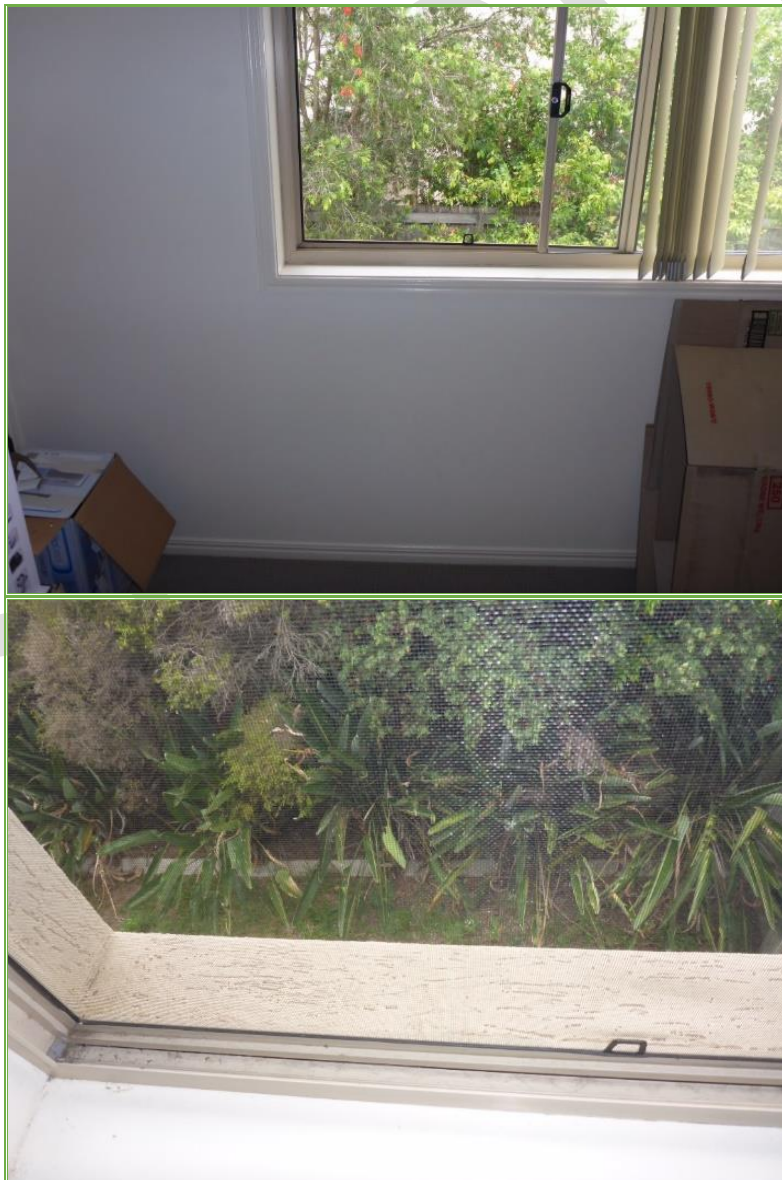
**Where it is:** Internal

**What it is:** Windows have no restrictors, this is a safety hazard.

**Results:** At the time of inspection some of the windows do not have the restrictors on them. These items are a potential safety hazard and needs to be addressed. A window opening must be provided with protection, if the floor below the window in a bedroom is 2 m or more above the surface beneath. The above recommendations should be implemented straight away as a matter of urgency.

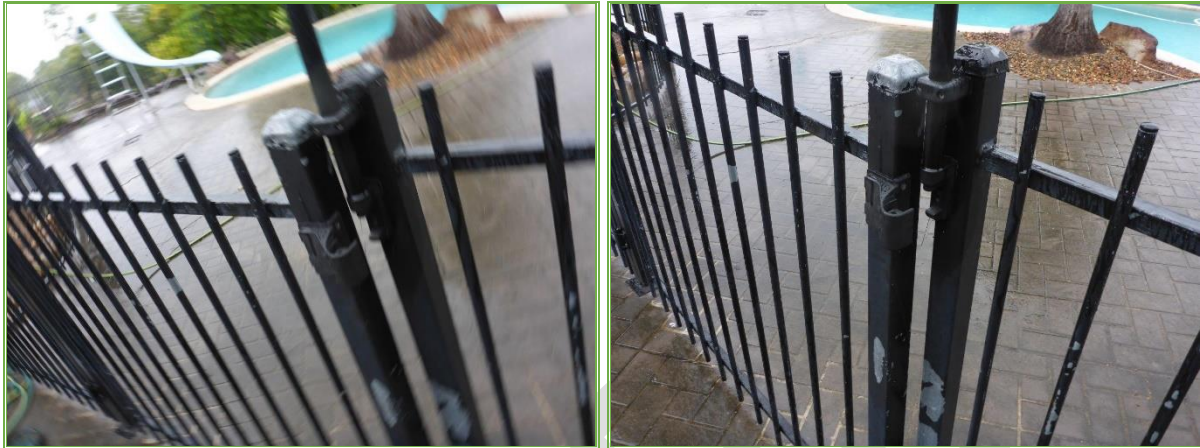
**Where it is:** External

**What it is:** Pool gate - not latching correctly.

**Results:** The pool gate should automatically close to comply with Australian Standards and relevant state based legislation. Commenting on compliance with Legislation and Local Laws is outside the scope of this Report so this defect is noted for your information advice and further action. Maintenance of the pool gate and its fixings is urgently required. It represents an urgent and serious safety hazard if left unattended. Recommend a pool certifier to determine the method and the extent of any remedial work required and costs.

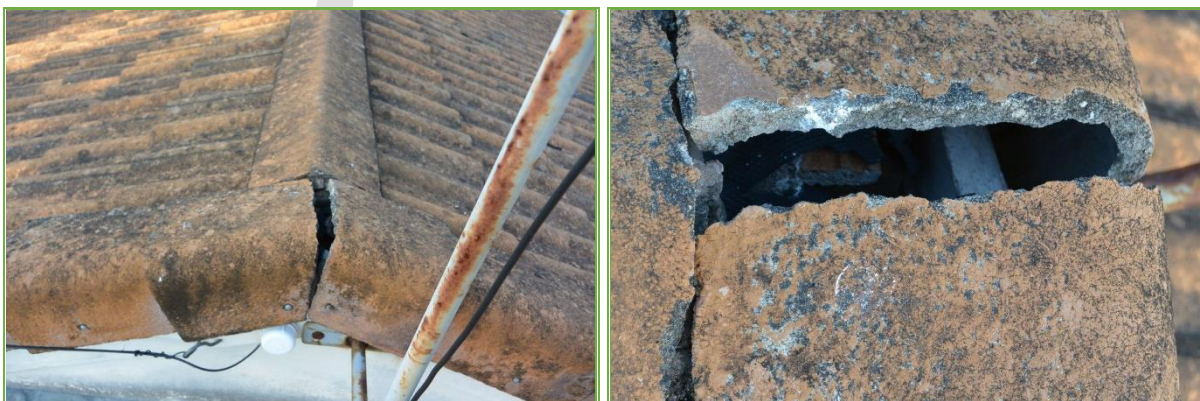
**Where it is:** External Roof

**What it is:** Cracked/Broken Tiles.

**Results:** Broken or cracked tiles are the result of aging and the weather as well. If left (Not repaired or replaced) the broken/cracked tiles may allow water to enter into the roof void causing damage to the ceiling lining and may cause damage to the roof structure, which can lead to conditions that are conducive to structural damage. Recommend a roof contractor to further investigate and repair the roof as soon as possible.

The above recommendations should be implemented as soon as possible.

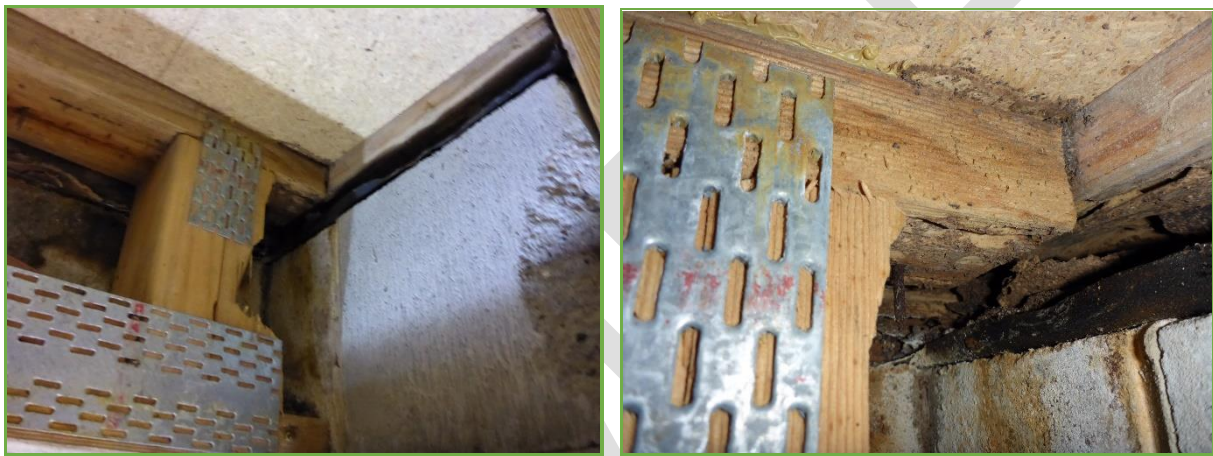
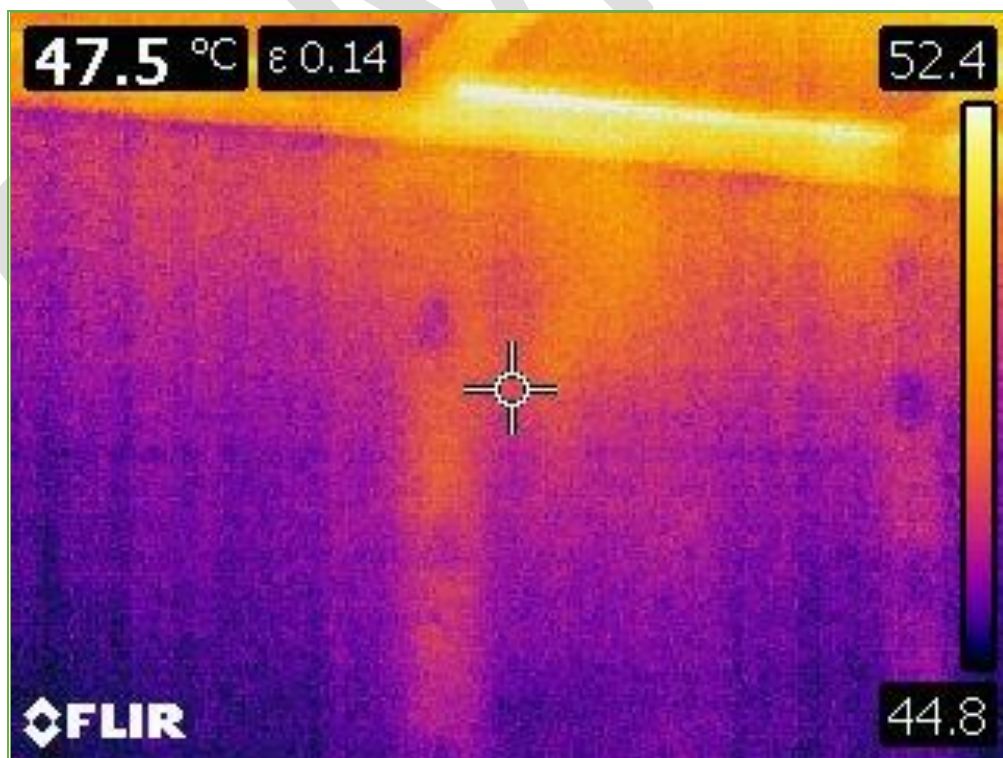
**Where it is:** Subfloor entry & garage back wall.

**What it is:** Termite damage subfloor and suspected termites or high moisture with thermal.

**Results:** Although no evidence of live termite activity was found in the area at the time of inspection it is suspected that termites was identified on the property. Further inspection of external and internal areas may be required in order to correctly identify the damage by termites and may include works of an intrusive nature. It is strongly recommended that a Licensed Builder ascertain the structural integrity and the extent of the unknown damage that may be concealed. It is also recommended that a Licensed Pest Company advise the treatment or method that should be carried out. The above recommendations should be implemented as soon as possible.

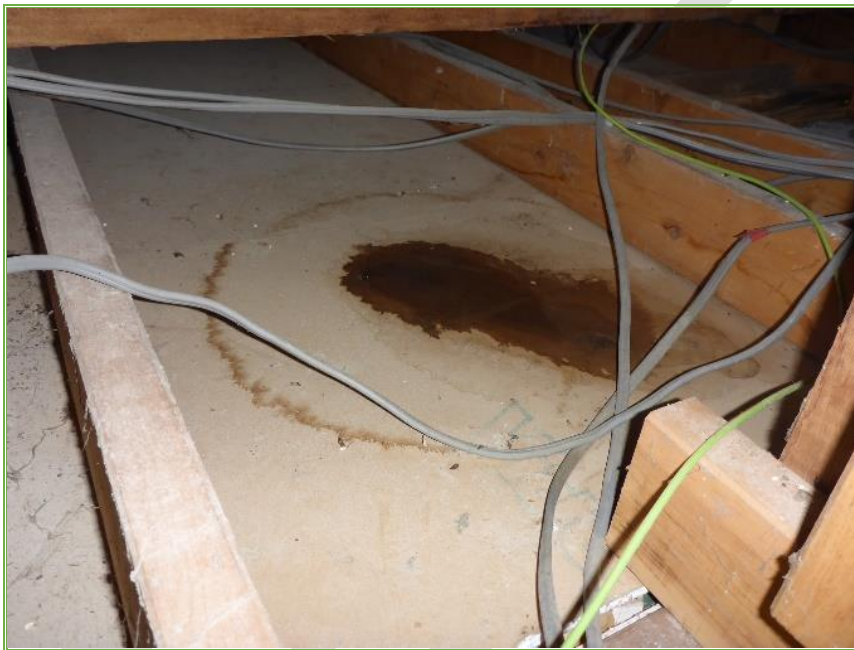
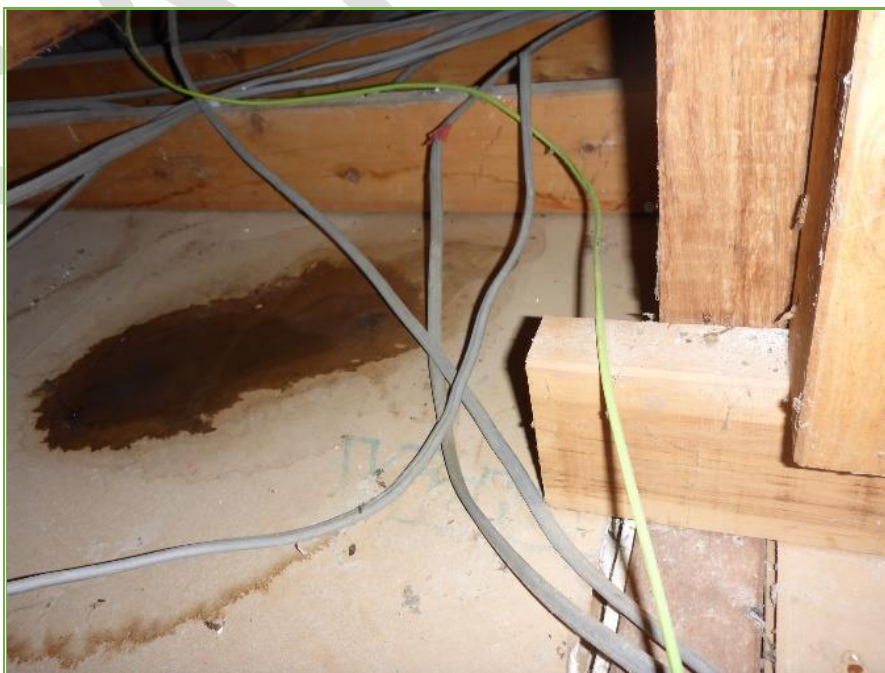
**Where it is:** Roof Void

**What it is:** Water leak – active

**Results:** As the surrounding area was found to be damp at the time of inspection the leak is ongoing and requires urgent action. If left, not repaired it can cause damage to the ceiling lining and may cause damage to the roof structure, which can lead to conditions that are conducive to structural damage. Recommend a roof contractor to further investigate the leak and repair the roof as soon as possible. The above recommendations should be implemented as soon as possible.

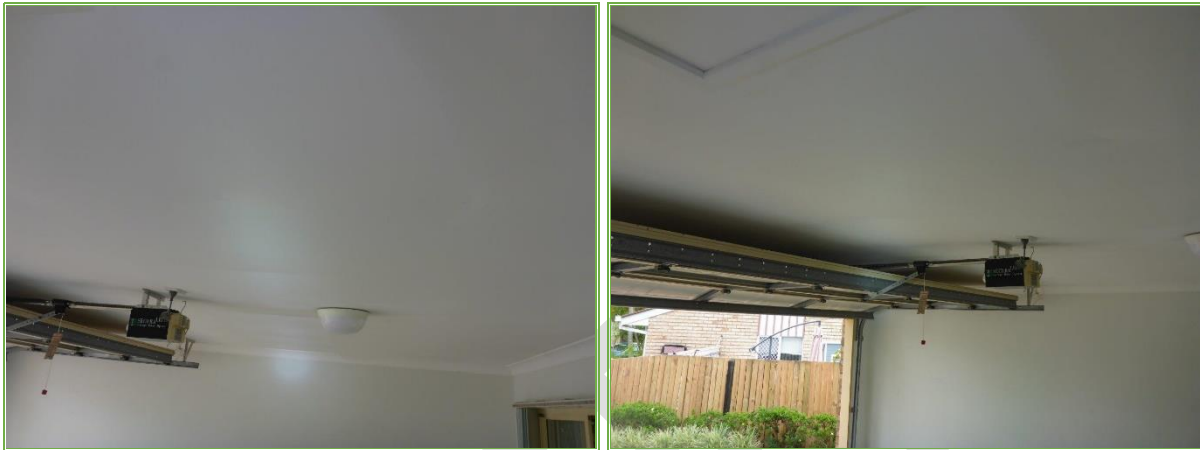
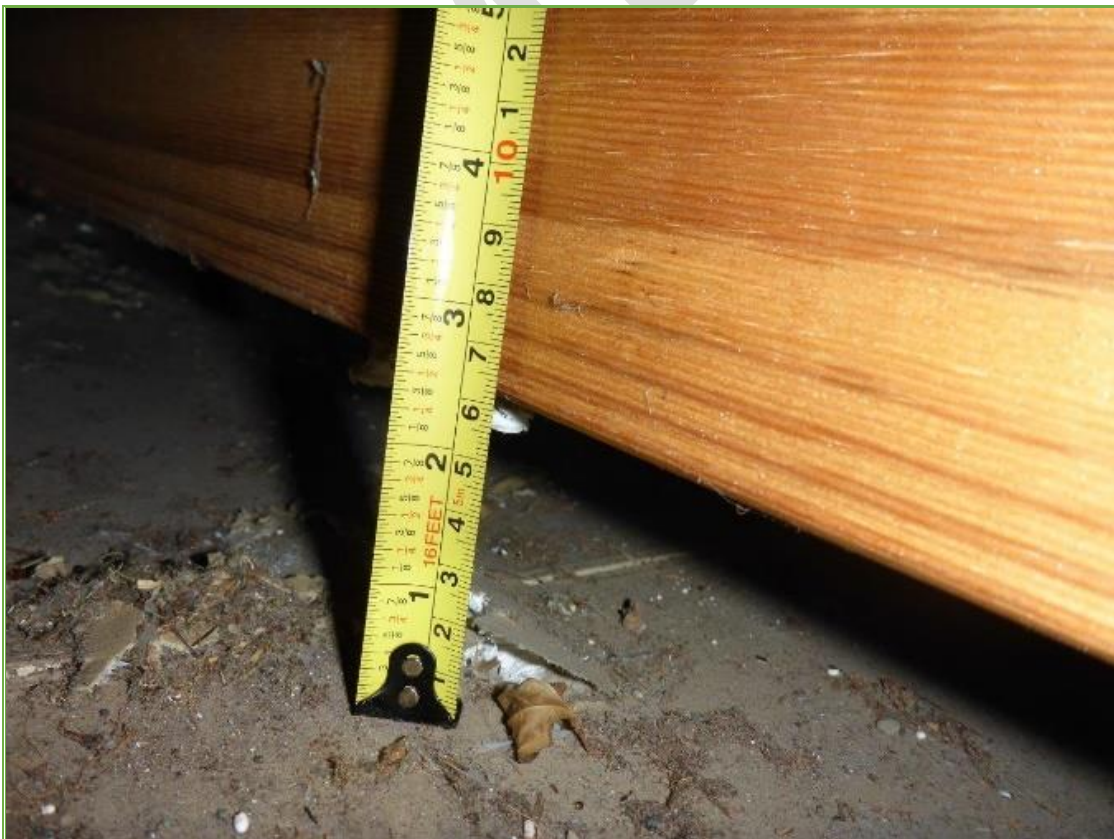
**Where it is:** Garage

**What it is:** Ceiling –Sagging

**Results:** Sagging to the ceiling generally indicates that the building materials have swollen due to contact with water or that fixings, nails, or glue have become loose and require reattachment. In some cases, sagging ceiling linings may also indicate that there are structural issues causing surfaces to warp twist or sag. Where sagging appears to be major appointment of a structural engineer is advised to further inspect the property. A Licensed Tradesmen is recommended to determine the method and the extent of any remedial work required, and associated costs and the extent of the damage behind the ceiling cover.

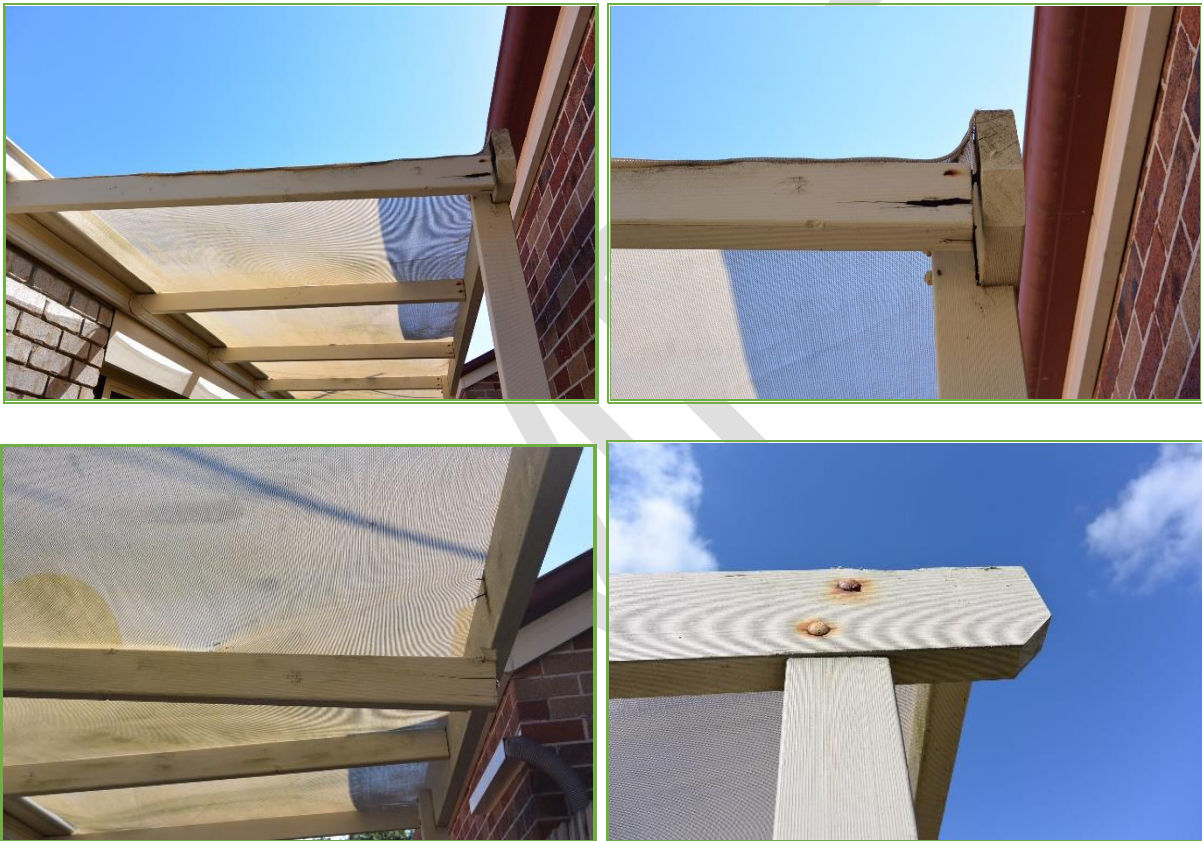
**Where it is:** External

**What it is:** Under cover area is loose and potentially could collapse.

**Results:** The primary structures are showing signs of deterioration as a result of damp conditions (wood rot) and rusty bolts which has created the loss of strength, which may cause the structure to fail and collapse. A Licensed Builder is recommended to determine the method, cost and the extent of any remedial work required and to determine the structural integrity of the structure. The above recommendations should be implemented as soon as possible as this is a safety hazard.

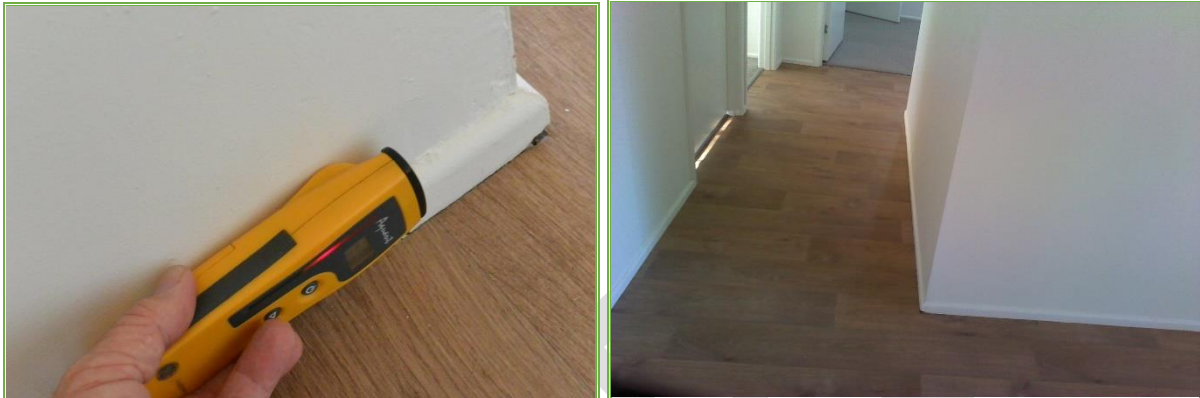
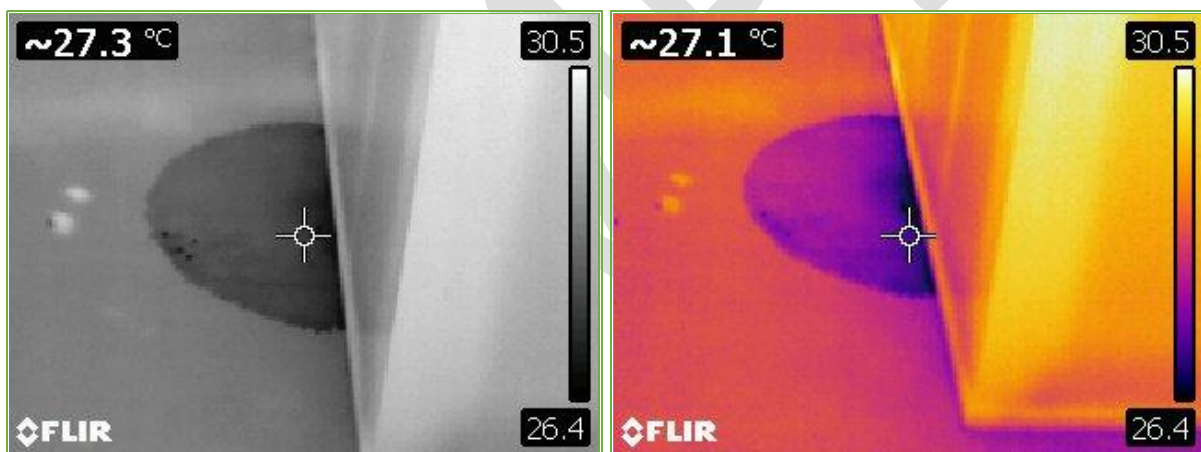
**Where it is:** Internal Bathroom and adjacent Wall

**What it is:** High Moisture and evidence of leaking.

**Results:** High Moisture was noted in wall, which can cause conditions conducive to structural damage. Under test conditions it was revealed that high moisture was evident in the secondary wall adjacent to the shower. Damp or wet conditions generally indicate a leak or poor ventilation, or failure of the waterproofing. Recommend a Plumber, to determine the cause and the method. The above recommendations should be implemented as soon as possible.

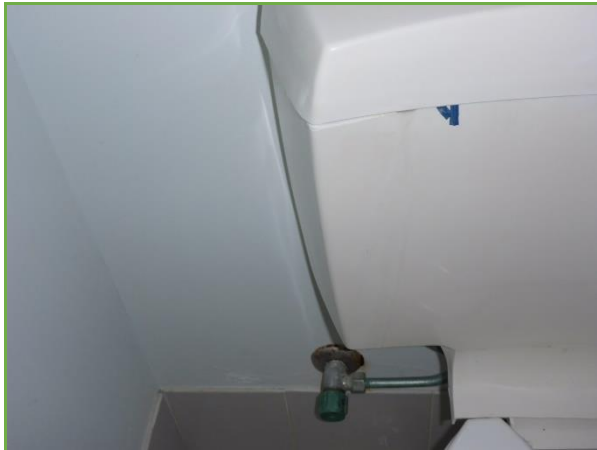
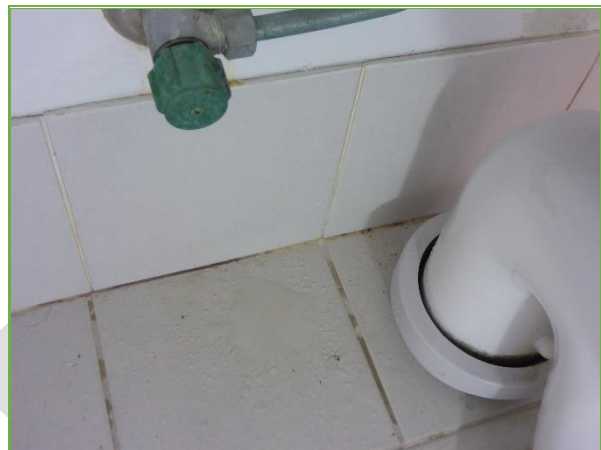
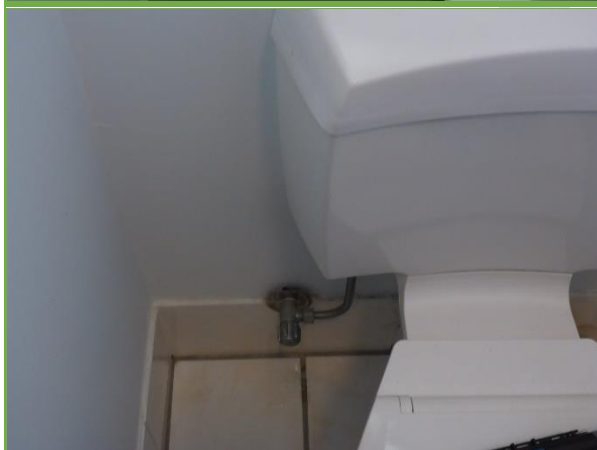
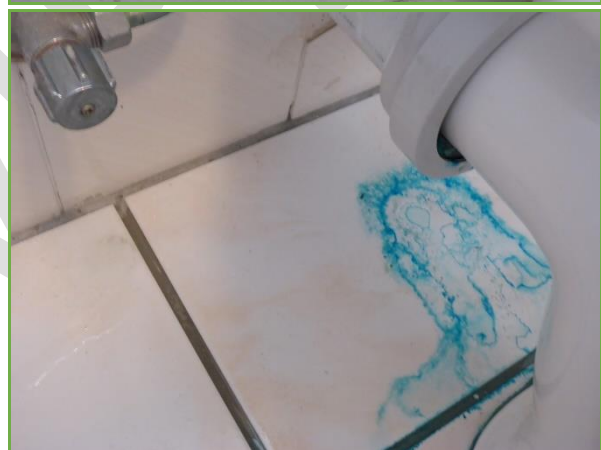
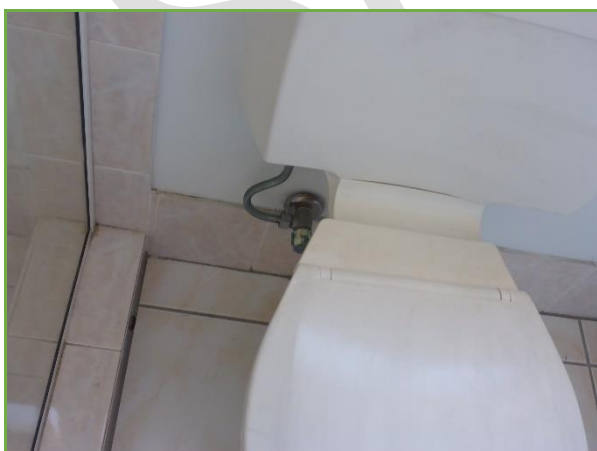
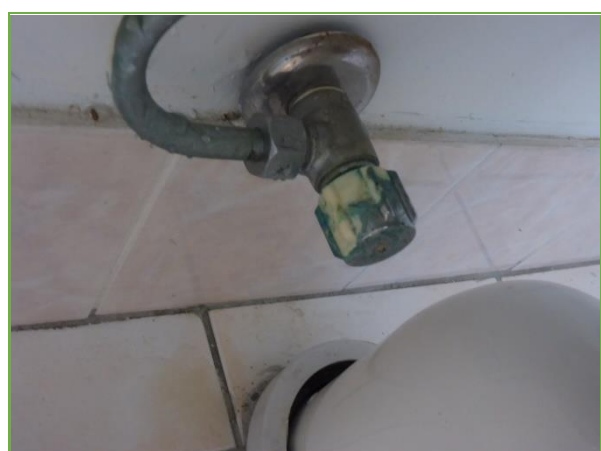
**Where it is:** Internal All Toilets

**What it is:** Toilets leaking – active.

**Results:** As the surrounding area was found to be damp at the time of inspection the leak is ongoing and requires urgent action as it can cause conditions conducive to structural damage. Regardless of the location if left unmanaged leaks can lead to serious damage of associated building elements and result in the need for replacement of building materials. Mould and other hazards such as electrical hazards may also arise if left unmanaged. A licensed plumber should be appointed to further investigate the leak. The above recommendations should be implemented as soon as possible.

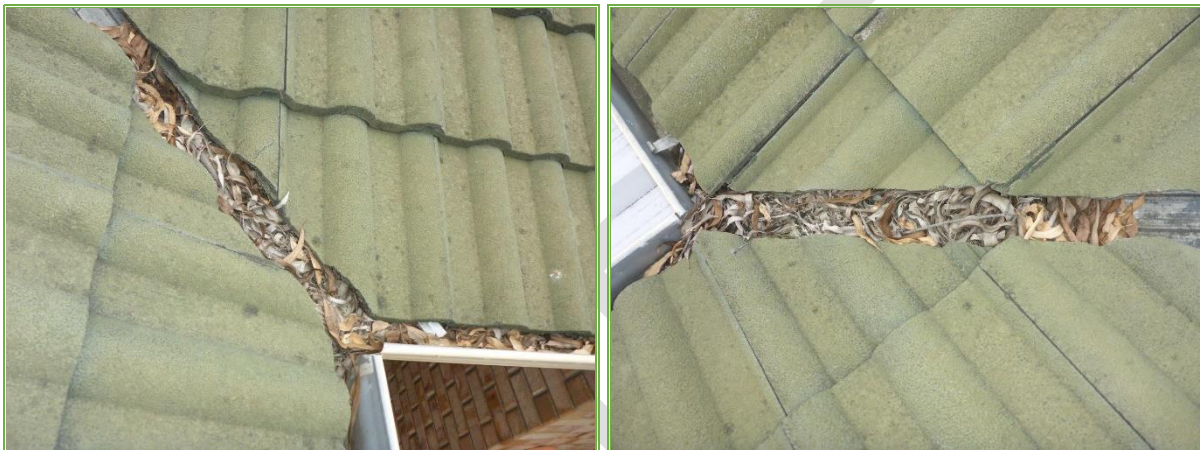
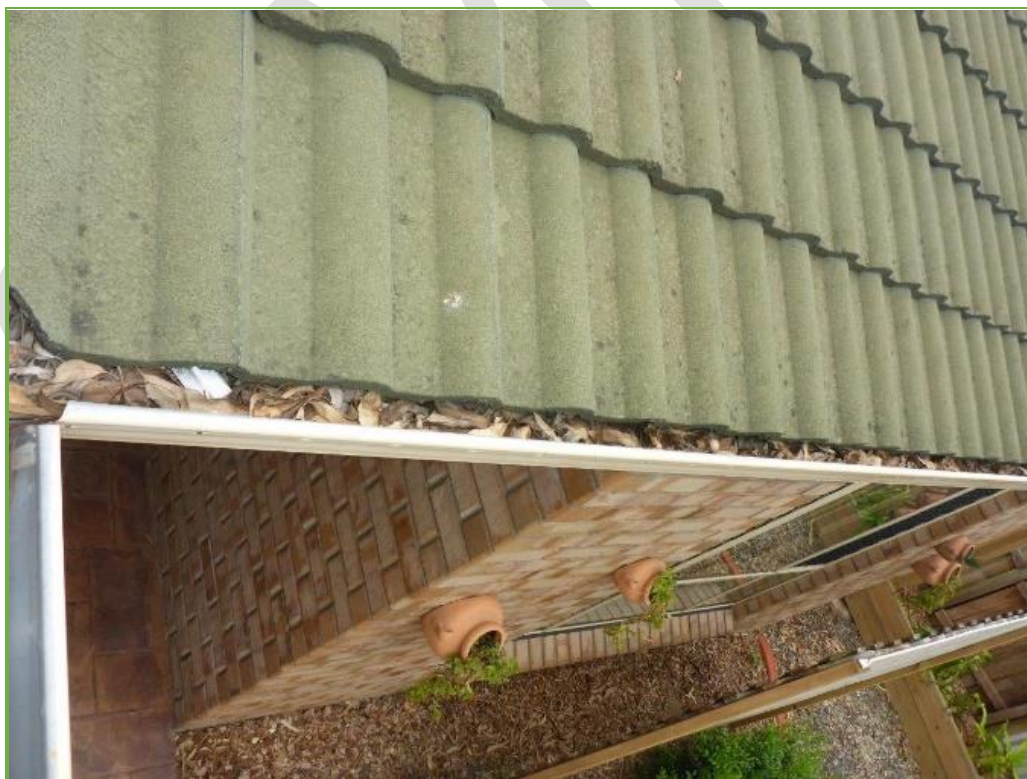
**Where it is:** External Roof

**What it is:** Gutters & Valleys blocked with debris (leaf litter)

**Results:** When you have blocking of the gutters/valleys and downpipes, they may lead to pooling of water and water may overflow into the eaves and exterior walls causing secondary defects, which can lead to conditions that are conducive to structural damage. Also the pooling of water can cause the gutters/valleys to rust and it also provides conditions that are conducive to termites. Recommend a licensed roof plumber for advice if there is significant damage to the general handyman to remove leaf litter and clean gutters/valleys.

The above recommendations should be implemented as soon as possible.

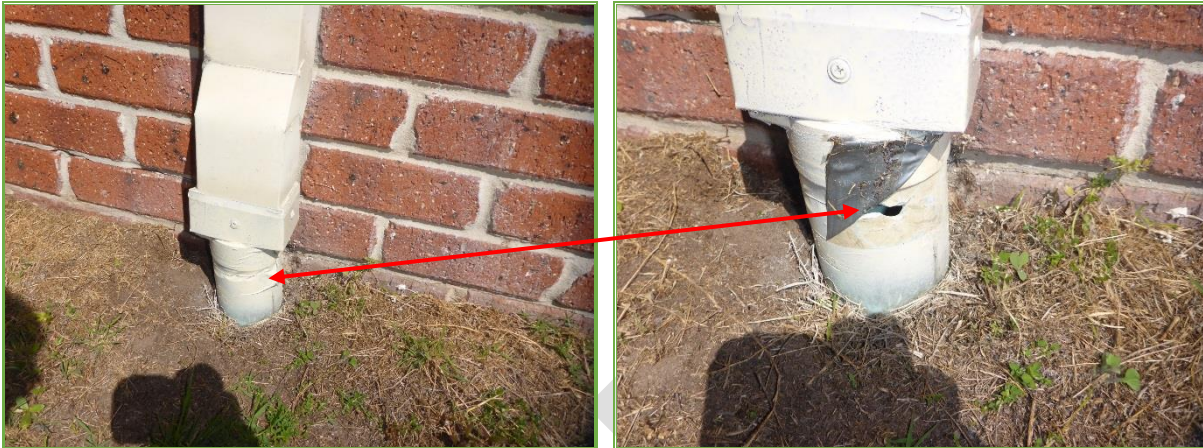
**Where it is:** External

**What it is:** Storm water Damage/Missing not adequately connected.

**Results:** Roof plumbing is not adequately connect to drainage which can cause conditions conducive to structural damage. When the roof plumbing does not drain adequately, the area can become quite damp and may lead to conditions conducive to structural damage, and it is also an environment that is conducive to termites. Recommend a plumber to repair or replace damage or missing roof plumbing. The above recommendations should be implemented as soon as possible.

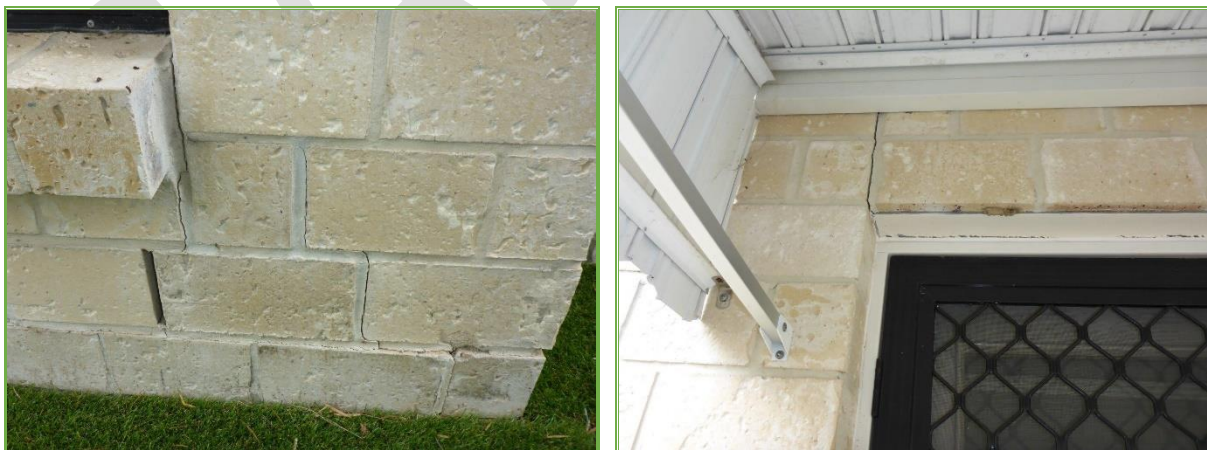
**Where it is:** External Wall

**What it is:** Cracking

**Results:** When minor cracks are in external walls, they are often considered to be an appearance defect, generally the cause may be expansion and contraction of the mortar due to environmental factors or it may be due to trees and their roots. Sometimes it can be due to poor insulation of the bricks when it was first laid. Recommend a Register Tradesman to repair this. Always monitor these cracks and if they should widen or become more numerous contact your building inspector.

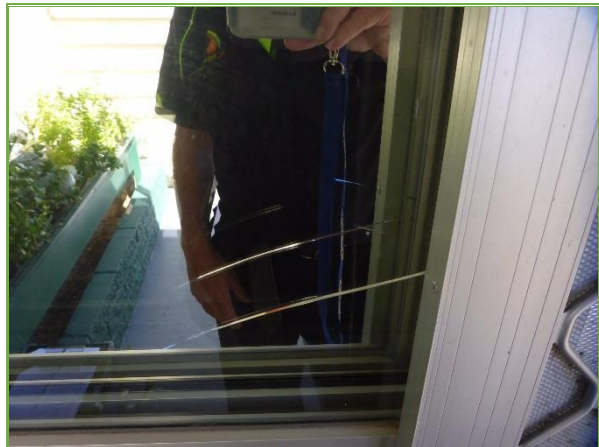
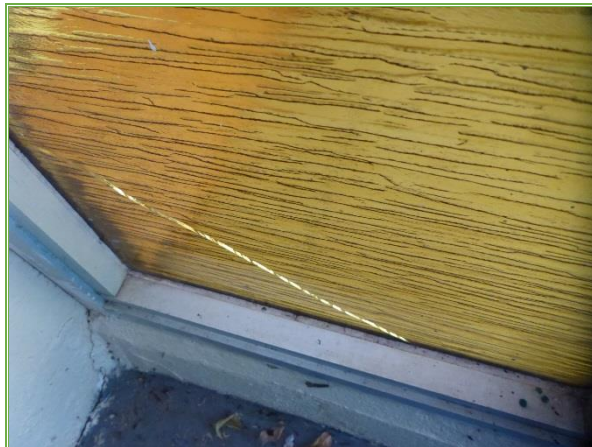
**Where it is:** External

**What it is:** Cracked Window.

**Results:** Cracking in windows may be caused by impact damage. Any cracked glass is a safety hazard and may allow water to penetrate into the surrounding building elements.

It is highly recommend that a qualified glazier repair or replace the broken or cracked glass. The above recommendations should be implemented straight away as a matter of urgency.

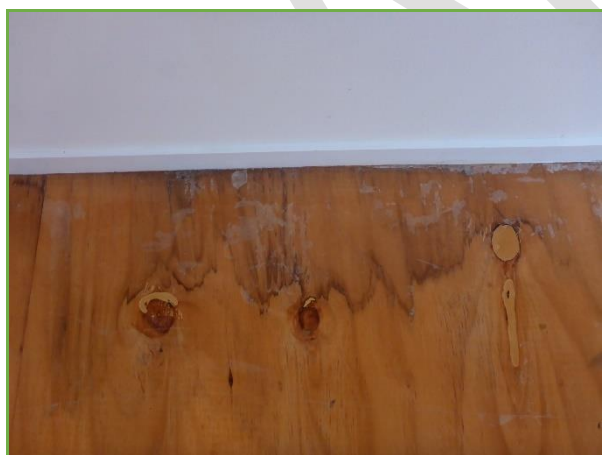
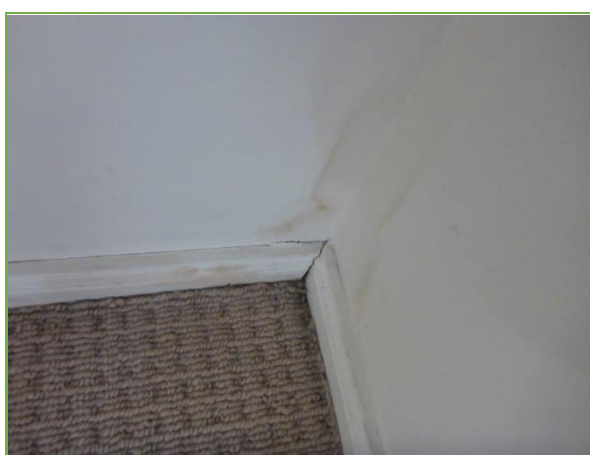
**Where it is:** Internal Bedroom Floor and Cupboard

**What it is:** Old water staining, dry at the time of inspection.

**Results:** Water staining indicates surfaces have been exposed to leaks over time. Where water damage is evident the primary requirement is to identify and rectify the source of the leak, the most critical factor is identifying the specific causes that have created these defects, and identifying if this is a recurring or ongoing problem or one that has been unresolved or resolved by the owner's actions in the past. Please be aware that linings when removed or replaced may reveal other currently concealed damage to the structures they are covering. A competent person is recommended to determine the method and the extent of any remedial work required, and associated costs and the extent of the damage behind the cover.

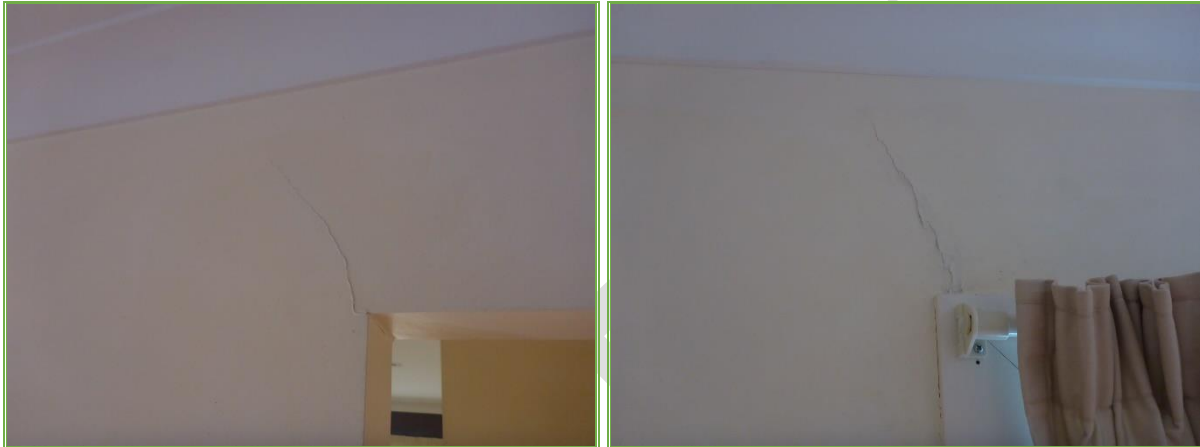
**Where it is:** Internal

**What it is:** Cracking

**Results:** When small localised cracks are noticeable, most times they are only an appearance defect and usually do not indicate that there is any structural damage. Generally, the cause is normal wear and tear over a period of time of the separation of building material and the paint and plaster along the joins. Always contact a building inspector should they become bigger or more numerous to further investigate. Cracking of this nature can be repaired with minor sanding and filling and repainting by a handyman or tradesman such as a painter. Always monitor these cracks and if they should widen or become more numerous contact your building inspector.

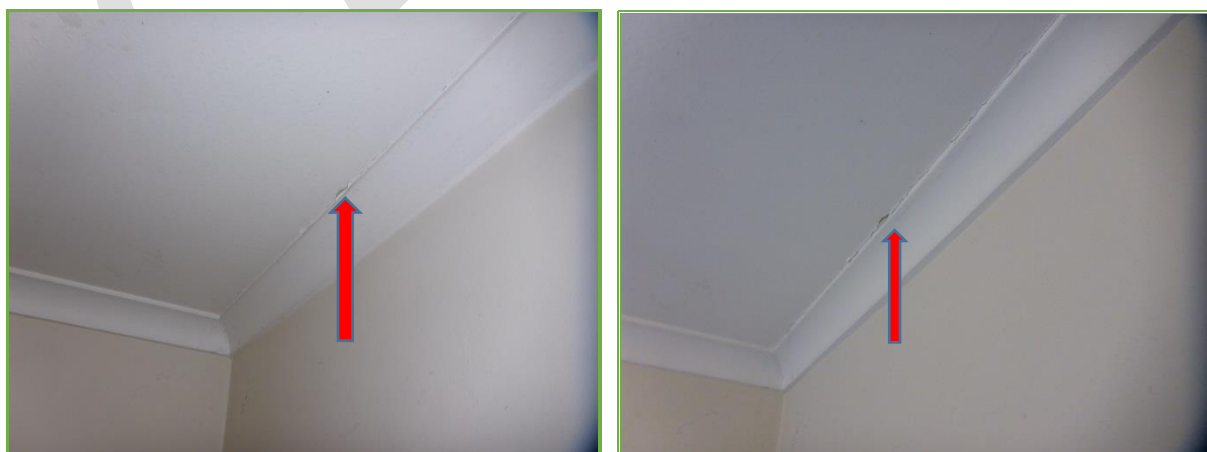
**Where it is:** Internal Bedroom

**What it is:** Flaky Paint

**Results:** Flaky or missing paint is normally just an appearance defect, it can also lead to deterioration of the building element as it is not sealed as it should be. Incomplete building elements can become affected by moisture which can then lead to conditions which can be conducive to structural damage. Incomplete painted areas should be painted to protect the underlying building element. Recommend a painting contractor to repair the painting. The above recommendations should be implemented as soon as possible.

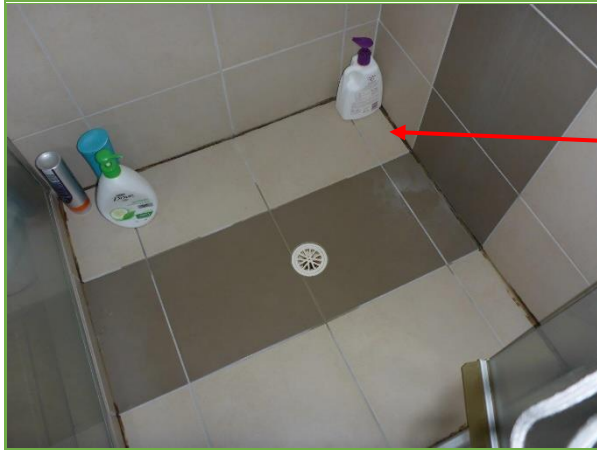
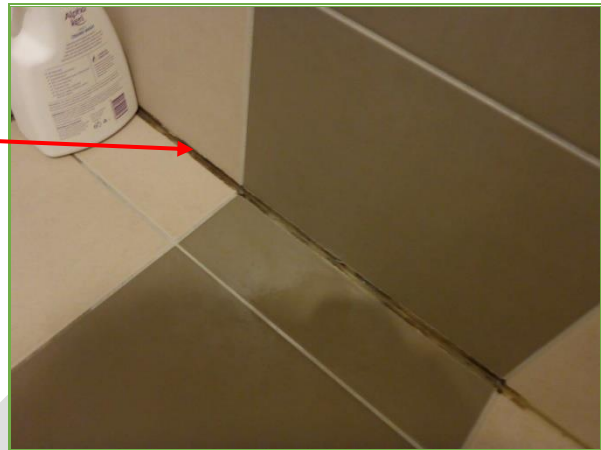
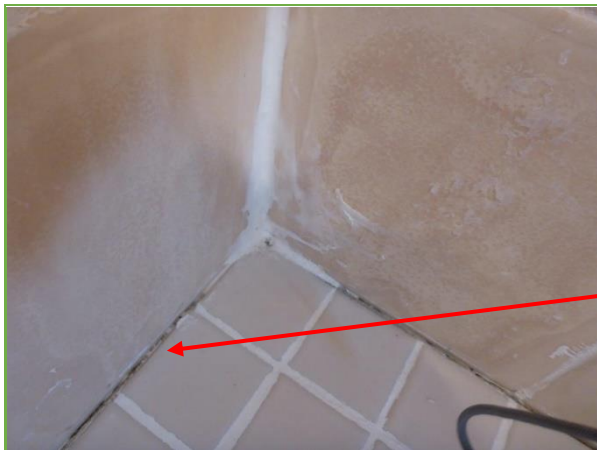
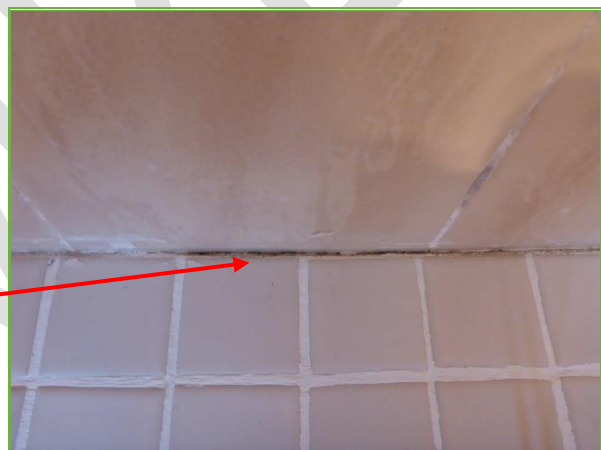
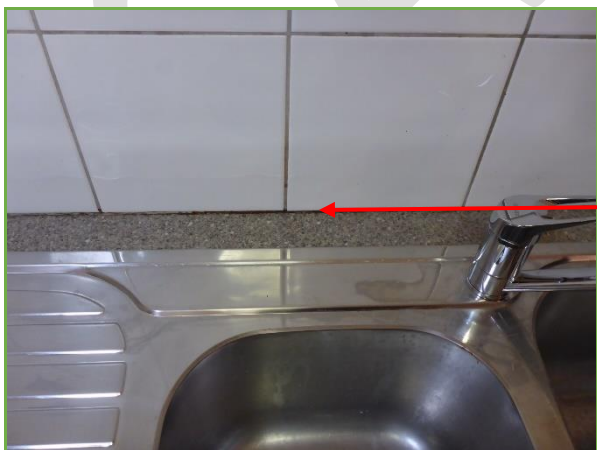
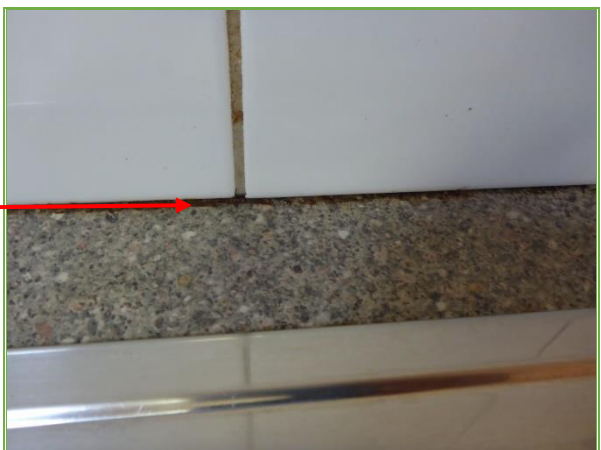
**Where it is:** Internal Bathrooms and Kitchen

**What it is:** Grout/Sealant is inadequate,

**Results:** Over time sealant and or grout can become deteriorated without proper maintenance, and can cause the area not to be water tight and may allow water penetration in to adjacent walls or floors, which can cause conditions conducive to structural damage. Recommend tiling contractor to repair or replace grout or sealant. The above recommendations should be implemented as soon as possible.

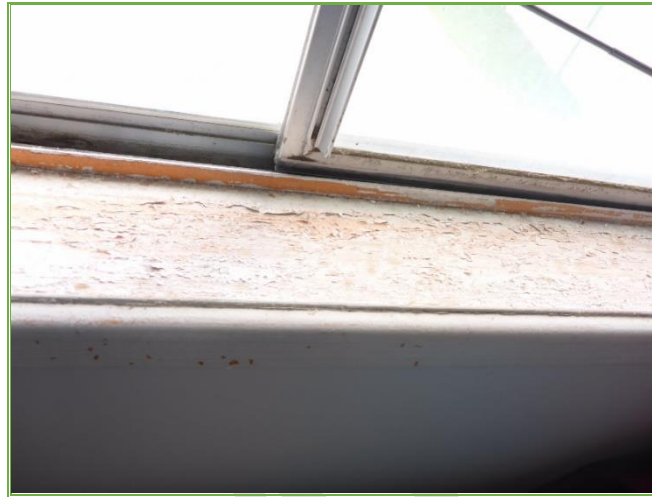
**Where it is:** Internal Bedroom Window Sills

**What it is:** Weathered timber

**Results:** When timber is exposed to the environment such as the weather it can become deteriorated over a period of time and cause Fungal Decay to the timbers, and it is then can become conducive to termites. The removal or rectification of these timbers that are weathered or have become fungal decay is recommended to minimize the risk of termite attack and secondary defects that can become conducive to structural damage. Depending on the level of damage to the building element, depends on what trades are required. The above recommendations should be implemented as soon as possible.

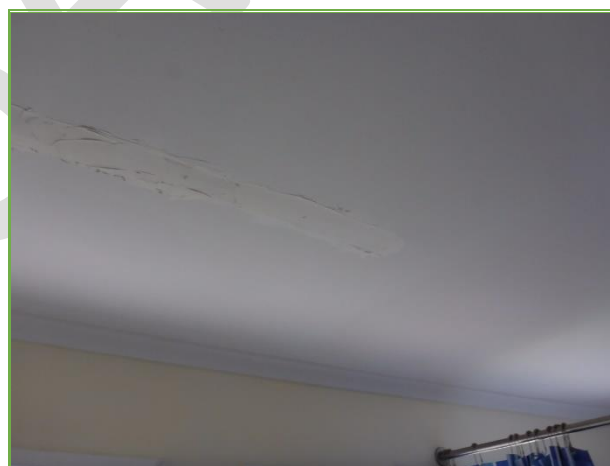
**Where it is:** Internal Bathroom

**What it is:** Old repairs– appears to have an evidence of repairs

**Results:** When there is evidence of repairs, the most critical factor is identifying the specific causes that have created these defects, and identifying if this is a recurring or ongoing problem or one that has been unresolved or resolved by the owner's actions in the past. Please obtain from owner in writing as to why the property was repaired. Please be aware that linings when removed or replaced may reveal other currently concealed damage they are covering.
