**PRE-PURCHASE  
STANDARD TIMBER PEST REPORT**

Report number: 10636

Inspection date: 1 January, 2016

Property address: 61 Sample Drive Sample South 4123

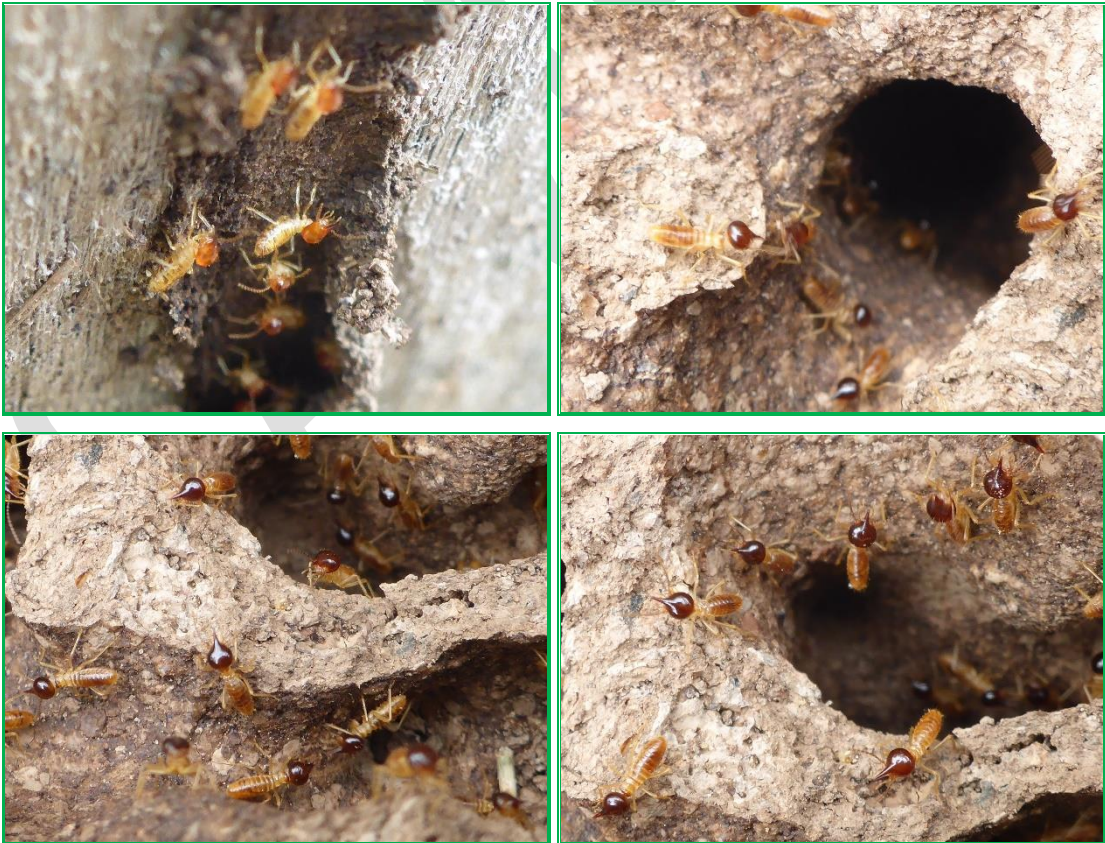
**Areas:** The Yard. **Location:** North West Boundary. **Affective Element:** Nest.

**Species:** Nasutitermes **Signs of attack:** Live and active. **Visible extent:** Widespread.

**Recommendation:** Highly recommend contacting Previous Pest Control company for advice to advise the treatment or method that should be carried out. A full termite management plan is highly recommended. The above recommendations should be implemented as soon as possible.

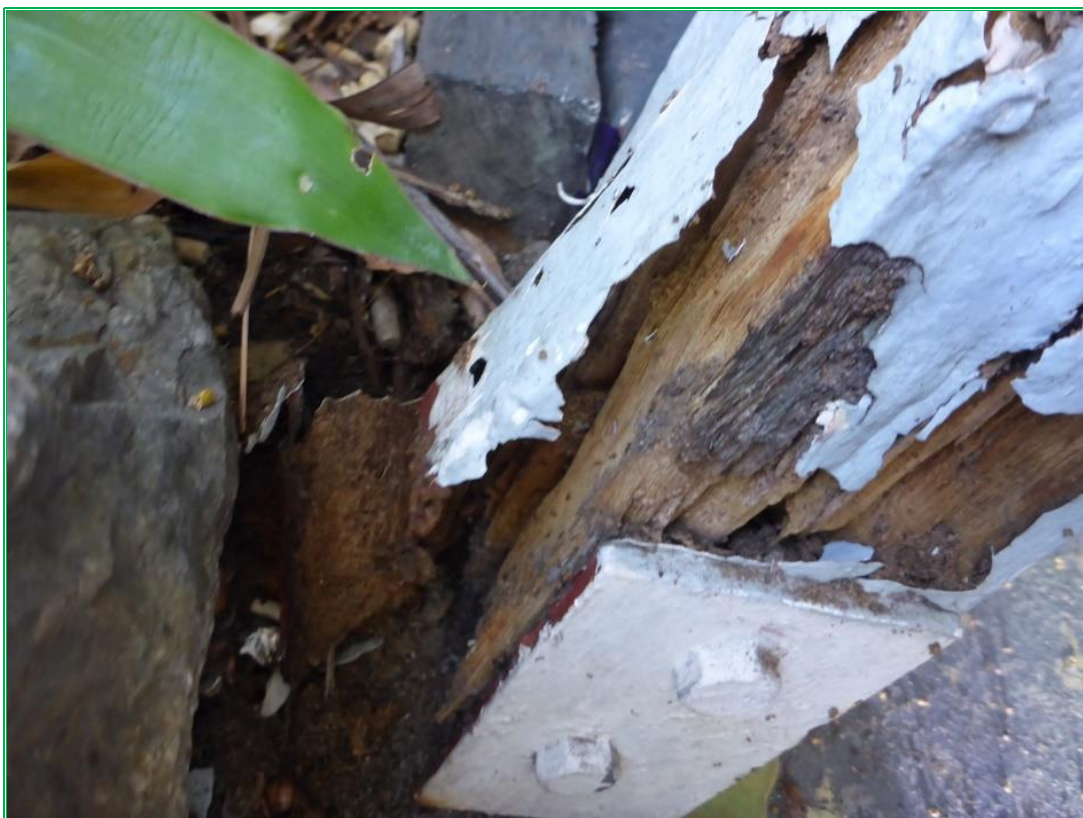
**Areas:** External

**Location:** Veranda Posts. **Affected Element:** Timber Structure

**Signs of Attack:** The timber is affected by the attack. **Visible Extent:** Widespread

**Recommendation:** Highly recommend contacting Previous Pest Control company to advise the treatment or method that should be carried out. A full termite management plan is highly recommended.

The above recommendations should be implemented as soon as possible.

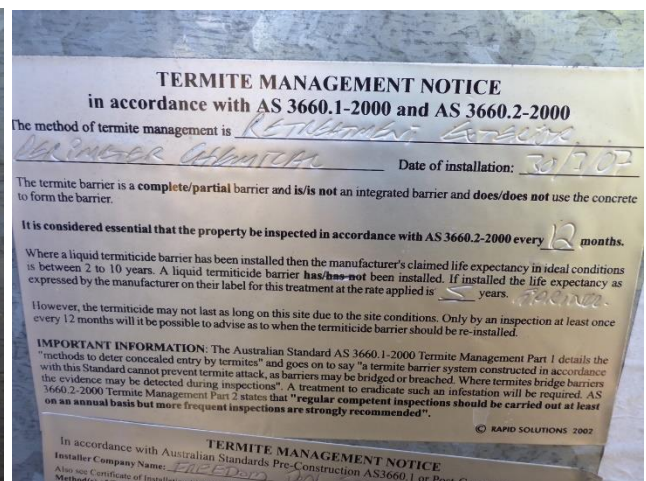
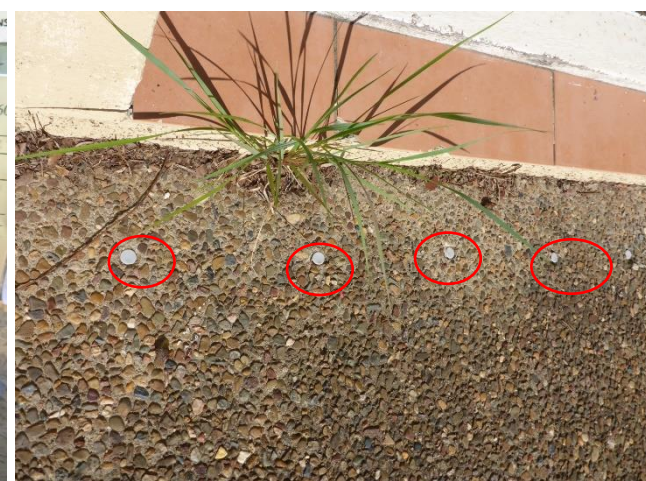
**Area:** Building Exterior.

**Previous Program:** Barrier with inspections every 12 months.

**Important Note:** If previous treatment is found. Please obtain from owner in writing as to why the property was treated, how it was treated, was there any termite damage and if so how was it repaired. If evidence of a previous treatment is noted and appropriate documentation is not available, the client must assume that the termite infestation may still be active in a concealed or inaccessible part of the property and that re-treatment may be required. Where perimeter termite barriers have been installed, the building owner should also ensure that the integrity of the barrier remains intact and that the inspection of possible termite entry points is not impaired.

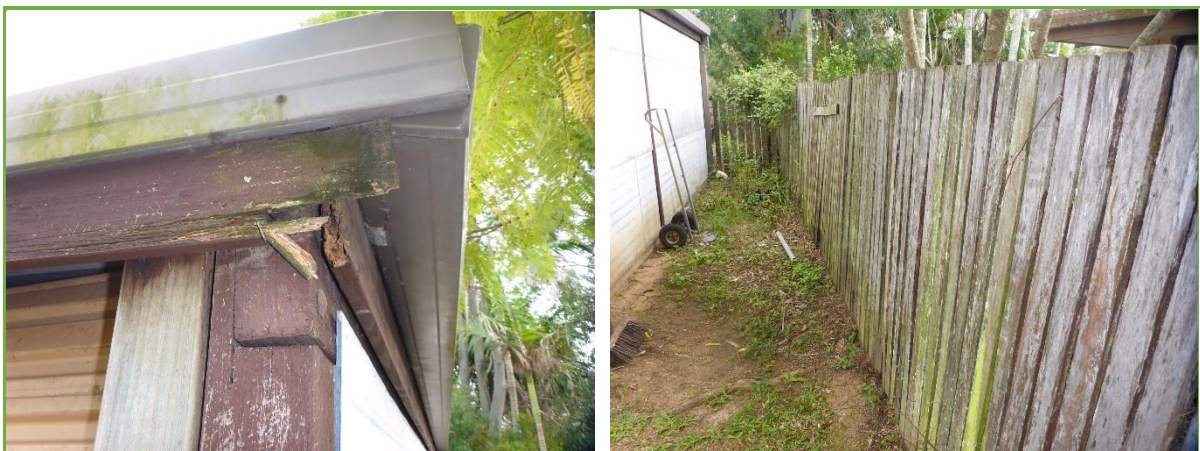
**Areas:** Exterior. **Location:** Fence and Facia above garage. **Affected Element:** Timber Post and palings and facia.

**Signs of Attack:** Splits in timber, Dark colouring. Collapse of a timber member.

**Visible Extent:** Widespread.

**Recommendation:** The structures are showing signs of deterioration as a result of damp conditions which has created the timbers to rot, which can lead to conditions conducive to structural damage. Wood rot may cause the structure to fail as what it was originally intended for. Regular maintenance of the timbers are required to prolong the life of this building element, which may include but not limited to Painting or Sealing. Recommend to first identify the cause of the timber rot, then replace the affected timber where required. A Licensed Builder is recommended to determine the method and the extent of any remedial work required and associated costs. The above recommendations should be implemented as soon as possible.

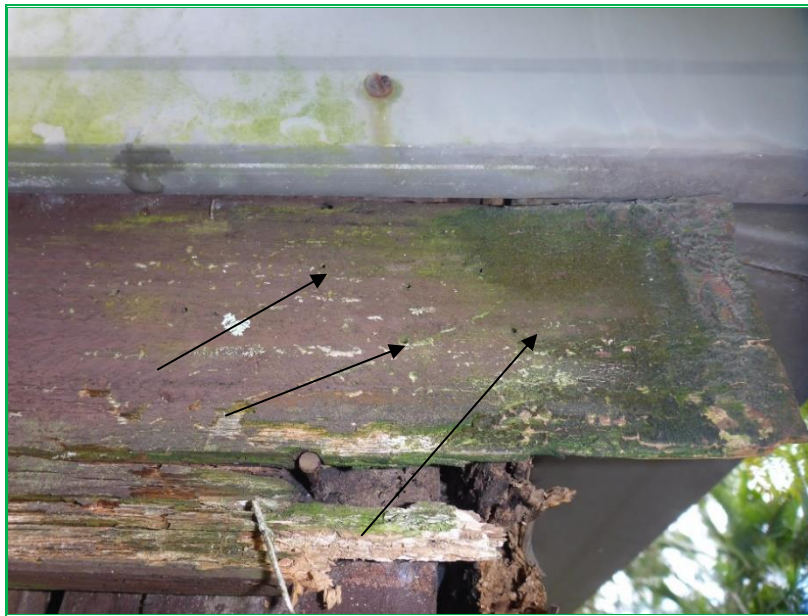
**Areas:** External. **Location:** fascia above the garage.

**Affective Element:** Timber fascia. **Species:** Undetermined

**Signs of attack:** Damage of timber. **Visible extent:** Widespread.

**Recommendations:** A management proposal is recommended and a quote to treat the live borers and ongoing inspections. These recommendations should be implemented immediately.

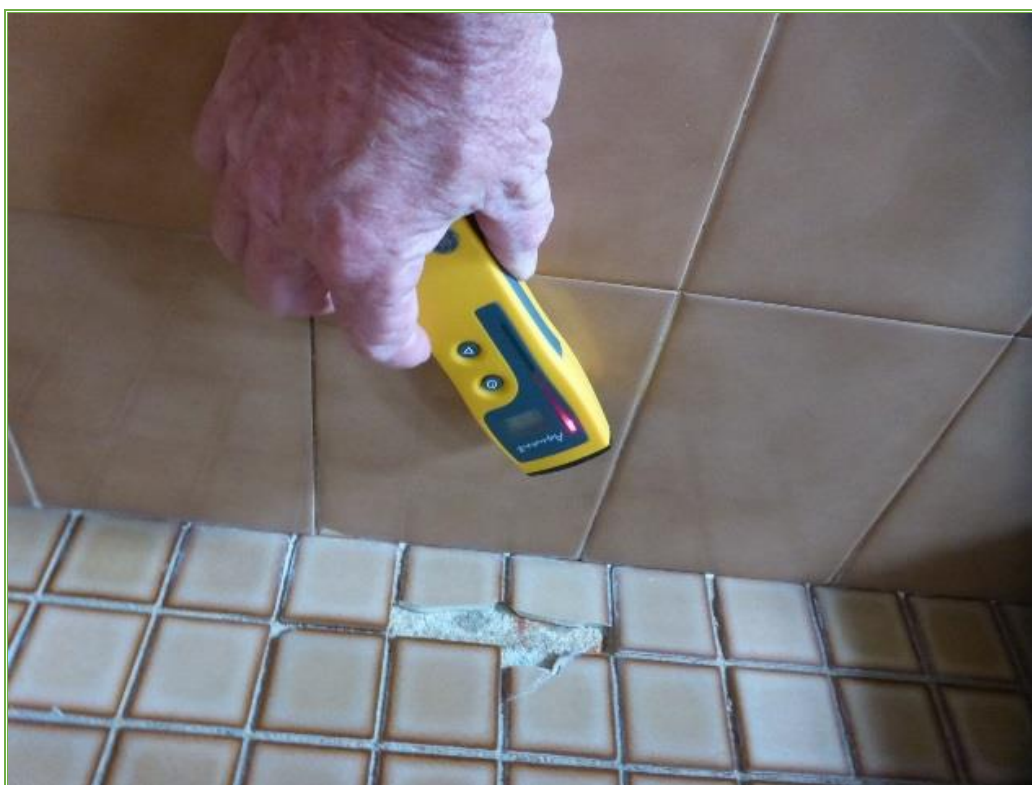
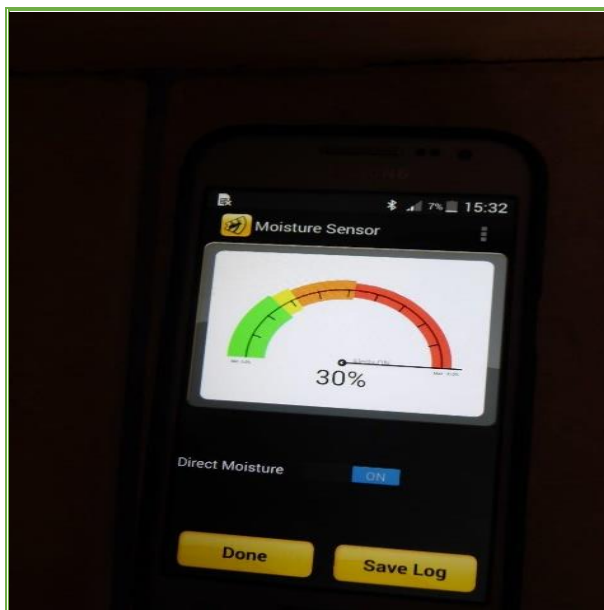
**Areas:** Interior **Location:** Bathroom wall. **Affected Element:** Bathroom Shower.

**Defect or Sign:** Elevated moisture level readings obtained under test conditions.

**Visible Extent:** Localised.

**Recommendation:** High moisture or damp conditions generally indicate a leak or poor ventilation, or failure of the waterproofing. The reason for this high moisture reading was not apparent at the time of inspection. Recommend a further investigation by a competent person such as a Registered Builder or Plumber, to determine the cause and the method to repair or replace affect building elements, which may include a more invasive inspection.

The building may just need to be monitored over a period of time to confirm or not that there is a moisture problem. With this type of testing the exact nature of the problem may be unclear, but it just needs to be monitored and then if the problem persist seek further investigation of an intrusive matter like an invasive inspection to determine the underlining problem. The above recommendations should be implemented as soon as possible. For further advice consult David 0421235310 who carried out the inspection.

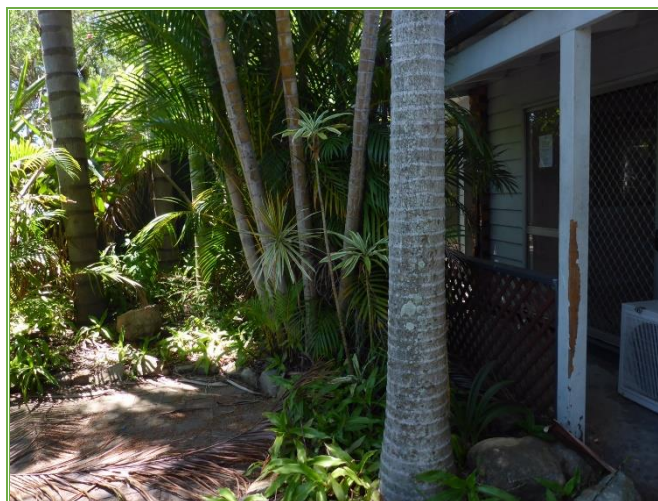
**Areas:** Exterior **Location:** Against the building. **Affected Element:** Inspection zone

**Defect or Sign:** Bridging and Breaching by built up of landscaping/soil and gardens and materials.

**Visible Extent:** Widespread

**Recommendation:** Unless appropriate written evidence of an alternative termite management program is provide, to help protect against undetected termite entry to the building, a continuous inspection zone of at least 75mm should be provided and maintained. The inspection zone forces the termites into the open where they can be detected more readily during regular inspections. Recommend removing the elements that are preventing a full visual of the inspection zone. Depending on the level of concealment depends on what trades to us. With concrete slab buildings, it is essential that the edge of the slab is permanently exposed. Importantly the edge of the slab should not be rendered, tiled, cladded, or concealed by flashings, adjoining structures, paving, soil, turf, landscaping, or the like. The above recommendations should be implemented as soon as possible. For further advice consult David on 0421235310 who carried out the inspection.

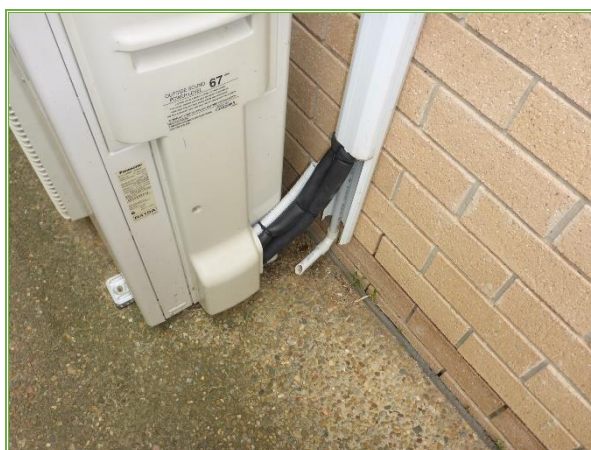
**Areas:** Exterior **Location:** Against the building. **Affected Element:** Wet conditions

**Defect or Sign:** Overflows not adequately connected or plumbed in. Gutters blocked and damaged and defective drainage, and timber in contact with the ground.

**Visible Extent:** Localised

**Recommendation:** When gutters and overflows are not adequately connected or plumbed in, and defective drainage they create an environment that is conducive to termite attack. Recommend that a qualified plumber rectify the gutters or overflows to ensure the area remains dry. The above recommendations should be implemented as soon as possible. For further advise consult David 0421235310 who carried out this inspection.
