This is a visual only Building Inspection & Report carried out in accordance with AS4349.0

Stage Fixing Stage REPORT (hereinafter called the "Report")

Report Number 13318

Property Address: Sample street

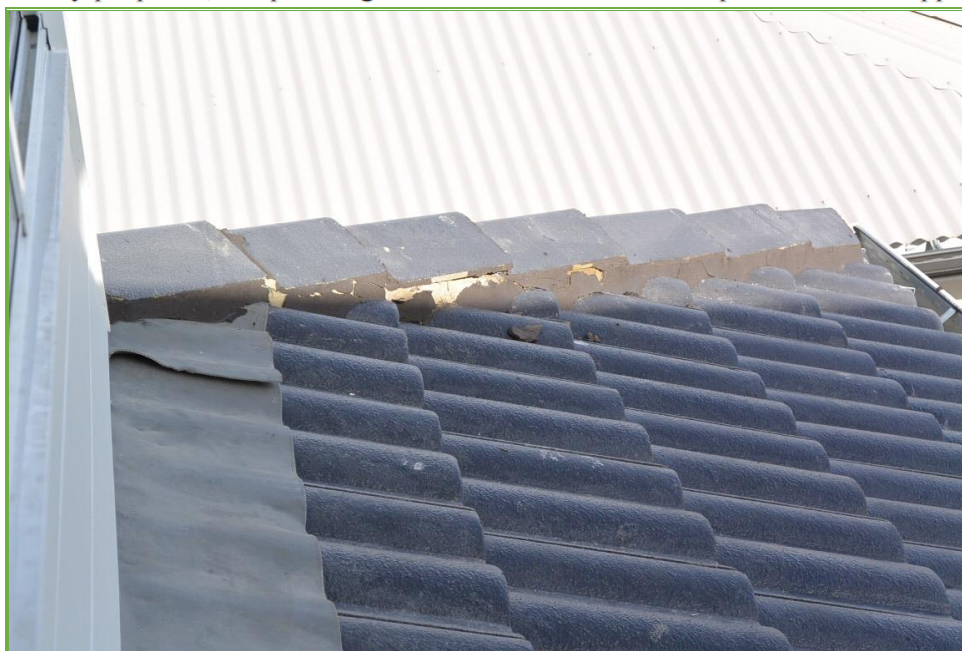
1. Substandard finished to the pointing on the tiles not workman like, and tiles are missing this will need rework before handover as marked.

Not in an appropriate, skilful way or with reasonable care and skill. We refer the builder to below: AS 2050, part 3.6 All must be in neat/regular appearance and uniform colour.

Unless documented otherwise, the absence of pointing where required by the BCA, *AS 2050 - Installation of Roof Tiles* or the contract is a defect. Within the first 12 months of completion of the work, pointing is defective if it becomes dislodged or washed out. Minor cracking of pointing is not a defect.

Within the first 12 months of completion of the work, pointing is defective if it is not uniform in colour, texture and trowelled off to provide a neat appearance. The rectification of pointing shall match the existing colour and texture as close as practicable.

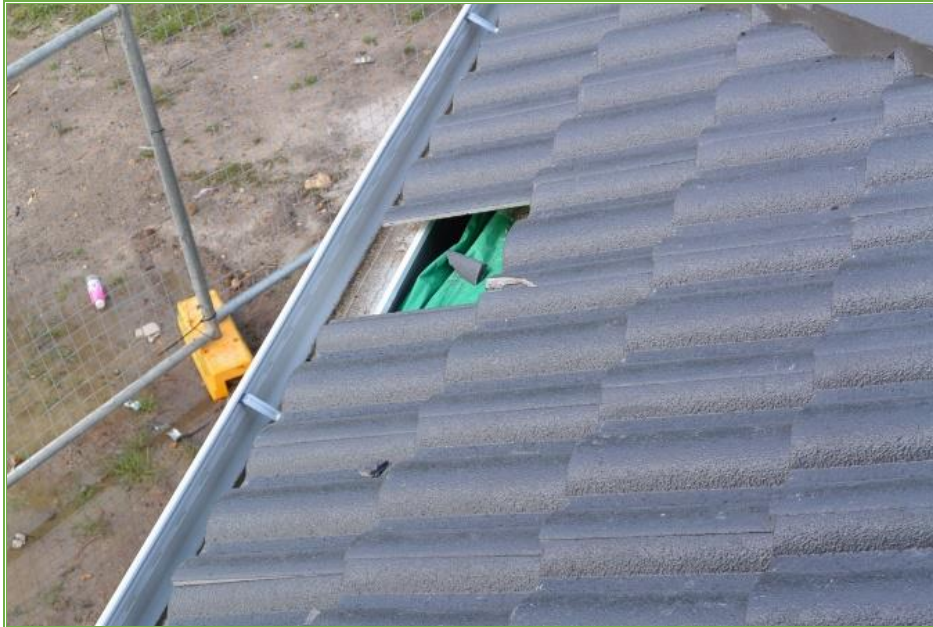
- Tiles missing these will need to be installed as a matter of urgency with the weather raining.

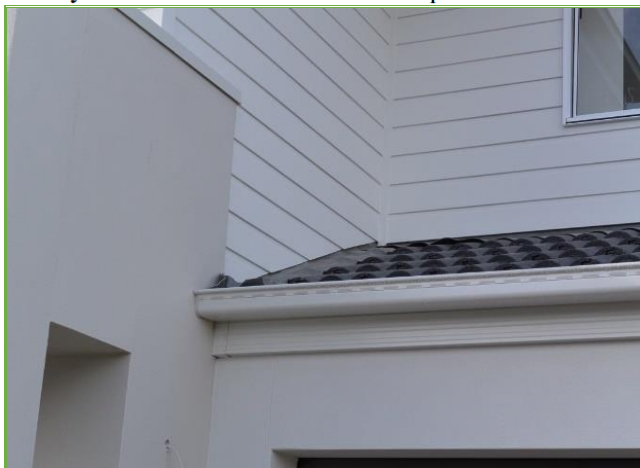
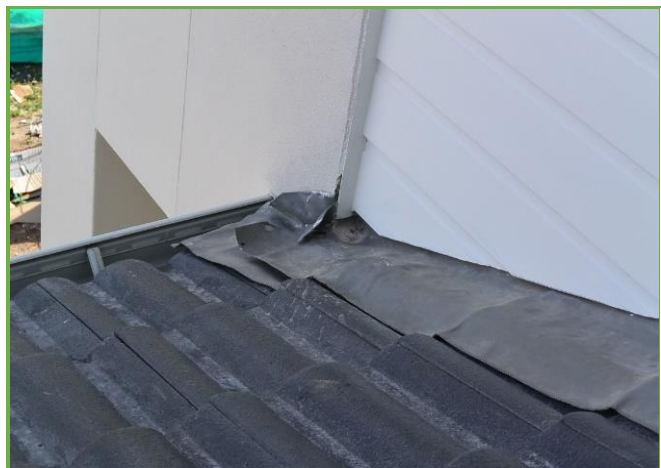
2. The flashing is substandard. This will need to be rectified before handover.

Completed flashings and accessories are defective if they leak under weather conditions anticipated by the BCA.

Flashings are defective if they are not provided in accordance with the requirements of the BCA. Wall and step flashings, and sloping flashings cut into walls are defective if they do not incorporate weathering folds, anti-capillary breaks and sealing.

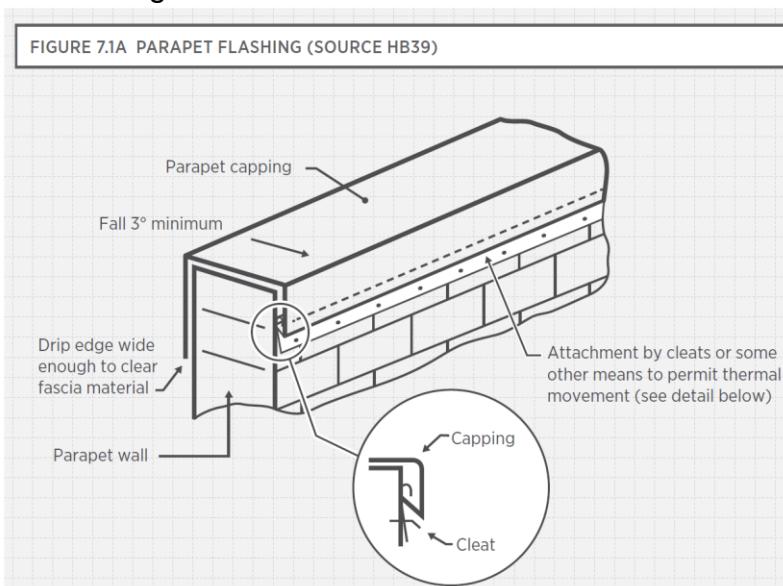
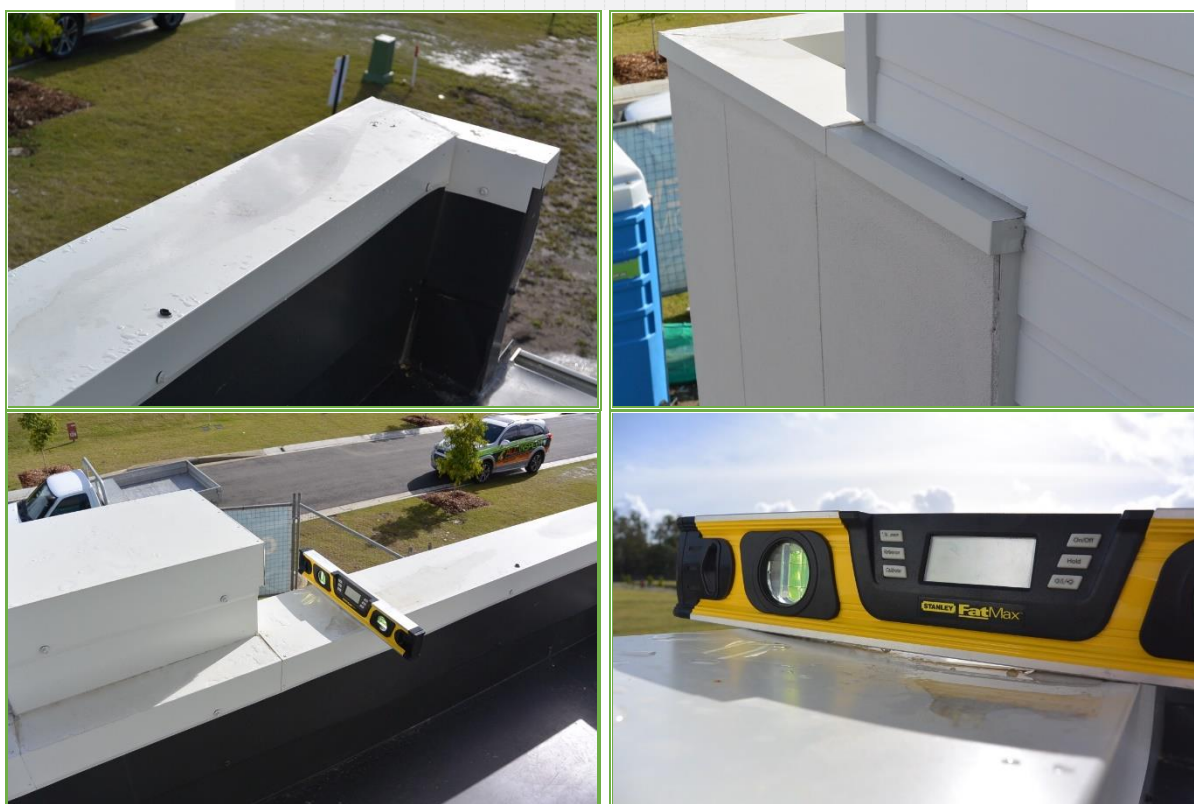
3. The parapet flashing is ponding water substandard installation has been installed concaved and the water is unable to drain away other areas have back fall. This will need to be rectified before handover.

Inadequate construction of roof flashings such as cavity flashings, stepped flashings, parapet flashings, apron flashings and hip and valley flashings are a major cause of leaking roofs. A minimum fall of 3 degrees

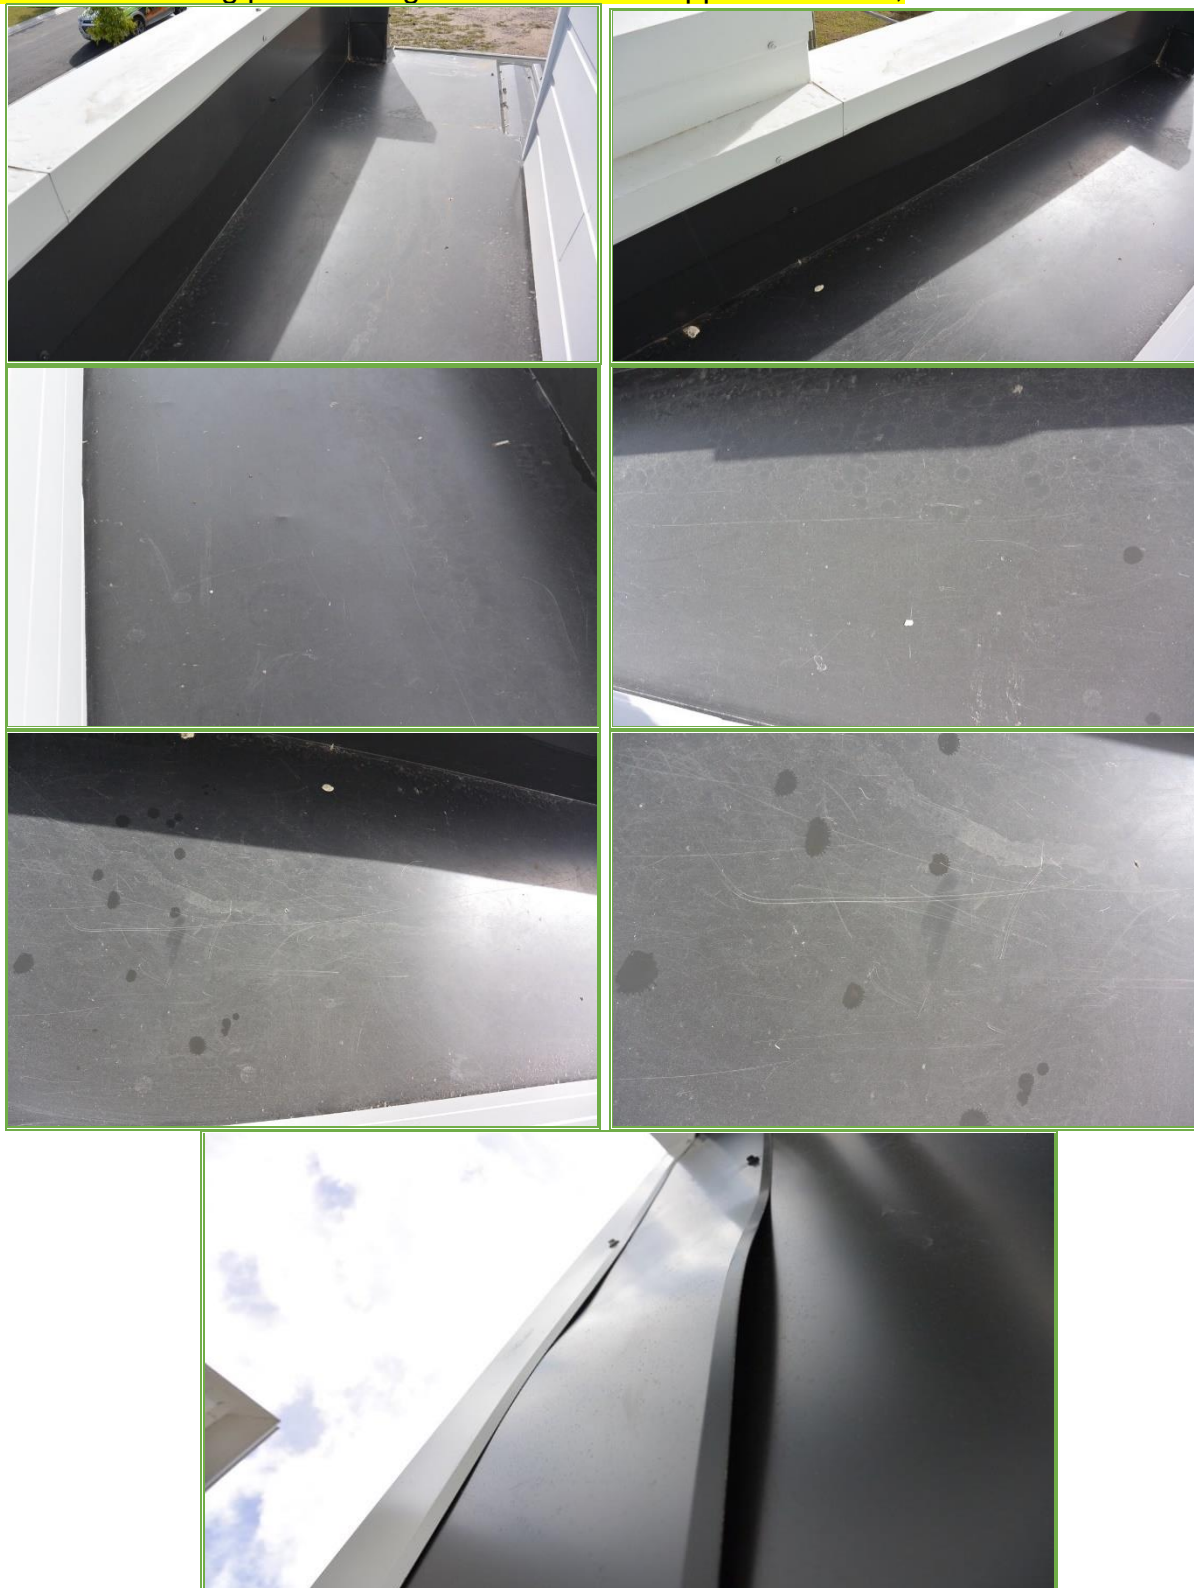
4. The roof sheeting has marks, scratches, dents caused during the carrying out of building work. Roof sheeting are defective if they are dented or mark in the first 12 months of completion, this will need to be rectified. We refer the Builder to Below

Within 12 months from date of completion of the works, staining, folds, splits, dents, open joints between panels, cracking and other distortions in roof cladding, are defects if they are visible from a normal viewing position at ground level or an upper floor level,

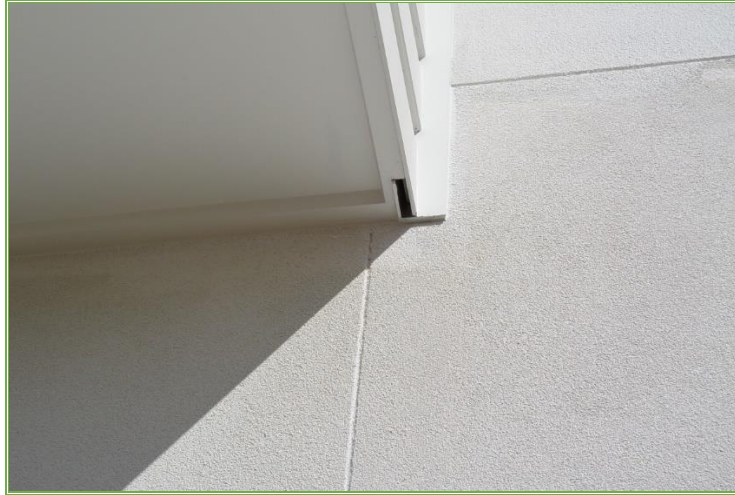
5. Gap to external area needs to be sealed. This gap must be sealed as per the NCC FP1.4.

It must be rectified before handover as marked as this will cause undue dampness and deterioration which is conditions conducive to structural damage.

A roof and *external wall* (including openings around *windows* and doors) must prevent the penetration of water that could cause—

- (a) unhealthy or dangerous conditions, or loss of amenity for occupants; and
- (b) undue dampness or deterioration of building elements.

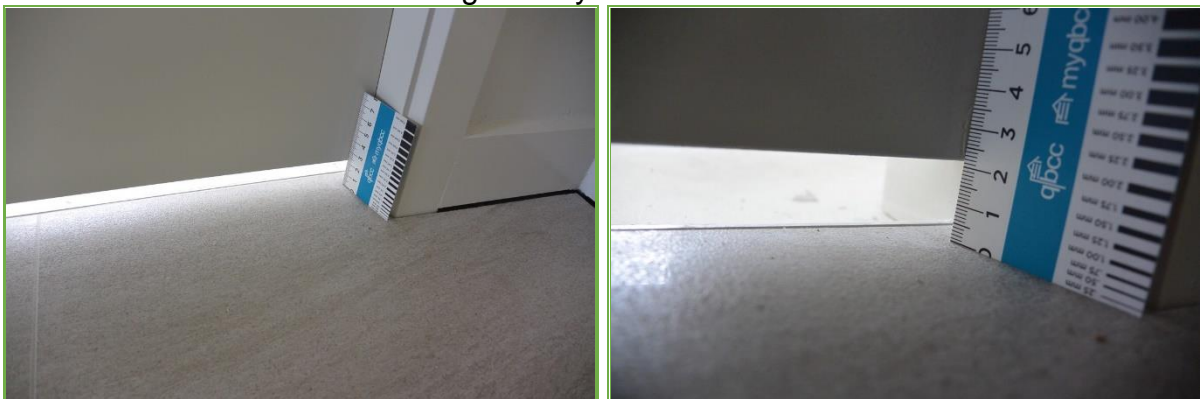
6. Door has excessive gaps; this will need to be reworked before handover. We refer the builder to the insert below.

A clearance between door leaves or between a door leaf and the frame is defective if it is less than 2mm or greater than 4mm in width

Unless additional clearance is required for removable toilet doors or air ventilation, a clearance between the door and the floor finish is defective if it is greater than **15mm** after installation of the floor covering.

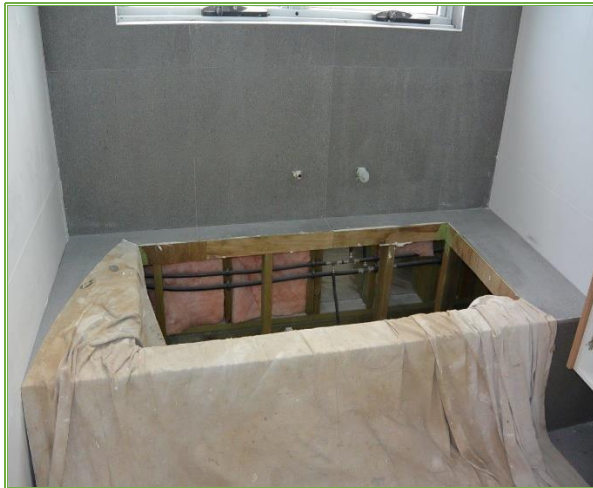
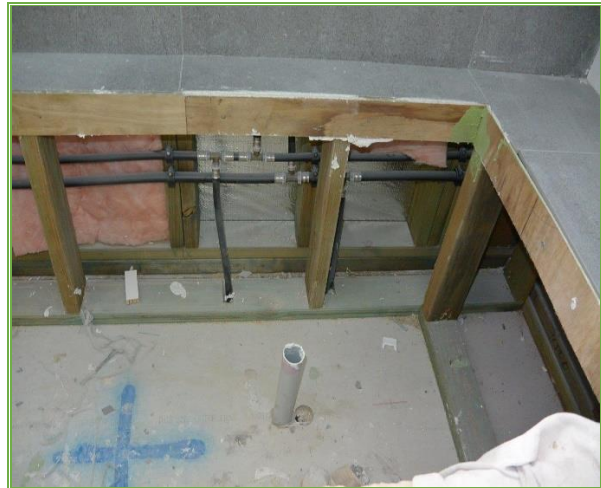
7. It was noted at the time of inspection that the main bathroom bath waterproofing has not been installed as per plan have substituted ply for the vertical up stand instead F/C sheeting and finishing flush with the tile which should have a lip up above the tiles all needs to be rework as per plan and AS 3740

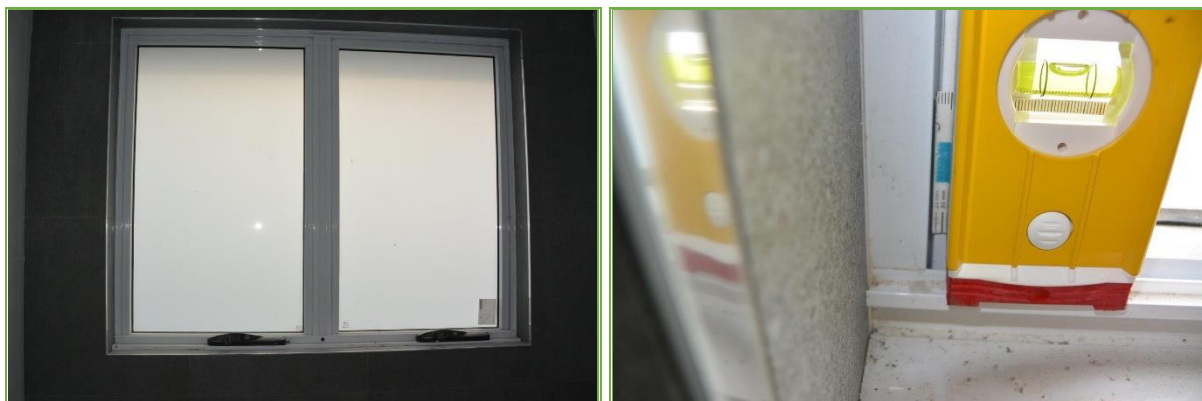
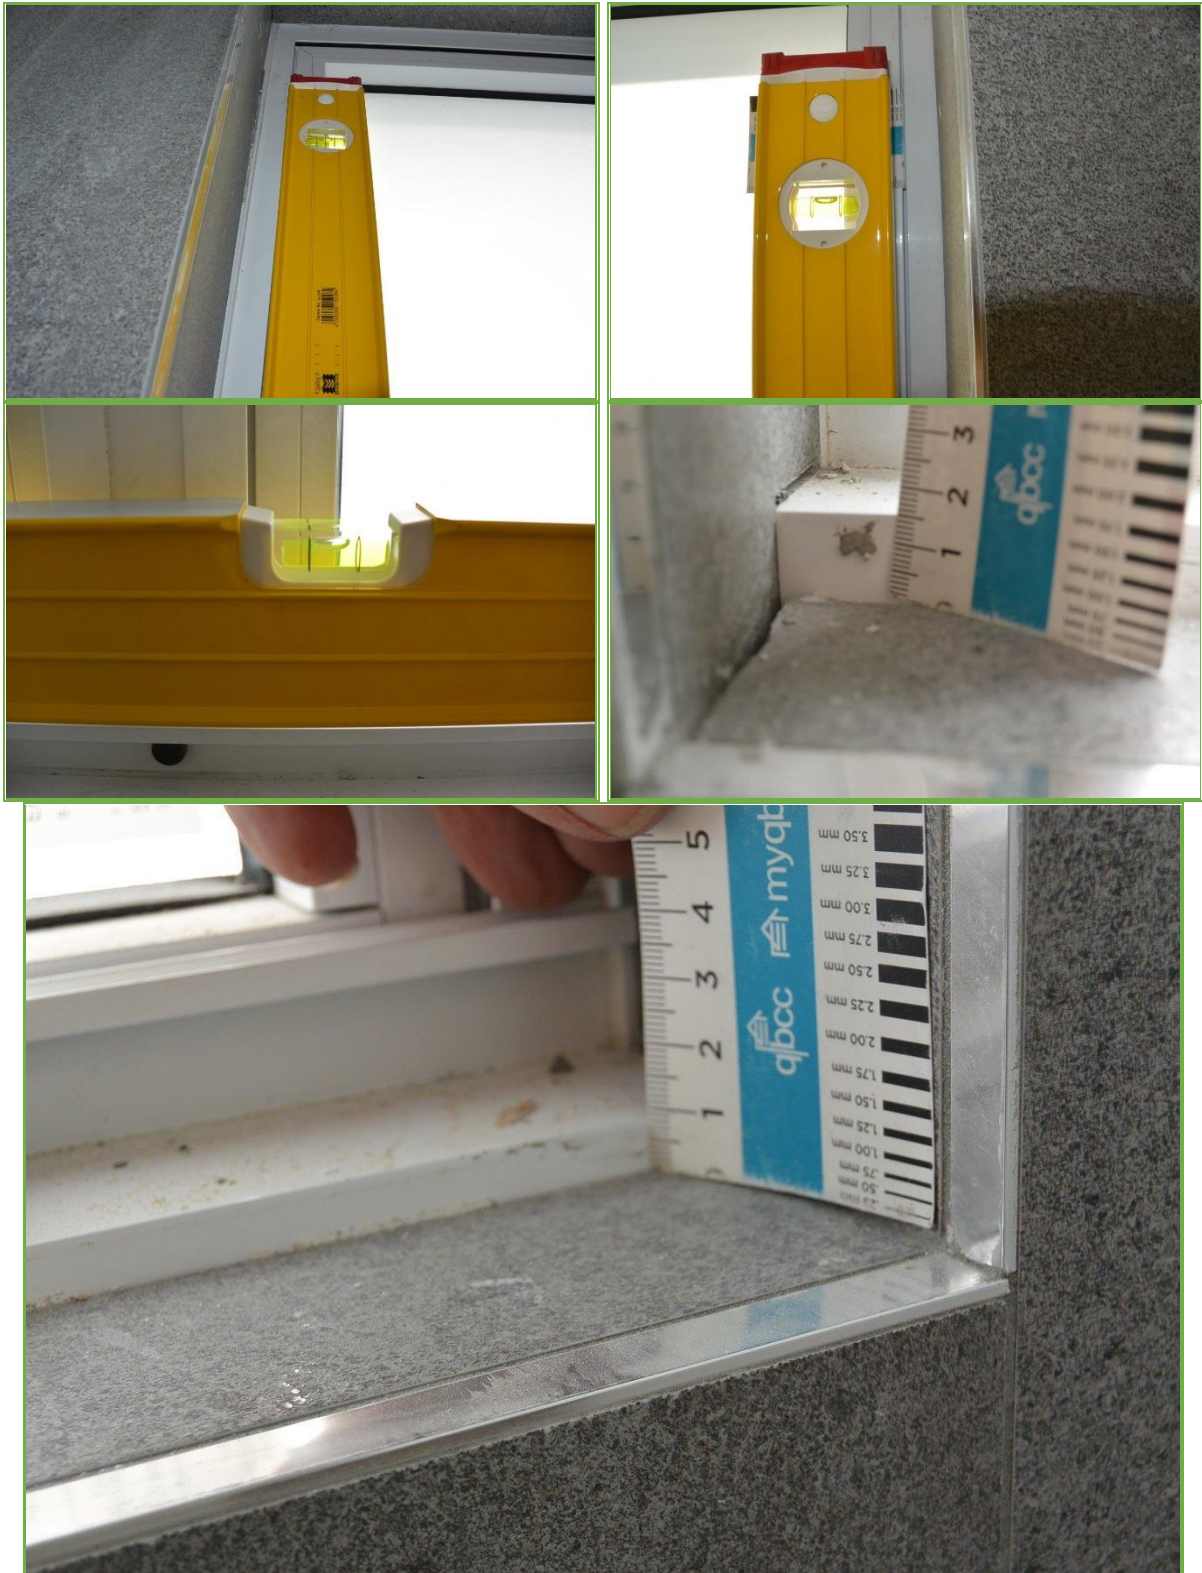
8. It was noted at the time of inspection that the main bathroom window appears to be installed out plumb and level therefor the tiling around the window is now uneven this needs to be rectified. We refer the builder to Australian Window Association the insert below step 3.

3. Frame must be packed plumb, square and not twisted between the openings. Ensure the sill is fully supported; failure to do so may result in sill roll on sliding windows. Sills on all windows and doors must be straight and level and should be packed and secured.

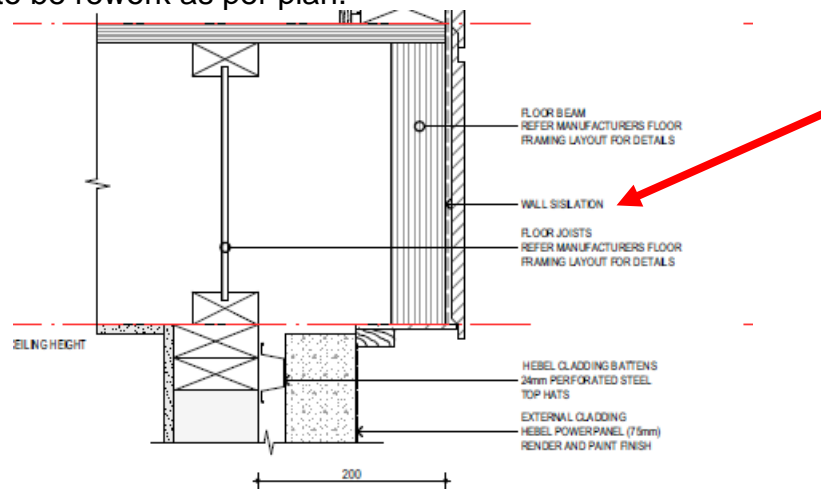
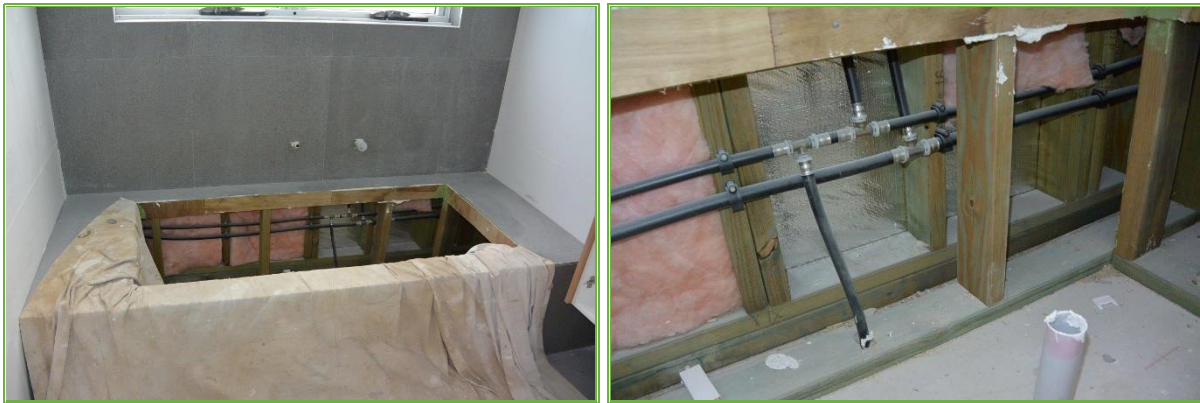
9. It was noted at the time of inspection that the main bathroom wall batts have been remove or missing this needs to be rework as per plan.

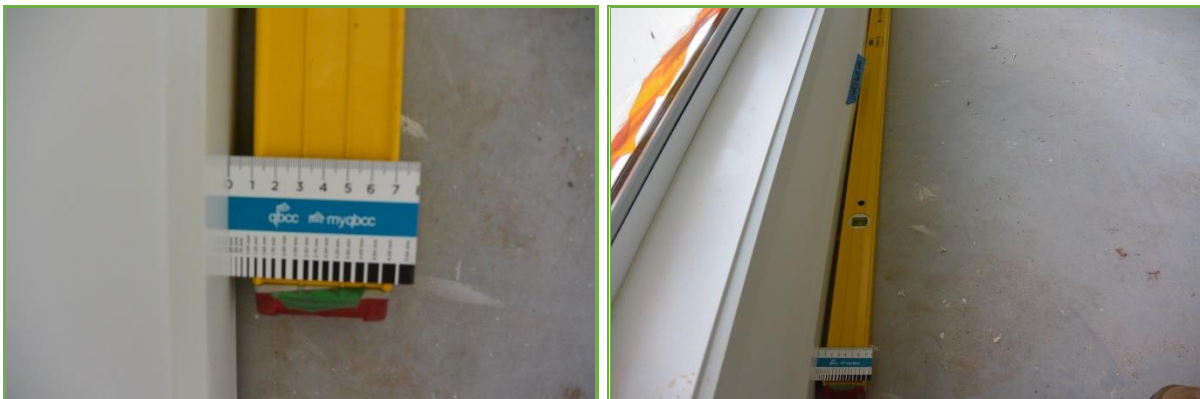
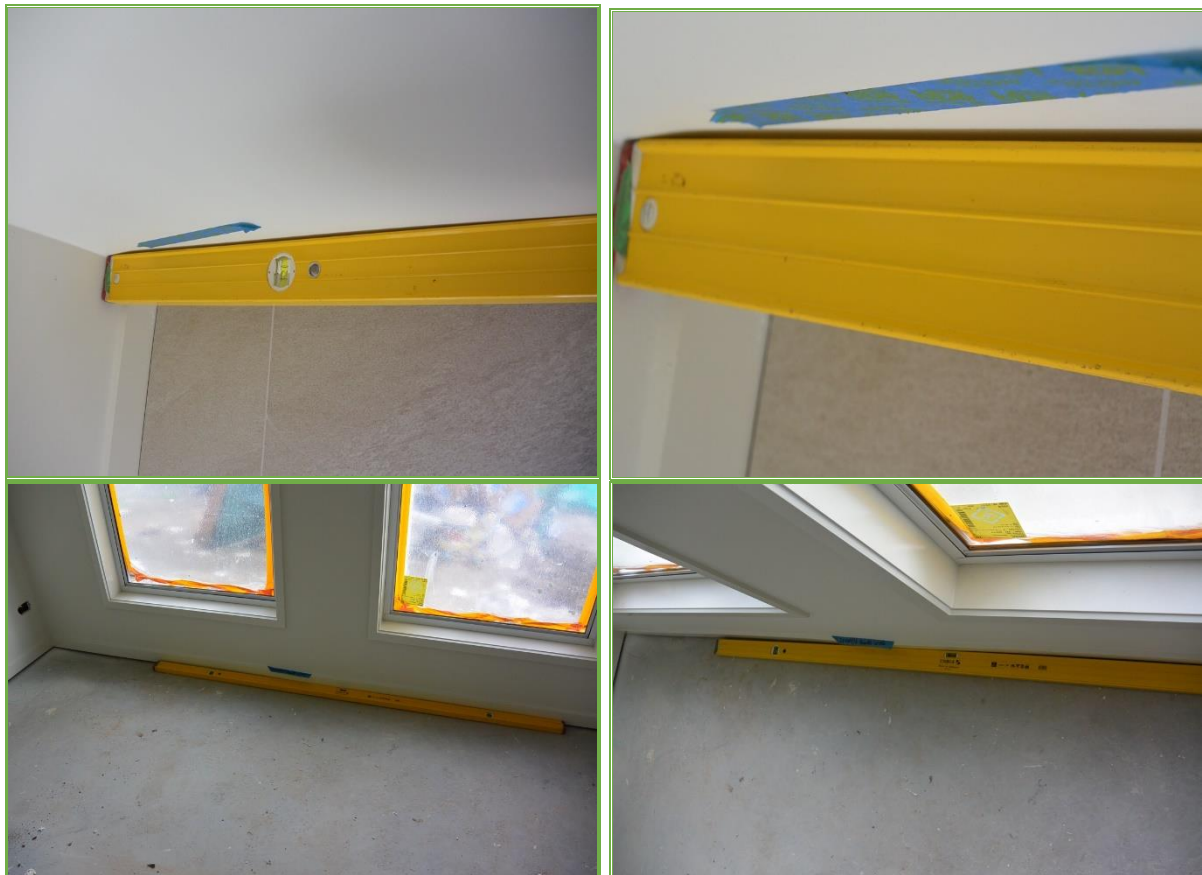
10. A few walls and ceilings exceed the allowable tolerance as marked, this will need to be reworked. We refer the builder to the insert below.

Within the first 12 months from completion of the work, frames are defective if they deviate from plane (horizontal or vertical bow) by more than 4mm in any 2m length of wall. Refer to Figure 1.3 A and B in this Guide for method of measurement. Frames that will be subject to the subsequent fixing of plasterboard must be such that when a 1.8m straight edge is placed over the wall frame the maximum deviation from the straight edge must not exceed 4mm over 90% of the area and not exceed 5mm over the remaining area. Within the first 12 months from completion of the work, frames that exceed these tolerances are defective. Refer Figure 5.3 which reproduces Table 5.2.2 from AS 2589.
