## **Pre-Purchase REPORT** (hereinafter called the "Report")

**Inspection Date: 4/11/2020**

**Property Address: A15 Sample St Upper sample 4122**

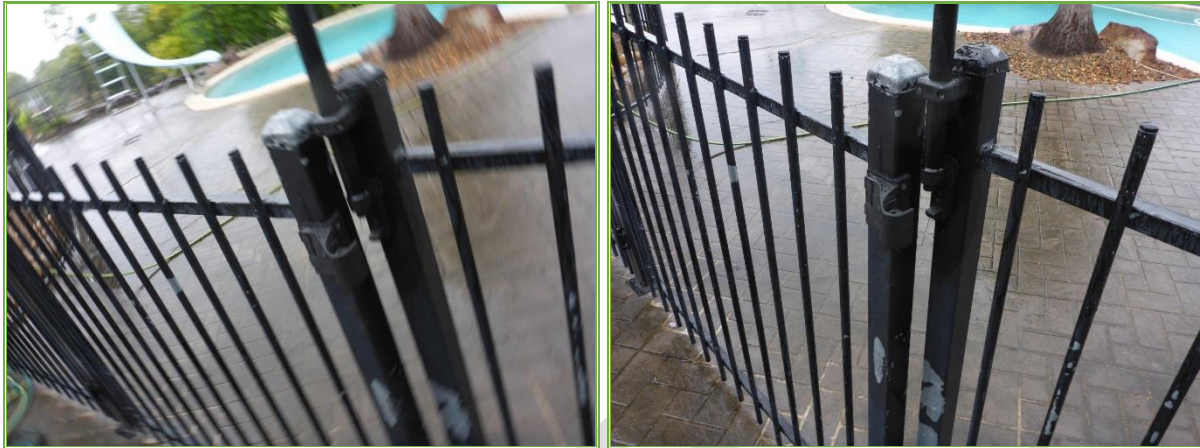
**Where it is:** External

**What it is:** Pool area appears to be non-complaint.

**Results:** Commenting on compliance with Legislation and Local Laws is outside the scope of this Report so this defect is noted for your information advice and further action. Maintenance of the pool area and its fixings is urgently required. It represents an urgent and serious safety hazard if left unattended. Recommend a pool certifier to determine the method and the extent of any remedial work required and costs.

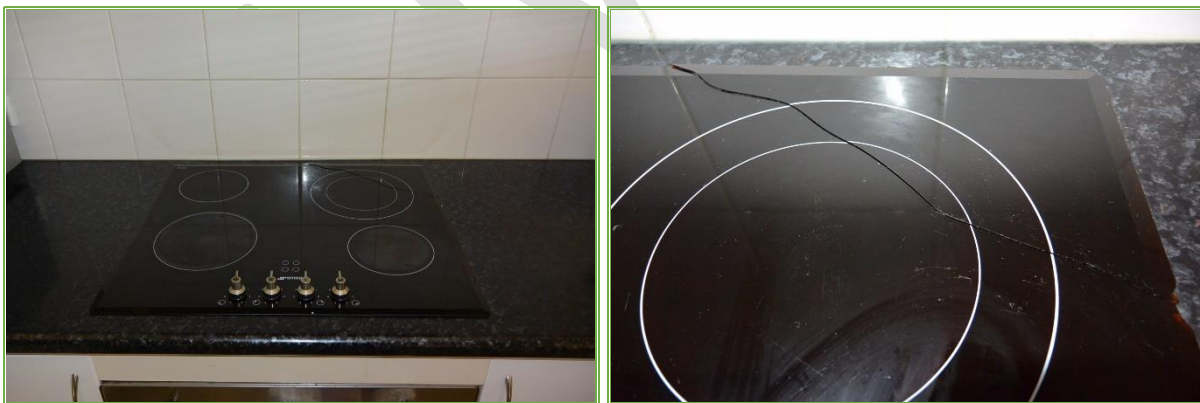
**Where it is:** Internal

**What it is:** Cooktop cracked, this may be a safety hazard.

**Results:** Damage occurs generally when building elements have either aged or decayed or as a result of impact damage (accidental or deliberate). Recommend an Electrician to further investigate. The above recommendations should be implemented straight away as a matter of urgency.

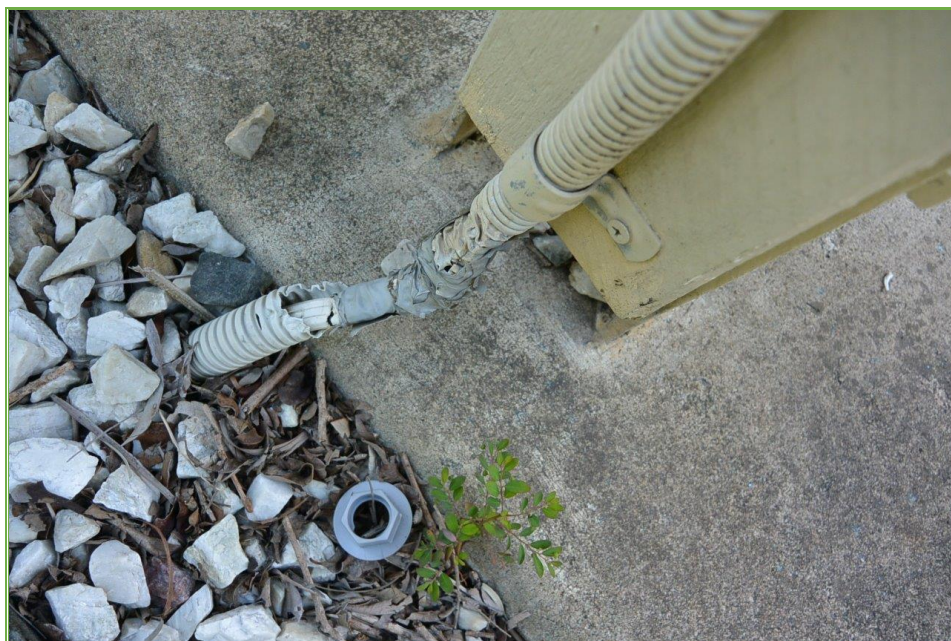
**Where it is:** External

**What it is:** Conduit damaged, this is a safety hazard.

**Results:** The conduit in this area was found to be deteriorating at the time of inspection. Reporting on electrical is outside of the scope of this report so this is noted for further investigation from a competent person.

Recommend an Electrician to further investigate. The above recommendations should be implemented straight away as a matter of urgency.

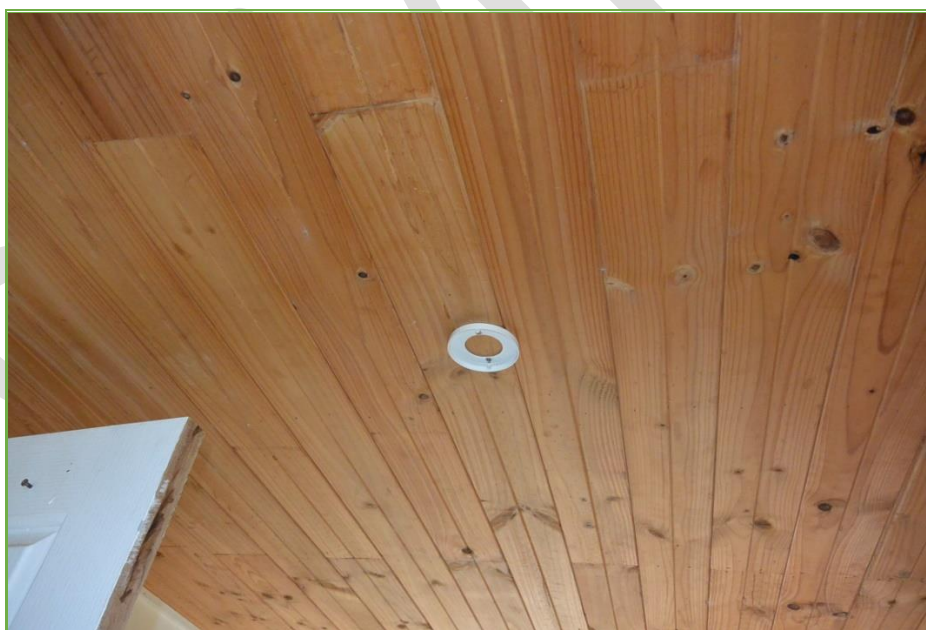
**Where it is:** Internal

**What it is:** Smoke detectors appear to be disconnected

**Results:** This is a safety requirement. The adequacy and testing of fire safety equipment is outside the scope of this standard inspection and report. It is strongly recommended that a further inspection be undertaken by a suitably qualified person.

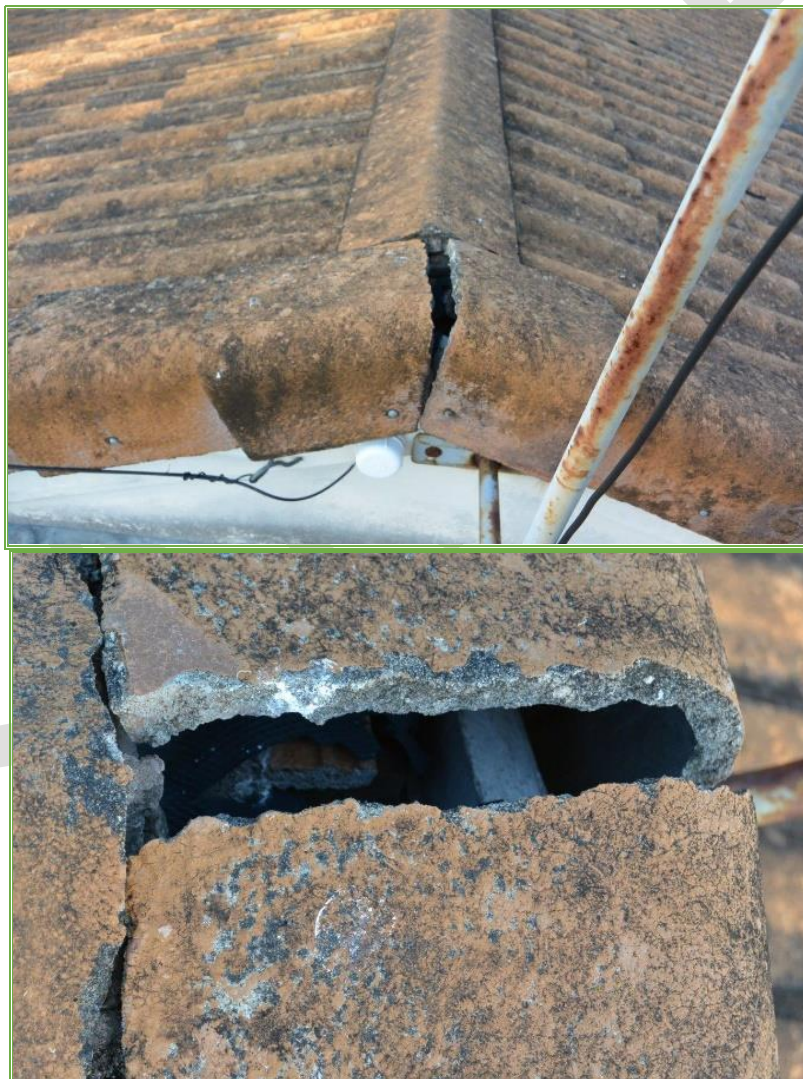
**Where it is:** External Roof

**What it is:** Cracked/Broken Tiles.

**Results:** Broken or cracked tiles are the result of aging and the weather as well. If left (Not repaired or replaced) the broken/cracked tiles may allow water to enter into the roof void causing damage to the ceiling lining and may cause damage to the roof structure, which can lead to conditions that are conducive to structural damage. Recommend a roof contractor to further investigate and repair the roof as soon as possible.

The above recommendations should be implemented as soon as possible.

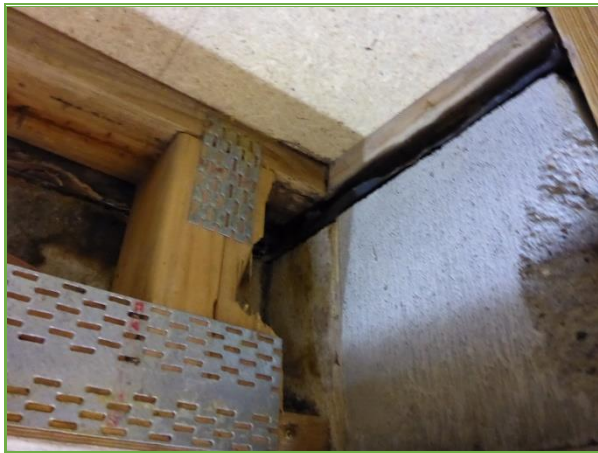
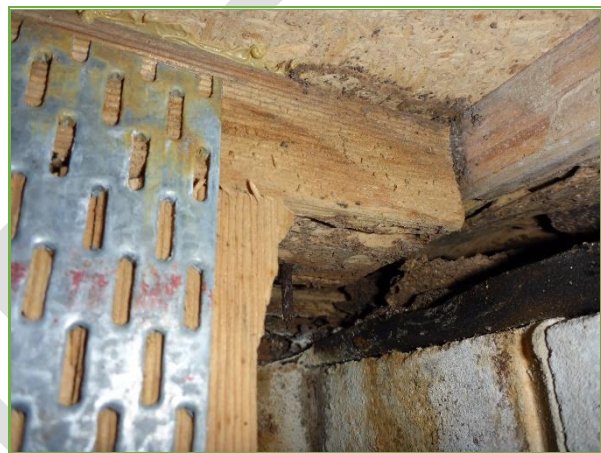
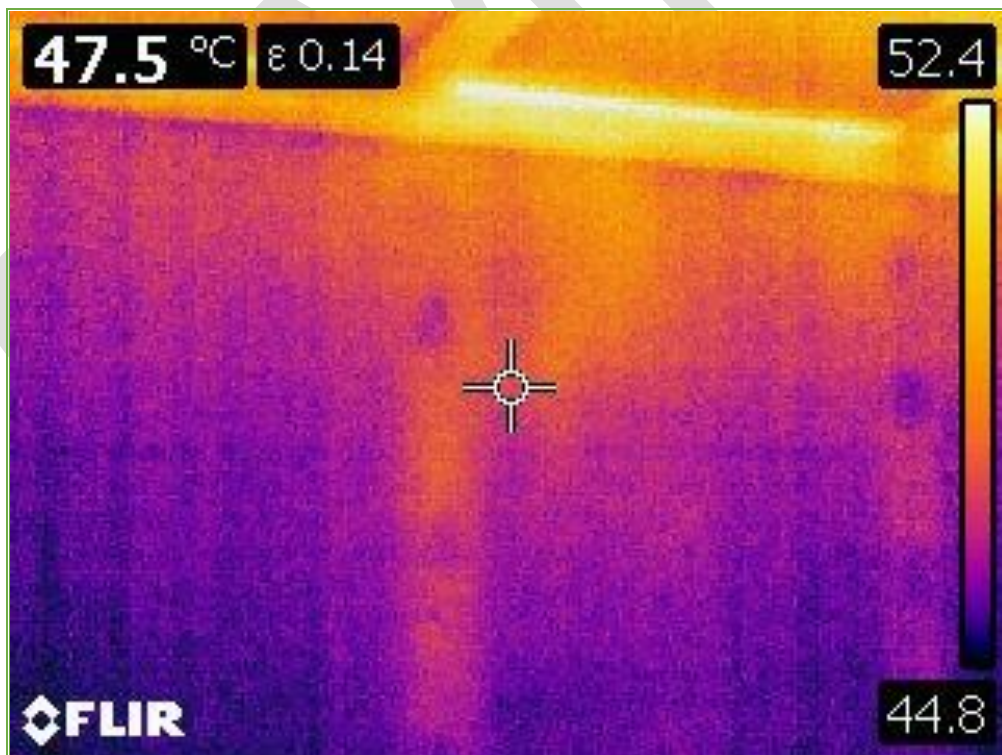
**Where it is:** Widespread.

**What it is:** Termite damage and live or a nest of termites or high moisture with thermal.

**Results:** Further inspection of external and internal areas may be required in order to correctly identify the damage by termites and may include works of an intrusive nature. It is strongly recommended that a Licensed Builder ascertain the structural integrity and the extent of the unknown damage that may be concealed. It is also recommended that a Licensed Pest Company advise the treatment or method that should be carried out. The above recommendations should be implemented as soon as possible.

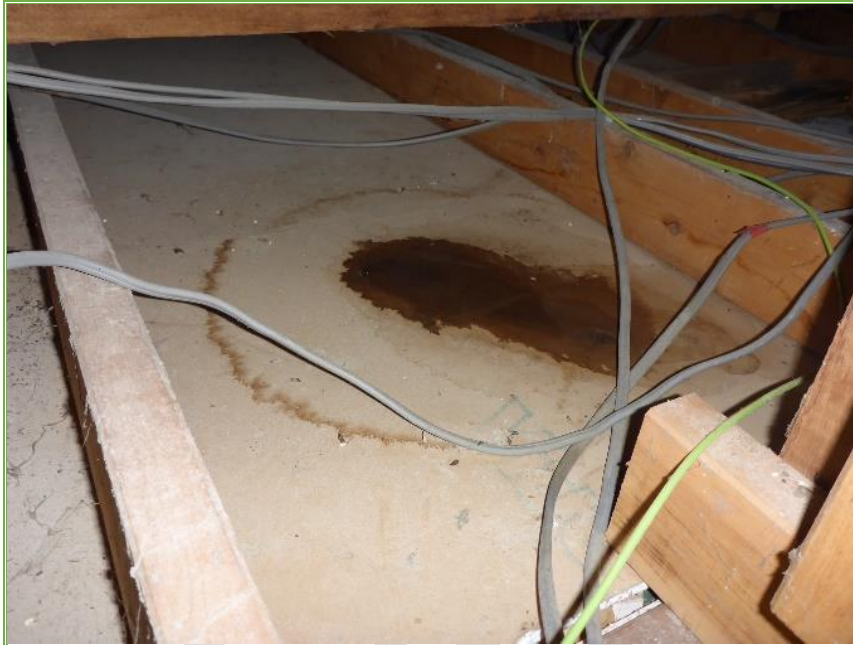
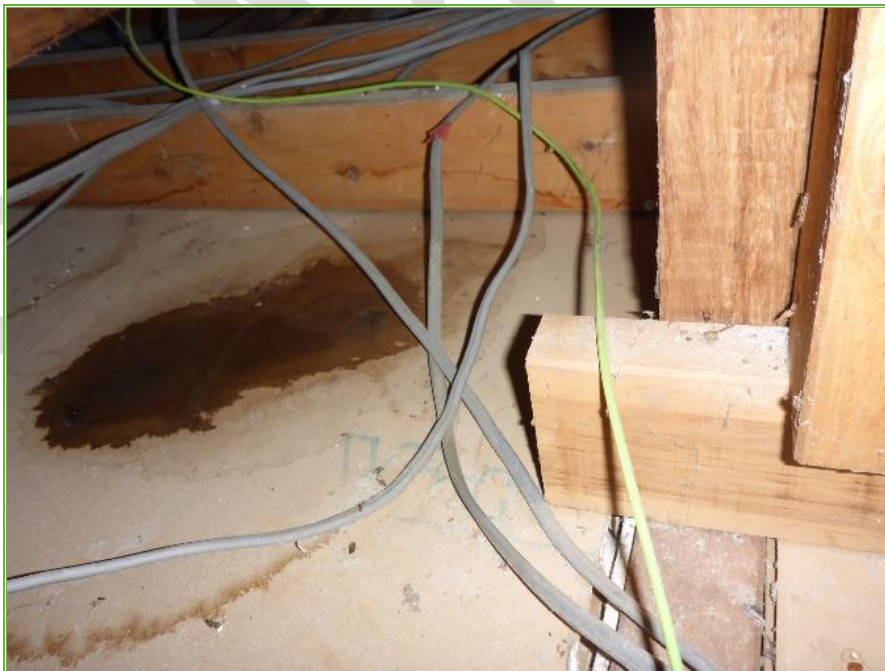
**Where it is:** Roof Void

**What it is:** Water leak – active

**Results:** As the surrounding area was found to be damp at the time of inspection the leak is ongoing and requires urgent action. If left, not repaired it can cause damage to the ceiling lining and may cause damage to the roof structure, which can lead to conditions that are conducive to structural damage. Recommend a roof contractor to further investigate the leak and repair the roof as soon as possible. The above recommendations should be implemented as soon as possible.

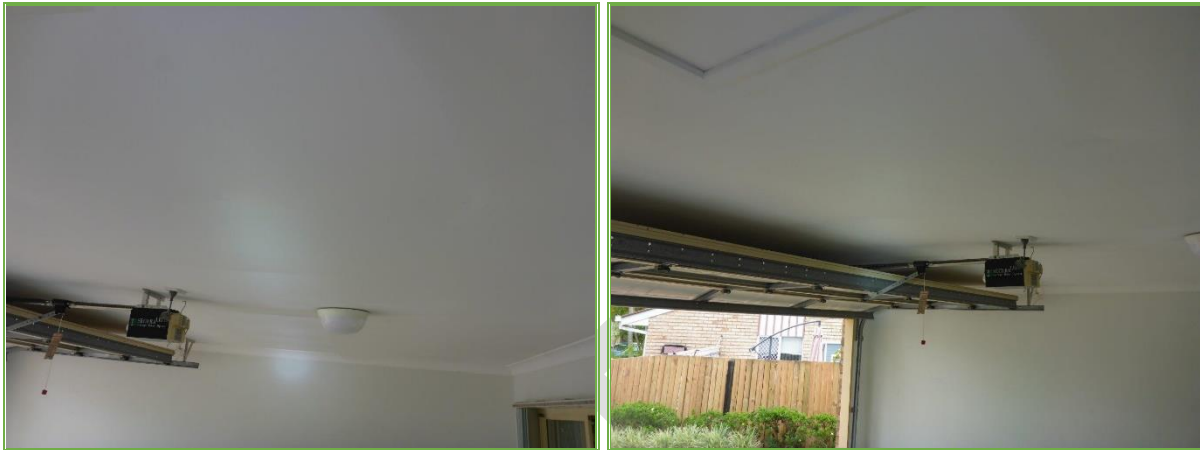
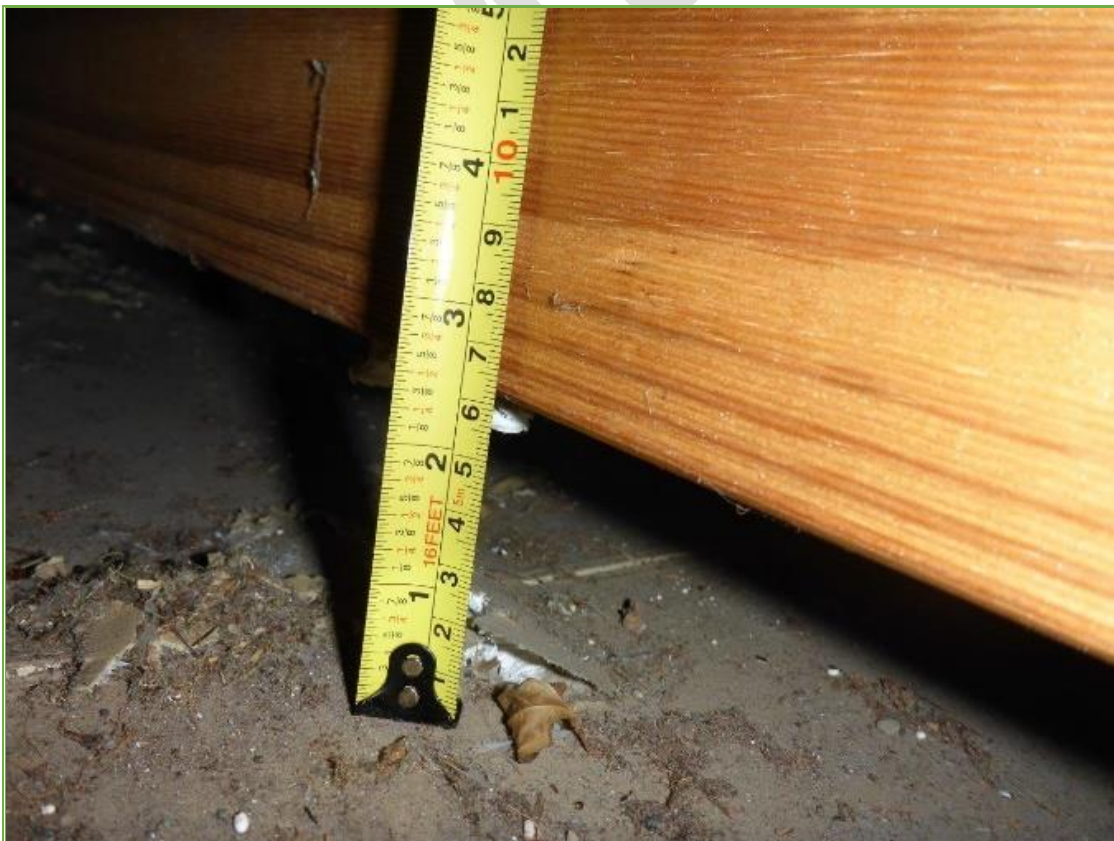
**Where it is:** Some areas.

**What it is:** Ceiling –Sagging

**Results:** Sagging to the ceiling generally indicates that the building materials have swollen due to contact with water or that fixings, nails, or glue have become loose and require reattachment. In some cases, sagging ceiling linings may also indicate that there are structural issues causing surfaces to warp twist or sag. Where sagging appears to be major appointment of a structural engineer is advised to further inspect the property. A Licensed Tradesmen is recommended to determine the method and the extent of any remedial work required, and associated costs and the extent of the damage behind the ceiling cover.

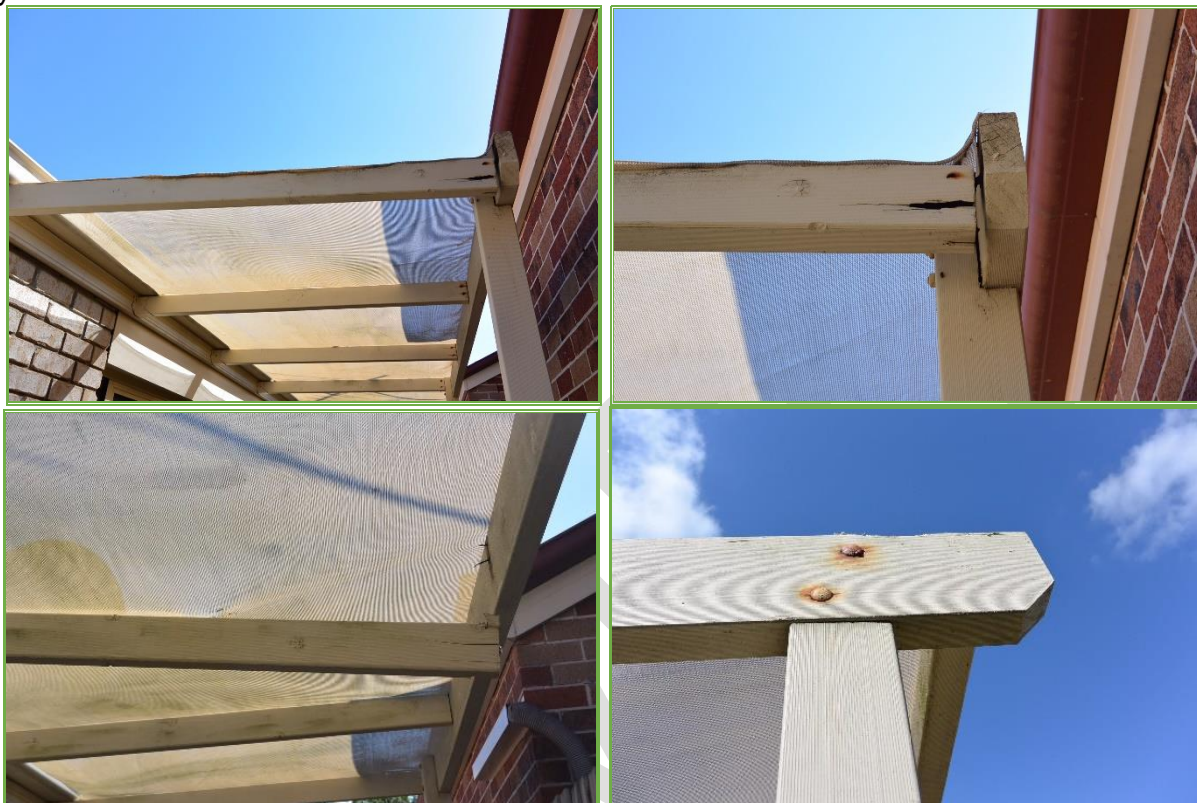
**Where it is:** A few areas

**What it is:** Under cover area is loose, structure is defective.

**Results:** The primary structures are showing signs of deterioration as a result of damp conditions (wood rot) and rusty bolts which has created the loss of strength, which may cause the structure to fail and collapse. A Licensed Builder is recommended to determine the method, cost and the extent of any remedial work required and to determine the structural integrity of the structure. The above recommendations should be implemented as soon as possible as this is a safety hazard.

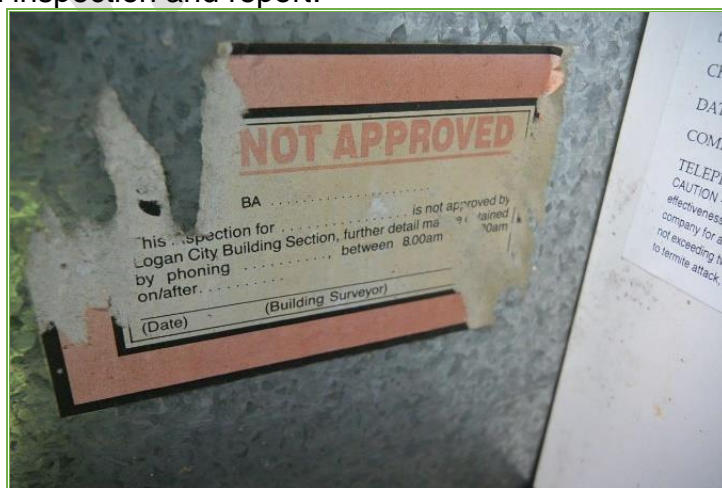
**Where it is:** External meter box

**What it is:** Council sticker saying not approved.

**Results:** The house may not be certified this will require further investigation by a legal person to determine if this property has been certified or not. Reporting on compliance is outside the scope of this standard inspection and report.

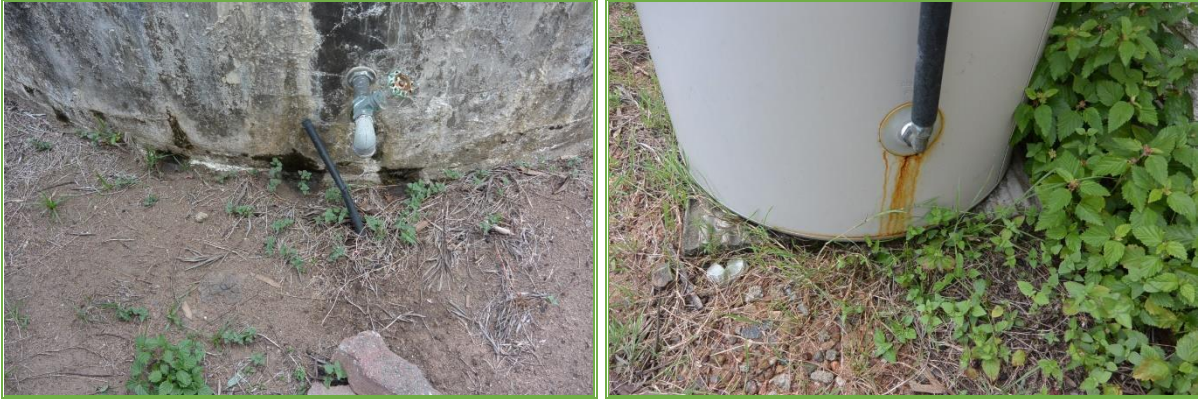
**Where it is:** Some areas.

**What it is:** The tank and HWS, plumbing is defective it appears to be leaking.

**Results:** This could be detrimental to the performance of the system and the rainwater tank. It is conditions conducive to termites as well. Recommend a Competent Person to determine the method and the extent of any remedial work required, and associated costs. The above recommendations should be implemented as soon as possible.

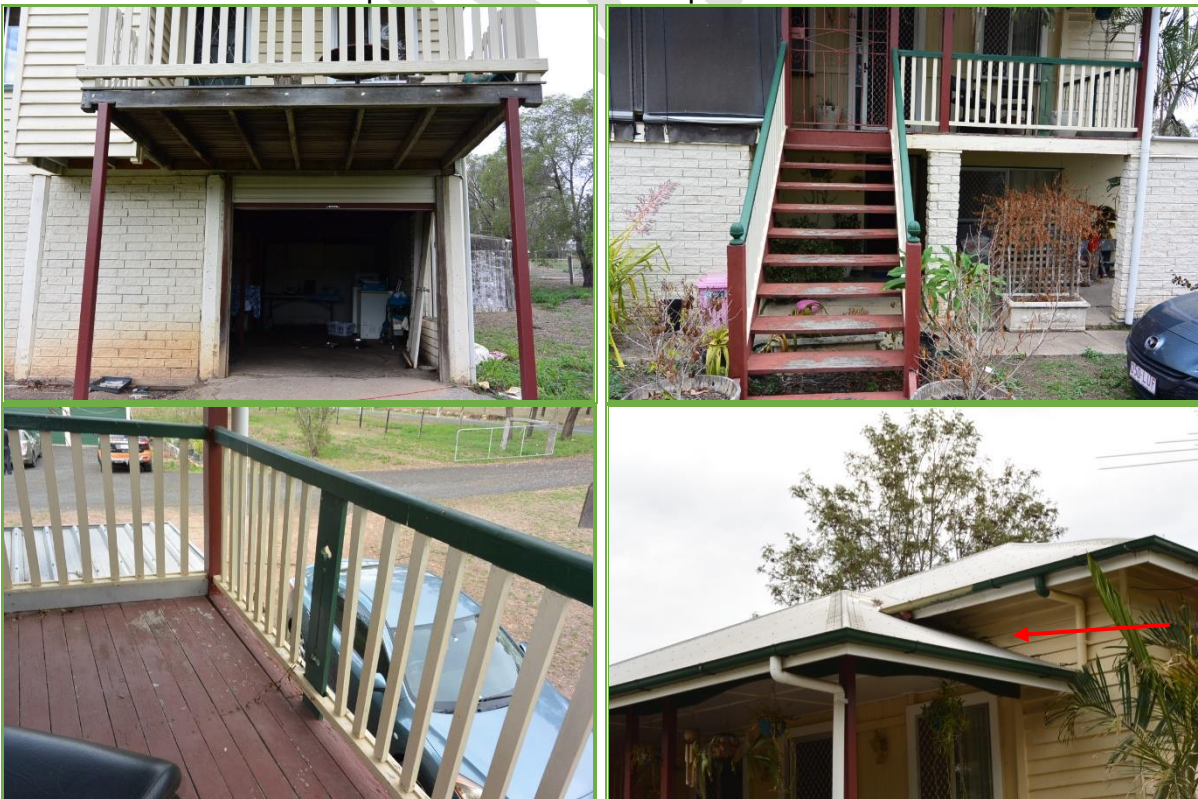
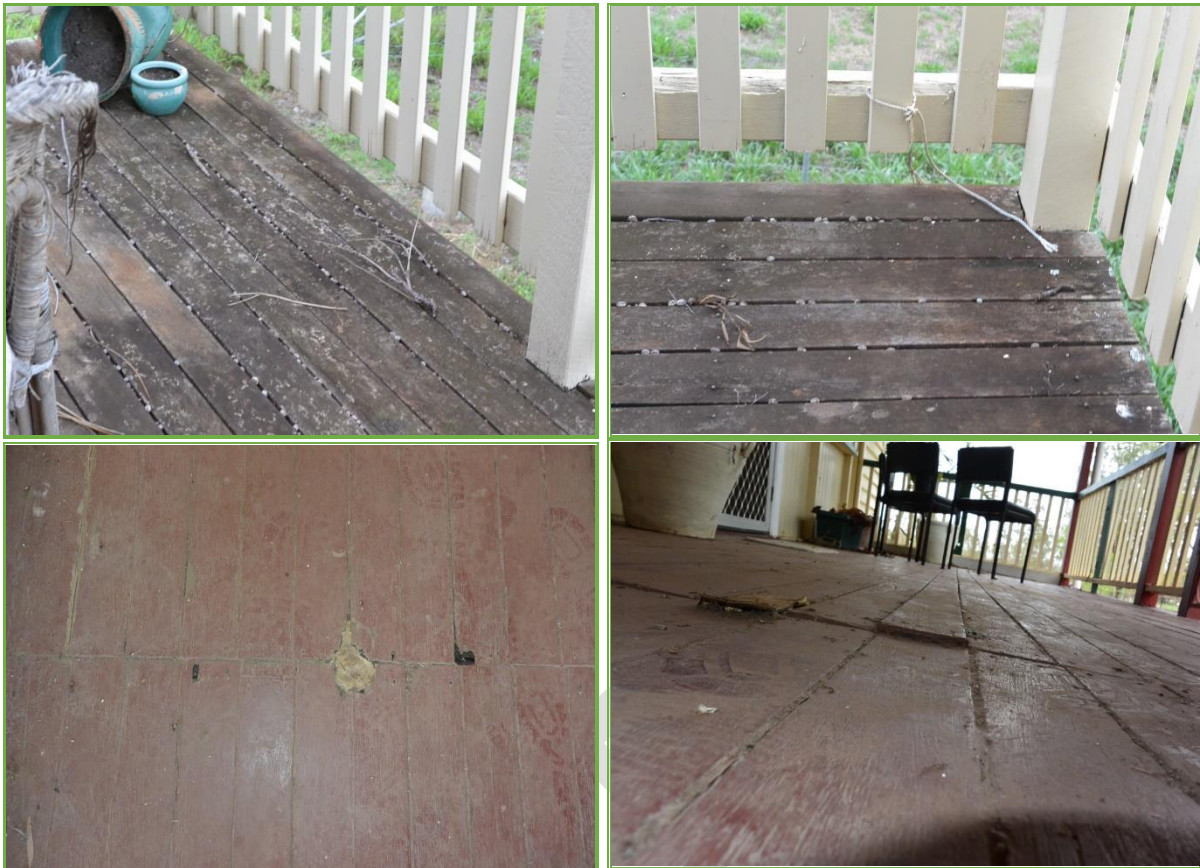
**Where it is:** Widespread

**What it is:** Wood Rot to the structure, nails popping through

**Results:** The structures are showing signs of deterioration as a result of damp conditions which has created the timbers to rot. Regular maintenance of the timbers is required to prolong the life of this building element which may include but not limited to (Painting, sealing)  
Recommend to first identify the cause of the timber rot, then replace the affected timber where required, the timeframe for this depends on the severity of the rot. Recommend a Competent Person to determine the method and the extent of any remedial work and costs. The above recommendations should be implemented as soon as possible.

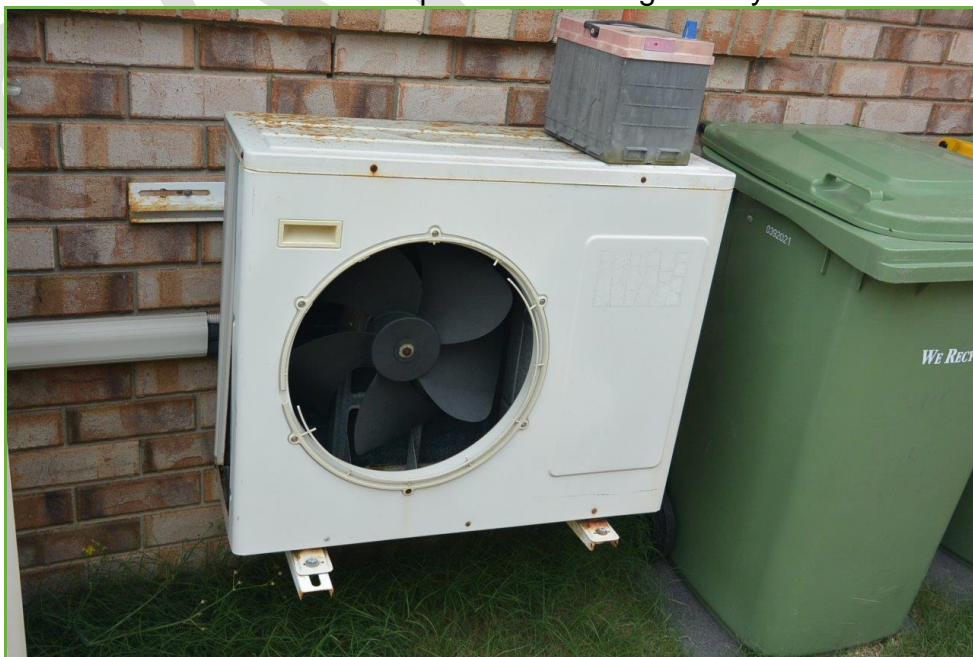
**Where it is:** A few areas

**What it is:** Damage fittings.

**Results:** The adequacy and testing of electricity is outside the scope of this standard inspection and report. Recommend a competent person like a Licensed Electrician to determine the method or work required and associated costs.

The above recommendations should be implemented straight away as a matter of urgency.

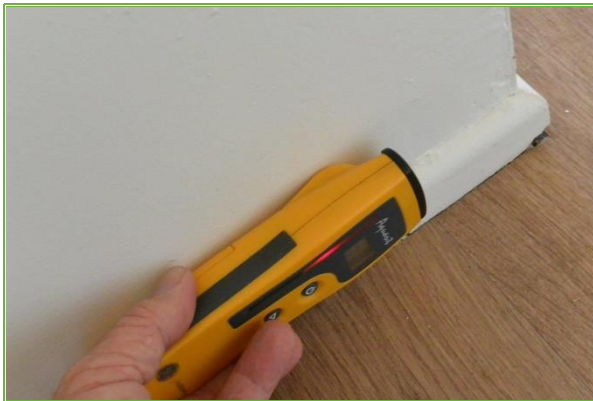
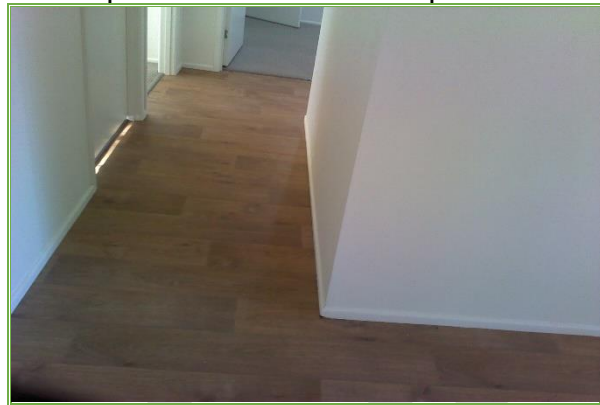
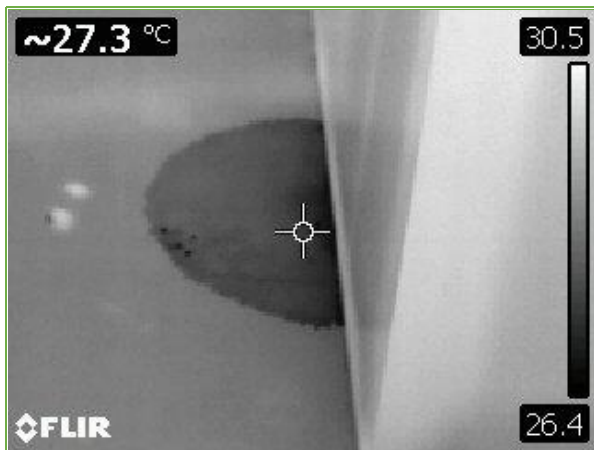
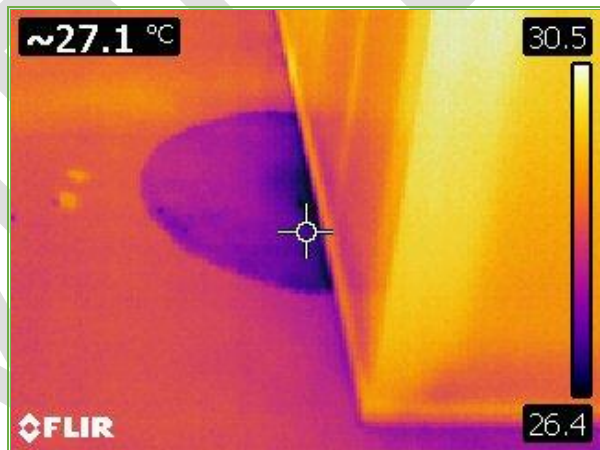
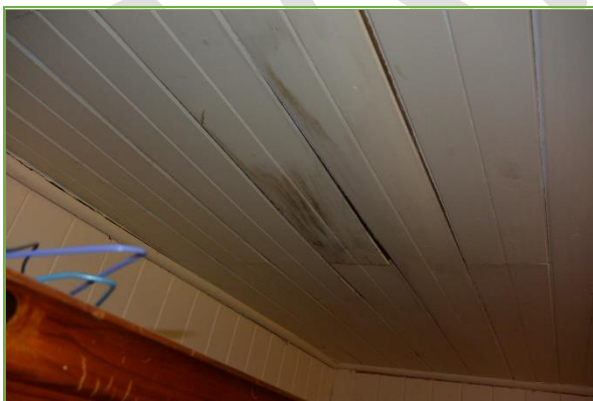
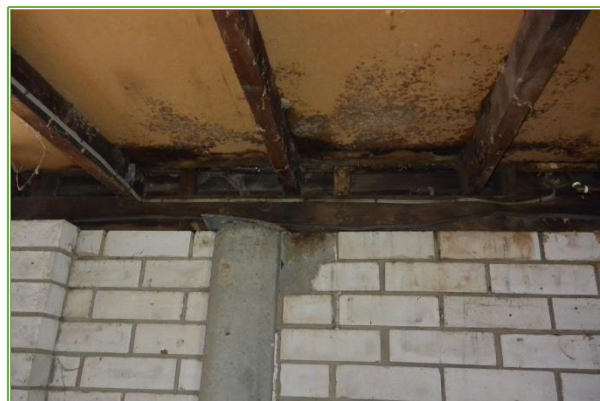
**Where it is:** Widespread.

**What it is:** High Moisture and evidence of leaking and water damage.

**Results:** High Moisture was noted in wall, which can cause conditions conducive to structural damage. Under test conditions it was revealed that high moisture was evident in the secondary wall adjacent to the shower. Damp or wet conditions generally indicate a leak or poor ventilation, or failure of the waterproofing. Recommend a Plumber, to determine the cause and the method. The above recommendations should be implemented as soon as possible.

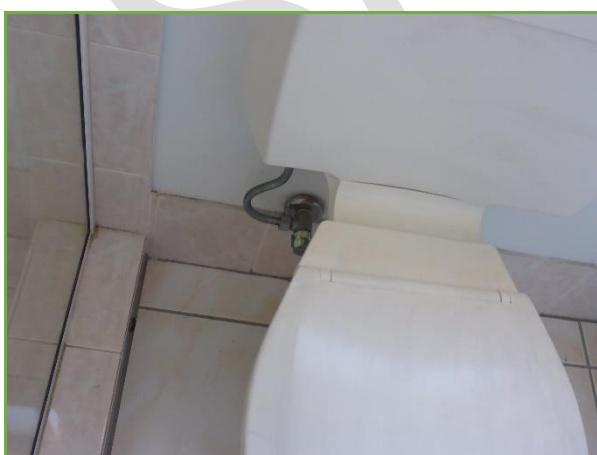
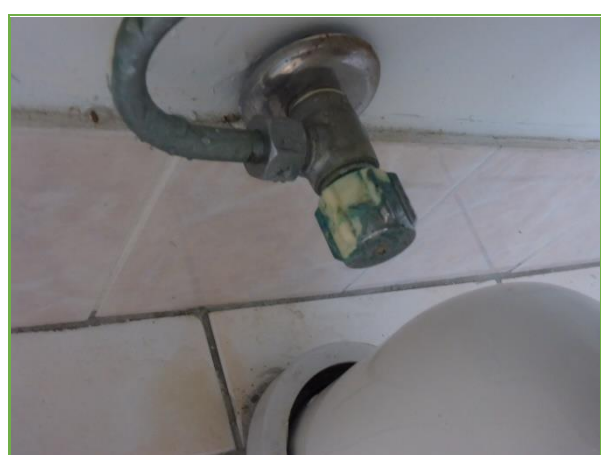
**Where it is:** Internal All Toilets

**What it is:** Toilets leaking – active.

**Results:** As the surrounding area was found to be damp at the time of inspection the leak is ongoing and requires urgent action as it can cause conditions conducive to structural damage. Regardless of the location if left unmanaged leaks can lead to serious damage of associated building elements and result in the need for replacement of building materials. Mould and other hazards such as electrical hazards may also arise if left unmanaged. A licensed plumber should be appointed to further investigate the leak. The above recommendations should be implemented as soon as possible.

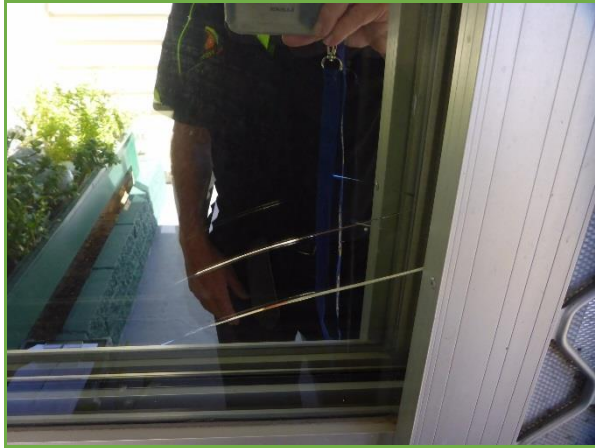
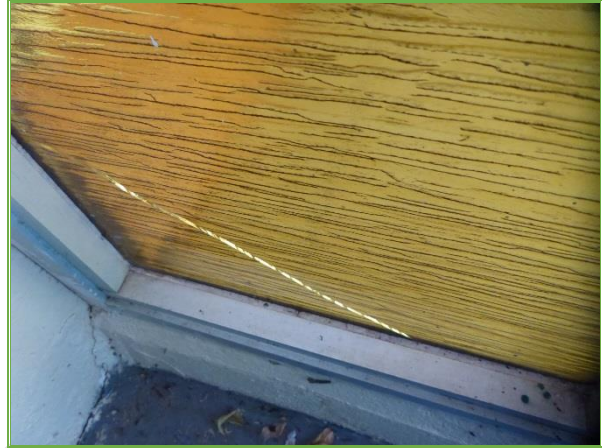
**Where it is:** A few areas.

**What it is:** Cracked Windows.

**Results:** Cracking in windows may be caused by impact damage. Any cracked glass is a safety hazard and may allow water to penetrate into the surrounding building elements.

It is highly recommend that a qualified glazier repair or replace the broken or cracked glass. The above recommendations should be implemented straight away as a matter of urgency.

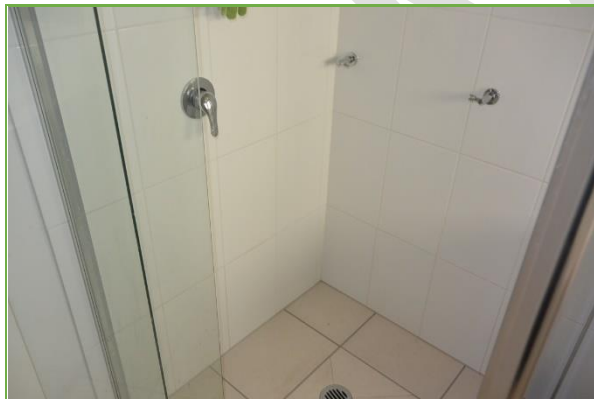
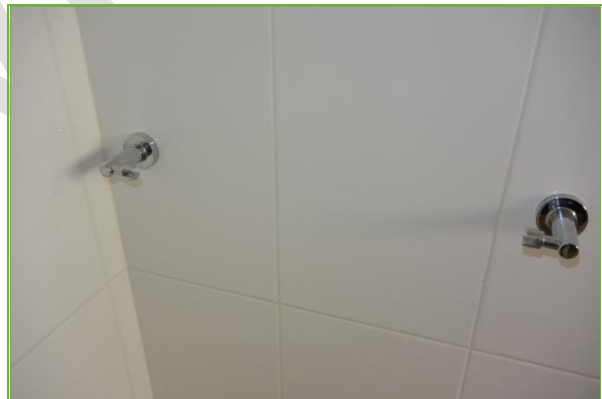
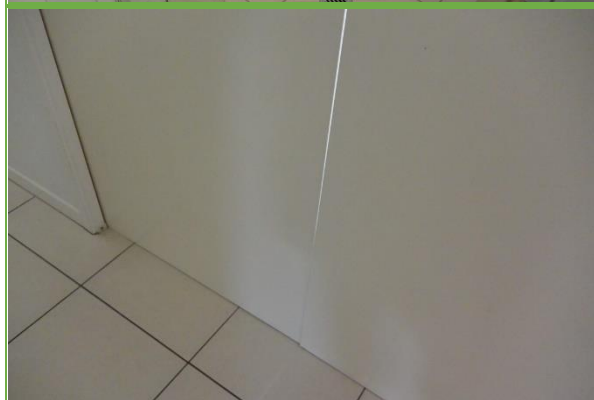
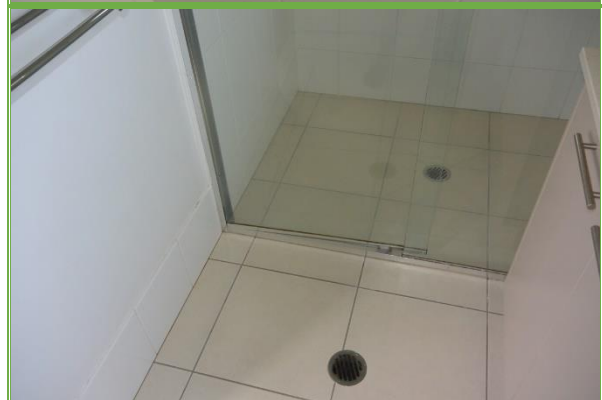
**Where it is:** Some areas.

**What it is:** Shelves are missing and a few doors are binding/stiff.

**Results:** Although some building elements may seem irrelevant or unnecessary all building elements have a purpose in the overall function and performance of that building element.

Recommend to rectify the defective building element, so as to have it fully functional as it is intended.

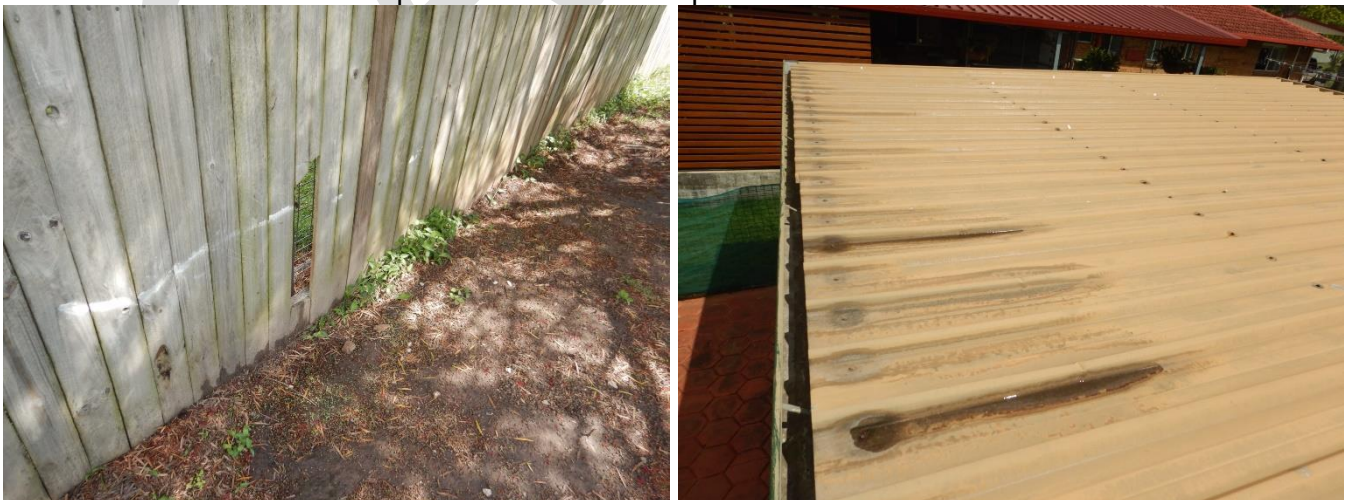
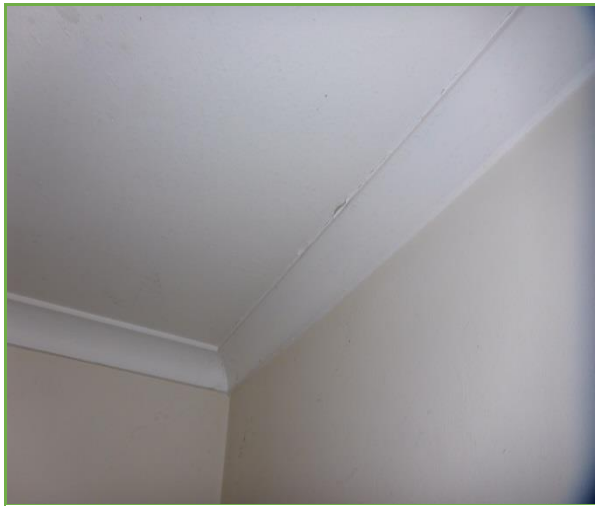
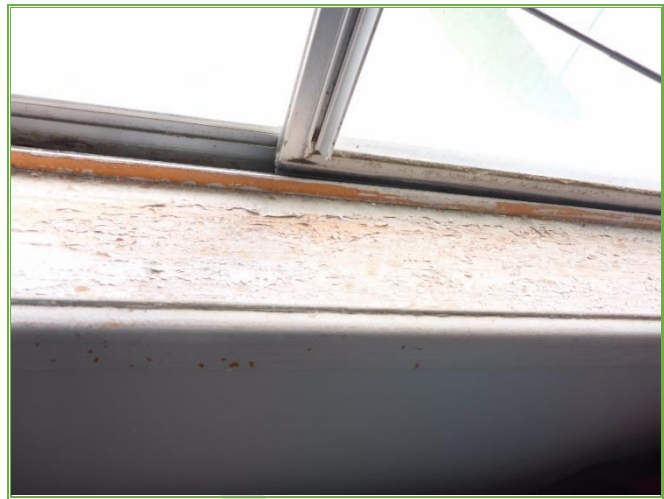
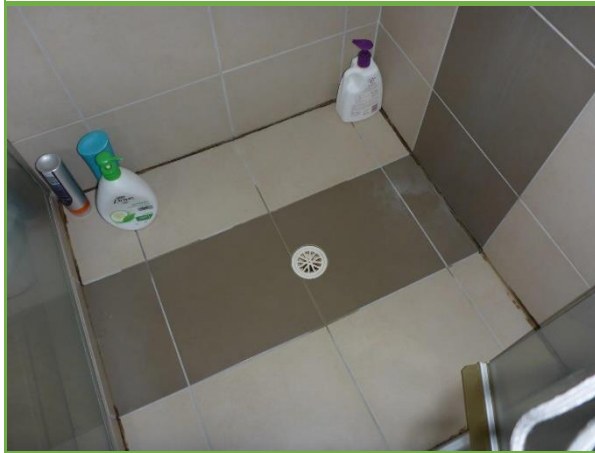
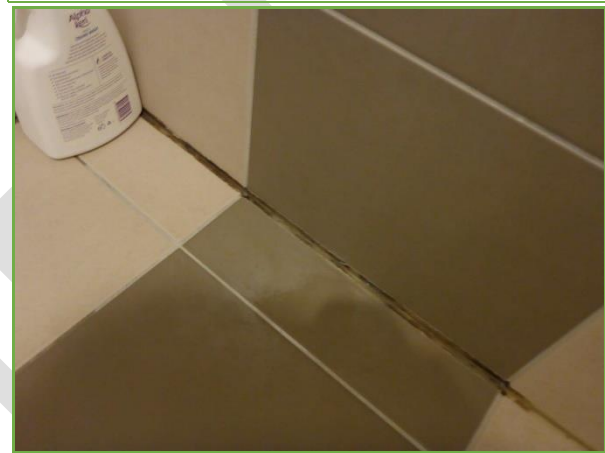
**Where it is:** Some areas.

**What it is:** General wear and tear, overgrown vegetation, normal maintenance to be carried out.

**Results:** General wear and tear over time building elements can become loose, deteriorated, leak and then there is swollen, splitting, Fungal Decay to the timbers, rust to the metals, corrosion, flaky paint, deteriorated grout/sealant, leaking plumbing fittings and it then can become conducive to structural damage and conducive to termites if normal maintenance is not carried out. Depending on the level of damage to the building element, depends on what trades are required. Competent Person is recommended to determine the method and the extent of any remedial work and costs. The above recommendations should be implemented as soon as possible.

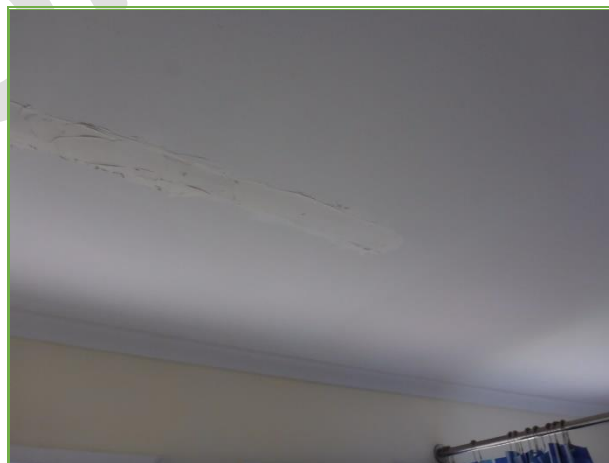
**Where it is:** Some areas.

**What it is:** Old repairs— appears to have an evidence of repairs

**Results:** When there is evidence of repairs, the most critical factor is identifying the specific causes that have created these defects, and identifying if this is a recurring or ongoing problem or one that has been unresolved or resolved by the owner's actions in the past. Please obtain from owner in writing as to why the property was repaired. Please be aware that linings when removed or replaced may reveal other currently concealed damage they are covering.

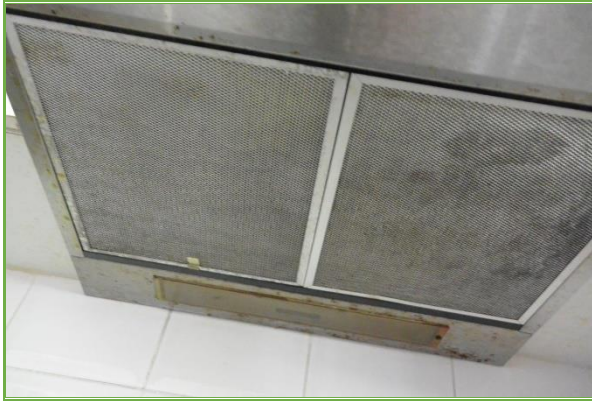
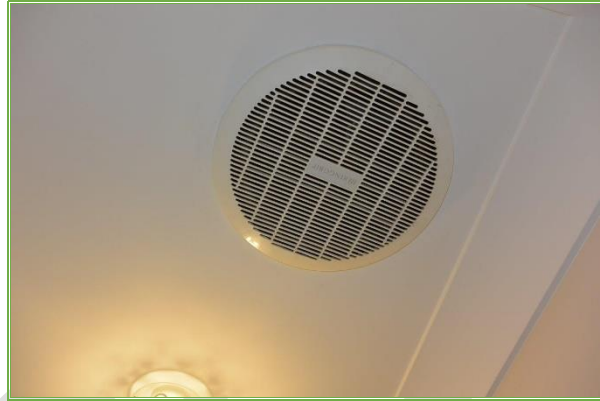
**Where it is:** A few areas.

**What it is:** Fitting or fixture non-operational.

**Results:** The range-hood light and toilet was found to be not operating correctly at the time of inspection. The adequacy and testing of appliances are outside the scope of this standard inspection and report. Recommend a competent person like a Licensed Electrician to determine the method or work required and associated costs.

The above recommendations should be implemented straight away as a matter of urgency.

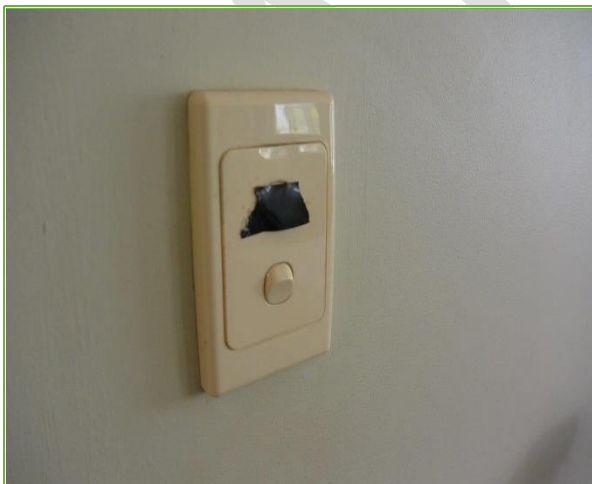
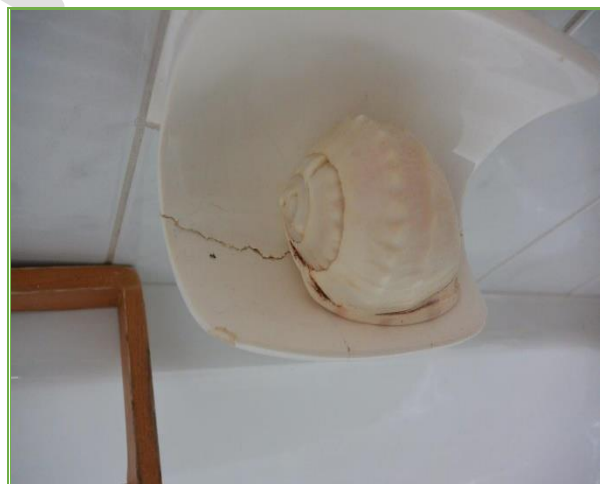
**Where it is:** A few areas

**What it is:** Damage switches and soap holder .

**Results:** Although some building elements may seem irrelevant or unnecessary all building elements play a key role in the operation and function of the overall structure and its performance. Replacement of any damage building element should be conducted as soon as possible. Depending on the building element which is damage, depends on what trades are responsible for such works, which may include but not limited to, plumber, electrician, builder or general handyman.
