**PRE-PURCHASE  
STANDARD TIMBER PEST REPORT**

Report number: 10636

Inspection date: 21 January, 2020

Property address: 61 Sample Drive Sample South 4123

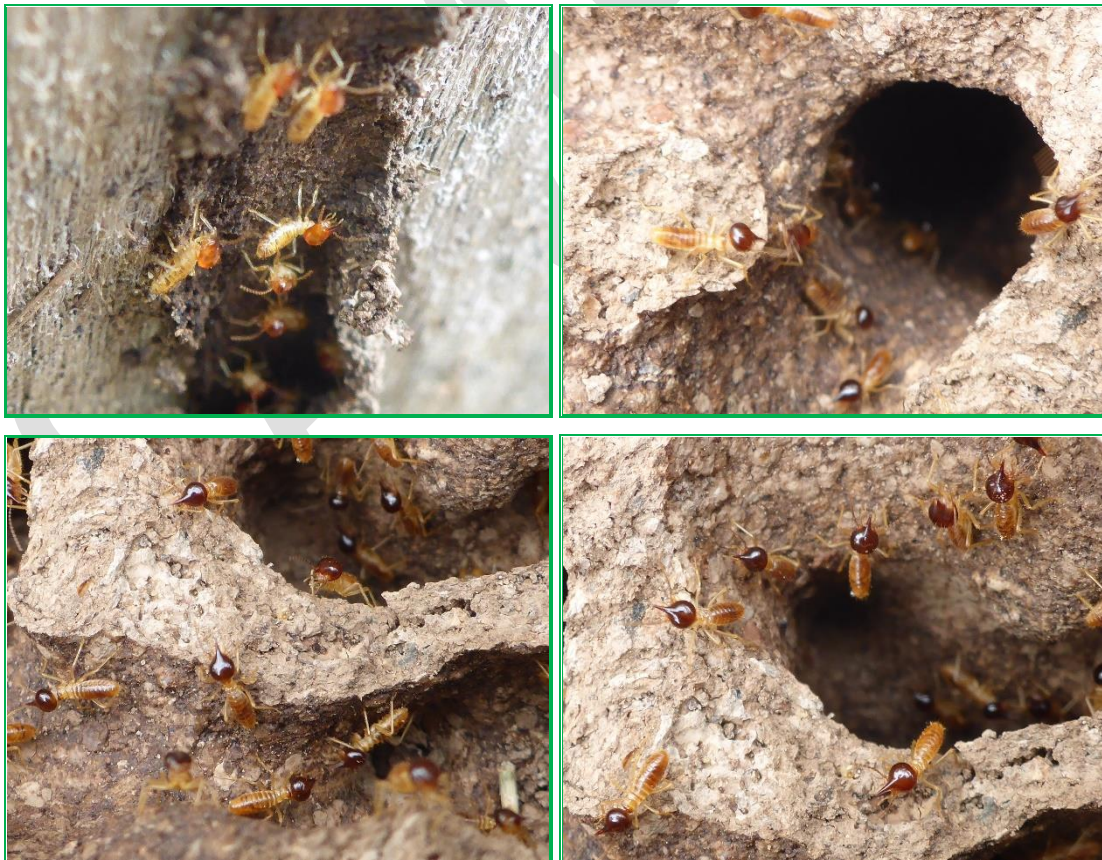
**D1 Active (live) termites – include the location, the genus and where practical the species involved and its potential to cause significant structural damage and whether a nest was or was not found**

**Areas:** Widespread.

**Species:** Nasutitermes      **Signs of attack:** Live and active. **Visible extent:** Widespread.

**Recommendation:** Highly recommend contacting Previous Pest Control company for advice to advise the treatment or method that should be carried out. A full termite management plan is highly recommended. The above recommendations should be implemented as soon as possible.

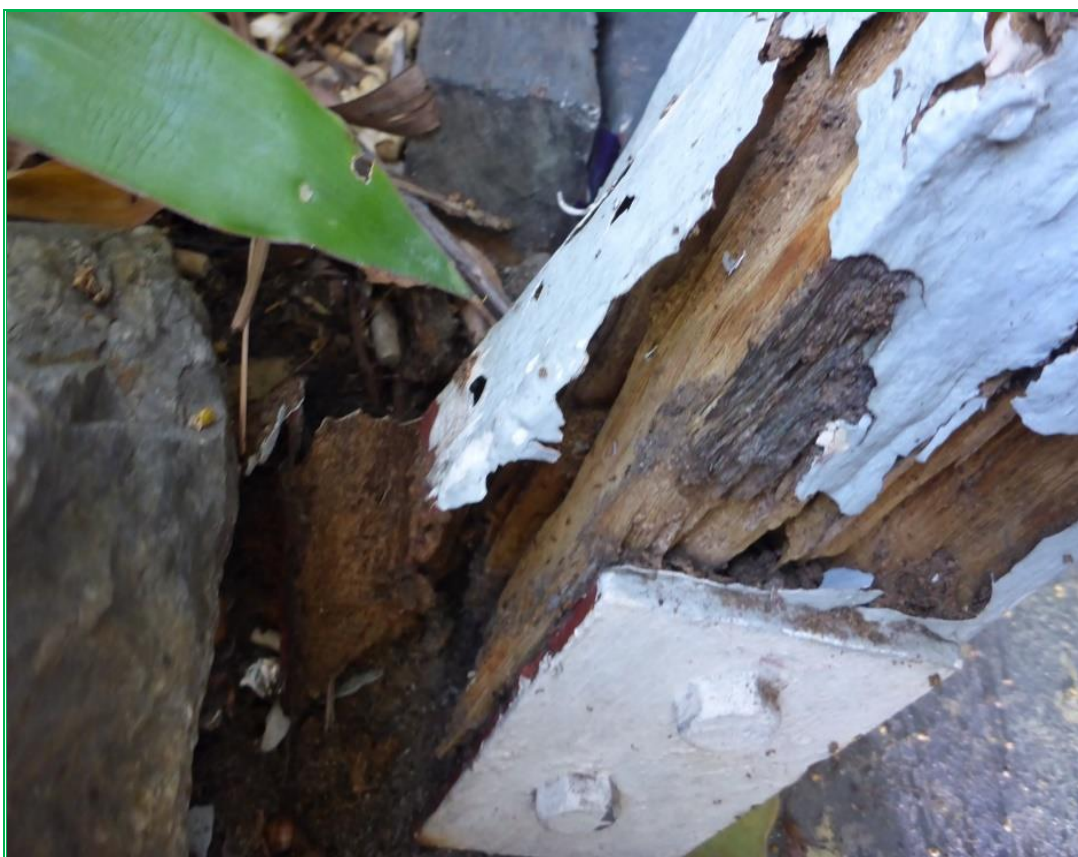
## D3 Termite workings and/or damage

**Areas:** Many areas.

**Affected Element:** Timber Structure

**Signs of Attack:** The timber is affected by the attack. **Visible Extent:** Widespread

**Recommendation:** Highly recommend contacting Previous Pest Control company to advise the treatment or method that should be carried out. A full termite management plan is highly recommended.

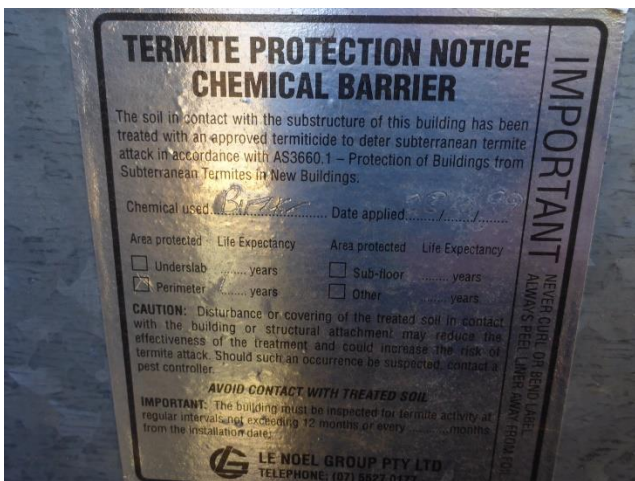
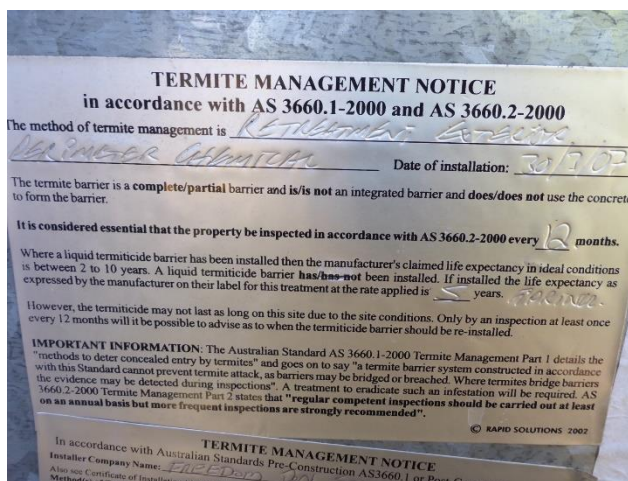
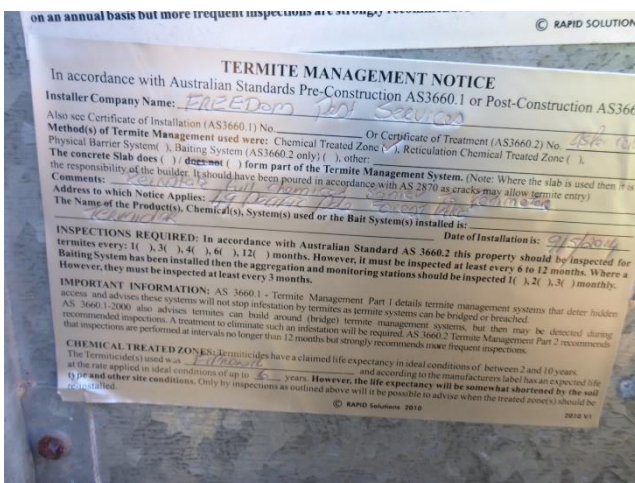
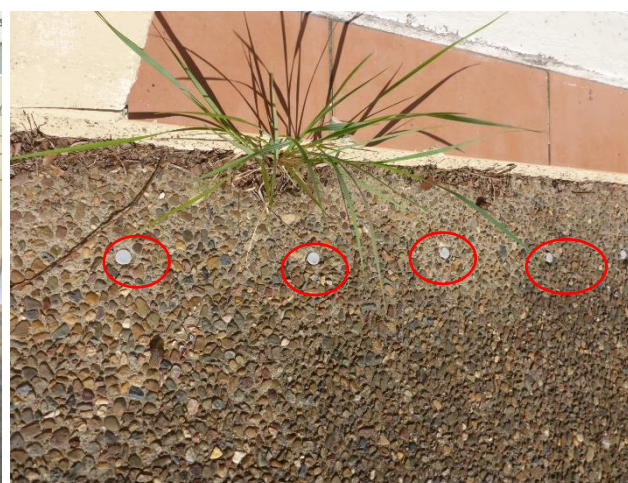
D4 Previous termite management program

**Area:** A few areas.

**Location:** Notice in the meter box and Holes drilled around the perimeter of the property.

**Previous Program:** Barrier with inspections every 12 months.

**Important Note:** Recommend contacting previous Pest Control company for advice

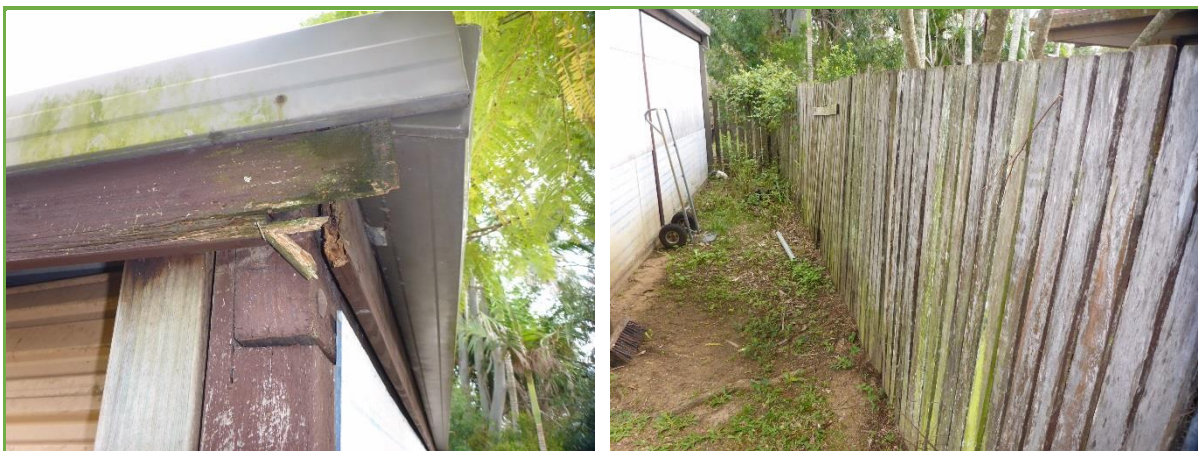
### D7 Fungal decay

**Areas:** Many areas.

**Affected Element:** Timber Post and palings and fascia.

**Signs of Attack:** Splits in timber, Dark colouring. Collapse of a timber member.

**Visible Extent:** Widespread.

**Recommendation:** The structures are showing signs of deterioration as a result of damp conditions which has created the timbers to rot, which can lead to conditions conducive to structural damage. Wood rot may cause the structure to fail as what it was originally intended for. Regular maintenance of the timbers are required to prolong the life of this building element, which may include but not limited to Painting or Sealing. Recommend to first identify the cause of the timber rot, then replace the affected timber where required. A Licensed Builder is recommended to determine the method and the extent of any remedial work required and associated costs. The above recommendations should be implemented as soon as possible.

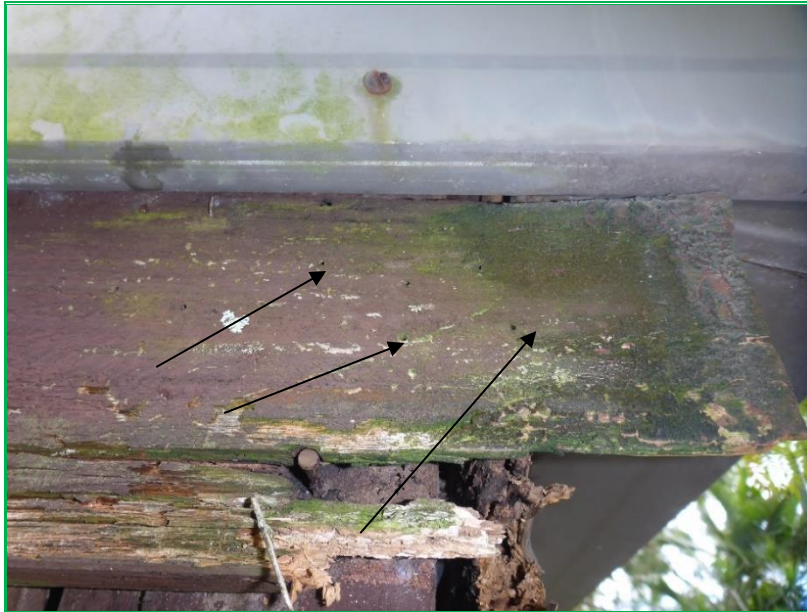
## D8 Wood borers

**Areas:** A few areas.

**Affective Element:** Timbers. **Species:** Undetermined

**Signs of attack:** Damage of timber. **Visible extent:** Widespread.

**Recommendations:** A management proposal is recommended and a quote to treat the live borers and ongoing inspections. These recommendations should be implemented immediately.

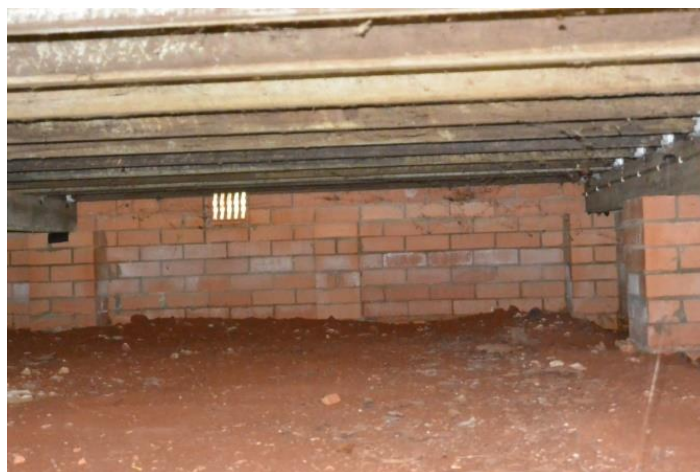
## D9 Lack of adequate subfloor ventilation

**What it is:** Efflorescence is caused due to moisture problems.

**Results:** Efflorescence is a common problem when you have a problem with moisture or dampness in concrete or masonry bricks. The best way to prevent the problem is to prevent moisture from infiltrating the walls. It is normally recognised by a white fuzzy product on the wall. If you have efflorescence it is always recommended to first find and treat the underlying problem that created it in the first place. Recommend a Competent Person to determine the method and the extent of any remedial work and associated costs. The above recommendations should be implemented as soon as possible.

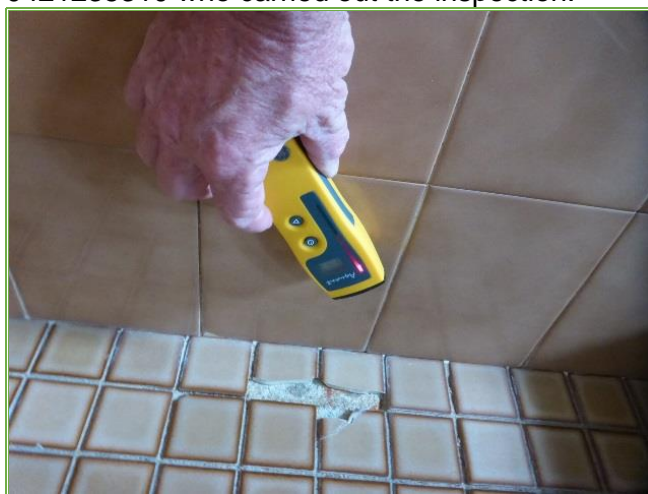
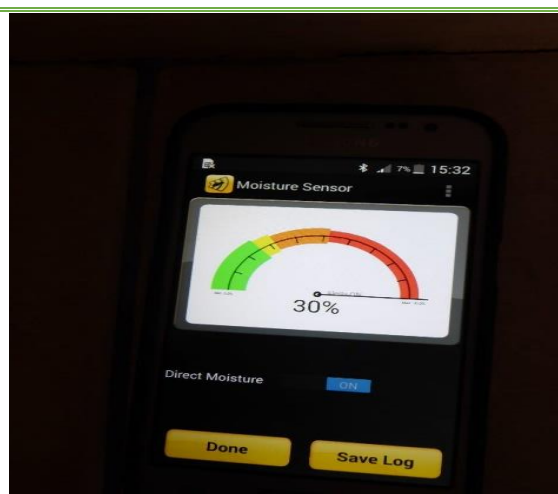
### D10 The presence of excessive moisture

**Areas:** Interior **Location:** Bathroom wall. **Affected Element:** Bathroom Shower.

**Defect or Sign:** Elevated moisture level readings obtained under test conditions.

**Visible Extent:** Localised.

**Recommendation:** High moisture or damp conditions generally indicate a leak or poor ventilation, or failure of the waterproofing. The reason for this high moisture reading was not apparent at the time of inspection. Recommend a further investigation by a competent person such as a Registered Builder or Plumber, to determine the cause and the method to repair or replace affect building elements, which may include a more invasive inspection.

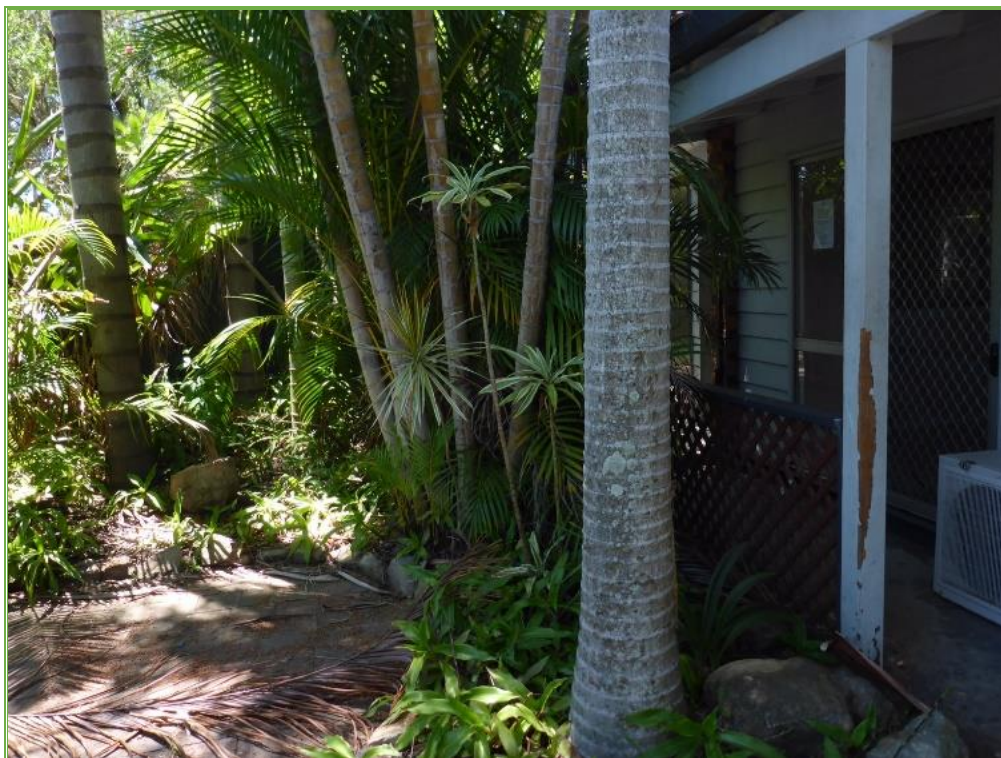
### D11 Bridging or breaching of termite barriers and inspection zones

**Areas:** Many areas. **Affected Element:** Inspection zone

**Defect or Sign:** Bridging and Breaching by built up of landscaping/soil and gardens and materials.

**Visible Extent:** Widespread

**Recommendation:** Unless appropriate written evidence of an alternative termite management program is provide, to help protect against undetected termite entry to the building, a continuous inspection zone of at least 75mm should be provided and maintained. The inspection zone forces the termites into the open where they can be detected more readily during regular inspections. Recommend removing the elements that are preventing a full visual of the inspection zone. Depending on the level of concealment depends on what trades to us. With concrete slab buildings, it is essential that the edge of the slab is permanently exposed. Importantly the edge of the slab should not be rendered, tiled, cladded, or concealed by flashings, adjoining structures, paving, soil, turf, landscaping, or the like. The above recommendations should be implemented as soon as possible. For further advice consult David on 0421235310 who carried out the inspection.

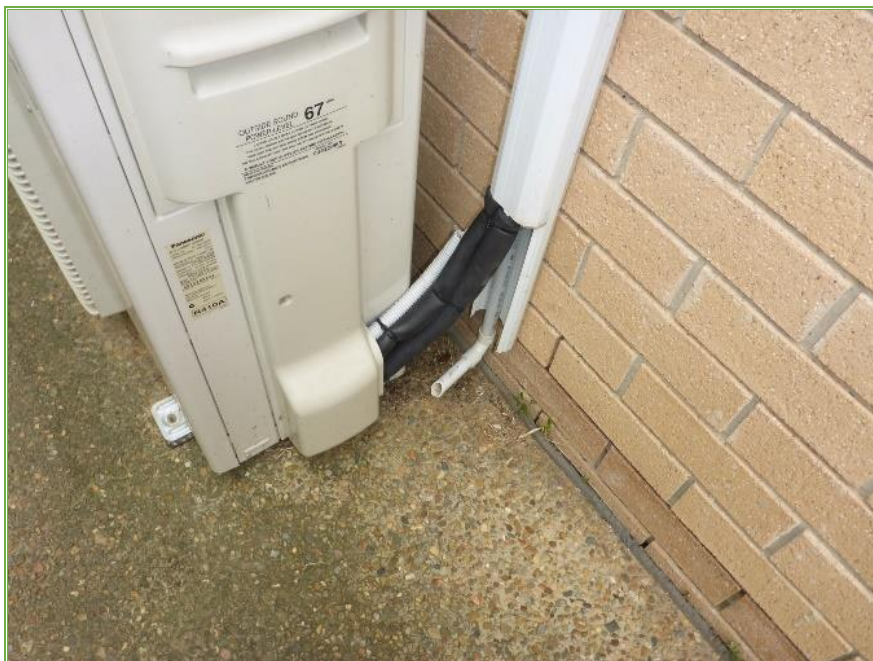
### D13 Other conditions conducive to timber pest attack

**Areas:** Exterior **Location:** Against the building. **Affected Element:** Wet conditions

**Defect or Sign:** Overflows/plumbing not adequately connected or plumbed in. Gutters blocked and damaged and defective drainage, and timber in contact with the ground.

**Visible Extent:** Localised

**Recommendation:** When gutters and overflows are not adequately connected or plumbed in, and defective drainage they create an environment that is conducive to termite attack. Recommend that a qualified plumber rectify the gutters or overflows to ensure the area remains dry. The above recommendations should be implemented as soon as possible. For further advise consult David 0421235310 who carried out this inspection.
