Stage Frame REPORT (hereinafter called the "Report")

ALL INSPECT
All Building & Termite Inspections

Report Number 13573 TIME: 8am

Property Address: Sample road

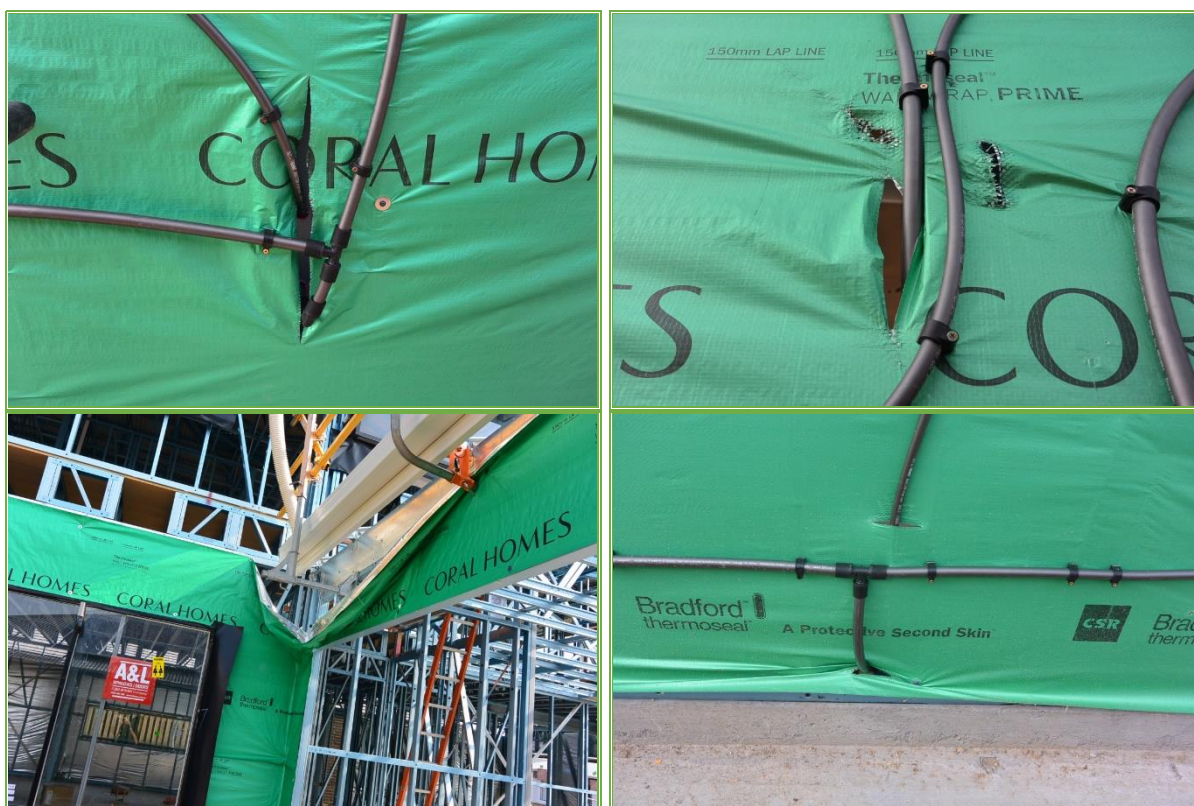
1. Sisalation has defects hole over cut (we do acknowledge that this is not complete) Sisalation has to be installed correctly to prevent moisture from transferring to the frame. Few areas have over cut thus allowing the transfer of water moisture to the frame, any moisture running down the wall will now exit into the frame. This will in itself cause additional defects at a later stage. **The bricklayer needs to ensure that the correct configuration of lapping has been set in place prior to installing the wall.** This needs to be complete otherwise considerable rework will have to take place to ensure that the builder comply with requirements of the BCA and Australian standards AS 4200. All holes will need to be patched to comply with Energy efficiency requirements “Pliable Building Membranes and Underlay’s” part 2 states: The only tapes that can be used on sisalation are AS 4254 compliant. Please note that any coloured tapes used on the foil side of the sisalation are defective. The tapes used to this side of the sisalation must be designed for installation on a foil surface and hence AS 4254 compliant.

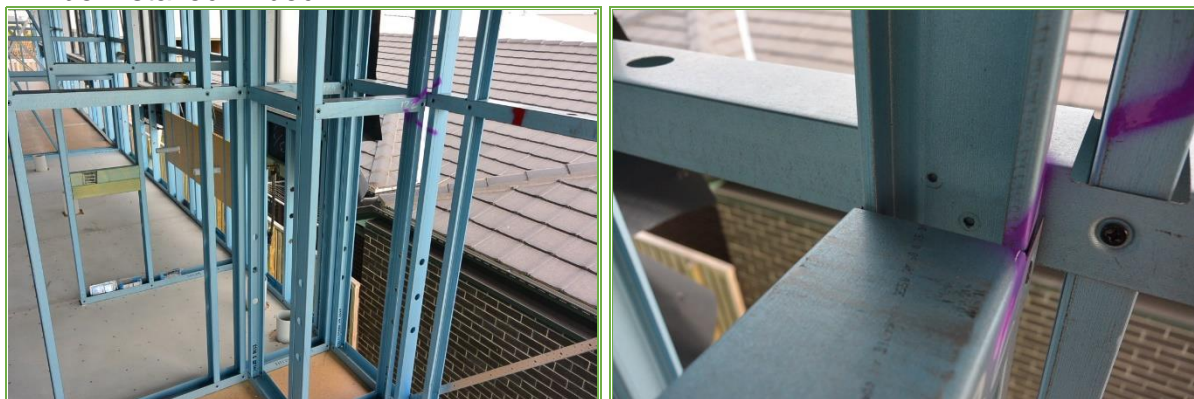
2. It was noted at the time of inspection that some fixing screws are missing will need to be installed in bed 1.

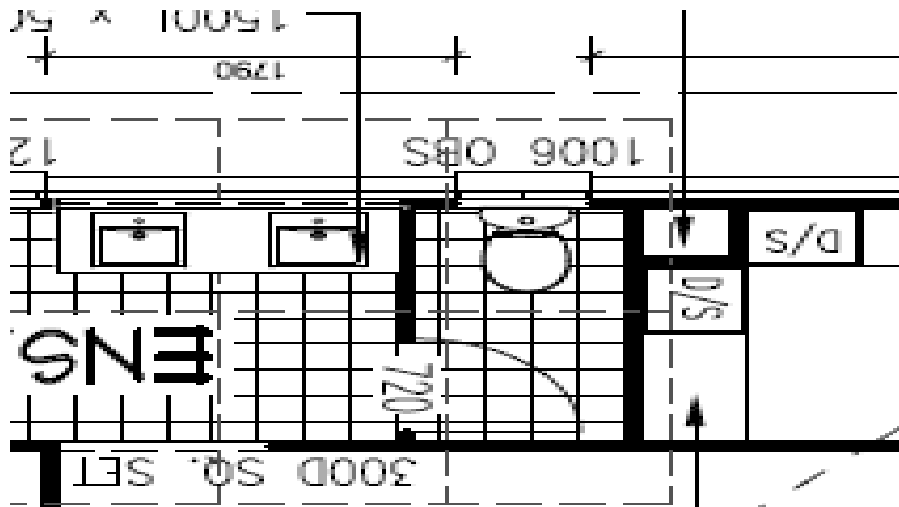
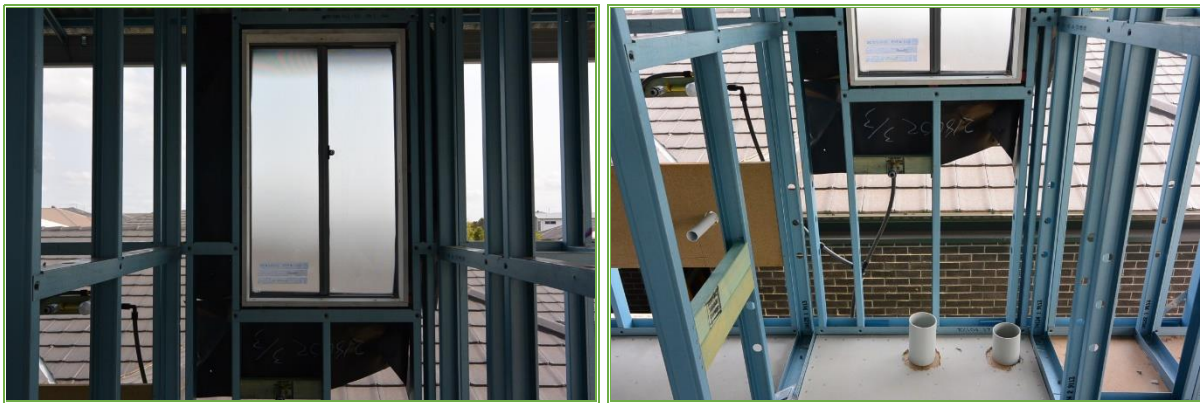
- It was noted at the time of inspection that the ENS toilet window is not centre to the room as per plan this will need to be rework.

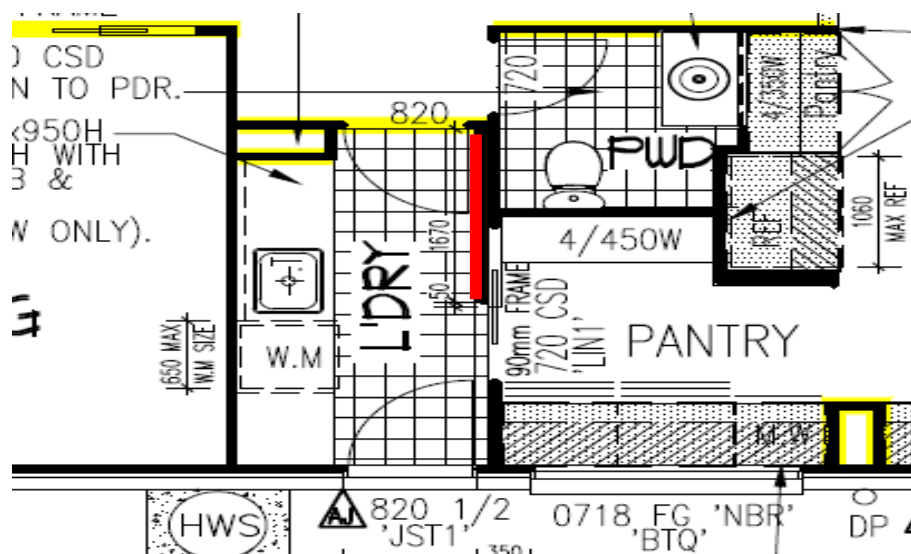
4. It was noted at the time of inspection that part of the LDRY wall is to be removed as per variation.

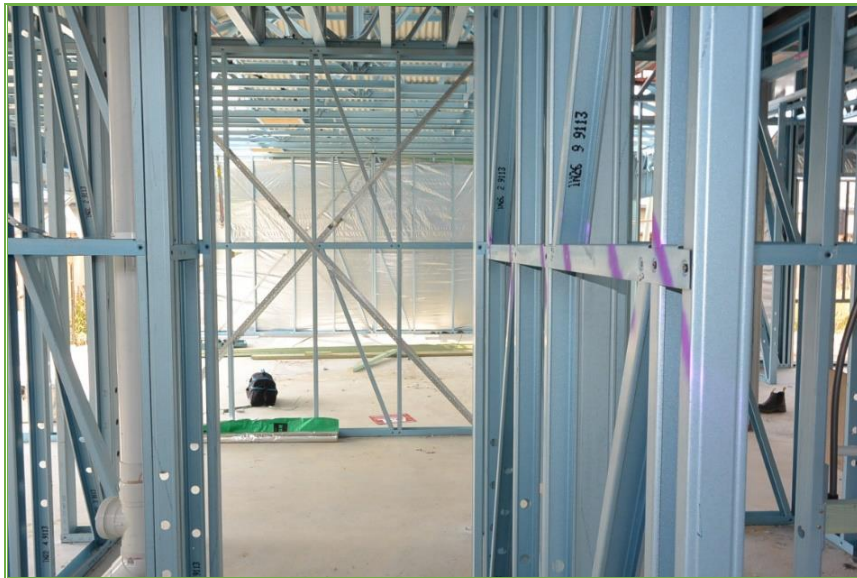
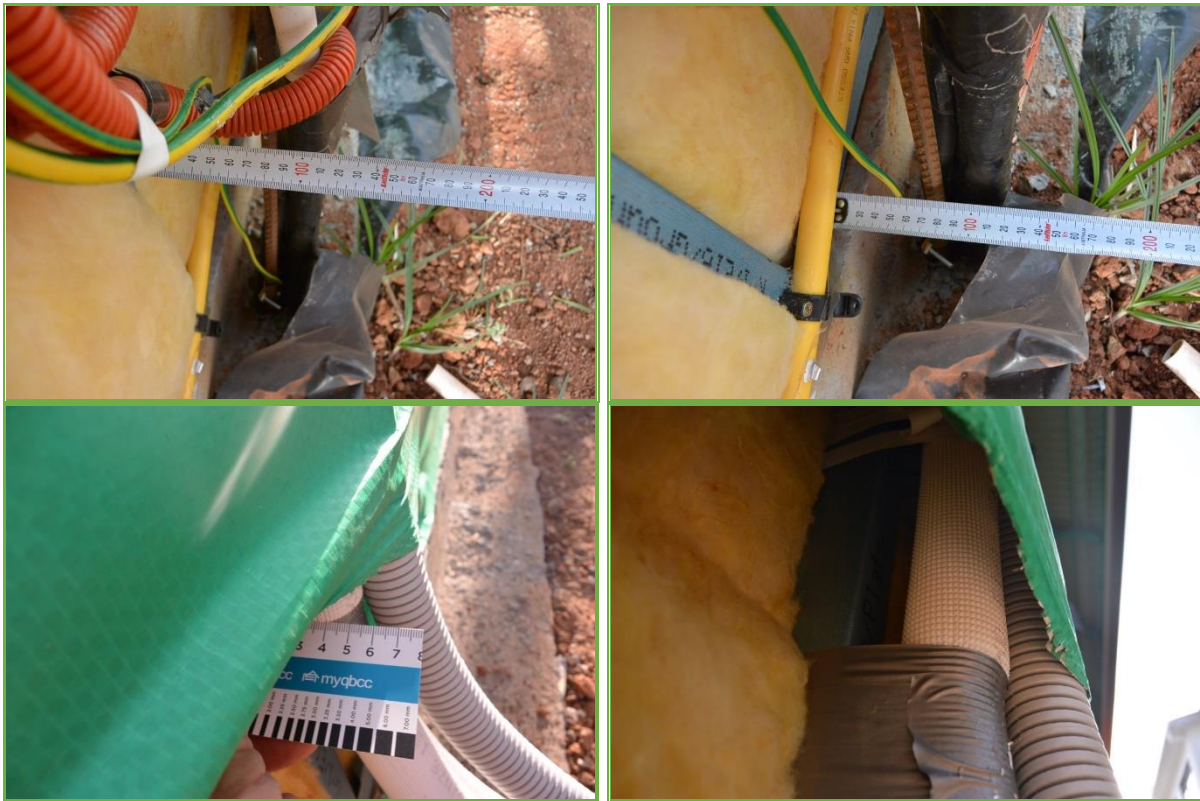
5. Frame electrical conduits and A/C pipes cavity breach

It was noted at the time of inspection that the electrical conduits installed to the cavity area of the dwelling will breach the minimums set down in the bricking Standard.

As such we refer the electrician/plumber and the builder to part 10.2. This part clearly states that a cavity must be a minimum of 35 mm. Given that the electrical conduits are 50mm to 65mm mm as per the photos below, the builder would need a 75mm to 100mm + cavity to make this work.

We noted from the installed slab that the builder's intentions are to install the cavity at about 35 to 40 mm. Given this configuration, the installation of all pipes electrical conduits on site will bridge the cavity. We understand that the electrician is looking for the quickest route to install his work; however, it cannot be at the breaching of an unrelated Standard.

The electrician will need to return to site and rework all of the external installation prior to brick installation. We refer the builder to AS 3700, clause 12.4.13, inserted.

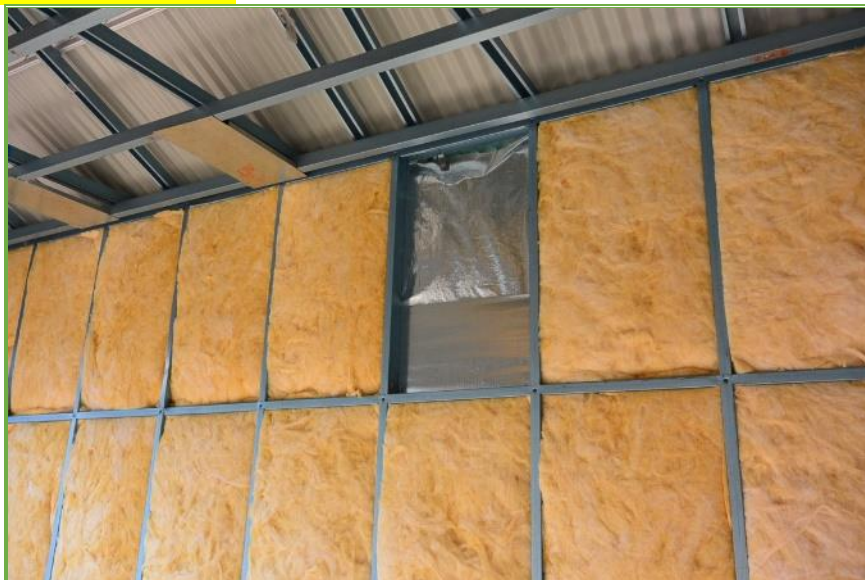
6. The wall insulation is missing not in an appropriate, skilful way or with reasonable care and skill listed below:

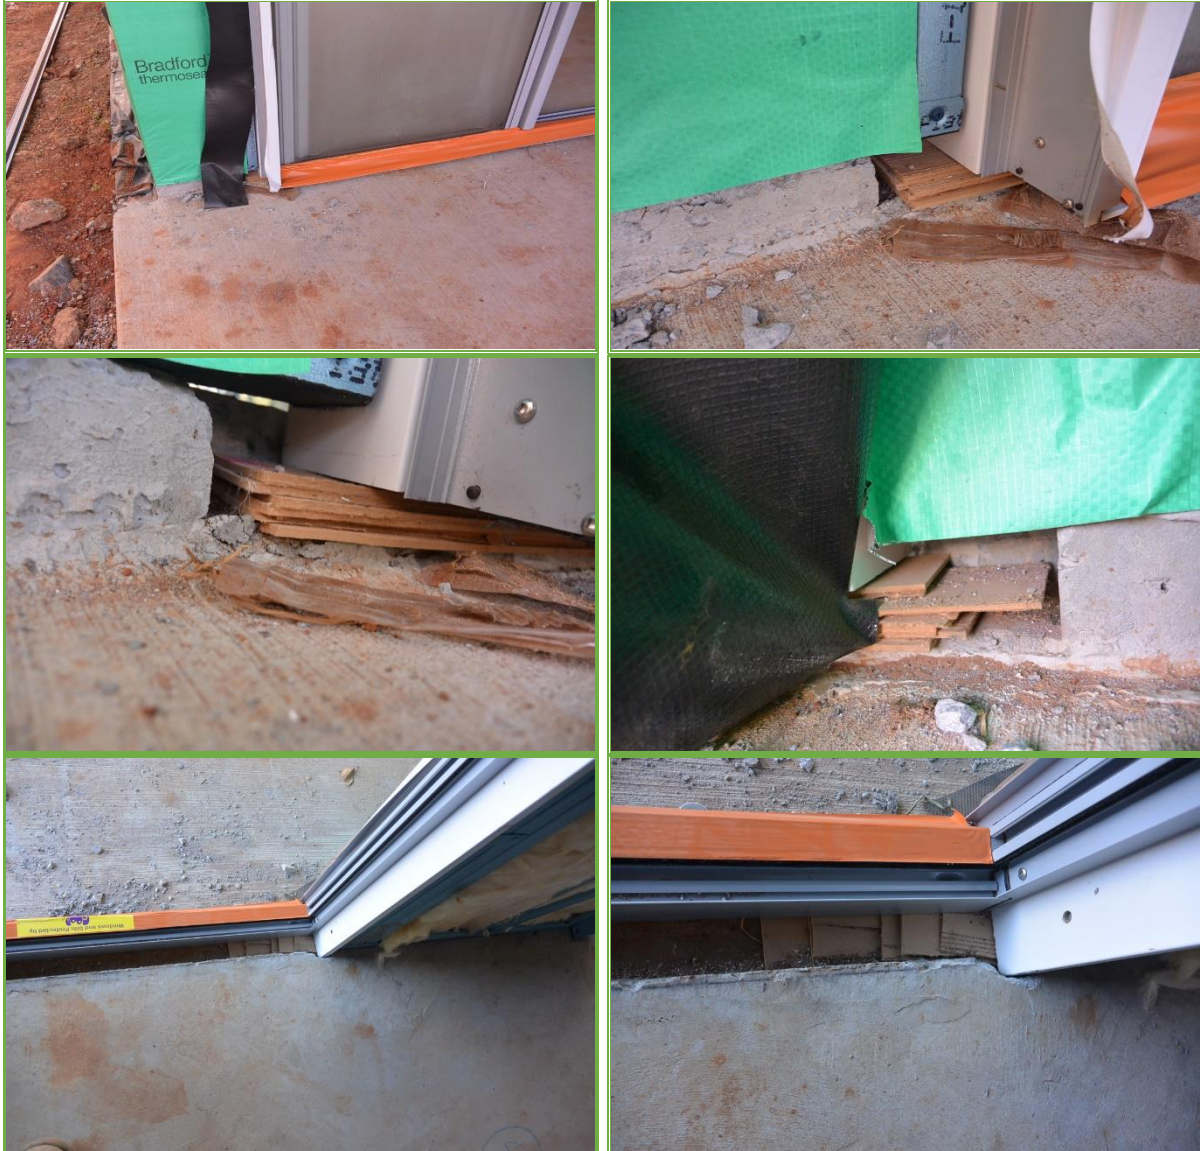
7. The alfresco doors have been packed with builder's rubbish not in an appropriate, needs to be solid material and durable fit for purpose, not skilful way or with reasonable care and skill listed below:

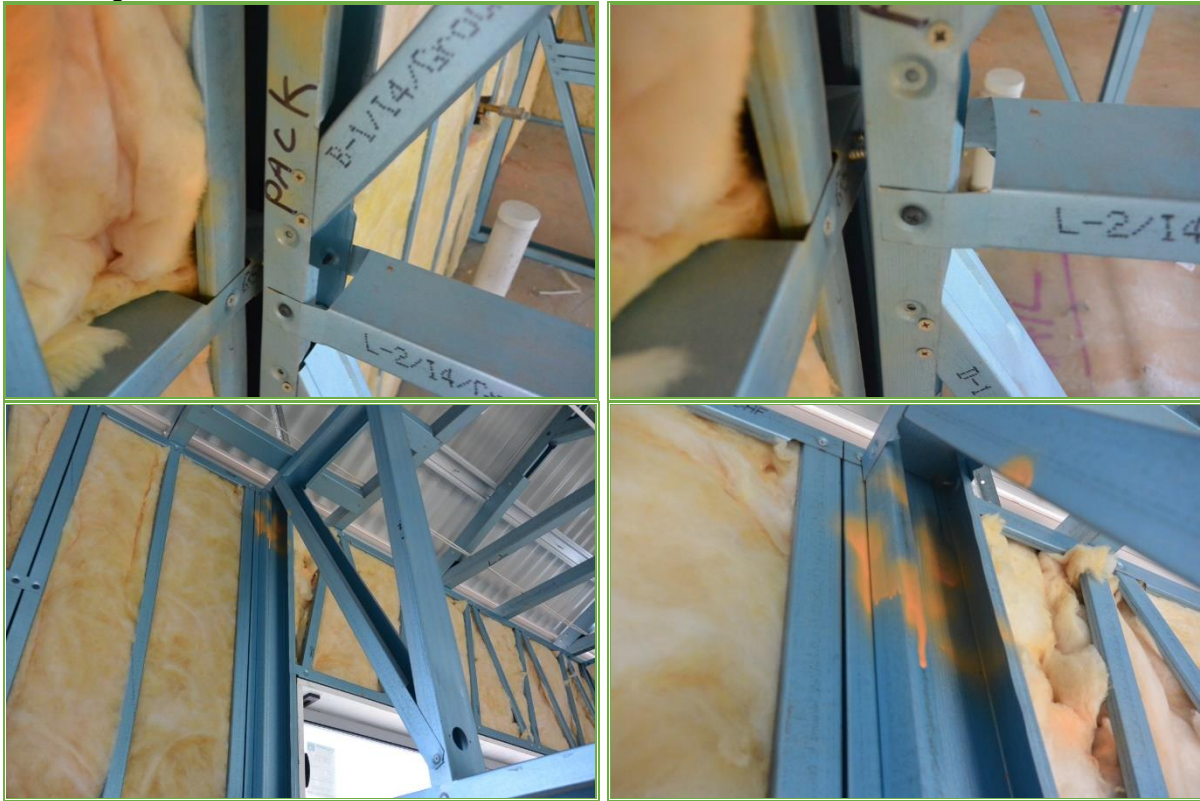
8. It was noted at time of inspection that the wall junction/connection requires packing or is loose and out of plumb, some studs with missing screws, this will all need to be reworked before linings are installed

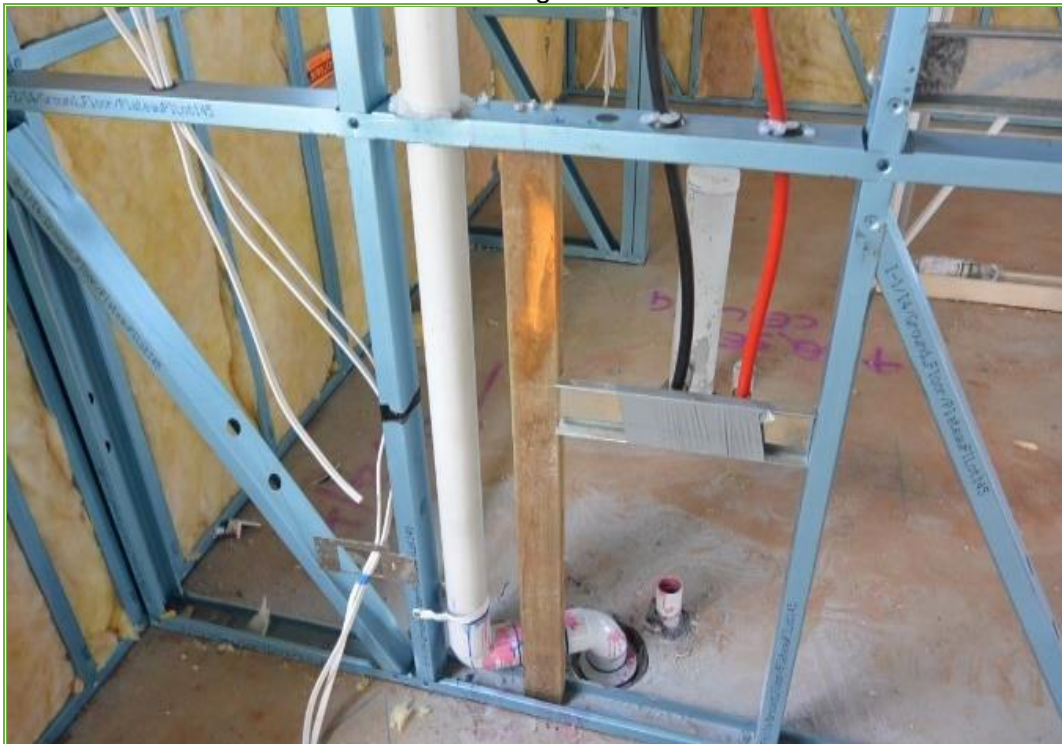
9. It was noted at time of inspection that some timber has been use by the plumber to support a fitting this should be steel not timber not termite proof our client is expecting a steel frame house this needs to be rework before lining are installed.

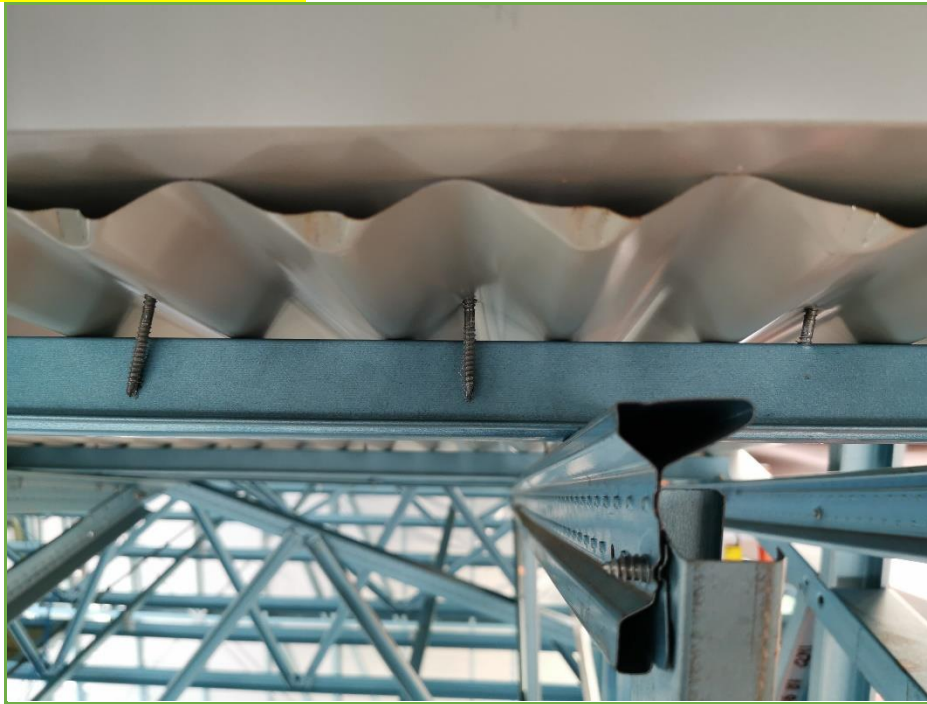
10. Some of the roofing screws to the garage have substandard works they have missed the batten, they will all need rework before handover, not in an appropriate, skilful way or with reasonable care and skill listed below:
