Frame (Defect Inspection) REPORT (hereinafter called the "Report")

Report Number 00024 Time:11:30 AM

Inspection Date: 17/03/2022

Property Address: LOT sample

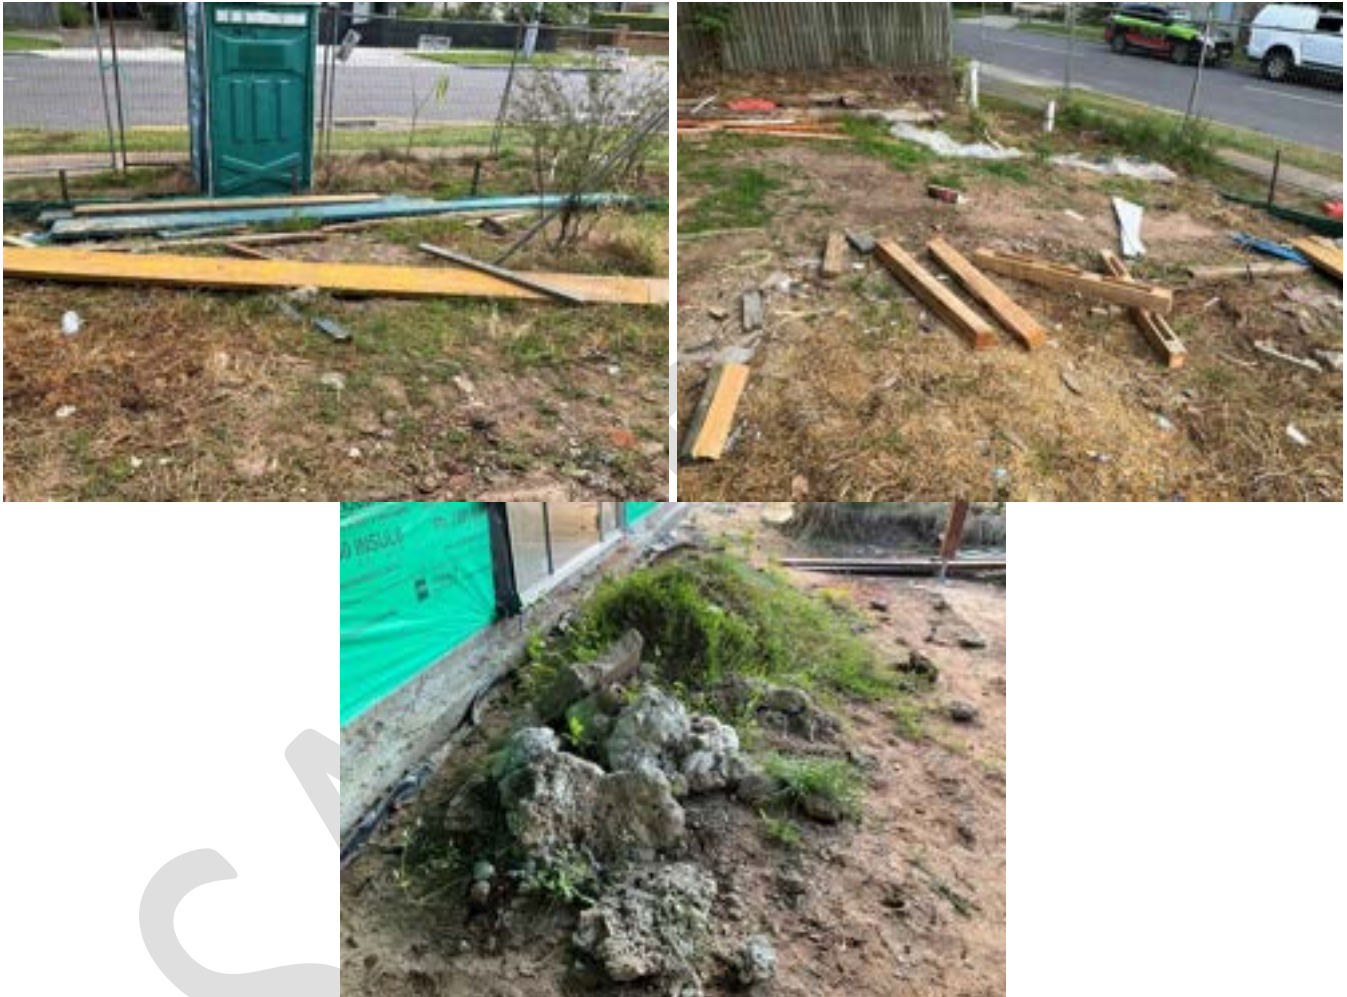
1. Poor housekeeping site rubbish unsafe. **Trip hazard.**

Many slips, trips and injury are the results of poor housekeeping, and this is often a sign of a lack of storage, maintenance and cleaning. This should be cleaned as soon as possible.

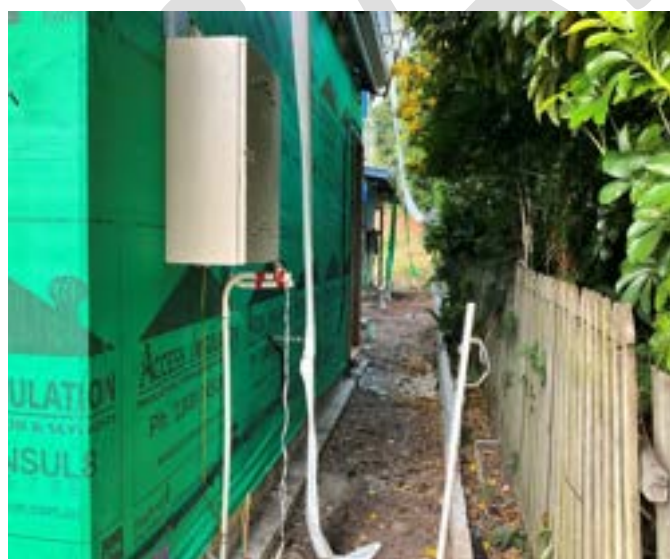
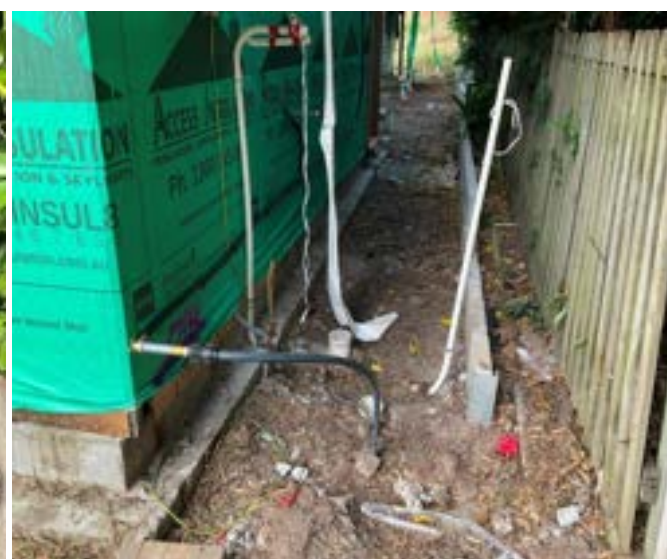
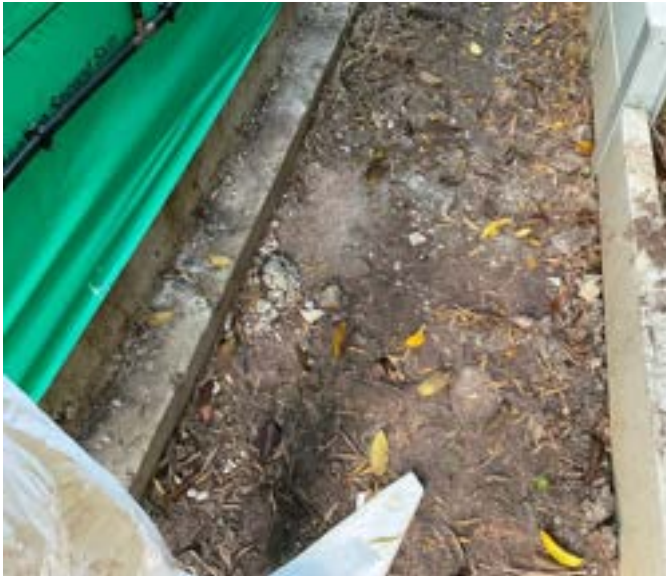
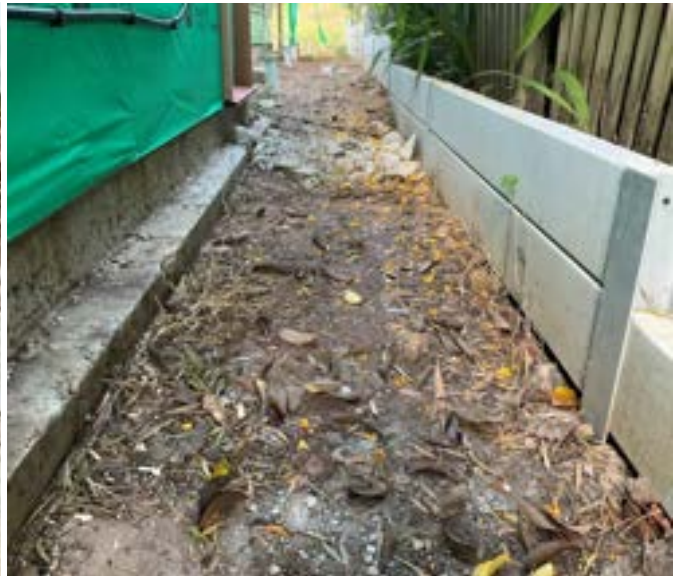
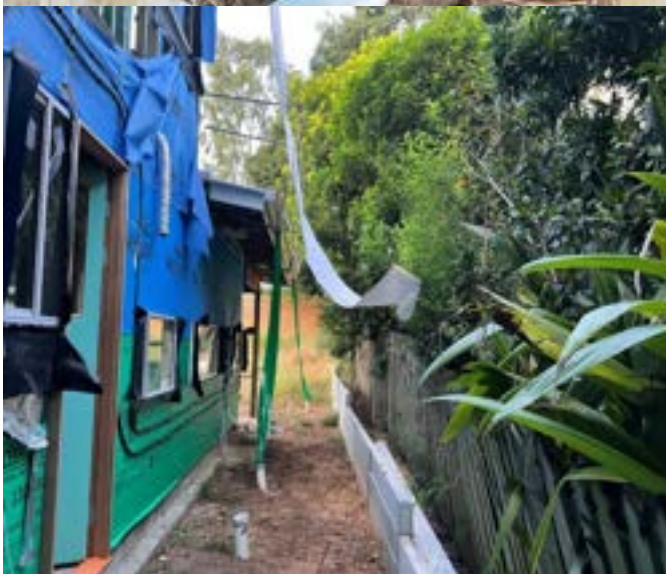
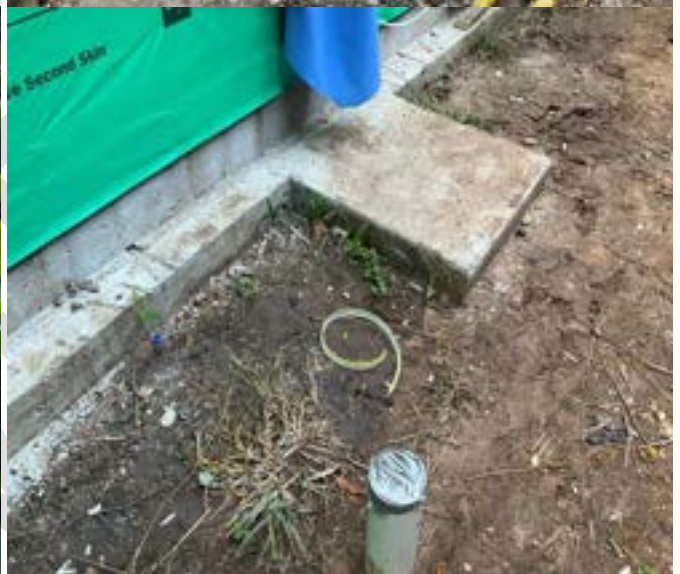
2. The slab footings have the opportunity to pool with water, due to the temporary down pipes not been reinstalled and ground levels not graded away from the home.

Water management on site is paramount to ensuring that the foundations are not damaged. Water, when seeping down beside the slab, between the slab and the dirt softens the dirt. The soils capacity to withstand the downward pressure of the forces of the weight in the slab is greatly reduced. Hence slab failure occurs. The BCA is very clear in its requirements to have the soil graded from the start away from the dwelling as a minimum of 50 mm over 1 m. This has not been done. We refer all to the BCA, part 3.1.2.3.

We also refer the builder to the soil report and engineering drawings that clearly call for the site drainage to be managed via sloping water away from the slab and more so, managing same. The builder must act on this defect now.

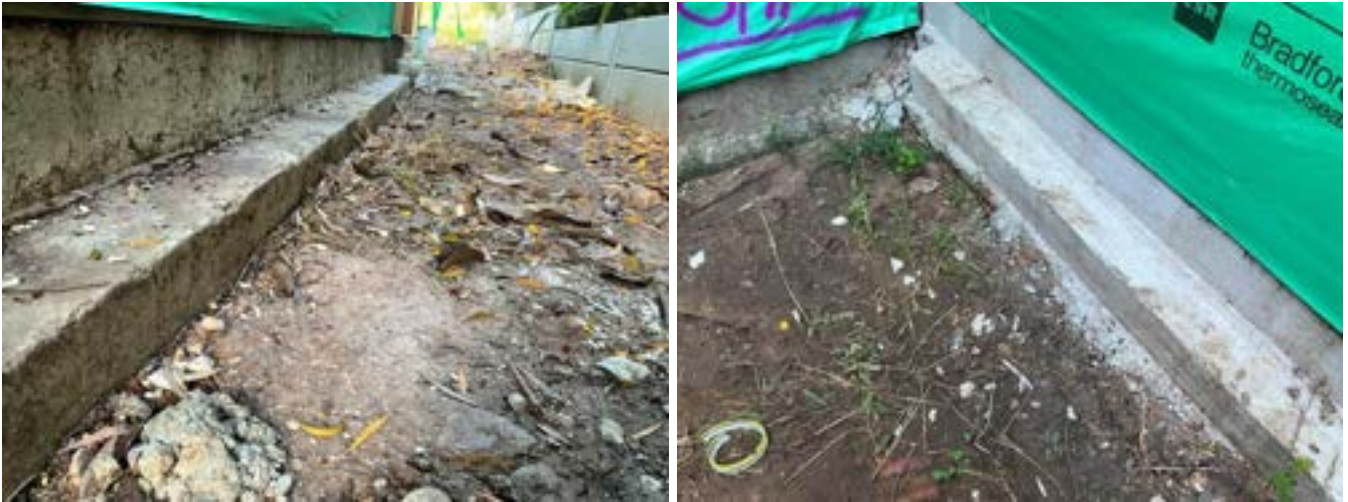
3. The polyethylene vapour barrier from beneath the concrete floor slab has not been turned up along the external side faces of the edge beams. It must be turned up prior to the slab edge being back filled. If not completed this will allow moisture ingress via slab edge dampness into the internal building wall skins and/or the floor coverings if not done. As per insert.

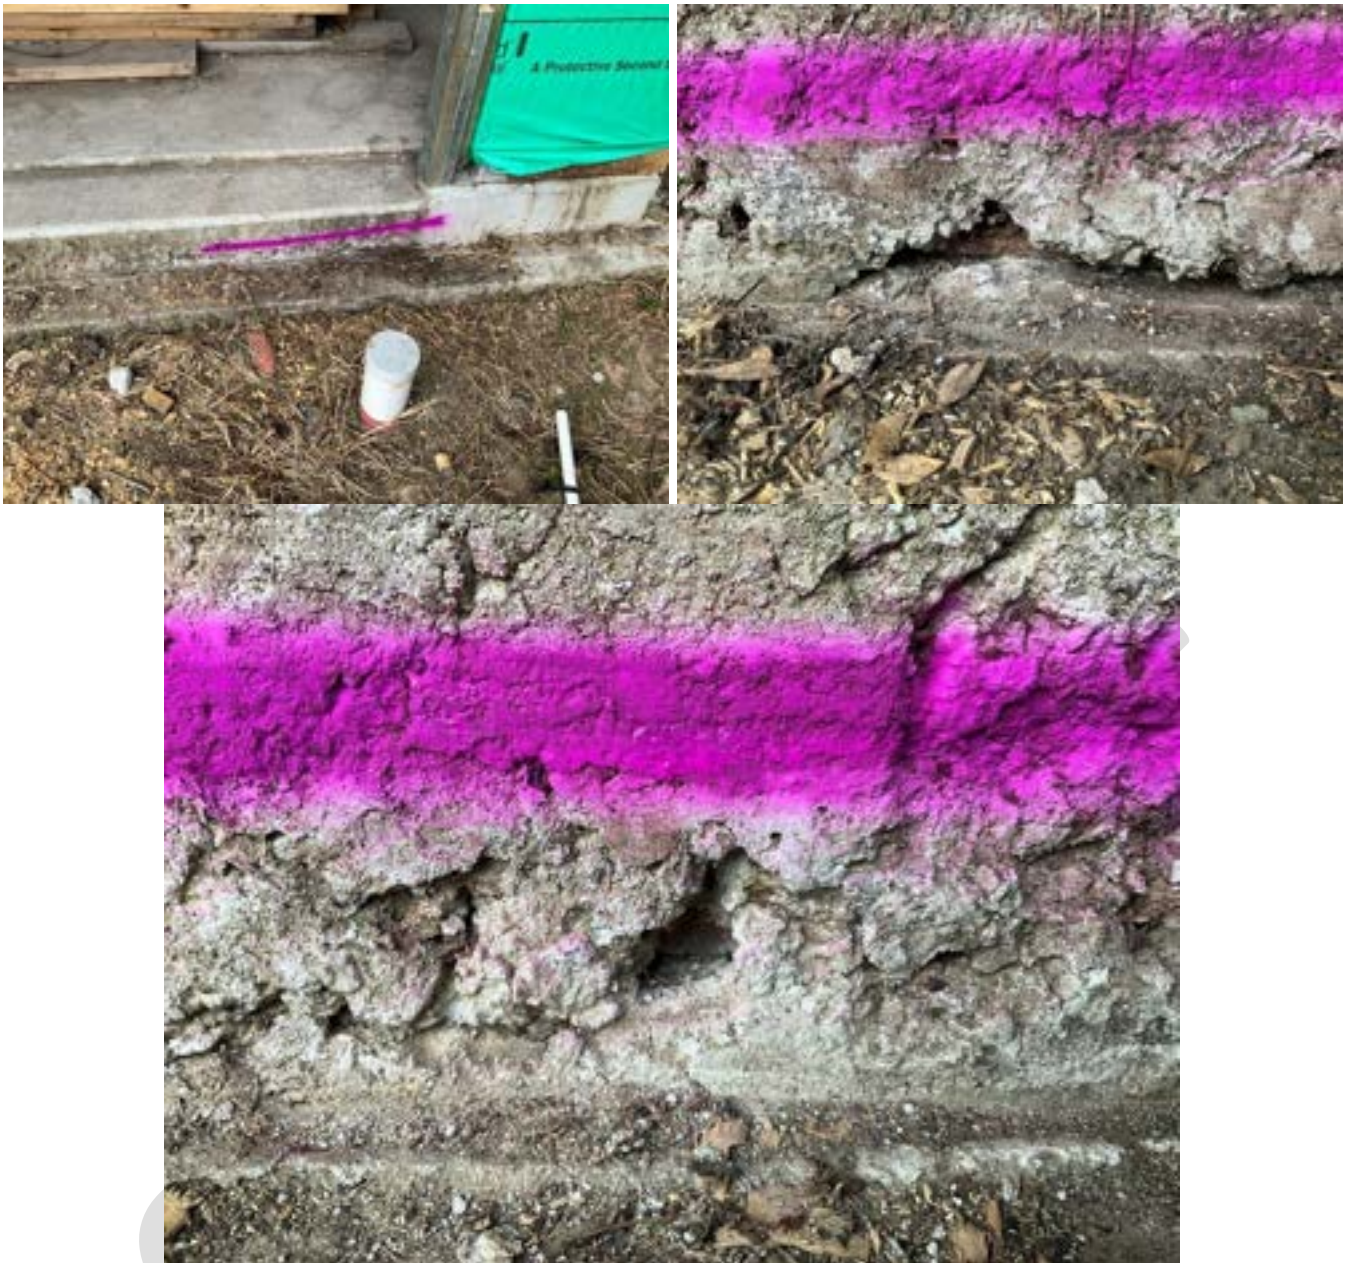
4. There are large areas of open concrete voids to the slab edge bonny slab edge. These areas are now showing the exposed reinforcement bars and that the slab has not been mechanic all compacted in areas as per the requirements of AS 2870. This must be reworked.

It is clear that the steel is not installed with the minimum concrete coverage area as per the mandated requirements of the BCA. We refer all to part 3.2.3.2. and AS 2870, part 6.4.7 that calls for the vibration.

The builder must:

- Send a competent person like the engineer to the site for approval **form 12 for the rectifications**. As per part 9, Division 2, section 74 of the BR 2021

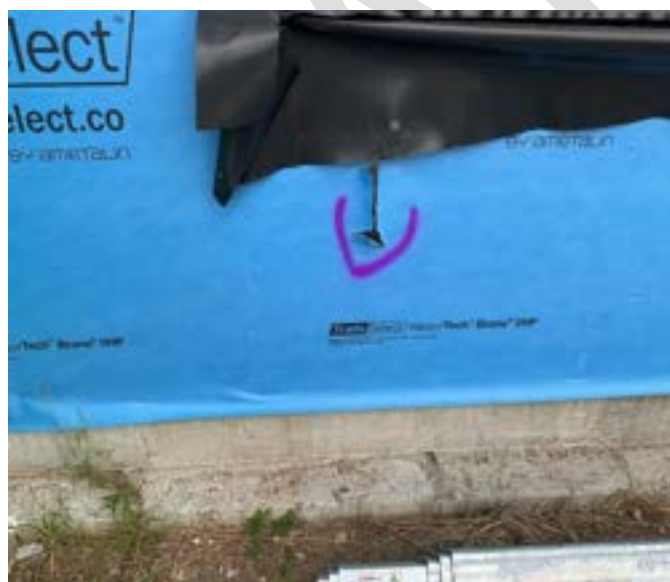
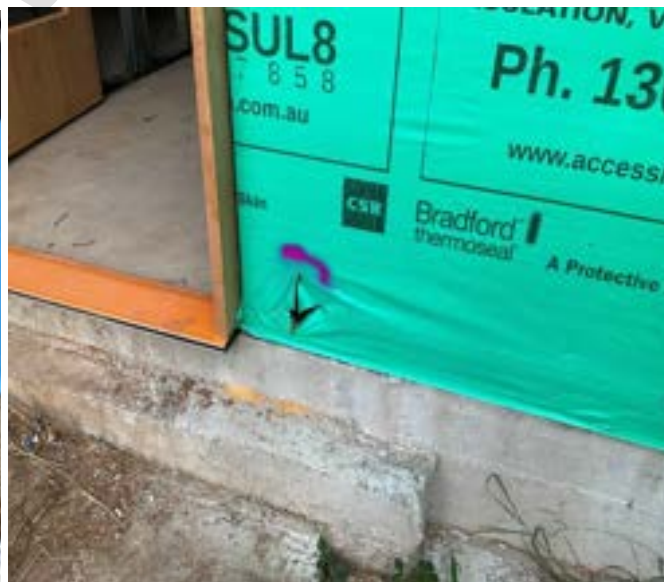
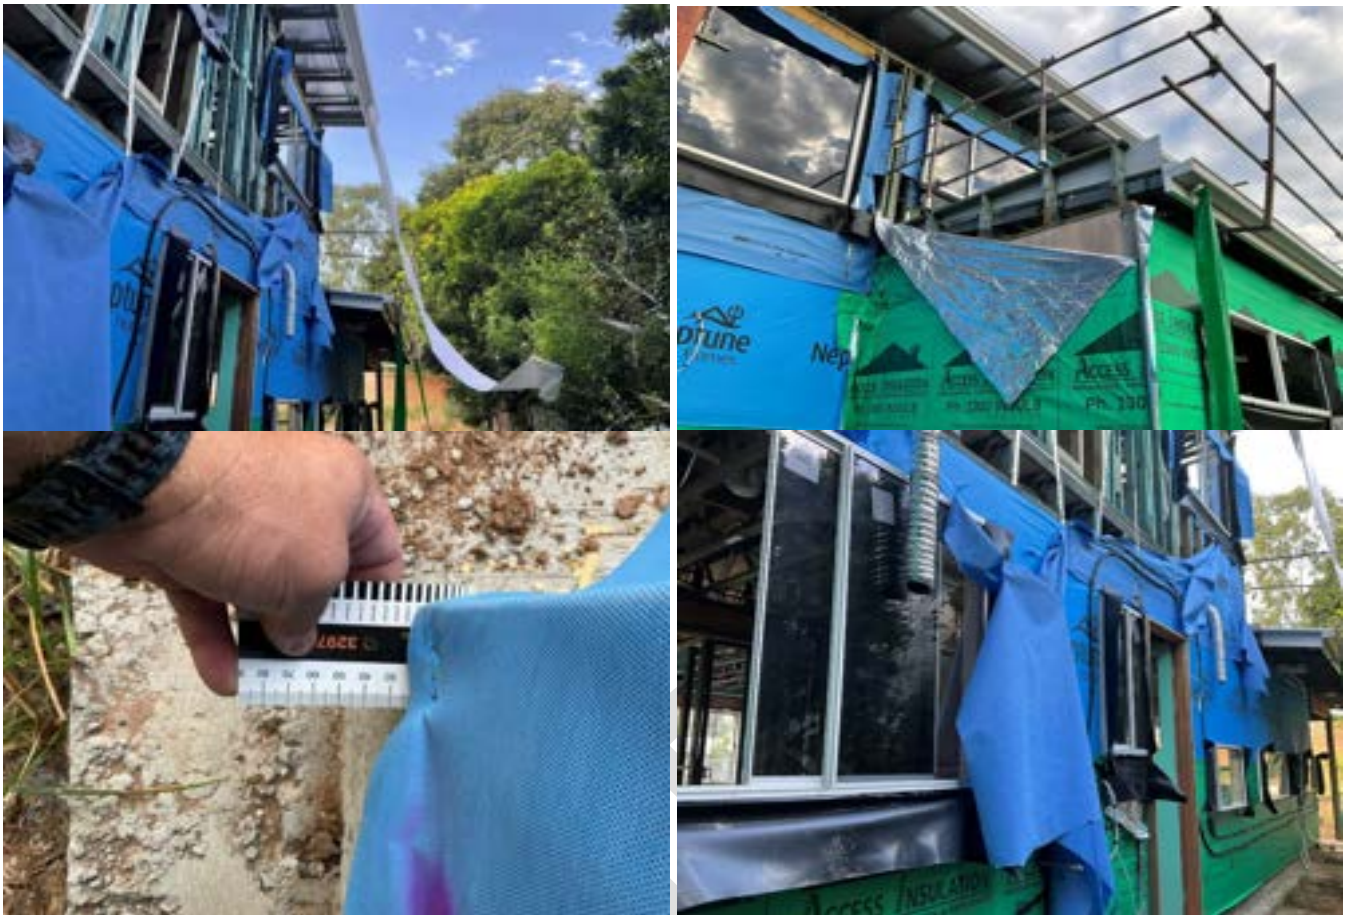
5. Sisalation has defects like holes and gaps; Sisalation has to be installed correctly to prevent moisture from transferring to the frame. This will need to be reworked.

Few areas have been over cut allowing the transfer of water moisture to the frame, any moisture running down the wall will now exit into the frame. This will cause additional defects at a later stage. **The bricklayer needs to ensure that the correct configuration of lapping has been set in place prior to installing the wall.** This needs to be complete otherwise considerable rework will have to take place to ensure that the builder comply with requirements of the BCA and Australian standards AS 4200. All holes will need to be patched to comply with Energy efficiency requirements "Pliable Building Membranes and Underlay's" part 2 states: The only tapes that can be used on sisalation are AS 4254 compliant. Please note that any coloured tapes used on the foil side of the sisalation are defective. The tapes used to this side of the sisalation must be designed for installation on a foil surface and hence AS 4254 compliant.

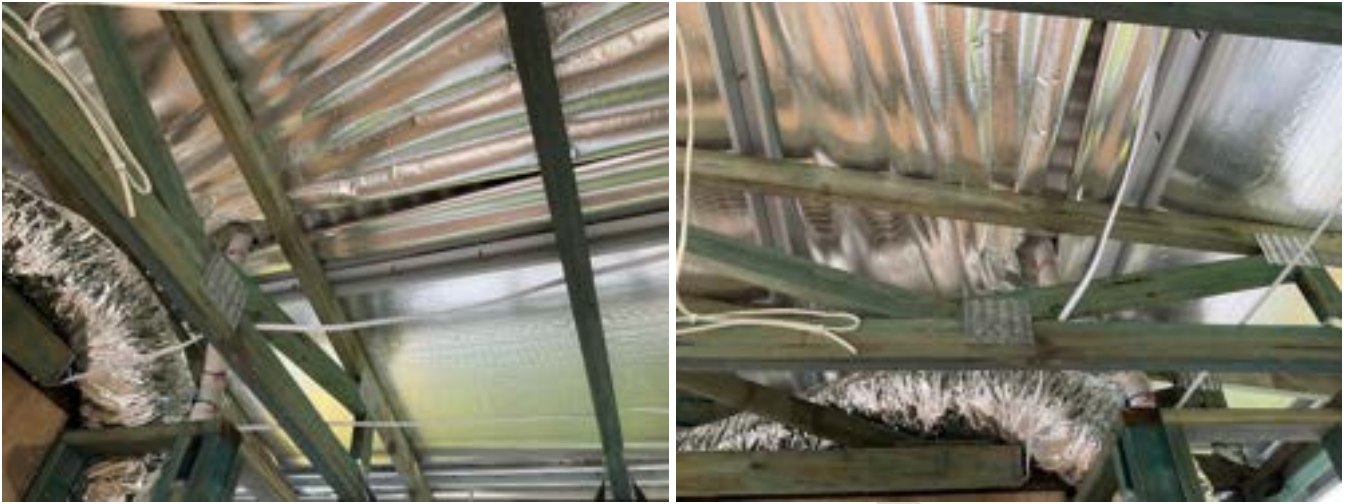
6. The roof penetrations to the sisalation have defects, needs reworking.

Sisalation has to be installed correctly to prevent moisture from transferring to the frame. Areas have over cut thus allowing the transfer of water moisture to the frame, any moisture running down will now exit into the roof void. This will in itself cause additional defects at a later stage. All holes need to be patched to comply with Energy efficiency requirements "Pliable Building Membranes and Underlay's" part 2 states: The only tapes that can be used on sisalation are AS 4254 compliant. Please note that any coloured tapes used on the foil side of the sisalation are defective. The tapes used to this side of the sisalation must be designed for installation on a foil surface and hence AS 4254 compliant.

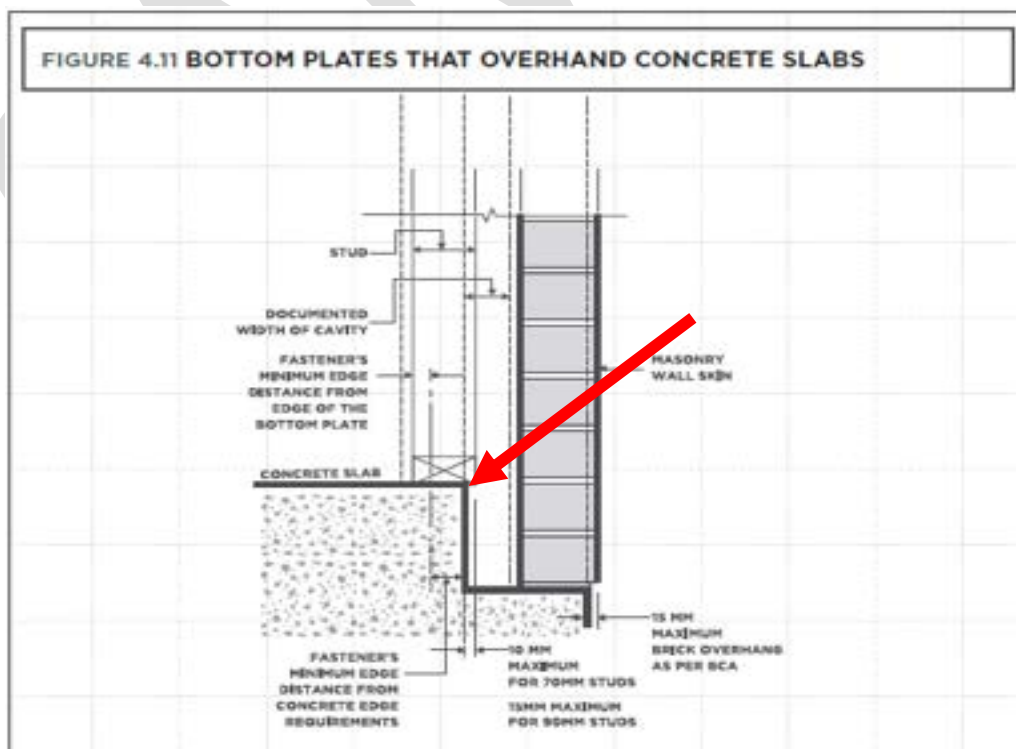
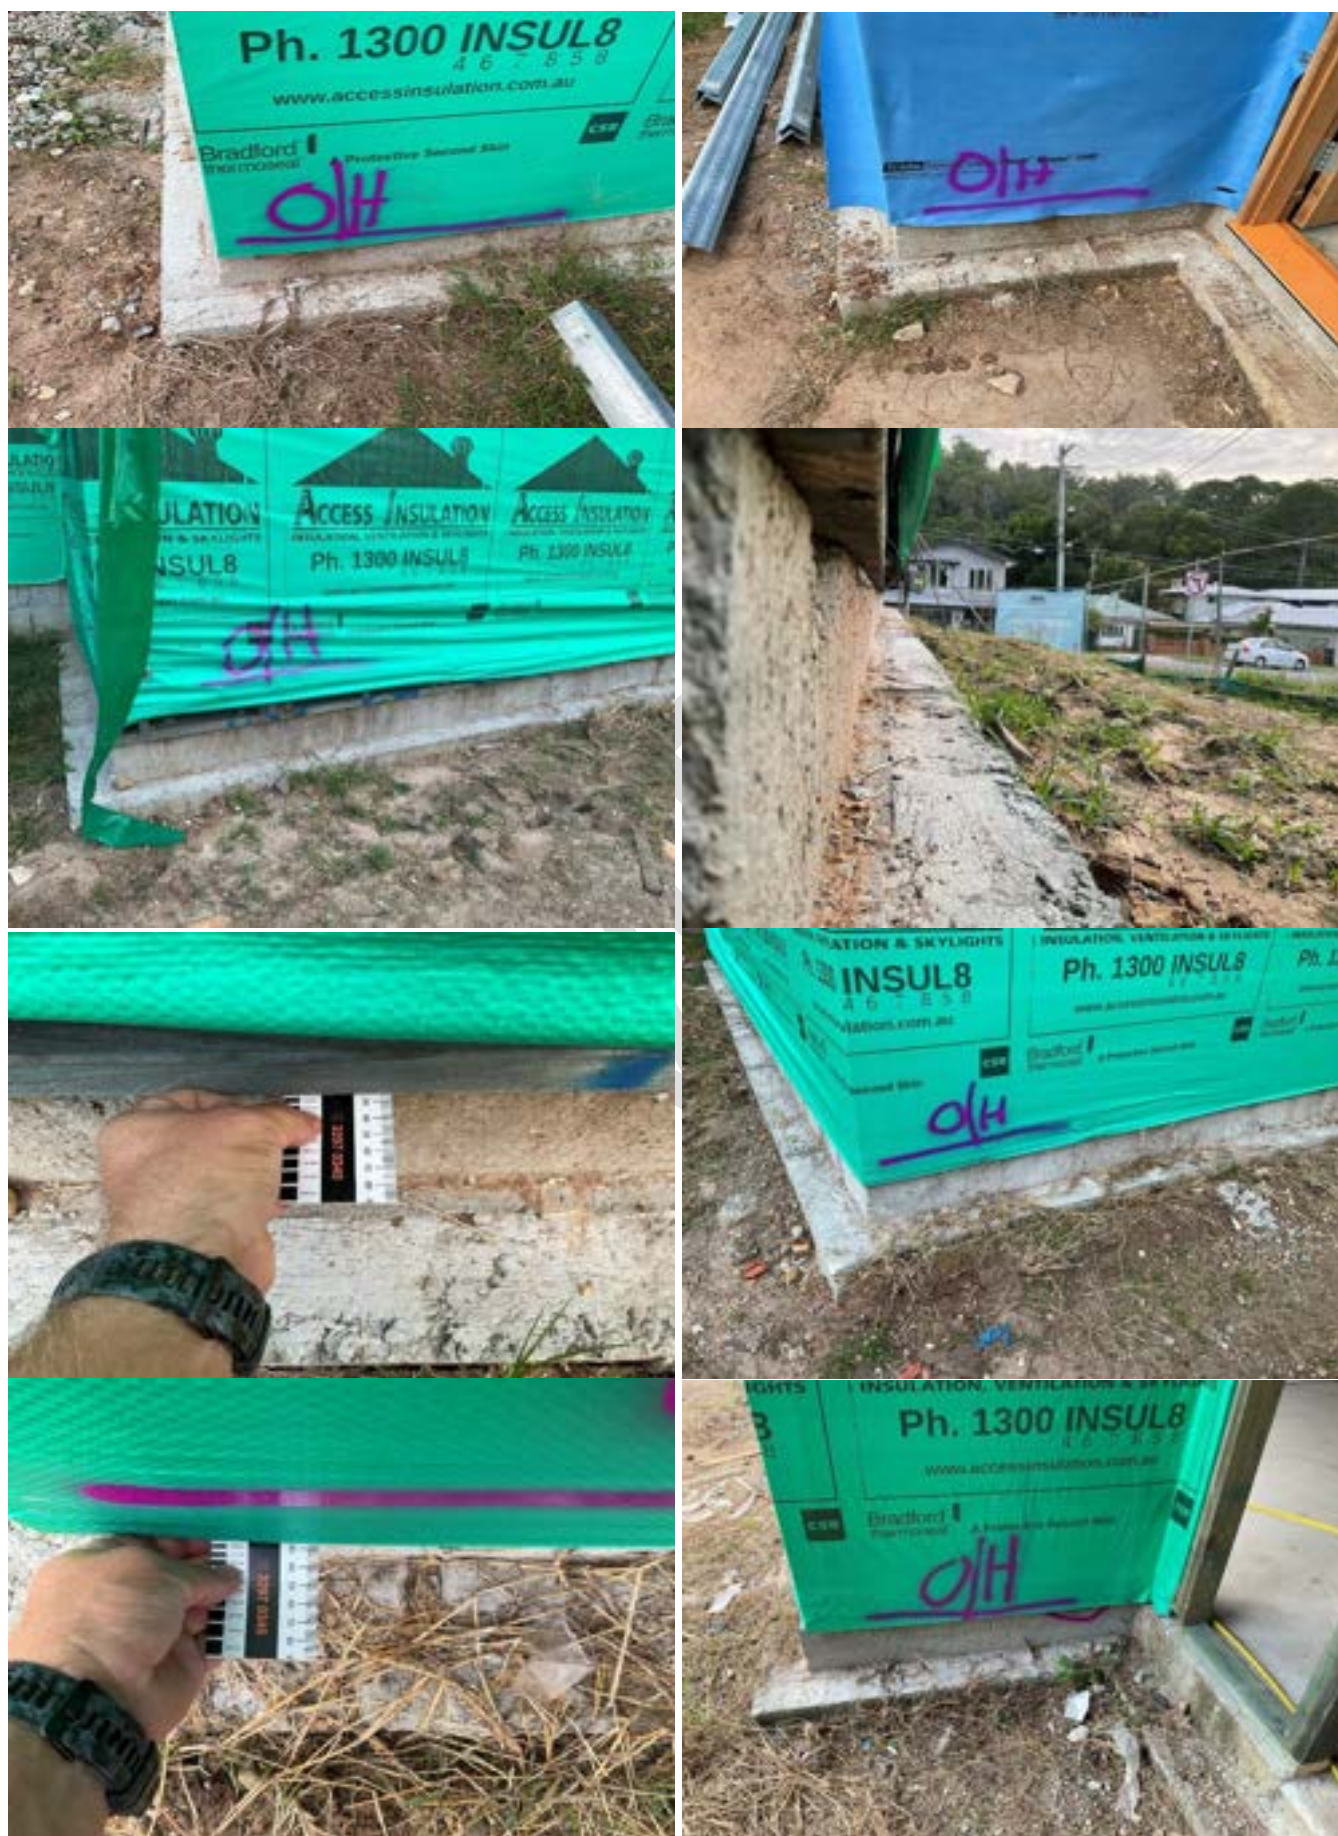
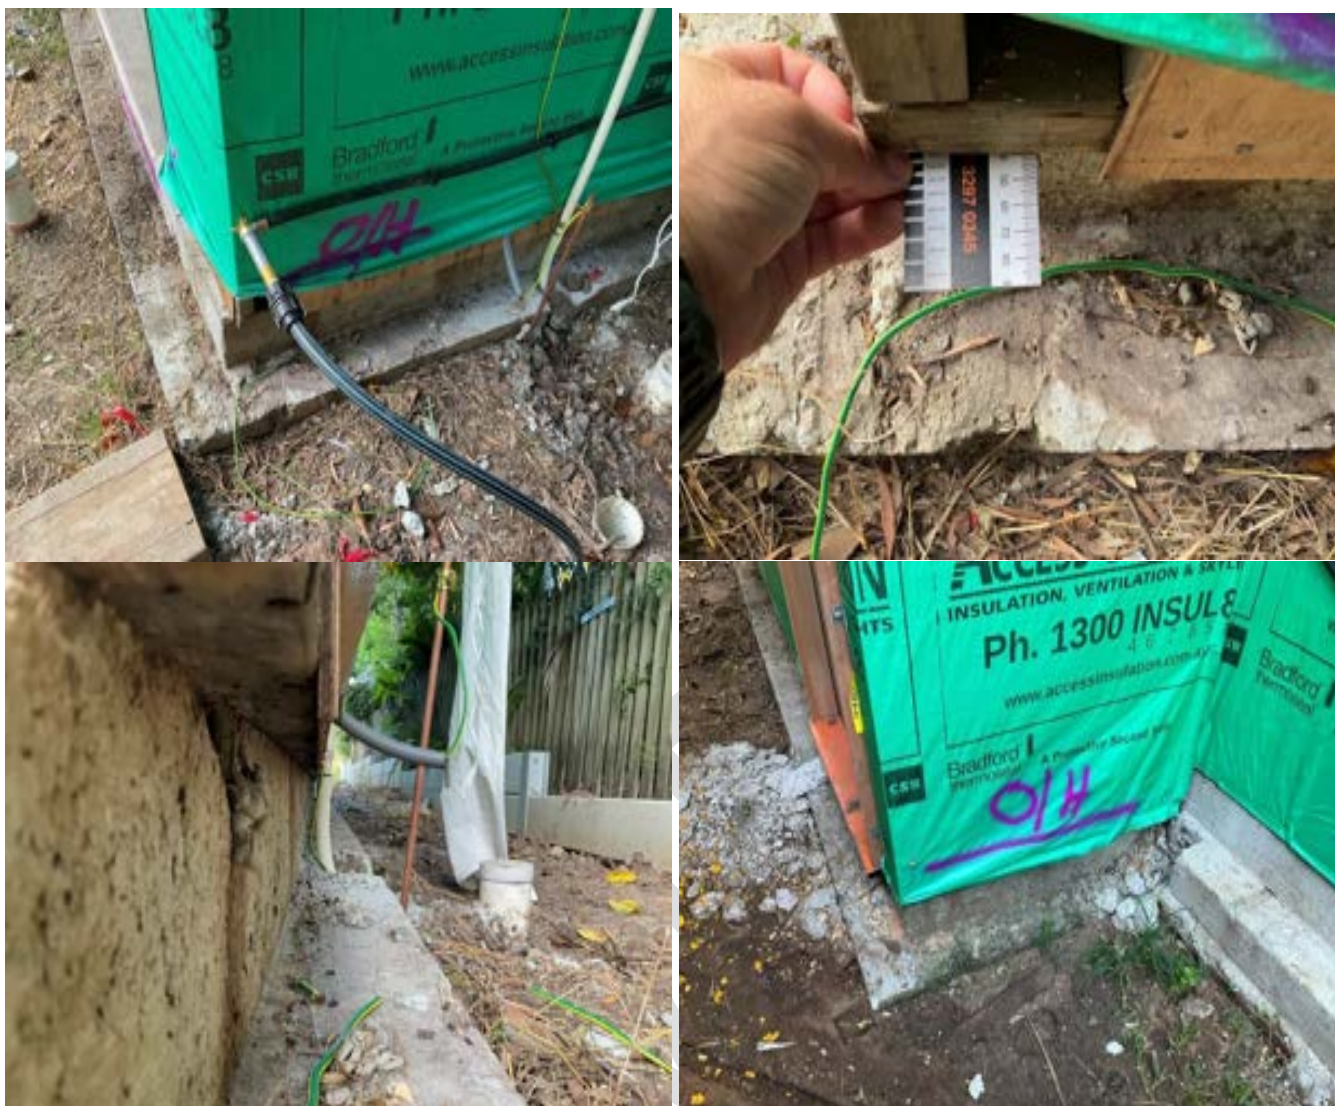
7. Bottom plates overhang to slab in excess of 10 mm. This will need to be rectified.

It was noted at the time of inspection that the bottom plates overhang to slab in excess of 10mm this will need to be reworked and completed before continuing. Have the site Engineer witness the repair of the slab to ensure that the builder has carried out the works in accordance with the process's and rectification statements in the engineering documentation.

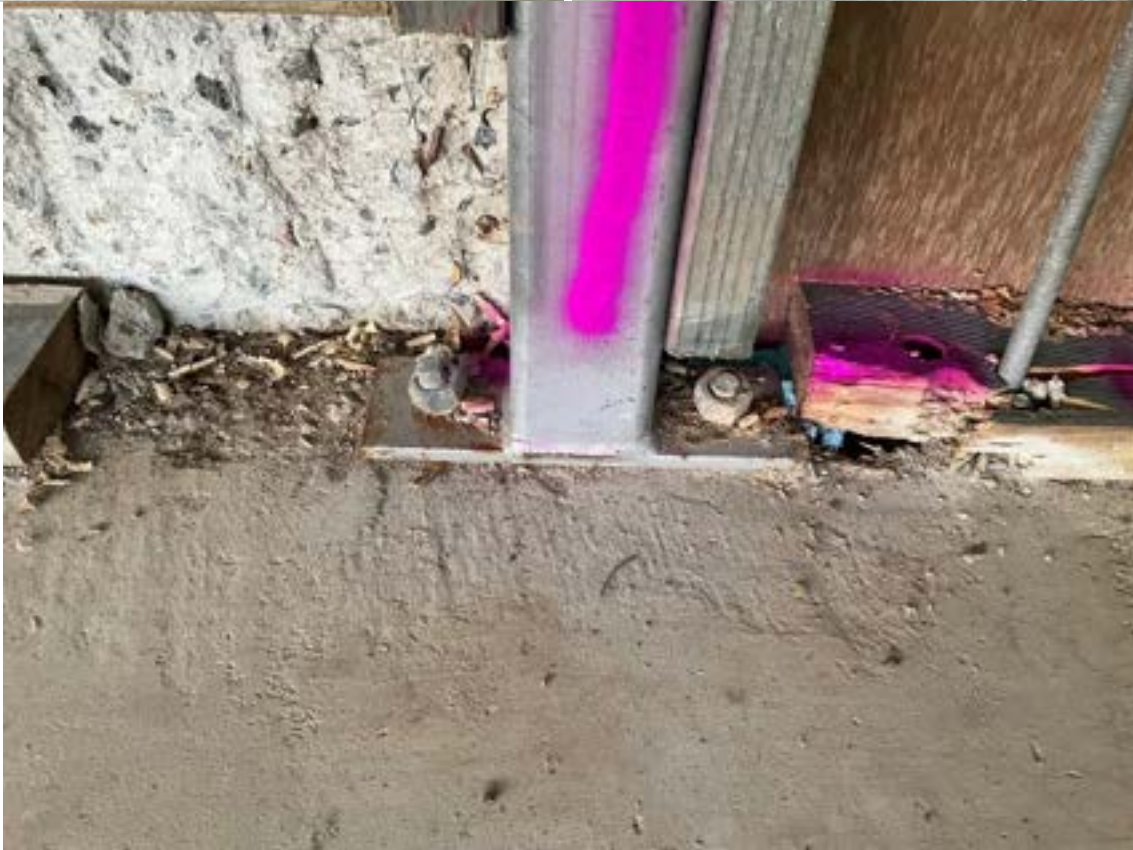
8. Bottom plate has been damaged, some studs are not fully supported this will need to be rectified. As per AS 1684.2

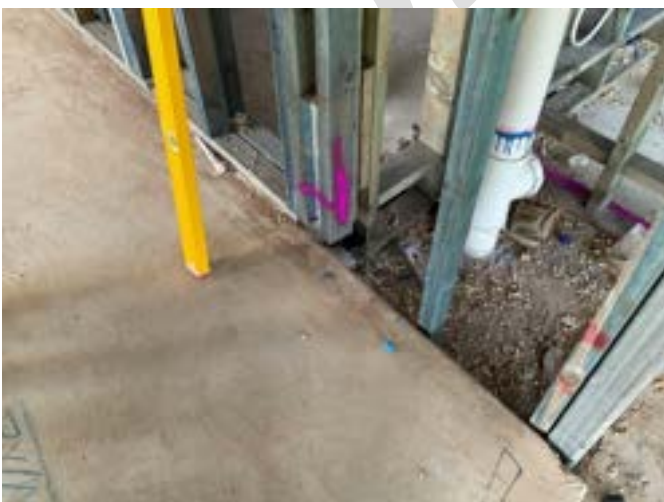
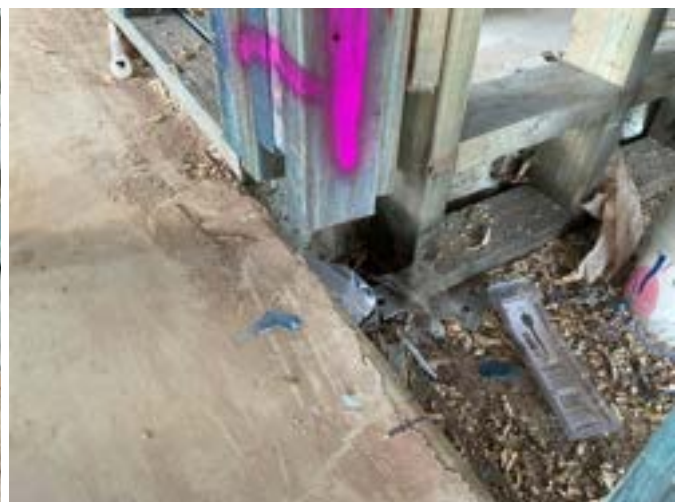
11. The load bearing studs are not supported, this will need rework, not in an appropriate, skilful way or with reasonable care and skill.

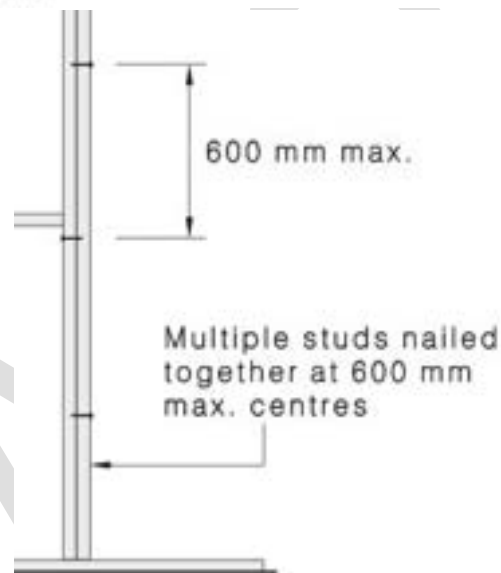
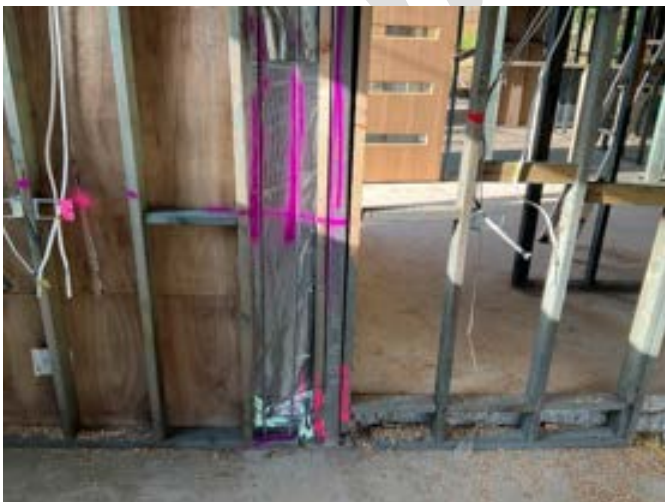
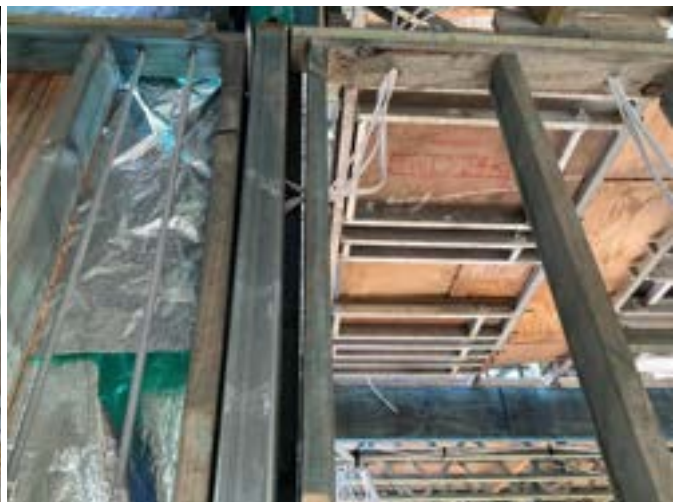
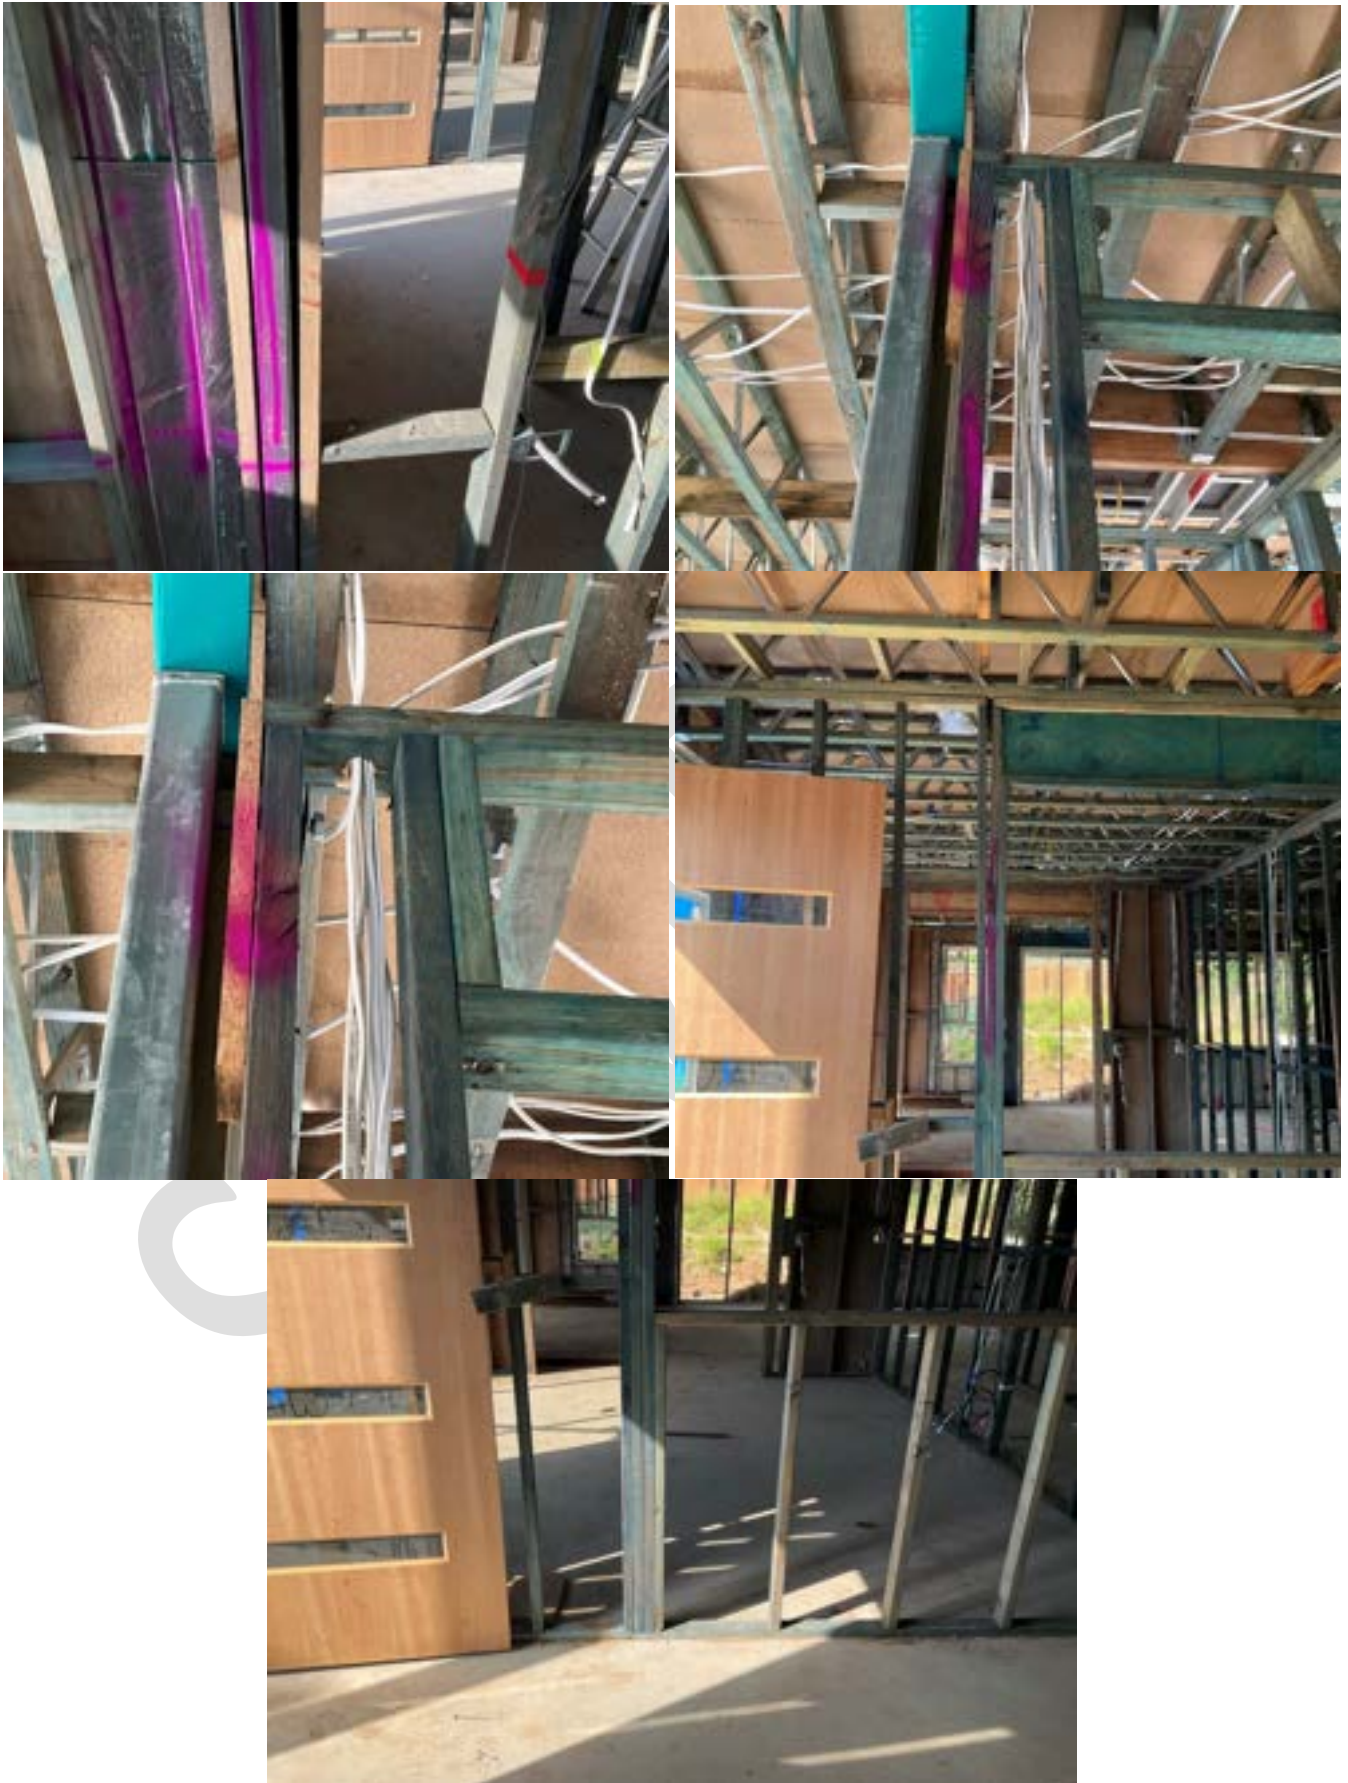
12. There are large gaps to the frame packers, studs/missing, this will need rework, not in an appropriate, skilful way or Multiple studs at sides of openings or in locations supporting concentrated loads shall be laminated together as follows. **AS 1684.2; 2.4**

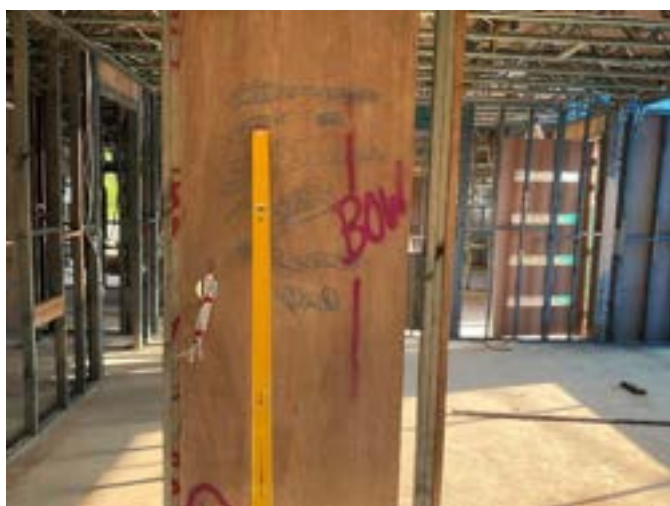
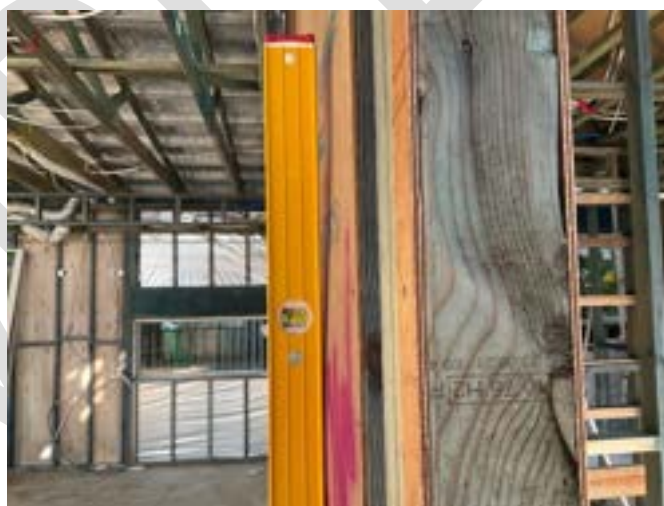
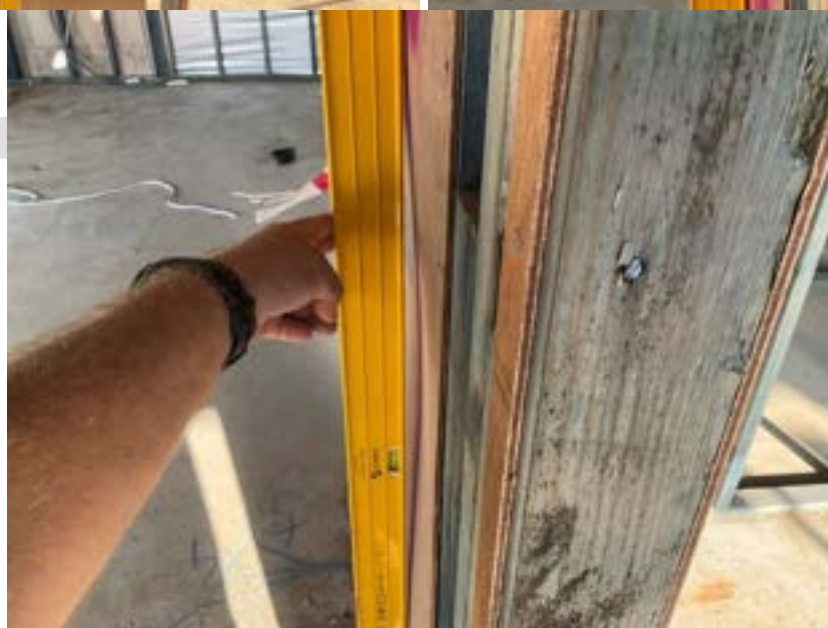
14. There are some bowed bracing sheets, this will need rework, not in an appropriate, skilful way or with reasonable care and skill.

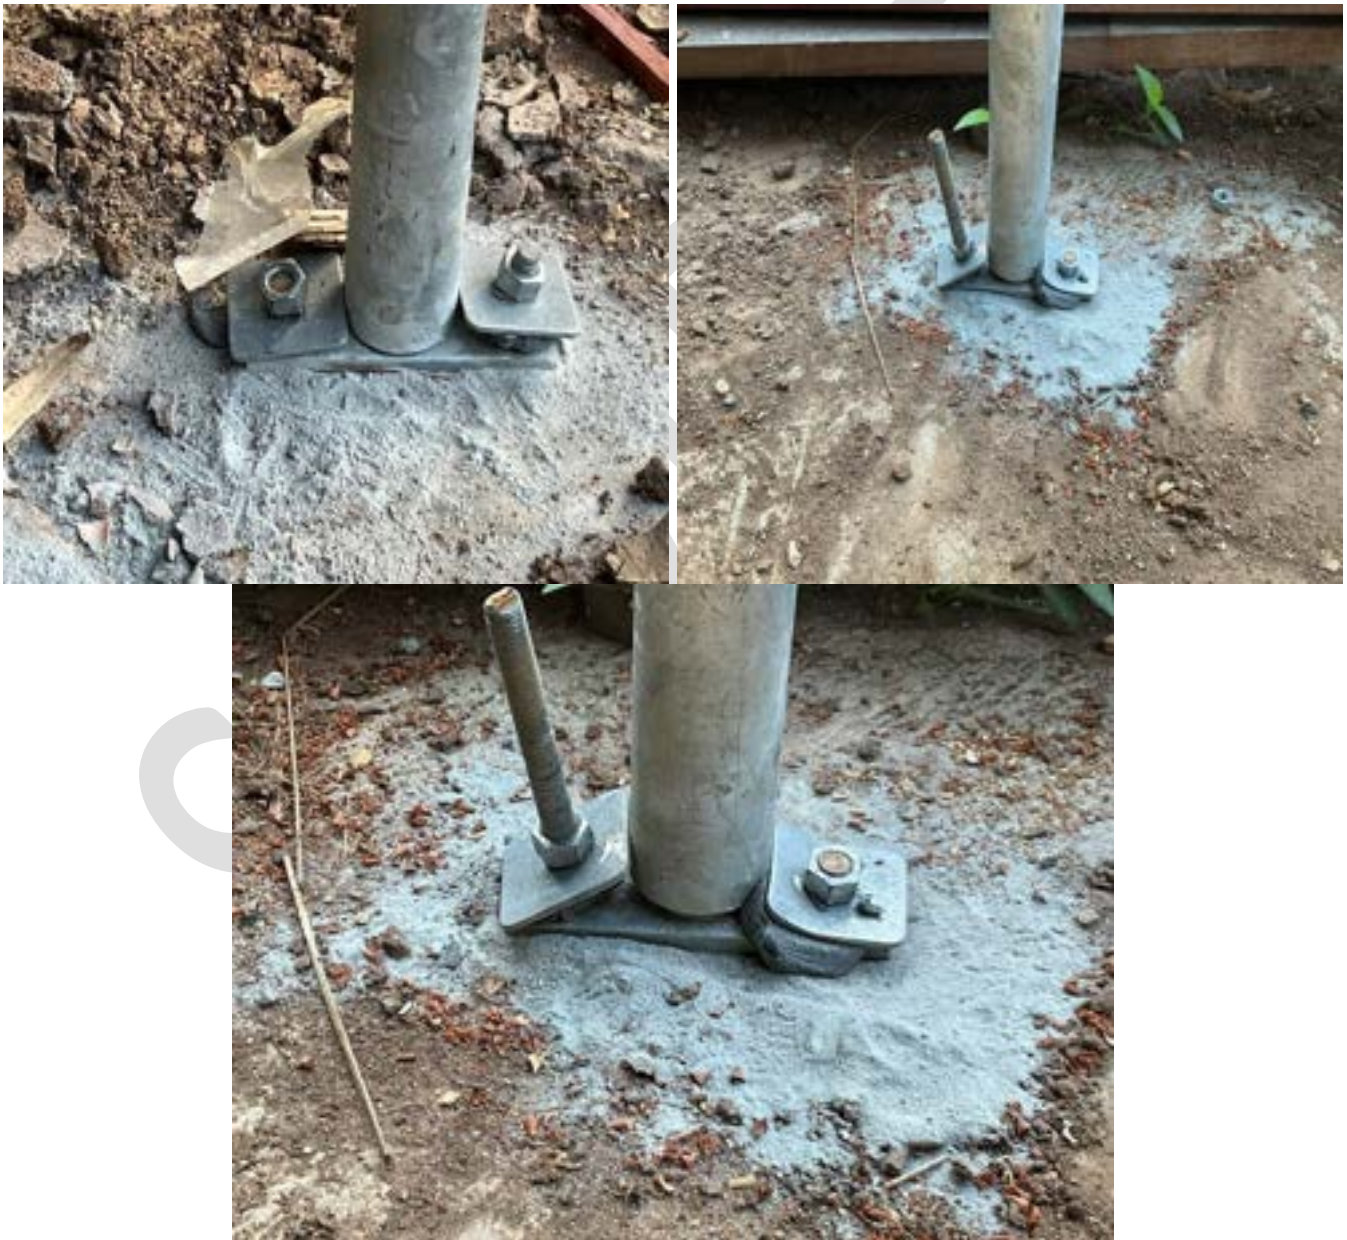
15. It was noted at the time of inspection that the fabricated steel connections the bolts do not extend 1 ½ turns beyond the face of the nut.

The Builder needs to rework these items as mark. we refer to AS 5131 and AS 4100. This will need to be reworked and completed before continuing.
