Frame (Defect Inspection) REPORT (hereinafter called the "Report")

Report Number 00024 Time:11:30 AM

Inspection Date: 17/03/2022

Property Address: LOT sample

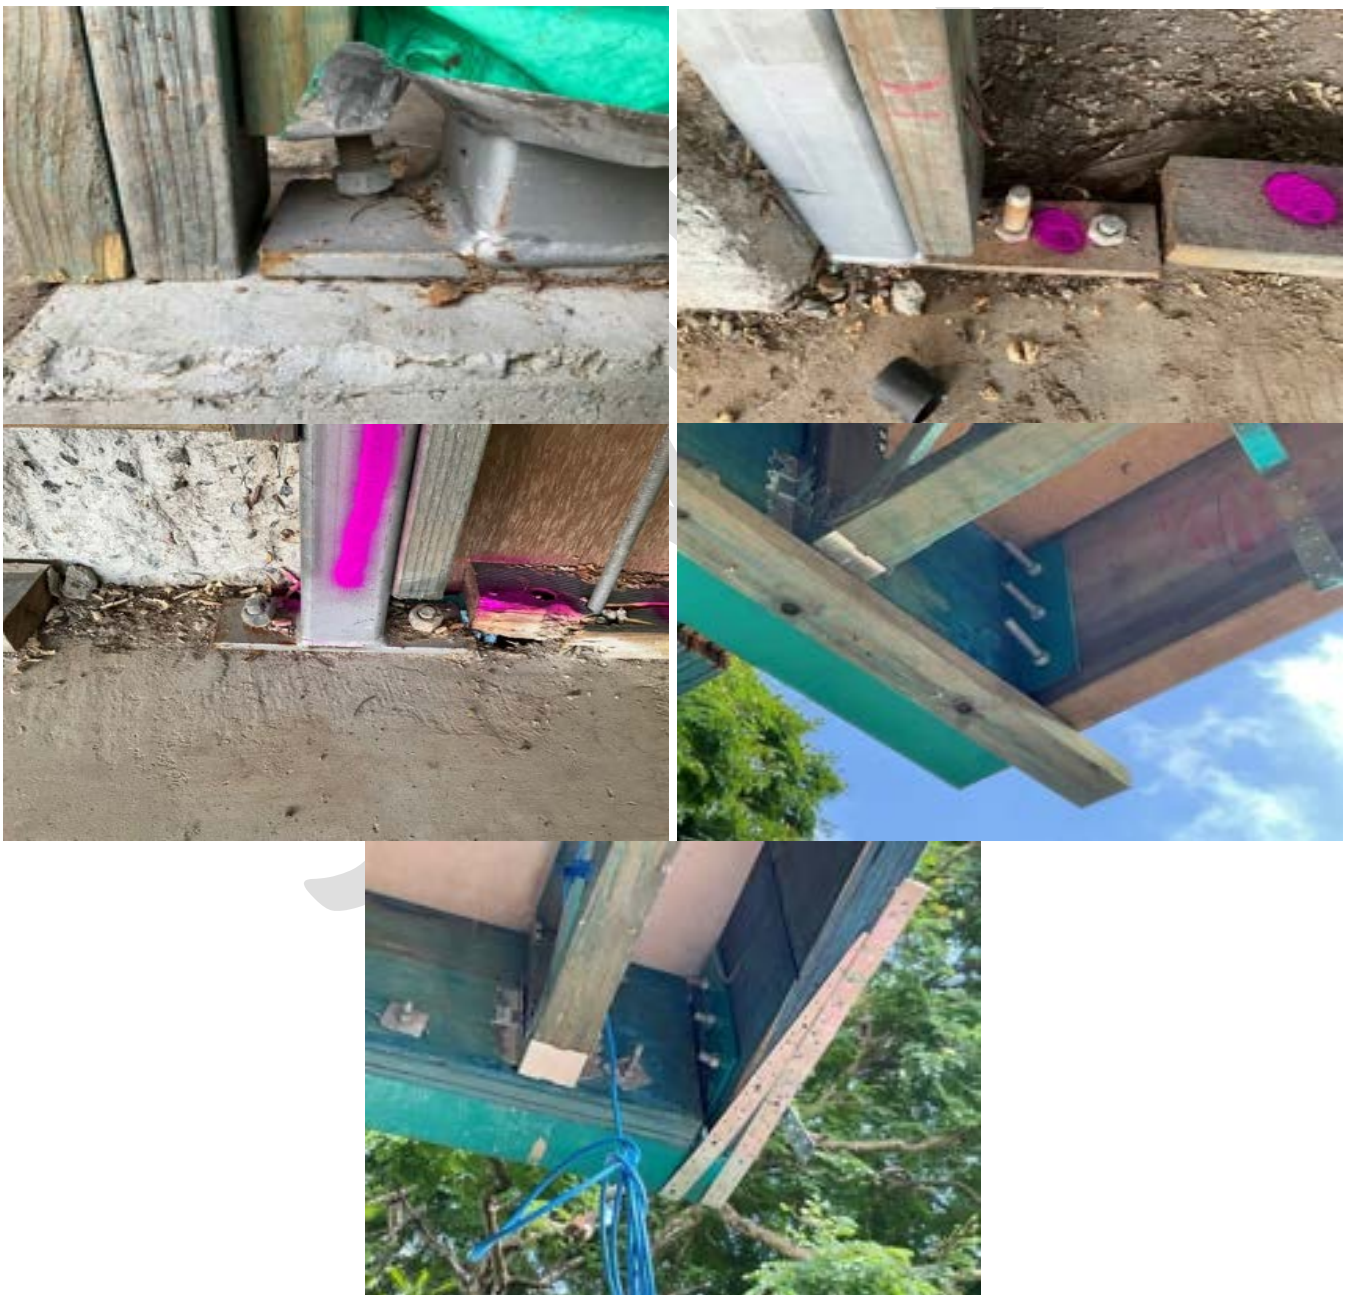
16. It was noted at the time of inspection that the fabricated steel connections some have no washer installed at all, these will need to be installed.

The Builder needs to rework these items as mark. we refer to AS 5131 and AS 4100. This will need to be reworked and completed before continuing.

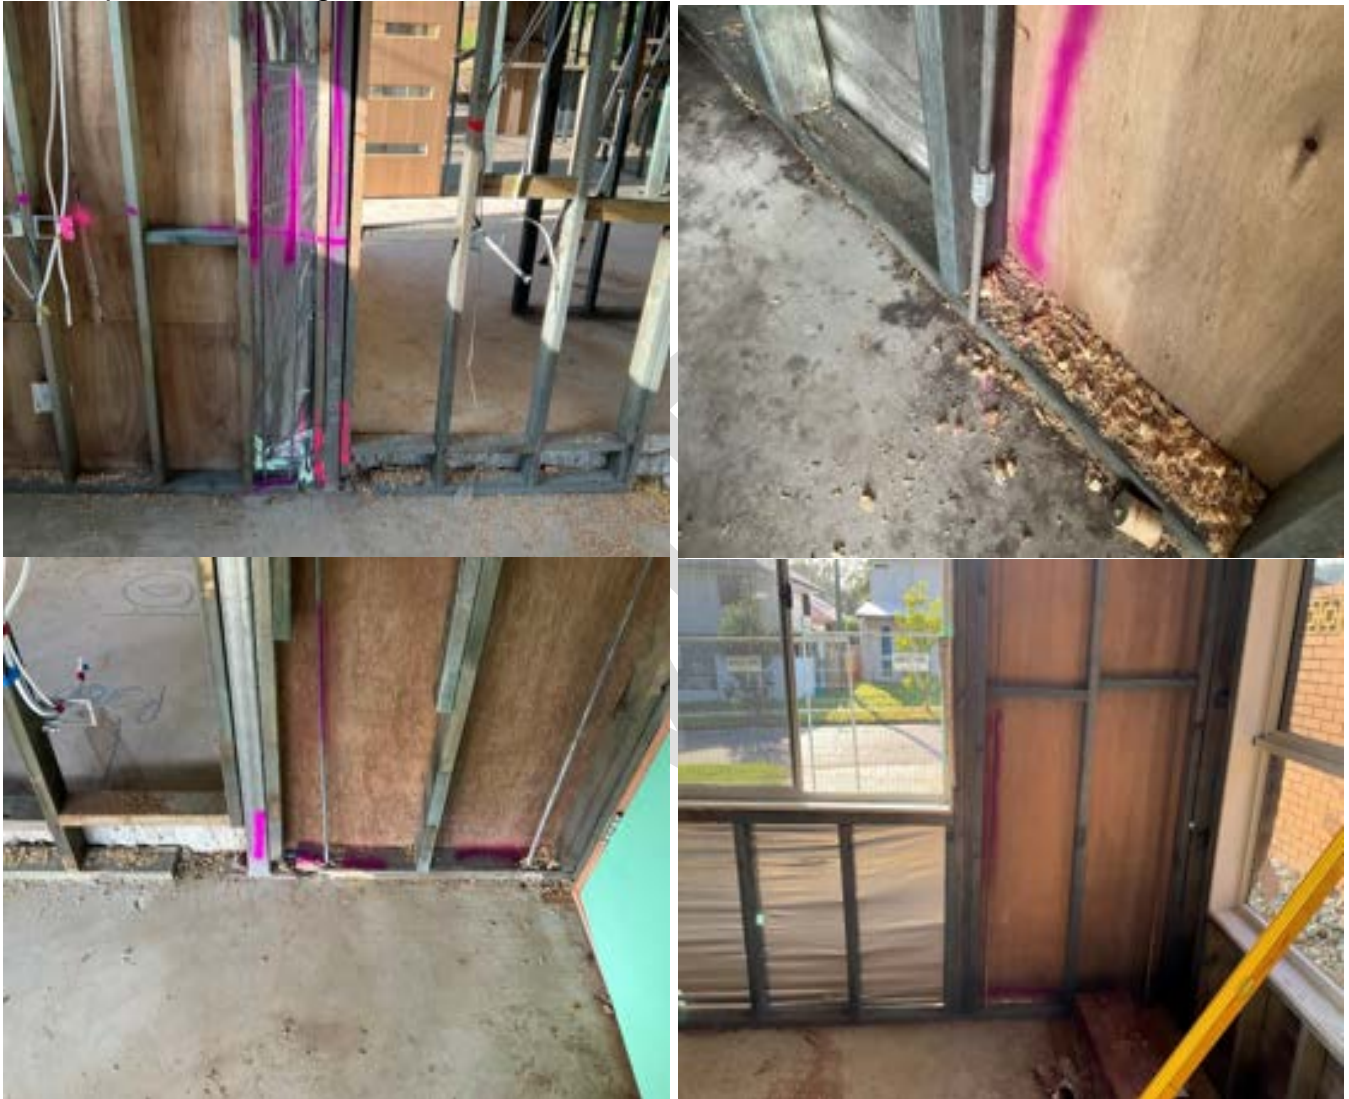
17. Tie down rods are loose, not installed, this will need to be rectified to comply with engineering.

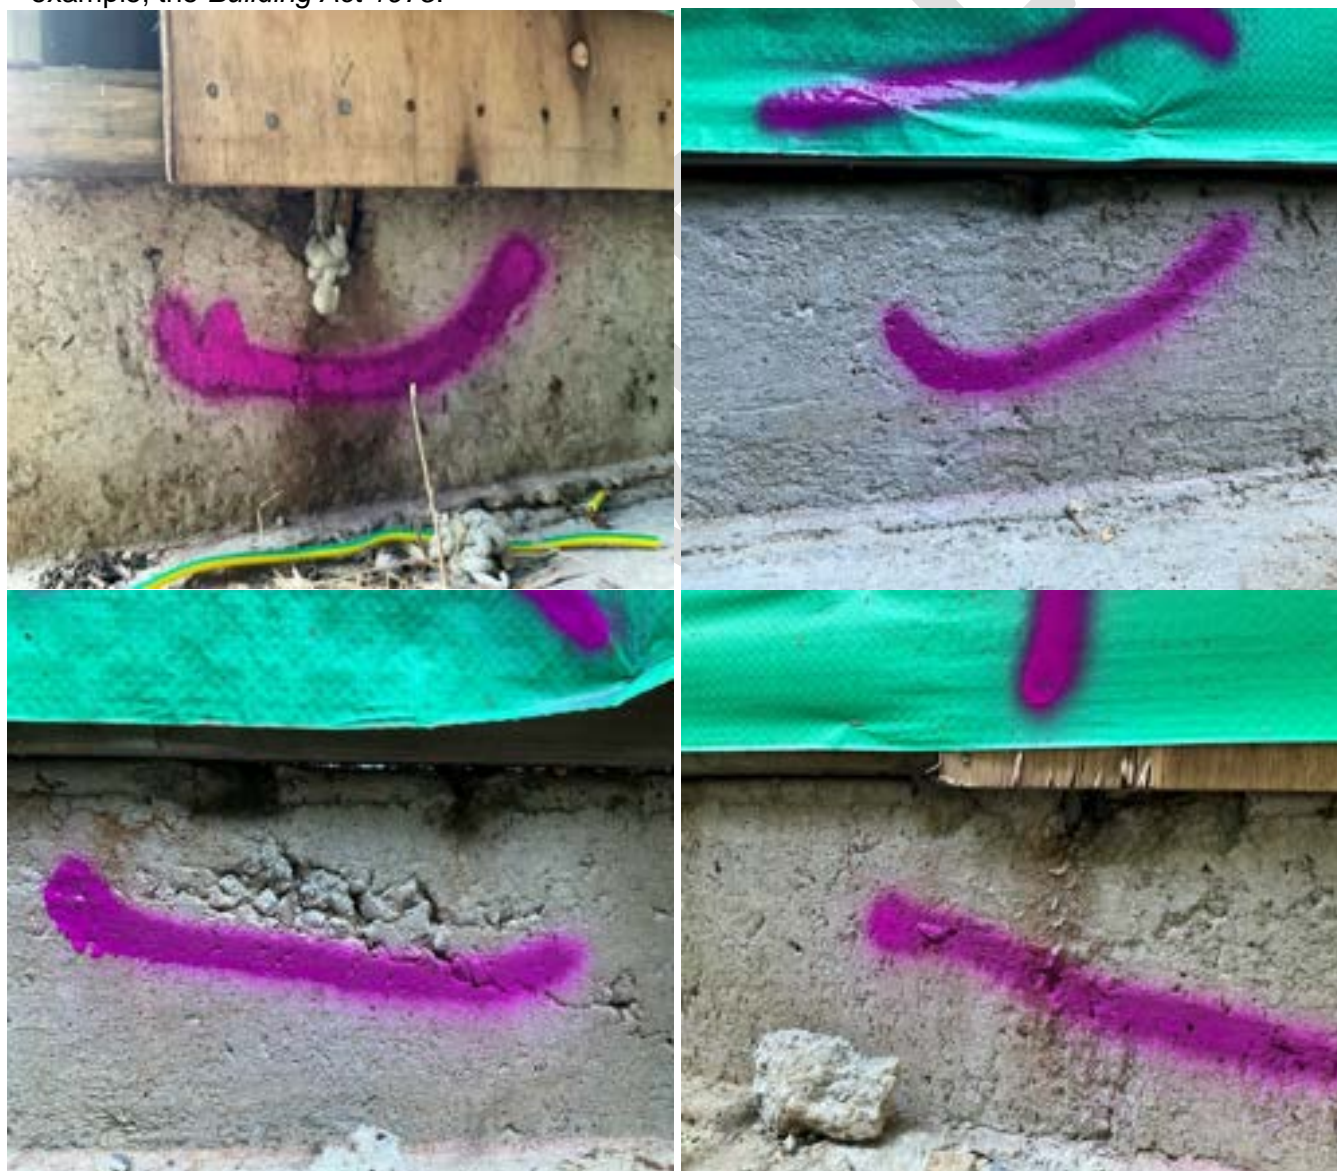
18. Some of the tie down bolts have broken out of the slab, this will need to be rectified to comply with engineering.

The installation of the tie down bolts are a vital structural component in the overall build of the dwelling. It stops the house from moving when forces, such as wind, are applied to a dwelling. This needs to be reworked and rectified. AS per AS 1684. BCA

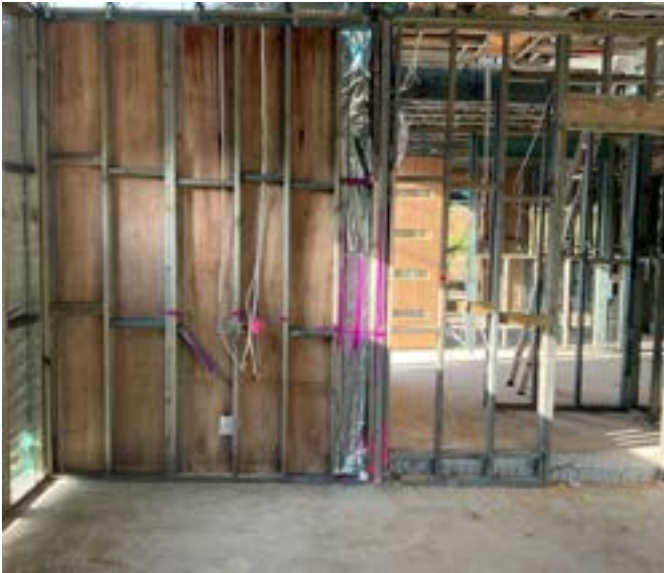
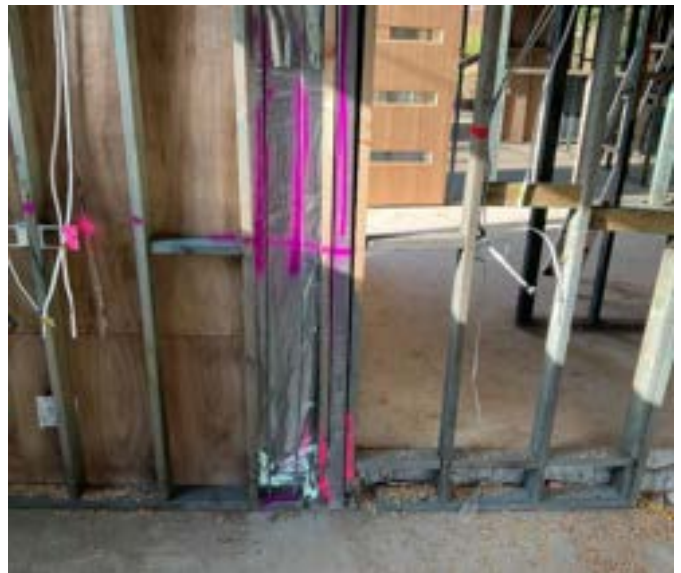
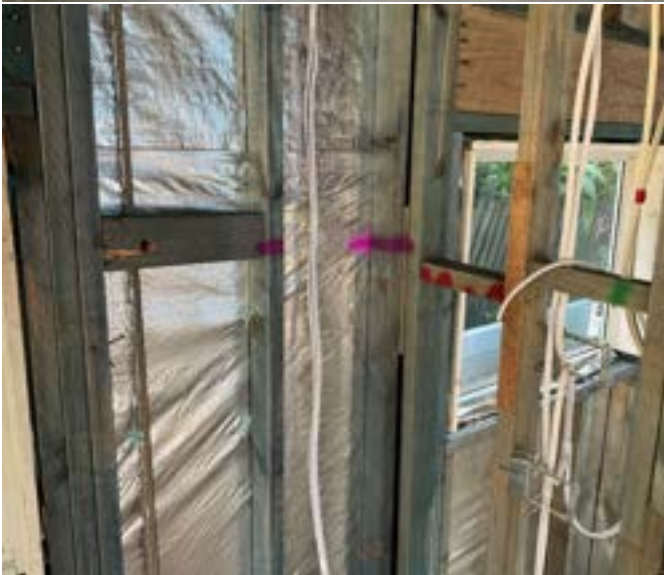
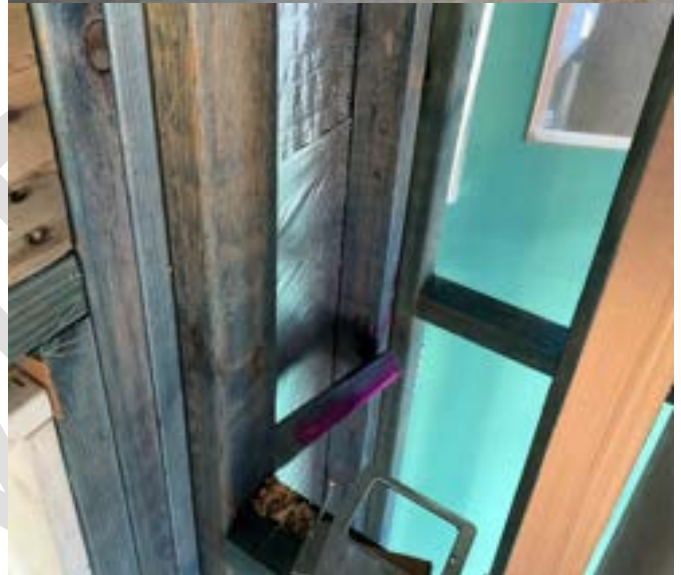
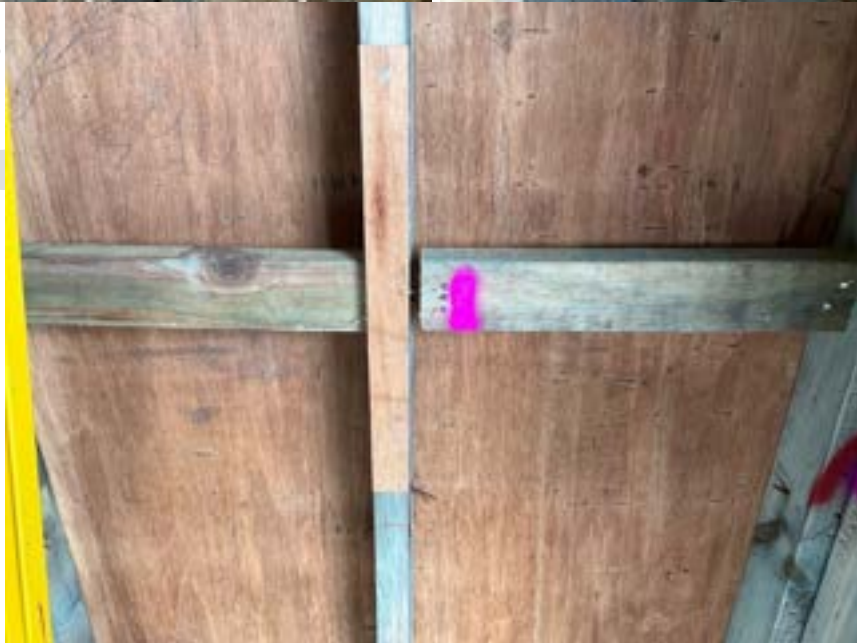
19. Some noggings are missing, loose, too far apart 1350mm and are not continuous, have been marked

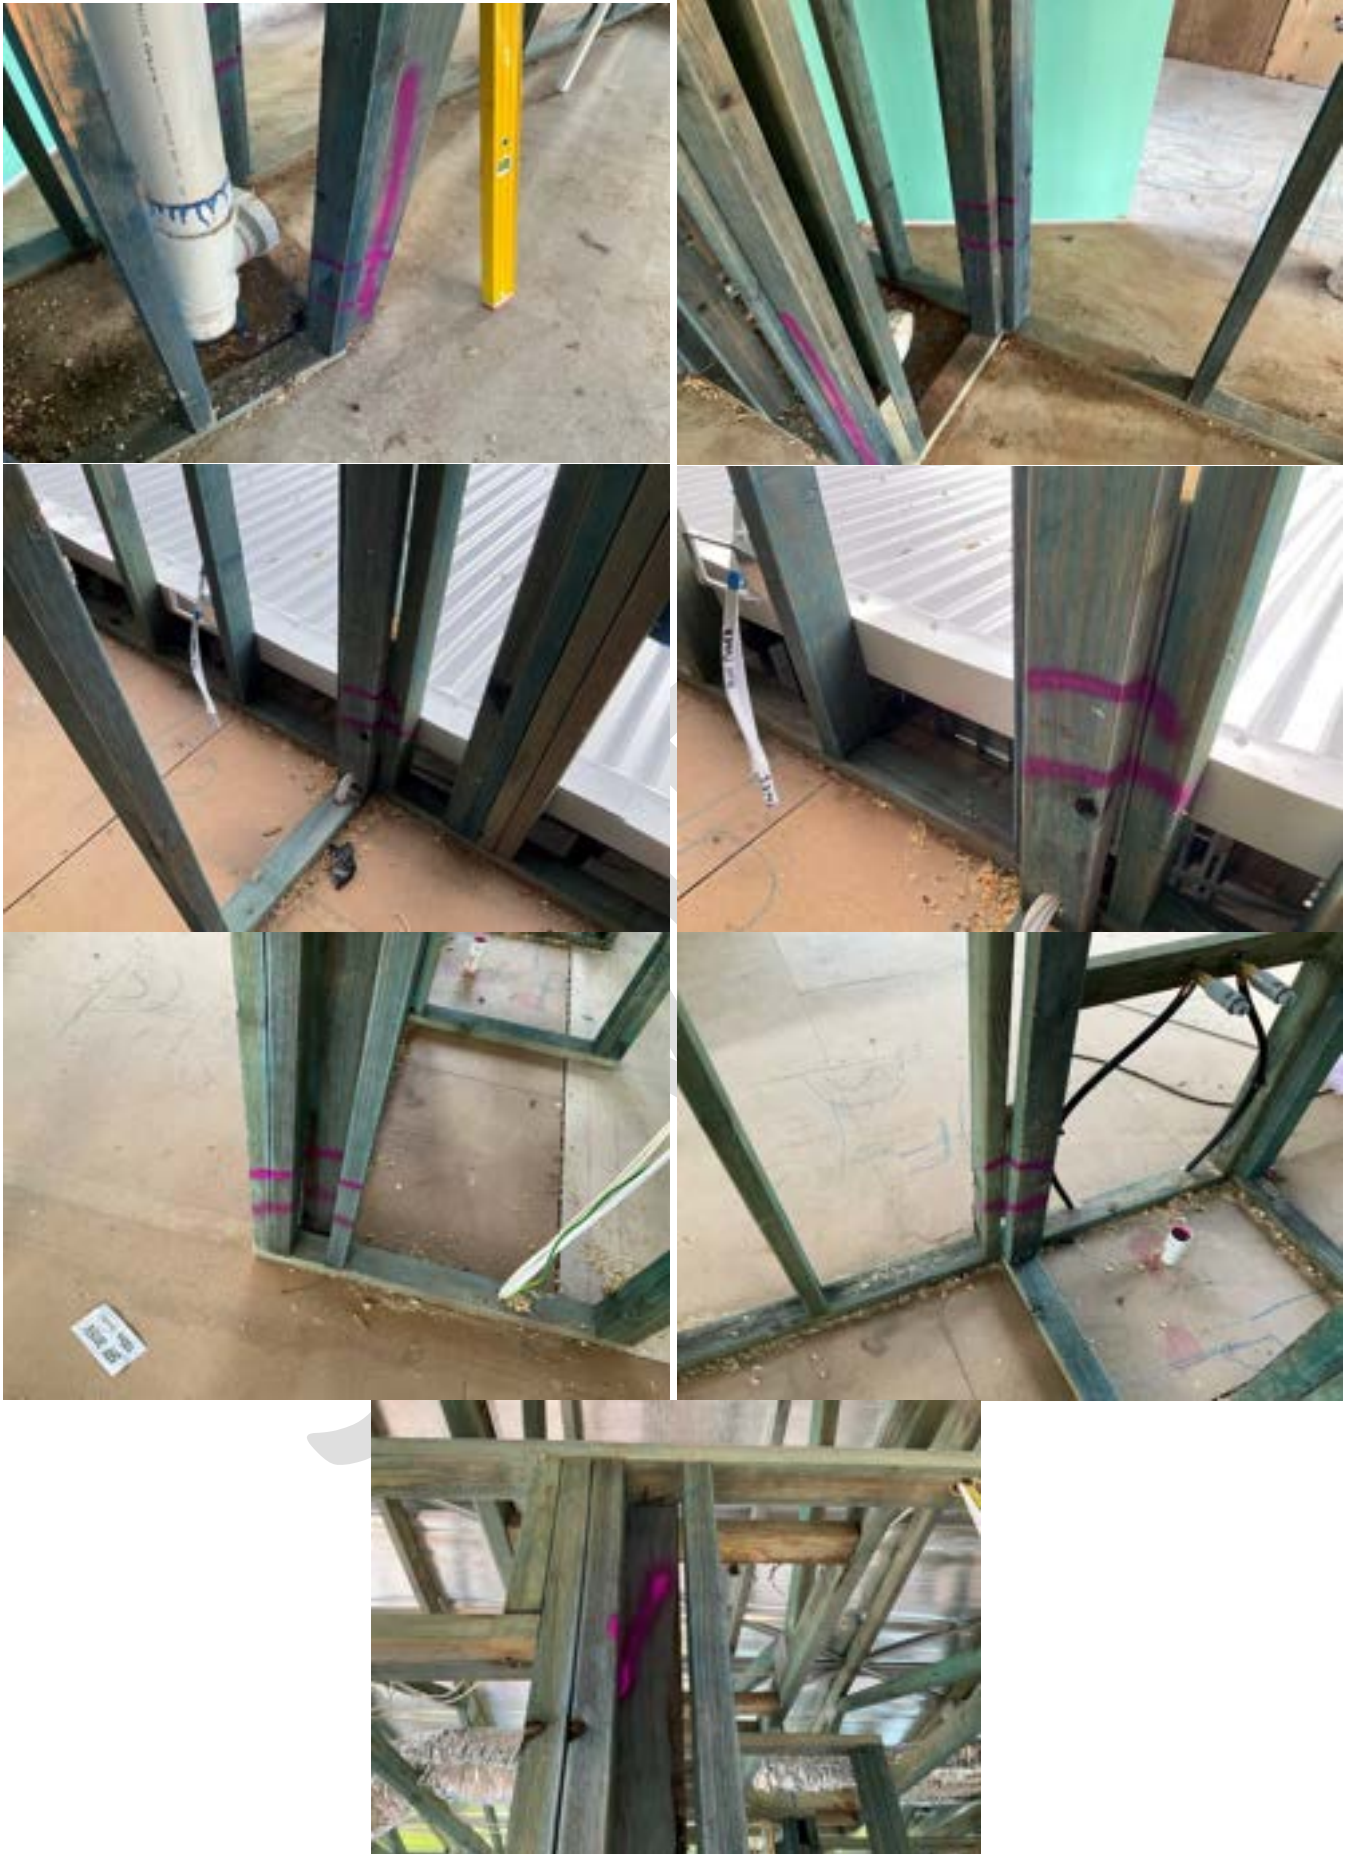
20. Intersecting blocks as marked have not been nailed and some are missing.

This does not comply with the standard, additional nails and blocks will need to be installed as per insert below:

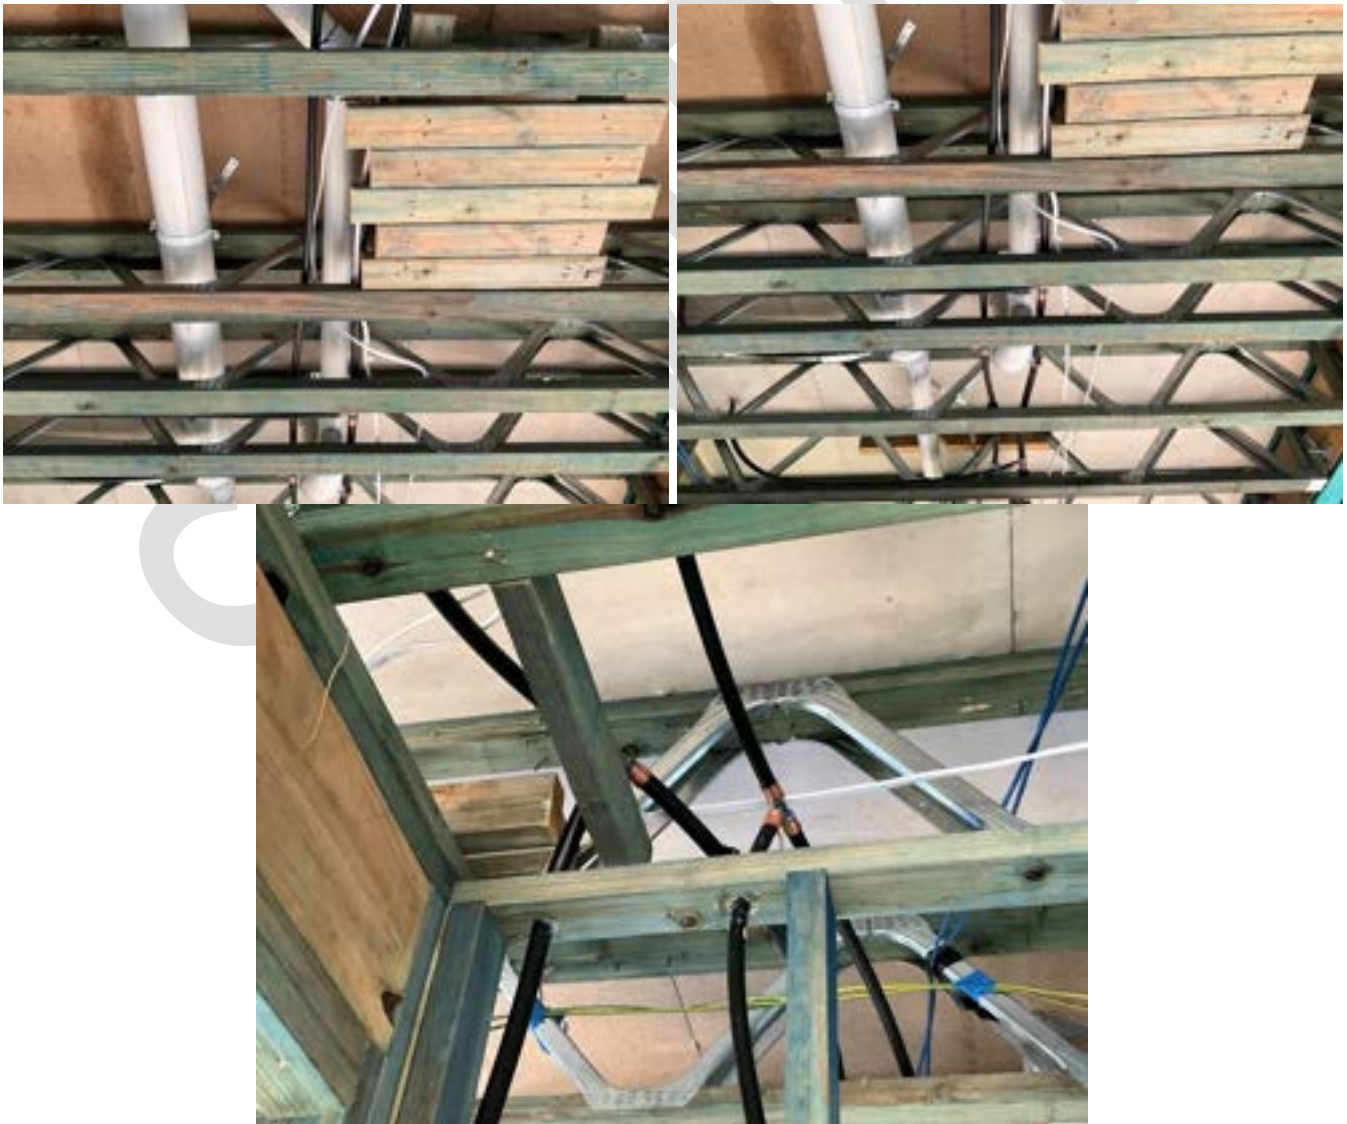
21. Substandard workmanship (poor installation) As per AS 3500.1 (5.3.2) - plumbing cannot be installed within 25 mm of an electrical wire. The electrical wire must be relocated or the plumbing relocated.

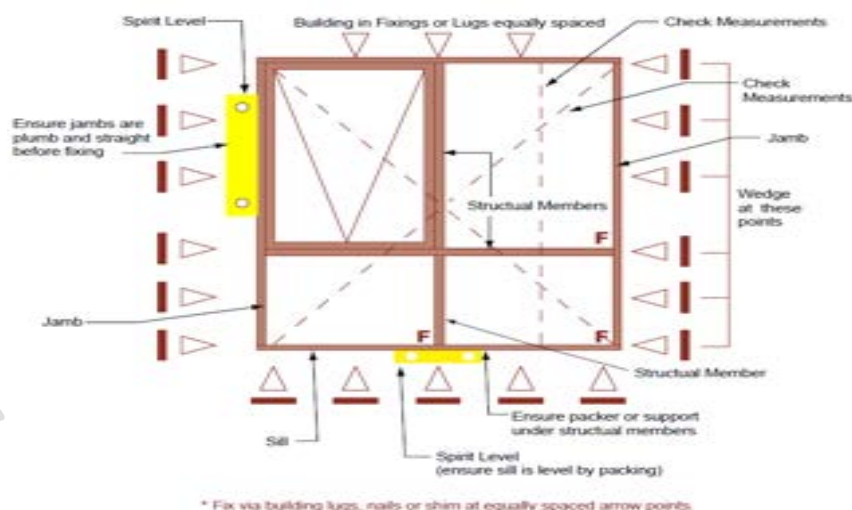
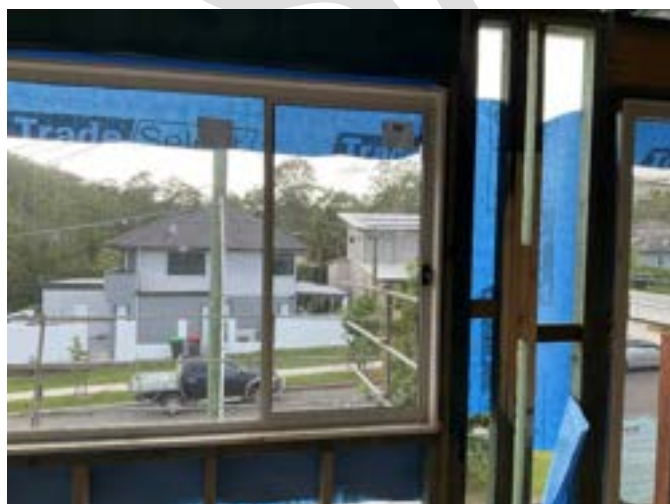
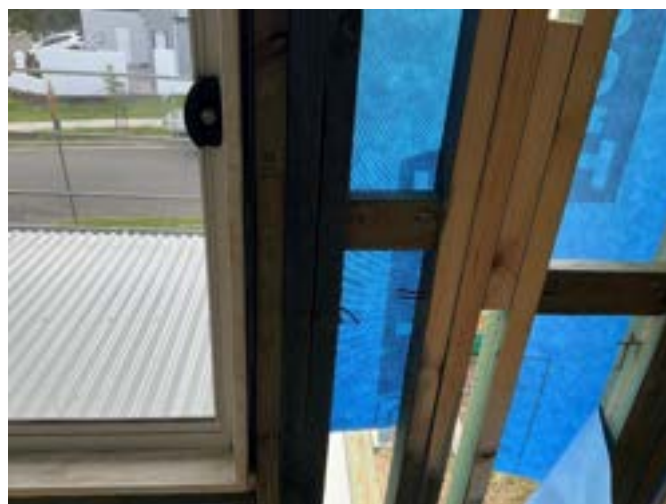
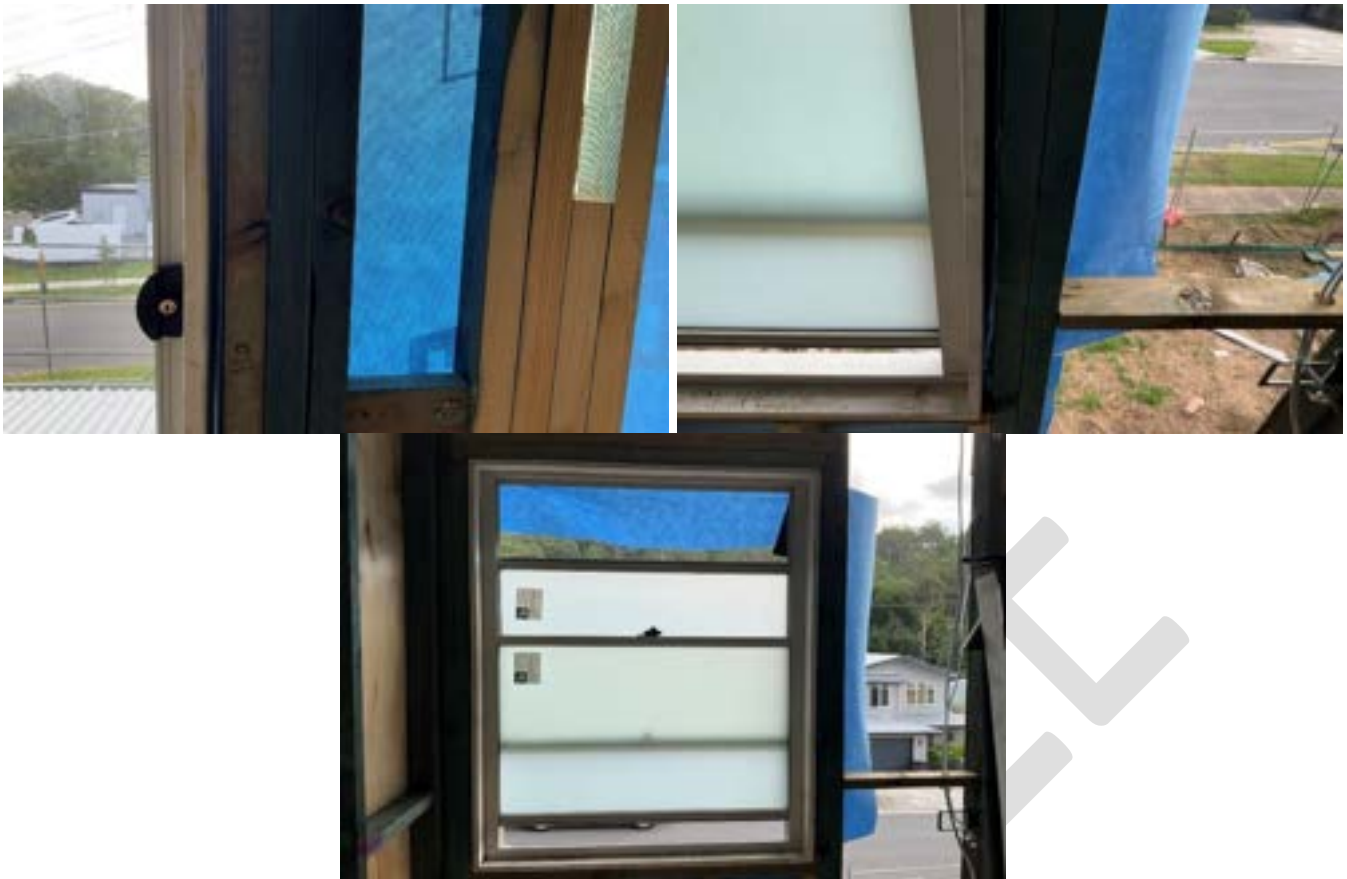
22. Some of the window/door frames have not been packed, not installed to the manufacture's installation guide as per below, this will need to be rectified.

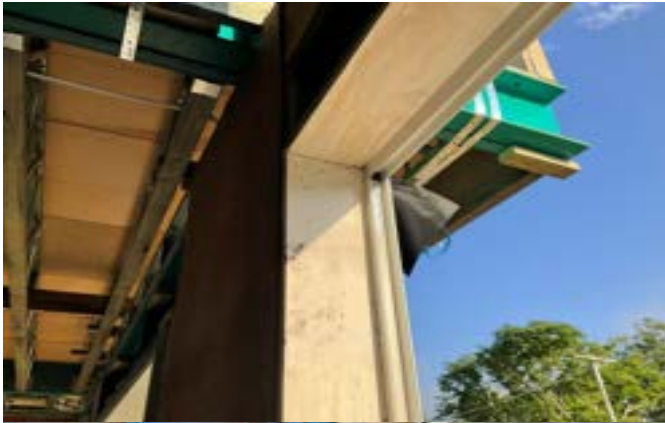
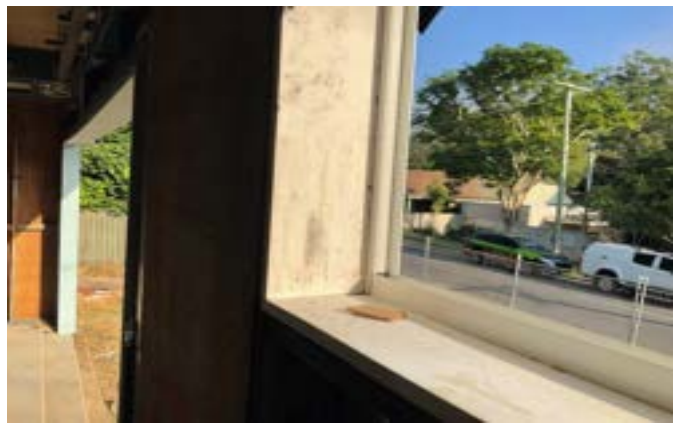
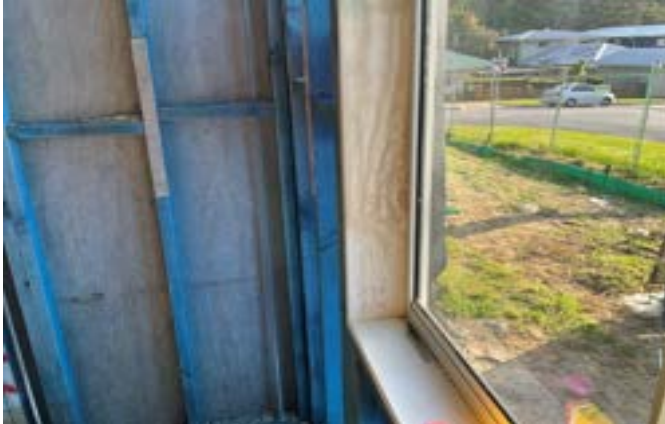
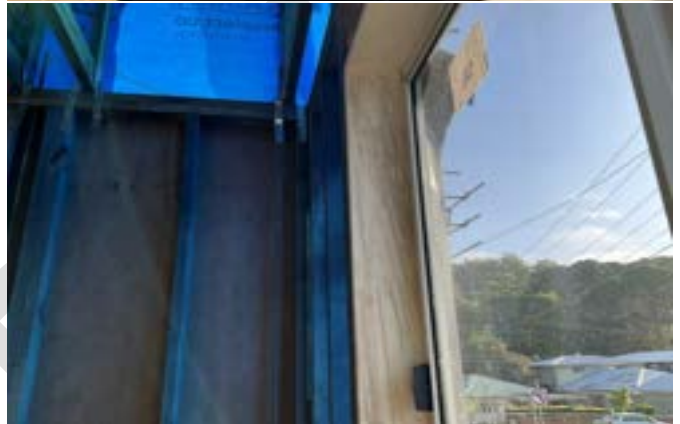
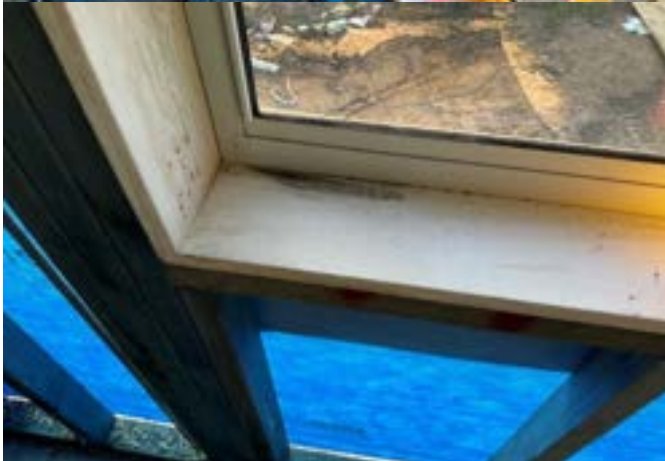
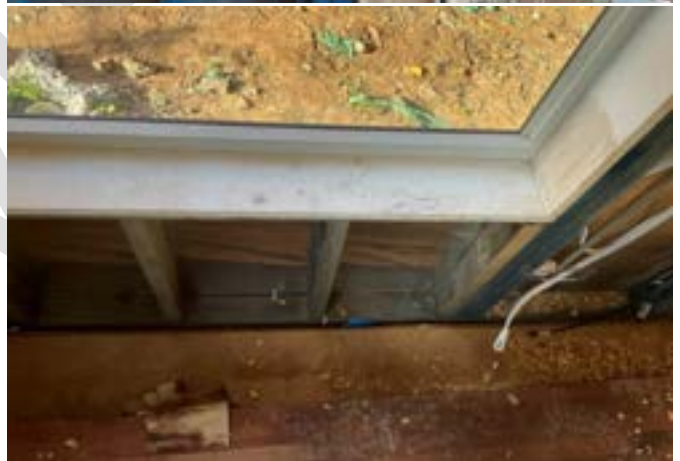
23. It appears that the window frames for the house have exposed to the weather moisture. As per AS 2047 inserted, some of the windows are now be defective and will need to be made “as new” prior to installing.

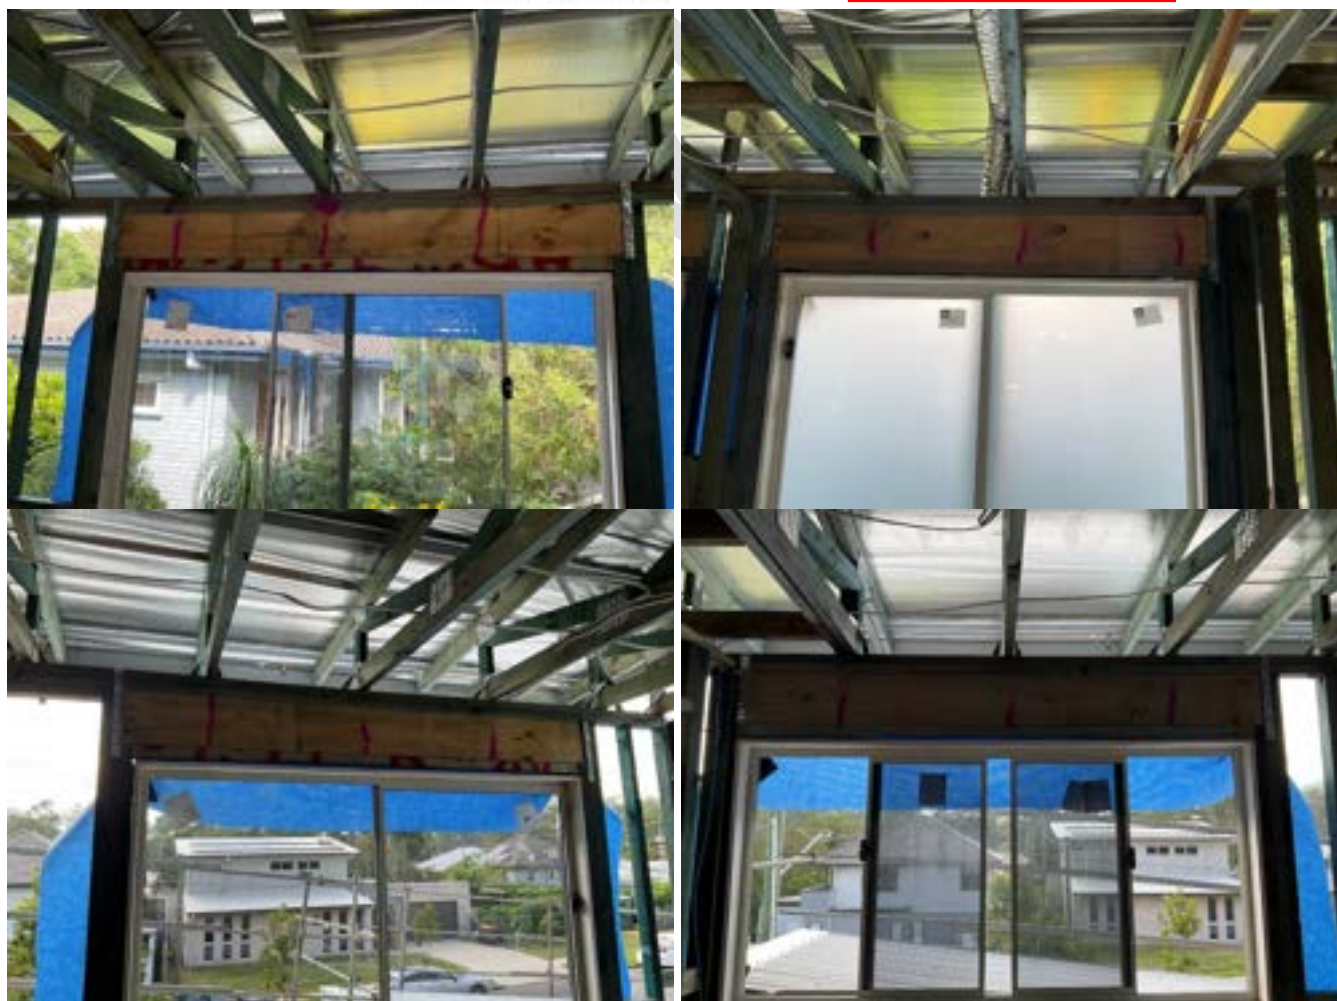
25. Openings in non-loadbearing walls (internal and external) greater than 1800mm shall have a lintel as determined by Table 23 for a ceiling load width of 1800mm. As per **AS 1684.2; 6.3.6.5:**

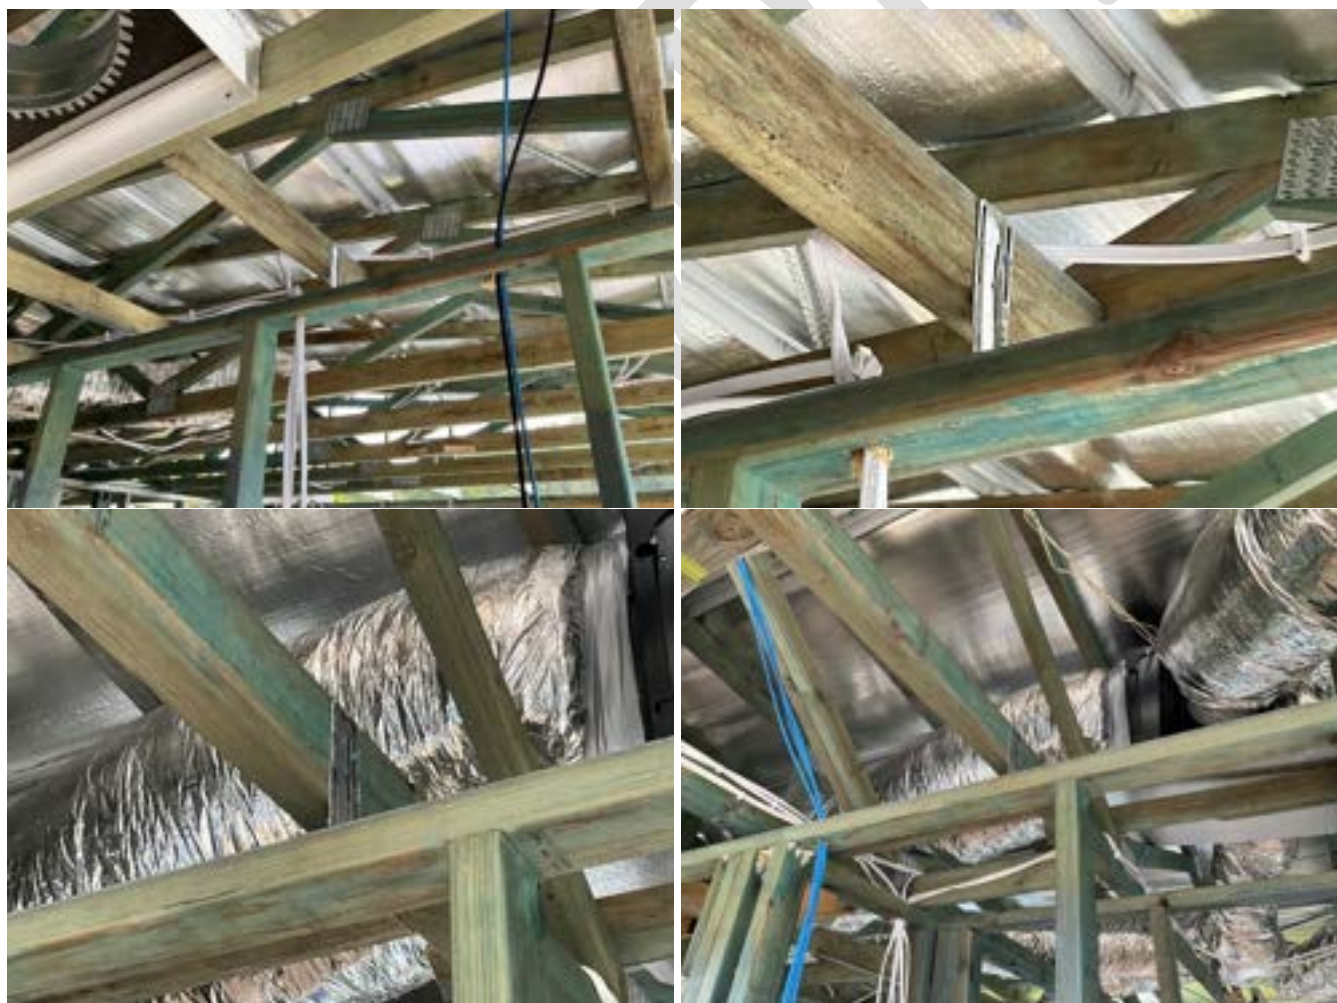
28. It appears that some of the L-brackets have been over driven, this doesn't not comply, see insert below for further information.

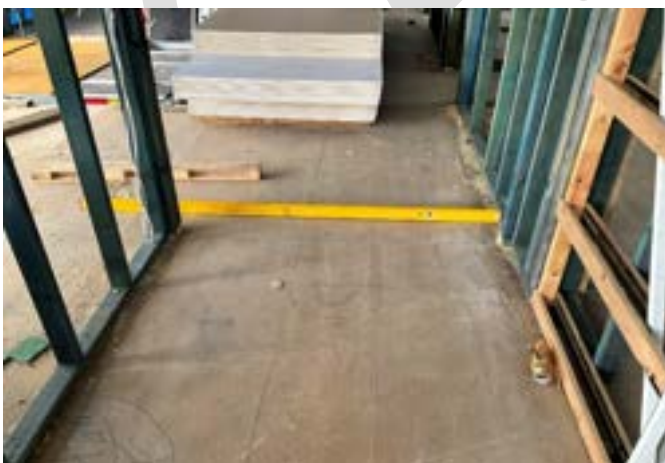
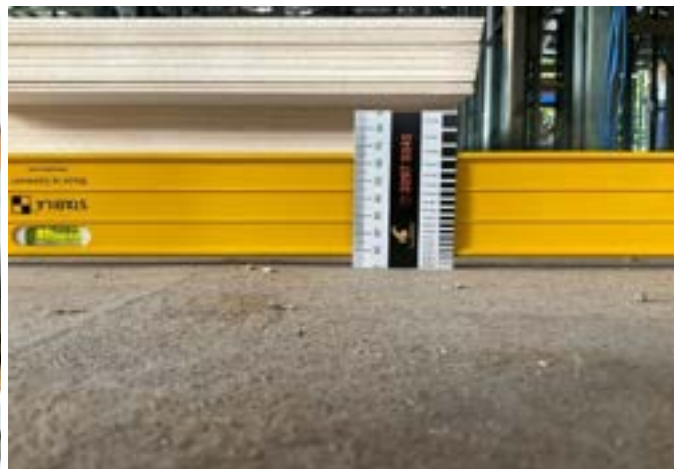
29. The upper floor has been affected by moisture and has swollen the particleboard joints; all will need to be rectified and fit for the finish floor coverings. Needs to be sanded and fit for purpose as AS 1860.2 and 14.4. As per inserts

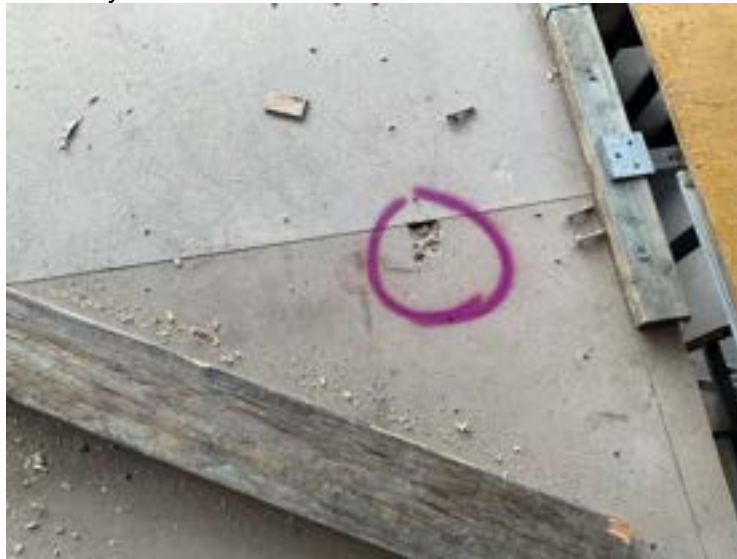
30. The flooring has been damaged and has large gaps, this will need rework, not in an appropriate, skilful way or with reasonable care and skill.

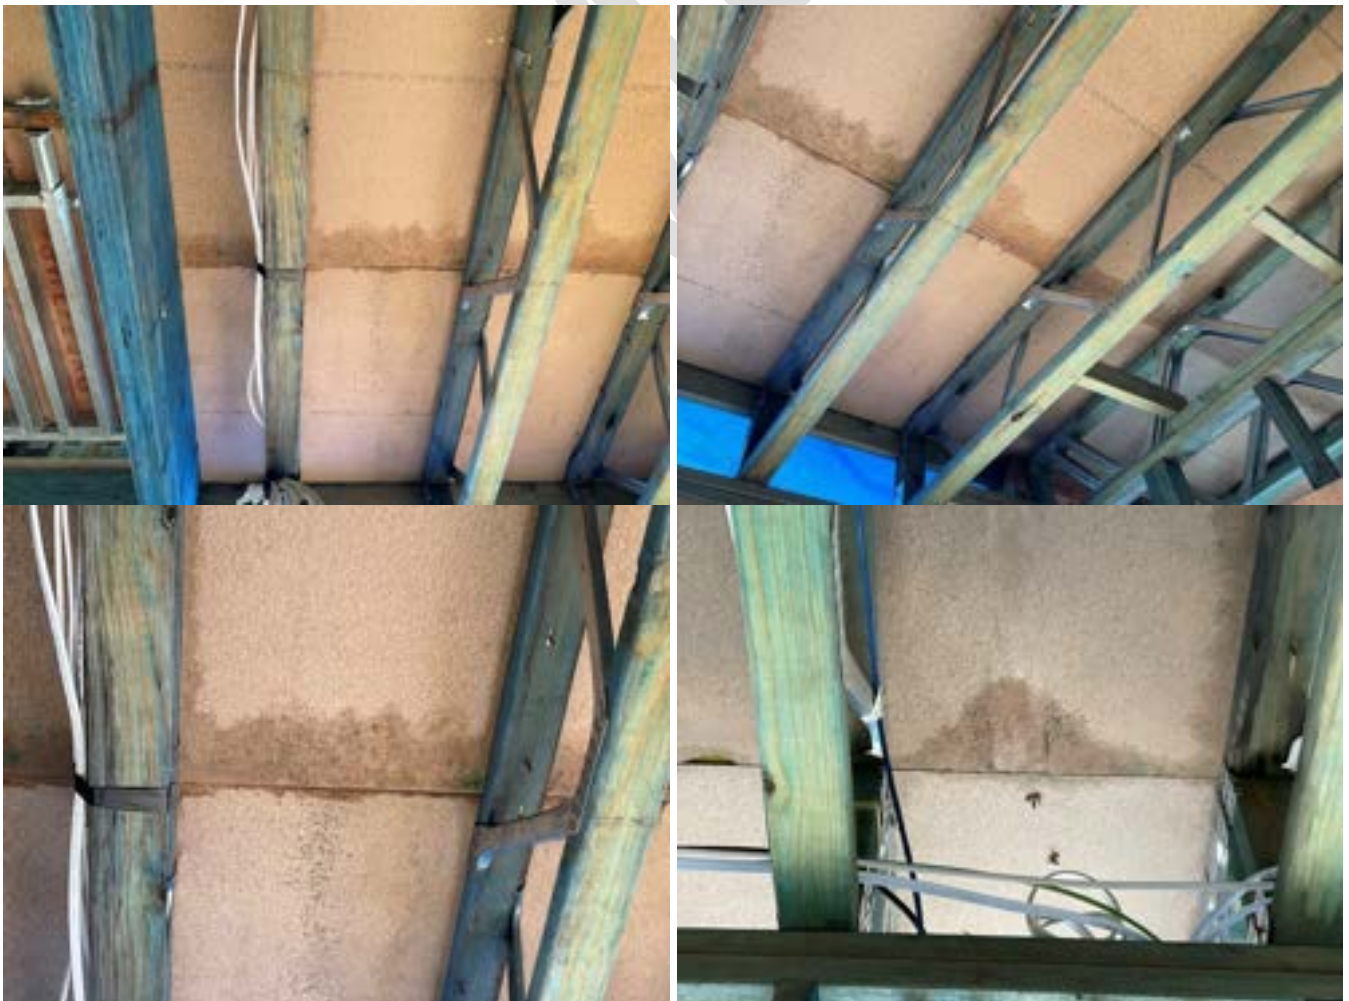
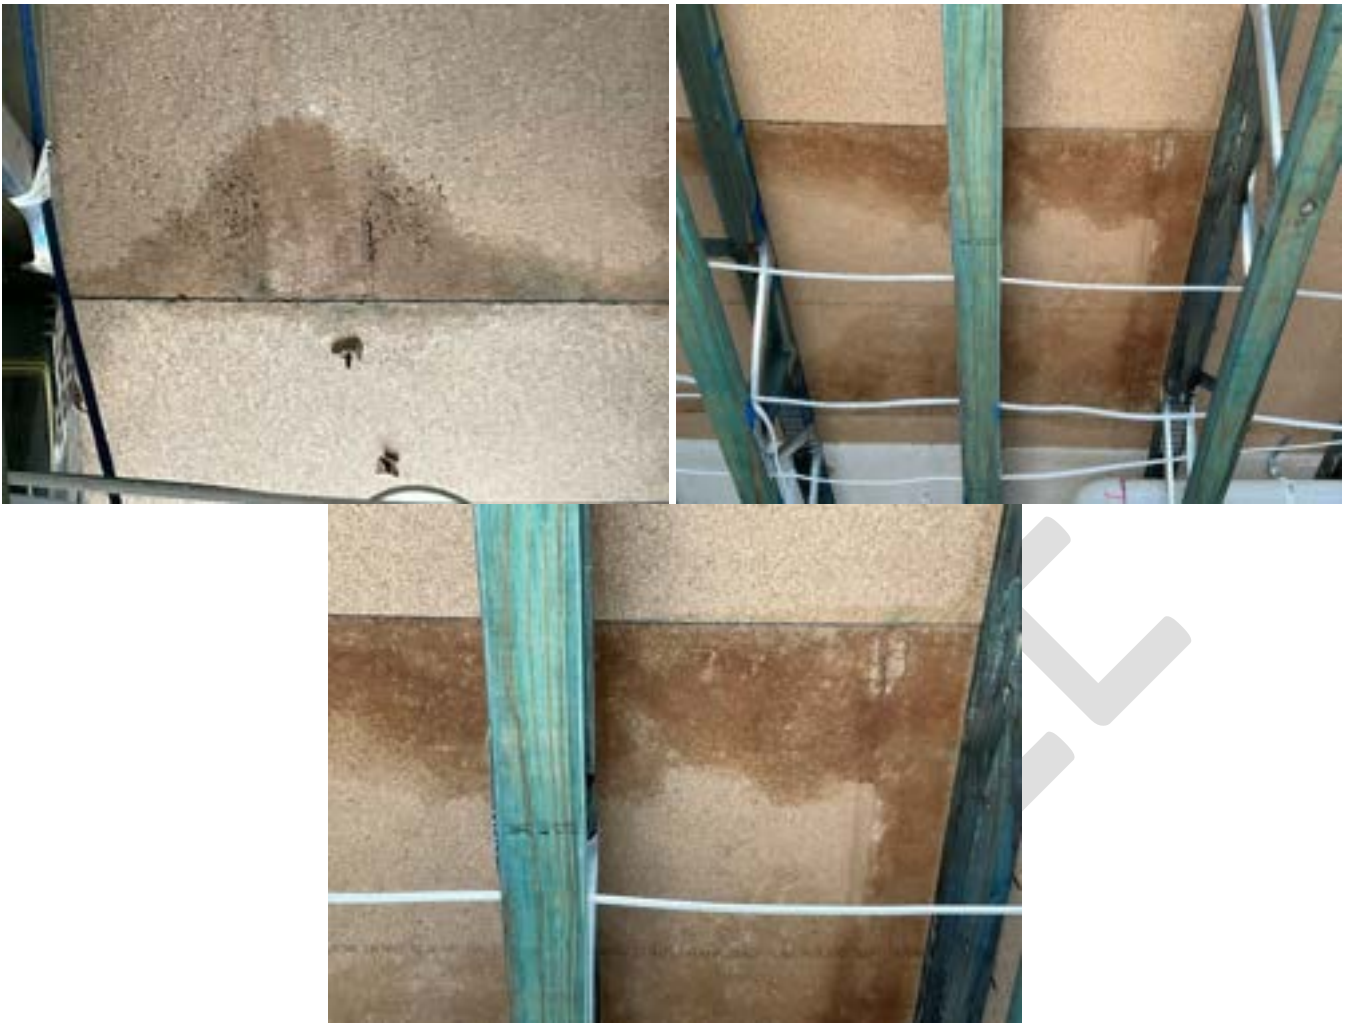
31. The flooring has been exposed to excess moisture and mould is forming on the underside, this will need to be further investigated by a hygienist to see if it can be treated or has to be replaced under the builders cost, not in an appropriate, skilful way or with reasonable care and skill.
