Frame (Defect Inspection) REPORT (hereinafter called the "Report")

Report Number 00024 Time:11:30 AM

Inspection Date: 17/03/2022

Property Address: LOT sample

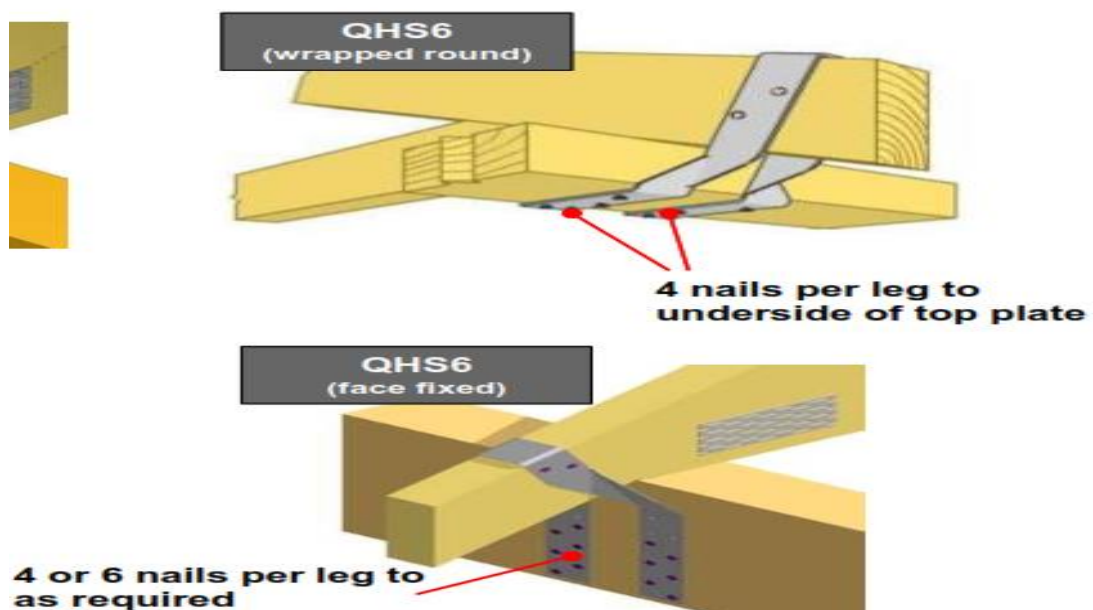
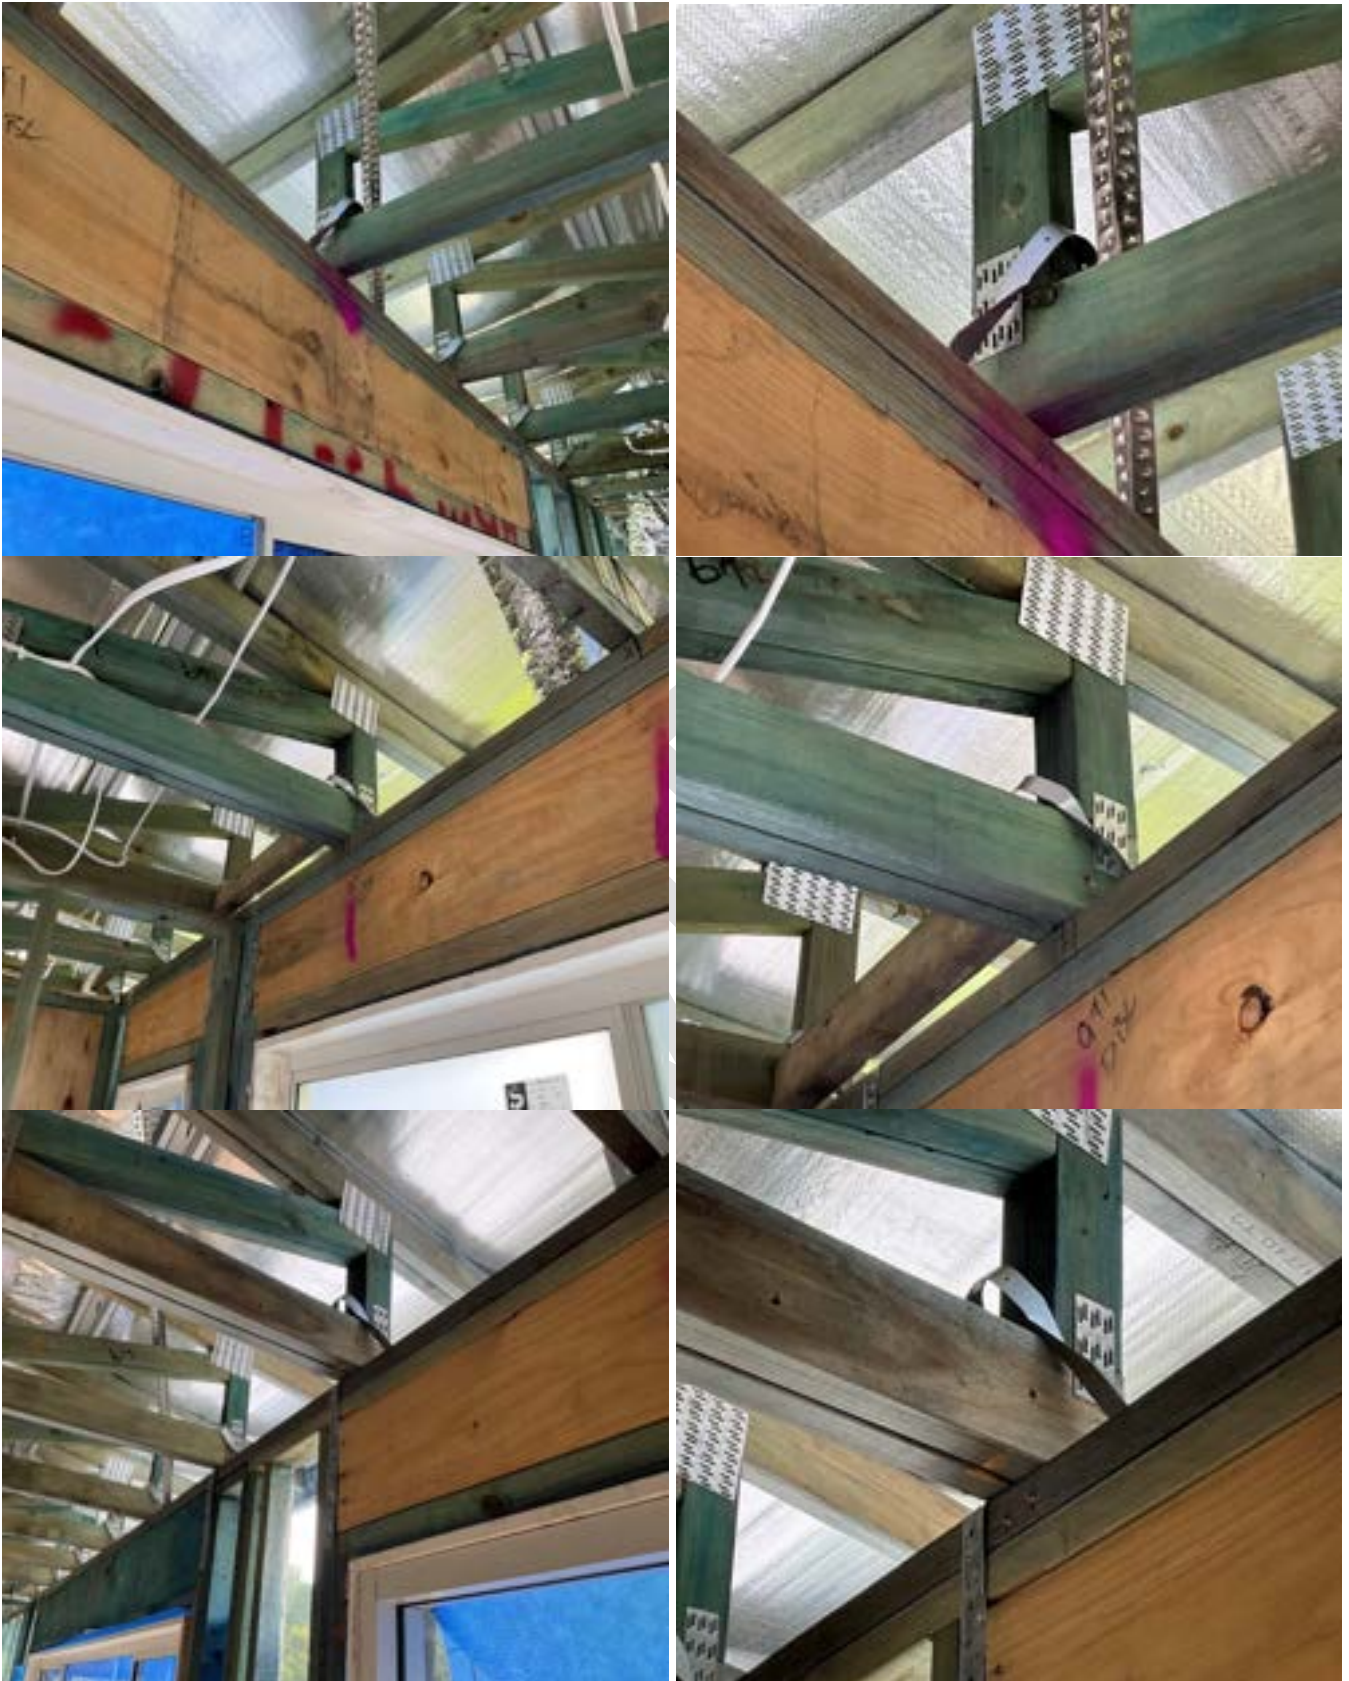
32. A number of the cyclone straps have been installed loose and therefore not in accordance with the manufacturer's installation instructions. Reworking is required to ensure the straps are secured snug against the rafter and top plate, ensuring they perform as designed in the event of a cyclone.

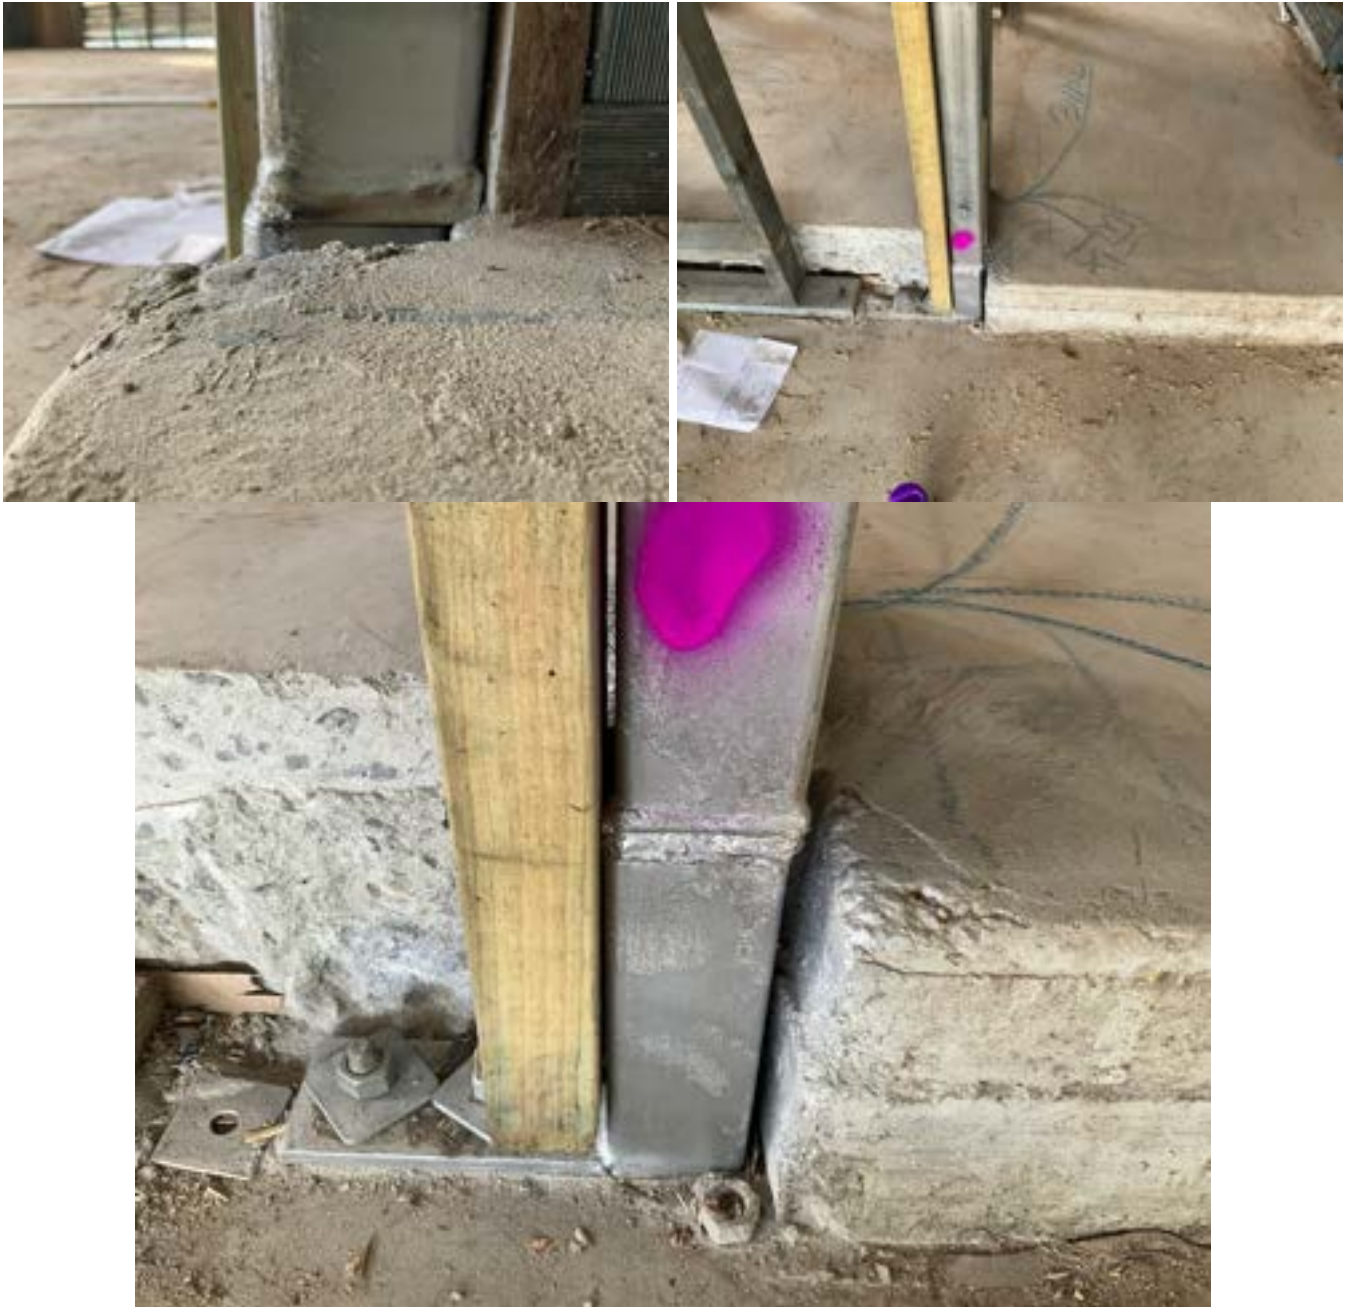
33. There is a steel post that has been modified but has not been welded together properly on all sides, this will need rework, not in an appropriate, skilful way or with reasonable care and skill.

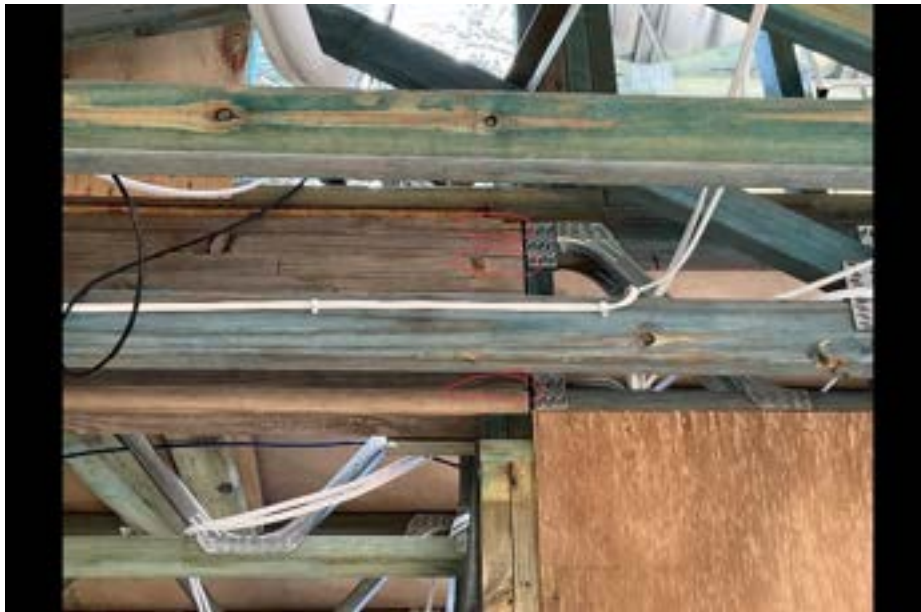
34. There is a laminated beam that has been left out in the weather and is starting to delaminate, owner has advised that these have previously been replaced due to weather damage, this will need rework, not in an appropriate, skilful way or with reasonable care and skill.

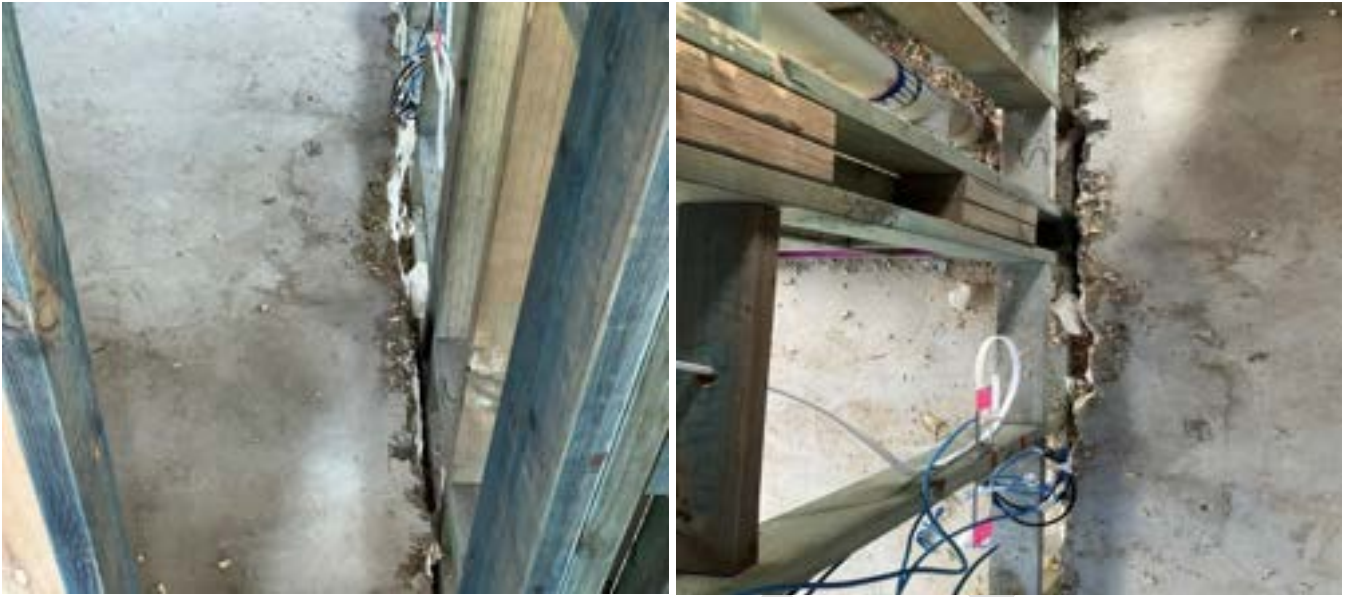
35. The concrete slab has been jack hammered substandard finish, steel Rio set back may be compromised, send a competent person like the engineer to the site for approval **form 12 for the rectifications**. As per part 9, Division 2, section 74 of the BR 2021: This will need rework, not in an appropriate, skilful way or with reasonable care and skill.
