## **(Pre-pour Inspection) REPORT** (hereinafter called the "Report")

**Report Number** Sample

**Inspection Date:** 30/04/2021

**Property Address:** Sample

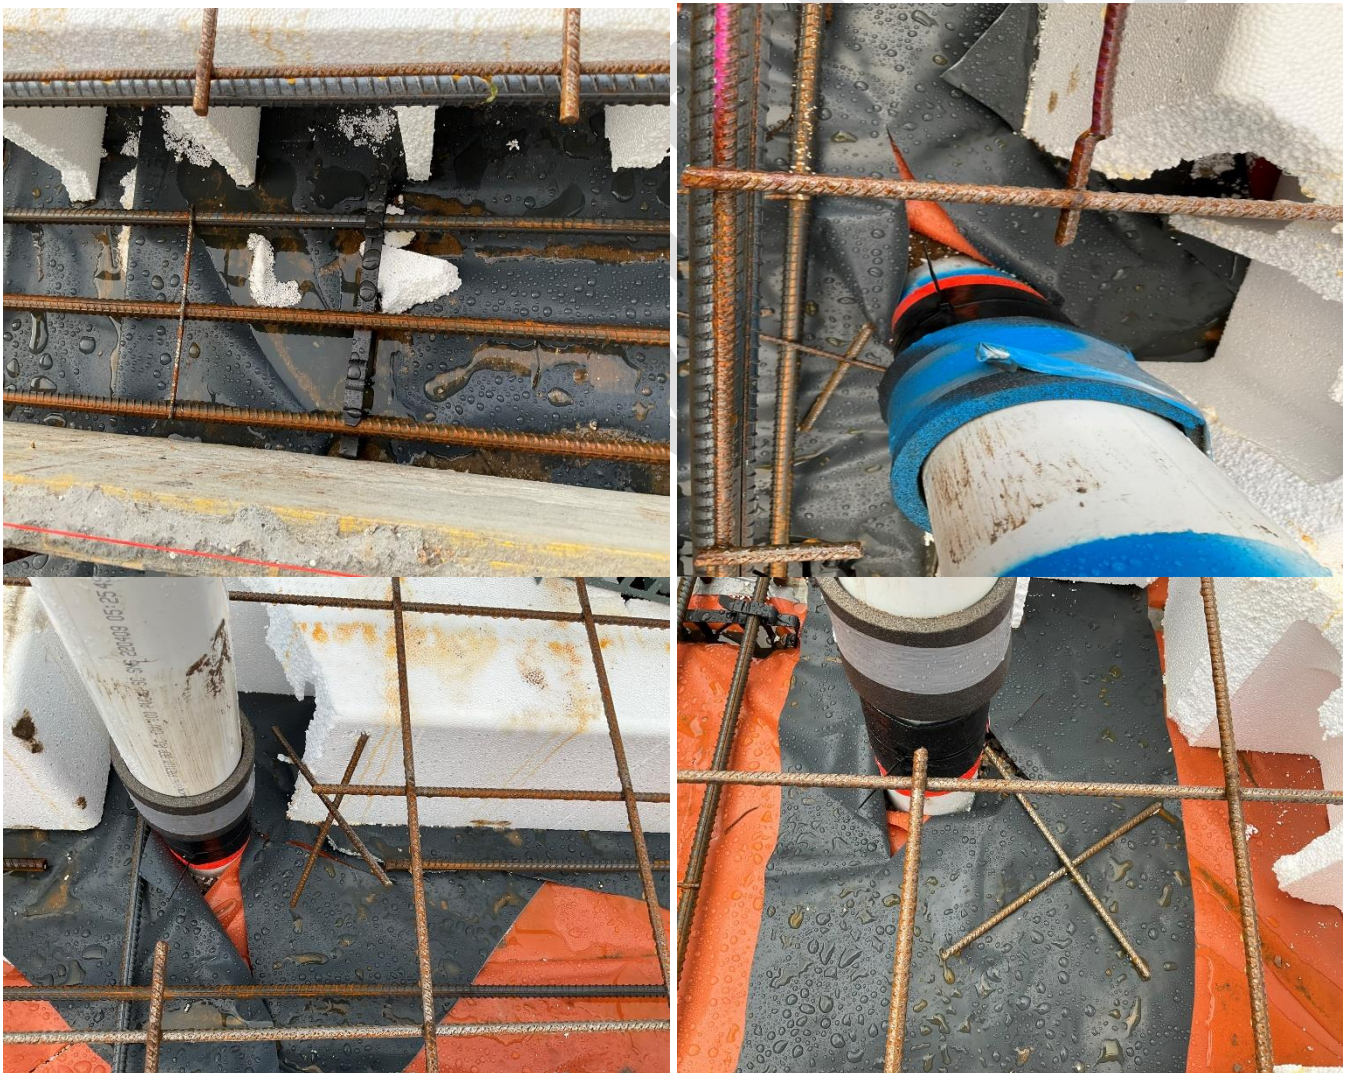
1. Pod debris and steel offcuts can potentially compromise the minimum concrete cover to reinforcement. The minimum distance from the outer edge of reinforcement bars to an internal surface is 20mm. **NCC 2019, 3.2.3.2 (d)**: This must be rectified before the pour.

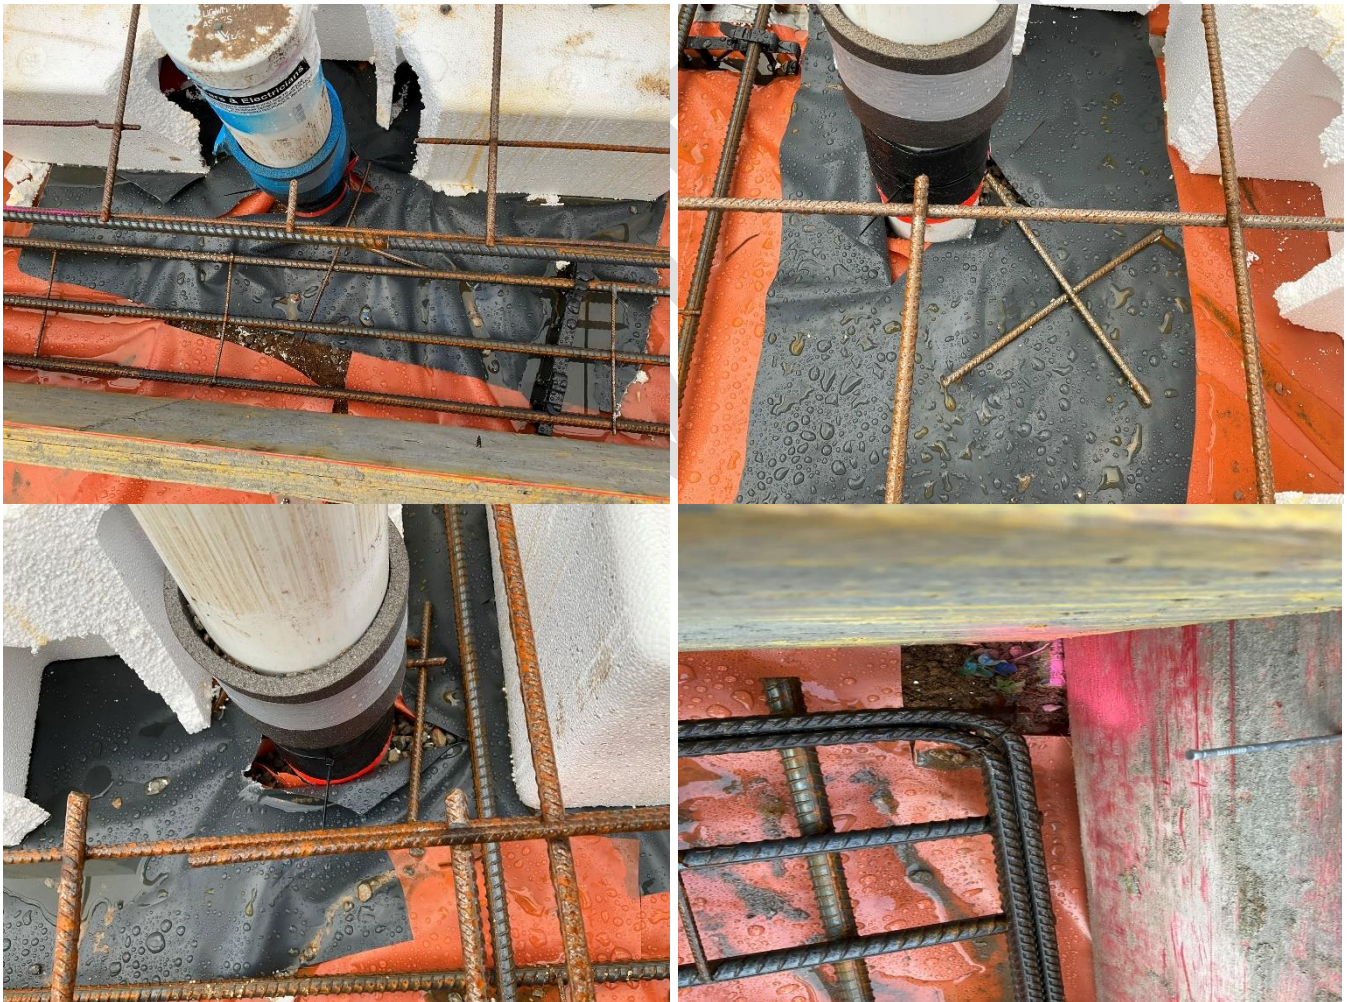
2. The pipe penetrations through the vapour barrier have not been fully taped, can see the ground and require further works.

There are also some cuts and tears throughout the vapour barrier that have not been taped correctly. This must be rectified before the pour.

- (i) lap not less than 200 mm at all joints; and
- (ii) tape or seal with a close fitting sleeve around all service penetrations; and
- (iii) fully seal where punctured (unless for service penetrations) with additional polyethylene film and tape.

These areas will need to be taped up and photographed before the pour is started.

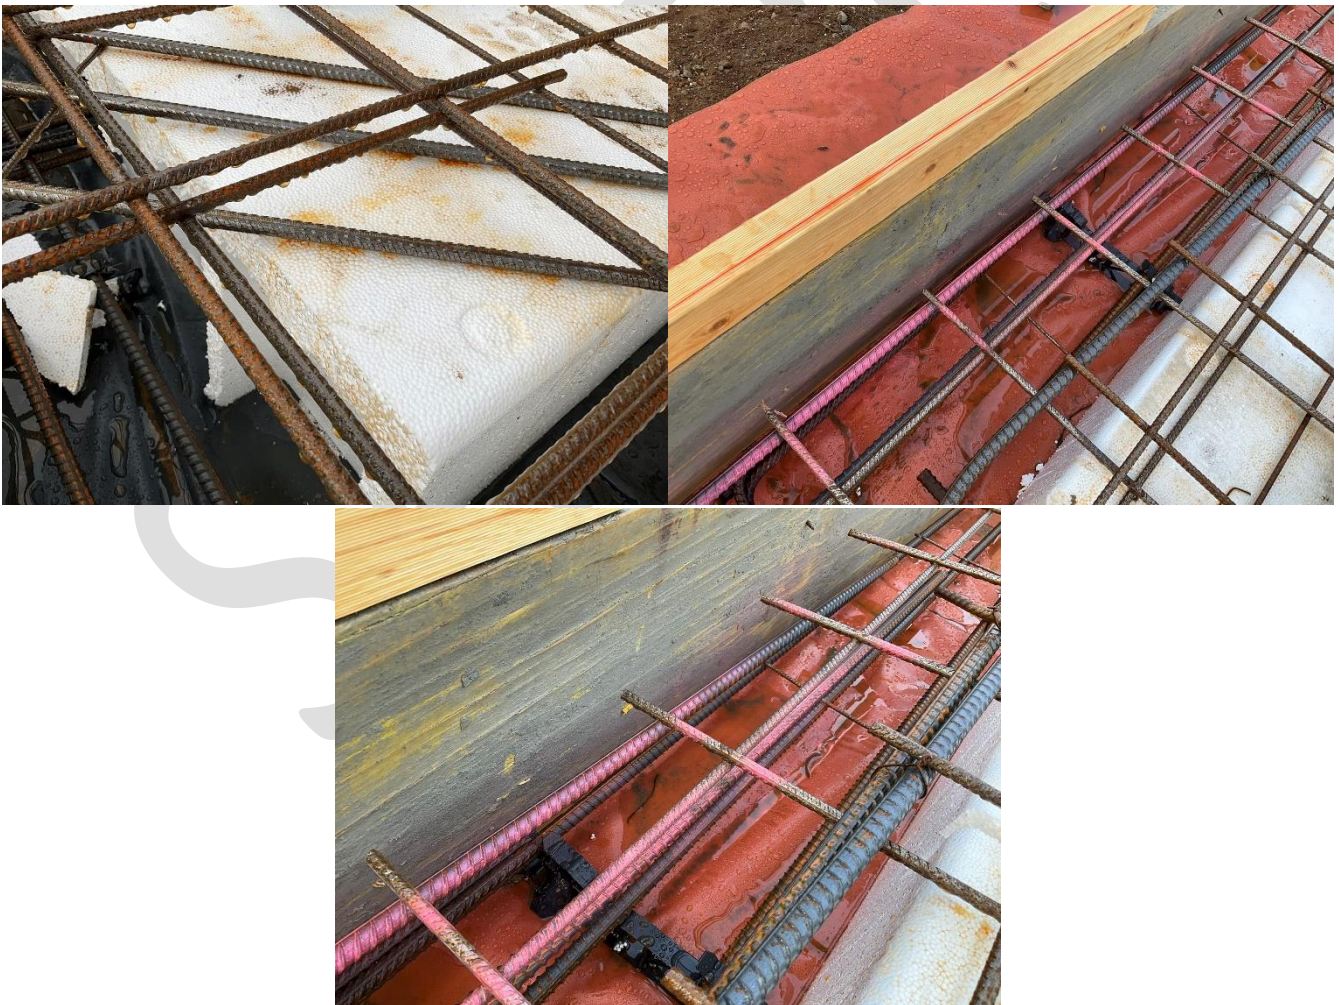
3. There are a number of loose reinforcement bars that may have the opportunity to move during the pour, all needs to be tied together to ensure the reinforcement steel has the require concrete cover as per AS 2870 and the engineering. This must be rectified before the pour.

**NCC 2019, 3.2.3.2 (f)(i):** - All reinforcement must be firmly fixed in place to prevent it moving during the pour

Areas of reinforcement have not been tied and therefore do not comply with the NCC.

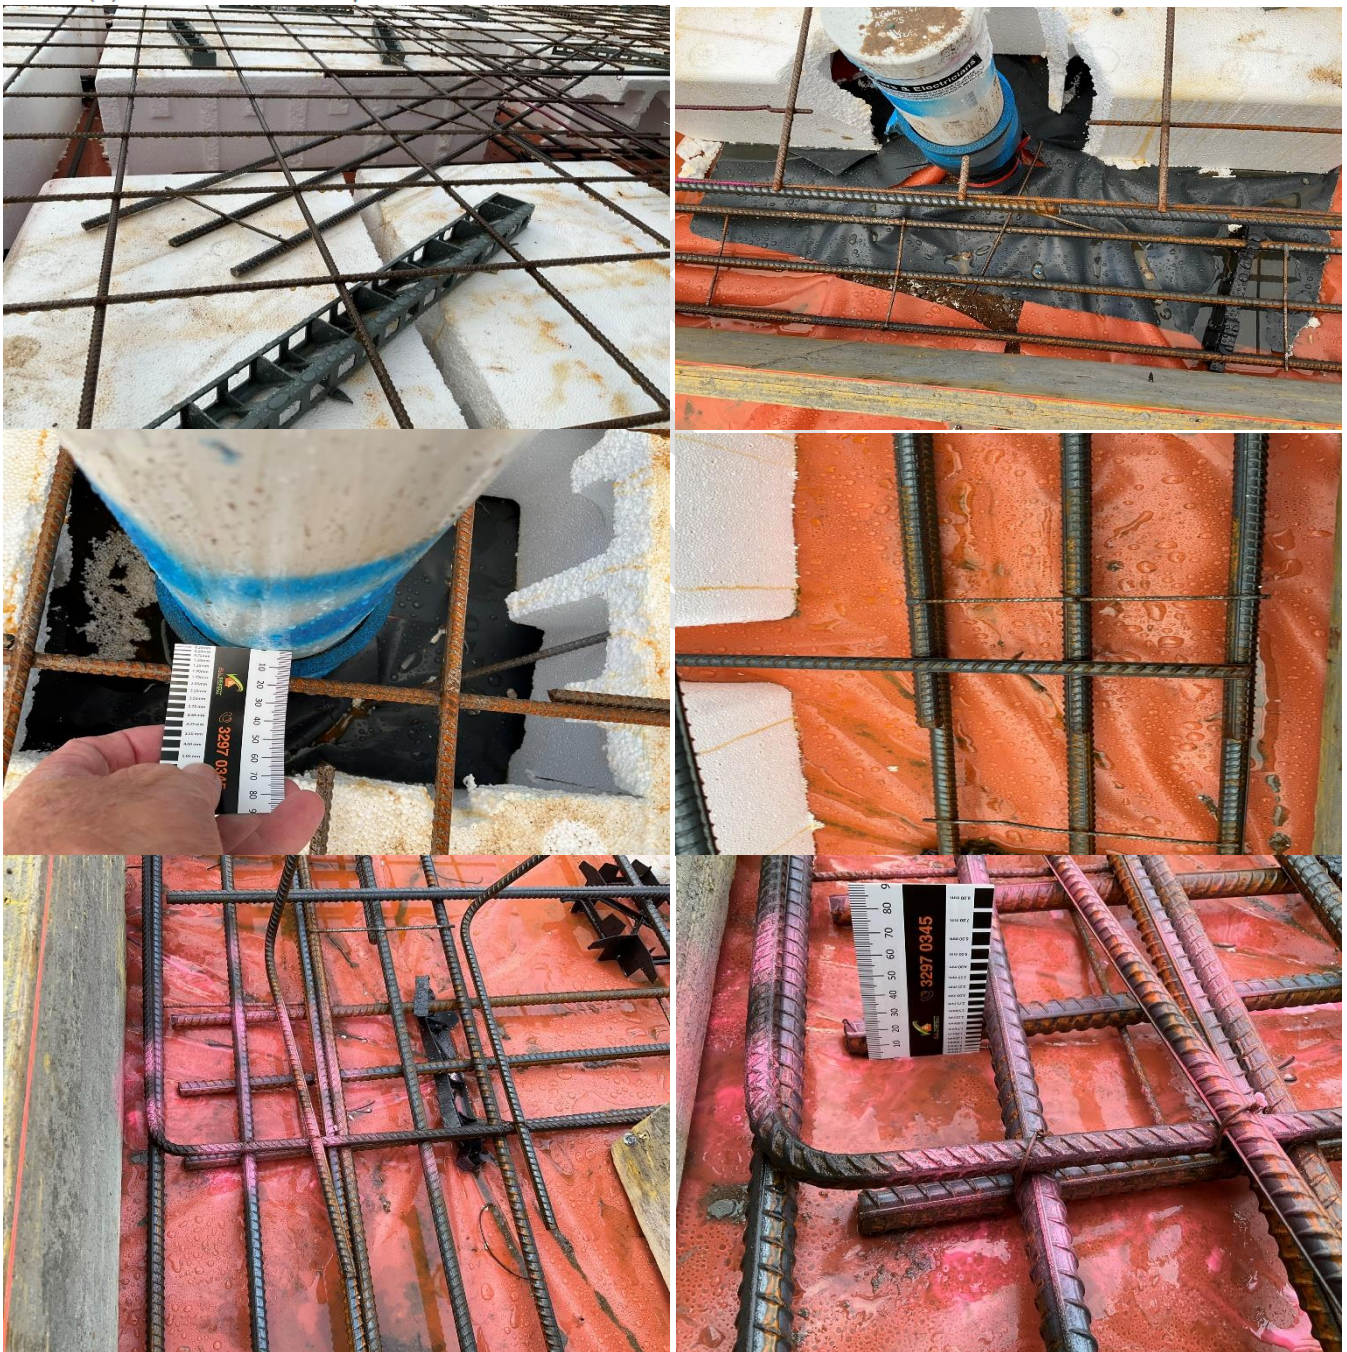
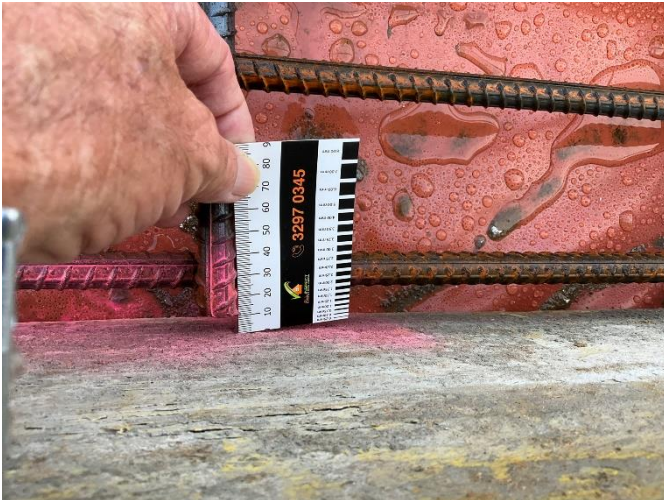
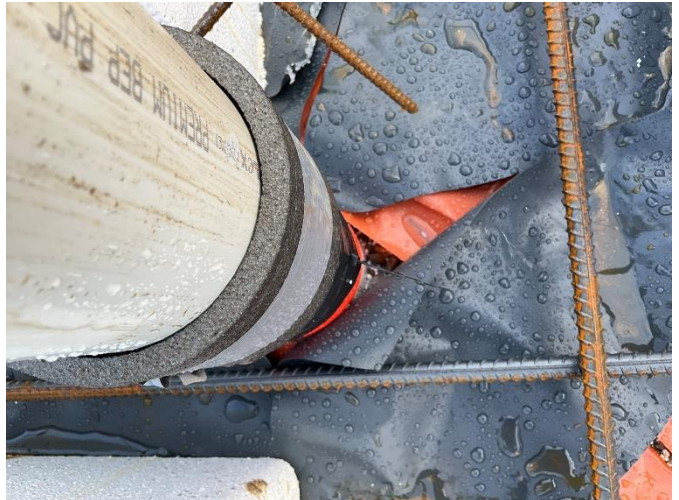
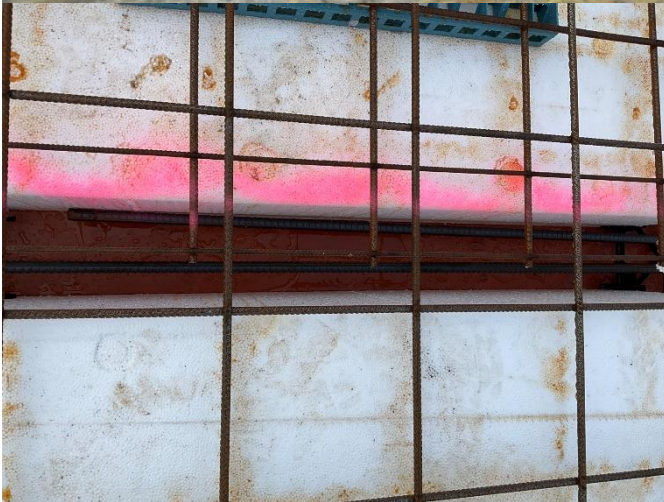
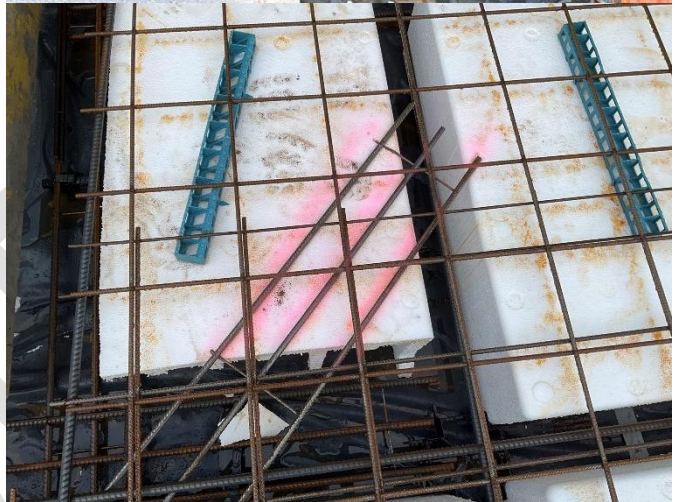
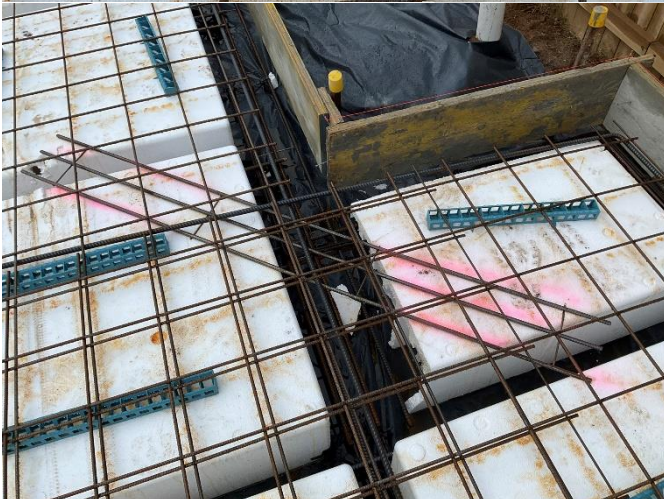
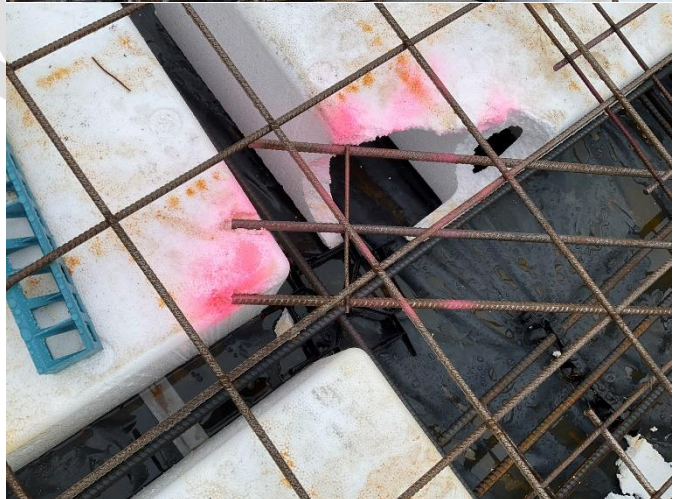
4. There are a number of reinforcement bars that breach the minimum distances from the reinforcement bars, concrete cover insufficient. This must be rectified before the pour.

Areas of reinforcement steel to this dwelling do not comply with this minimum requirement.

- (d) Footings and slabs-on-ground must have concrete cover between the outermost edge of the reinforcement (including ligatures, tie wire etc.) and the surface of the concrete of not less than the following:
- (i) 40 mm to unprotected ground.
  - (ii) 30 mm to a membrane in contact with the ground.
  - (iii) 20 mm to an internal surface.
  - (iv) 40 mm to external exposure.

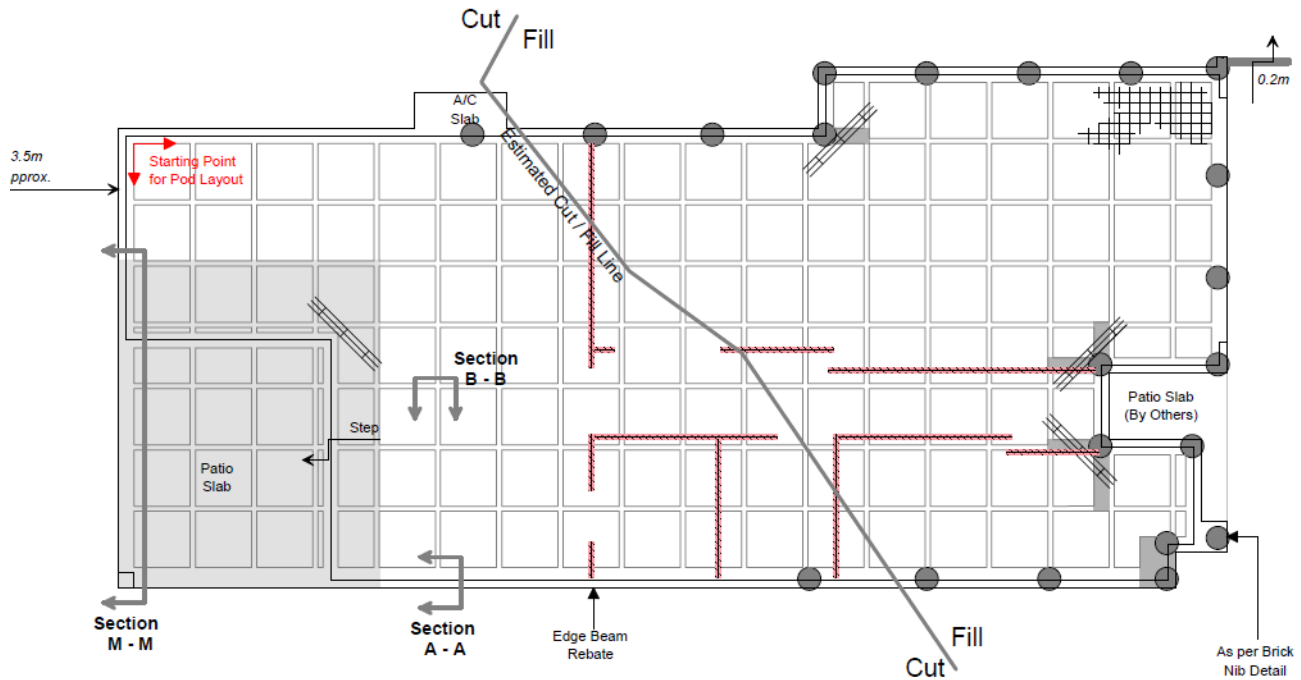
5. It appears that the cut and fill to the site is not consistent with the contour plan, the bored piers have been placed into the cut area of the site not the fill portion of the site as per soil test and bore log sheet. This will need to be re-checked before the pour.
