Handover REPORT (hereinafter called the "Report")

Report Number 11488

Inspection Date: 14/11/2019

Property Address: sample road

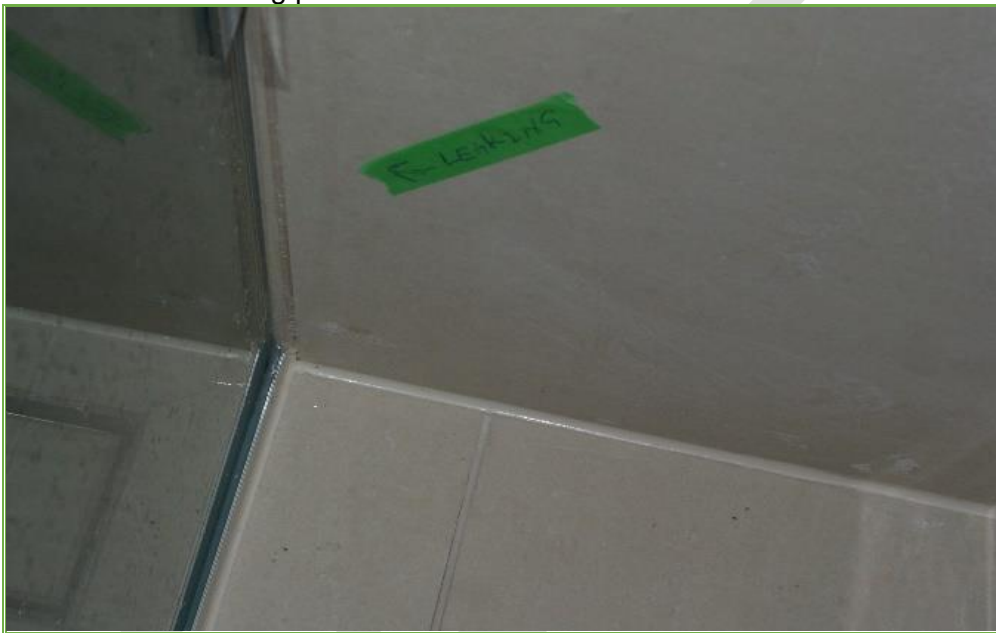
1. Main Bathroom, & Ensuite shower is leaking this will need to be rectified before handover.
We refer the Builder to below:

Any shower component that allows a fully enclosed shower recess to leak during normal usage is defective.

Within the first 12 months after completion of the works, shower recess and components are defective if they crack or don't perform as intended and cracks in shower bases, screens and glass are defects if they are visible from normal viewing position.

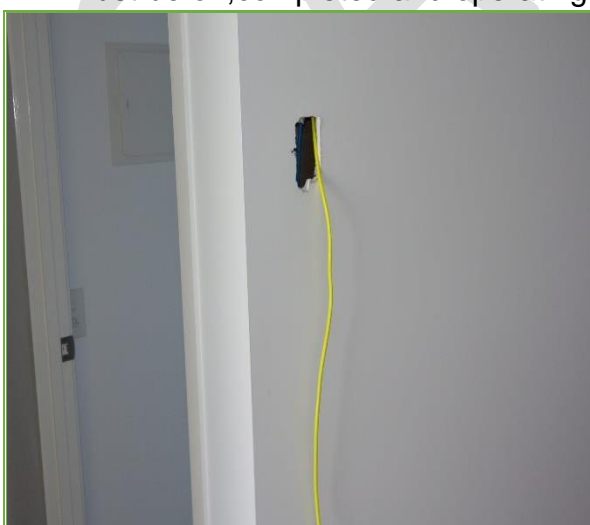
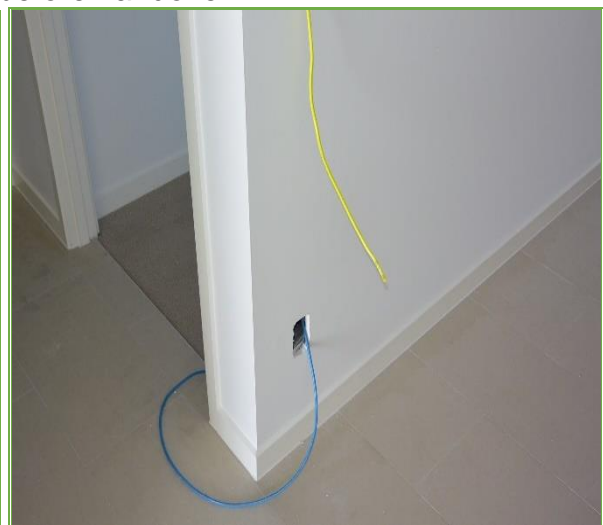
2. No power and some electrical fittings still needs to be finished, (Intercom, data) this must be on, completed and operating before handover.

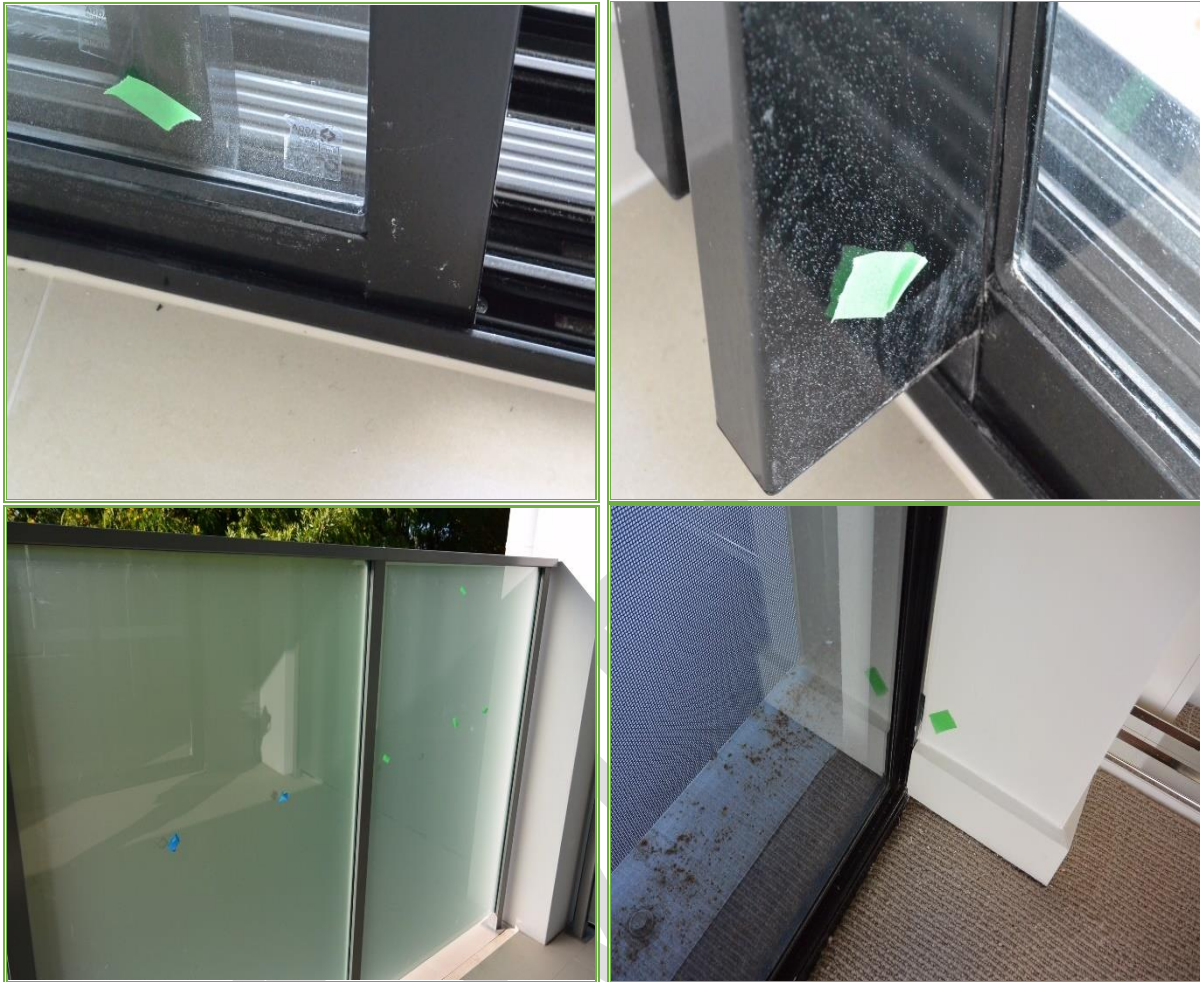
3. Cleaning still needs to be done, as marked, (cleaning of the window and door tracks, and between the mesh and windows, cleaning off overspray, marks on the external glass balustrading) this will all need to be done before handover.

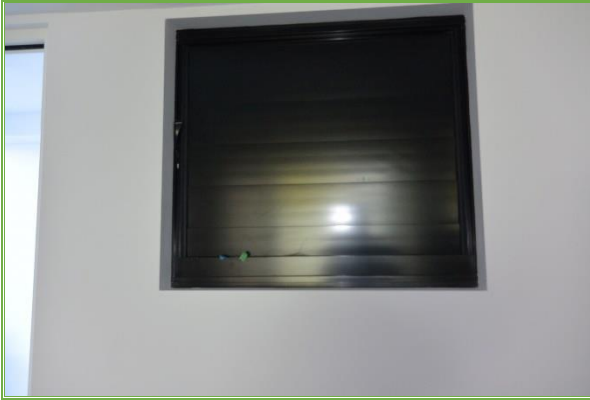
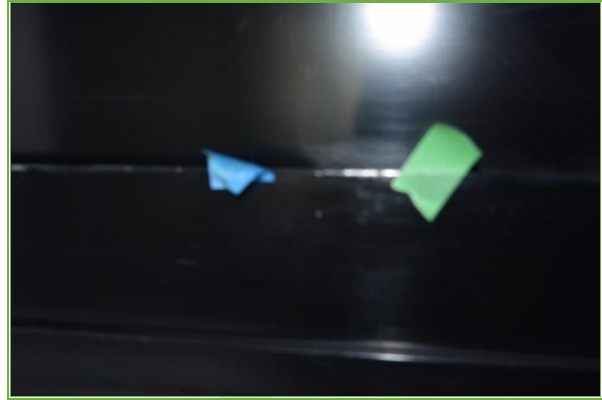
4. There are some items that have been damaged as a consequence of the carrying out of building work, listed below and marked:

Contractors will be liable to repair any consequential damage caused by, or as a consequence of carrying out building work on a residential building site or to a residential building on an adjacent site.

- Scratches to the louvers and window frame, this was new when it was installed must be new at handover.

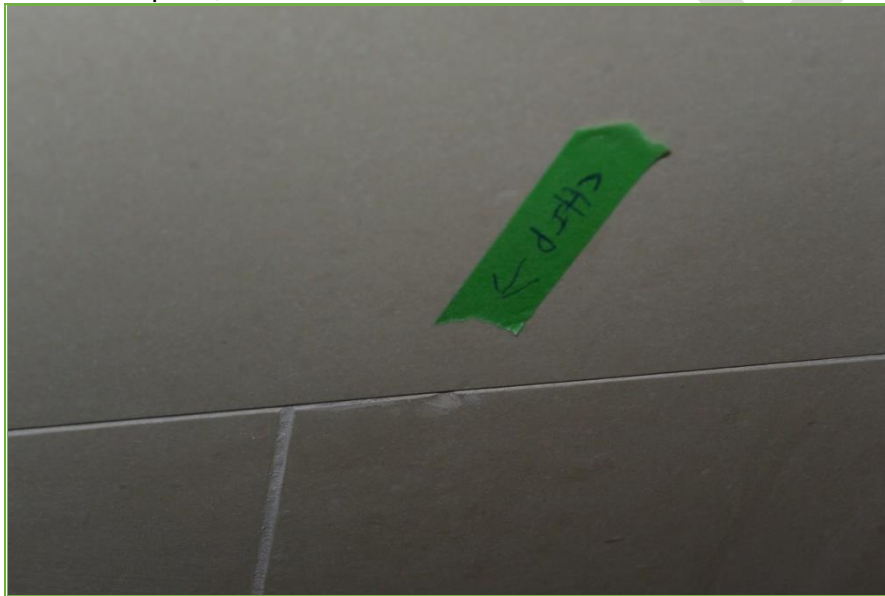
- Ensuite Shower chip tile, this was new when laid must be new at handover.

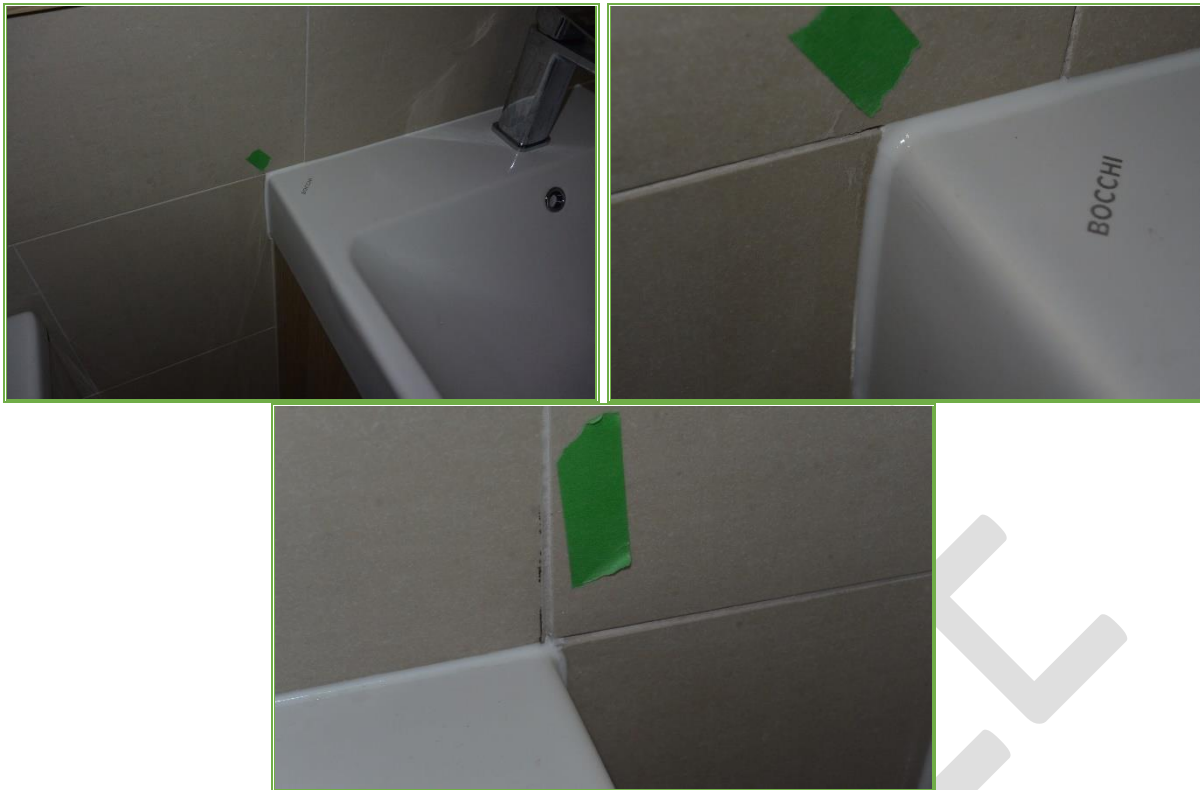
5. Voids in grout in main bathroom, this will need re-work before handover.

- Finished grout is defective if it is not uniform in colour and is not smooth, without voids, pinholes or low spots and finished to the cushion on cushion edged tiles and flush with square edge tiles, except for tooling in accordance with *AS 3958.1 - Ceramic tiles – Guide to the installation of ceramic tiles*.

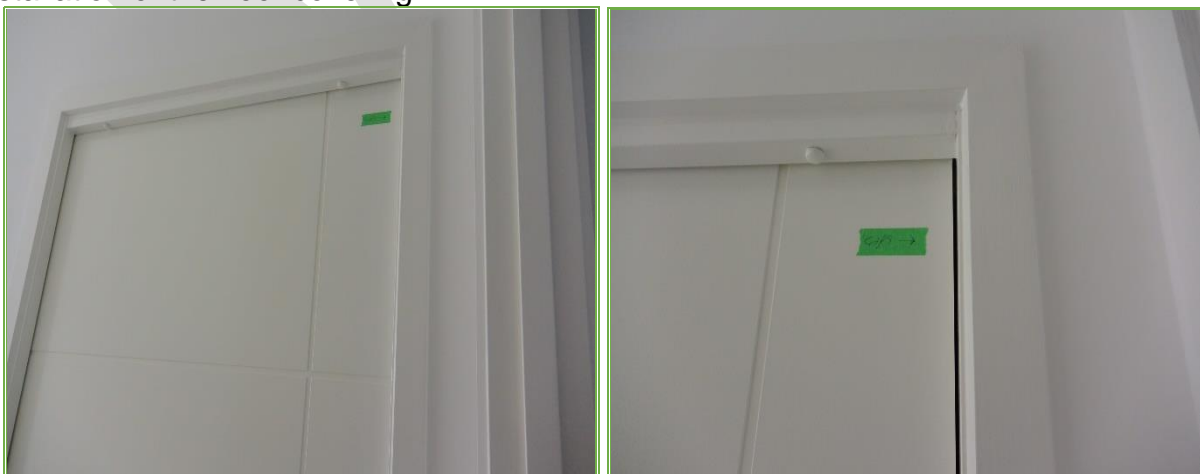
1. Bathroom slider door margins are uneven this will need re-work before handover.

With the exception of fire doors and unless documented otherwise, the installation of doors is defective, if within 12 months of completion of the work, clearances between door leaves and frames and between adjacent door leaves are not uniform and within 1 mm of the documented dimension. Within the first 12 months after completion and if not otherwise documented:

- a) A clearance between door leaves or between a door leaf and the frame is defective if it is less than 2 mm or greater than 5 mm in width
- b) Unless additional clearance is required for removable toilet doors or air ventilation, a clearance between the door and the floor finish is defective if it is greater than 20 mm after installation of the floor covering.

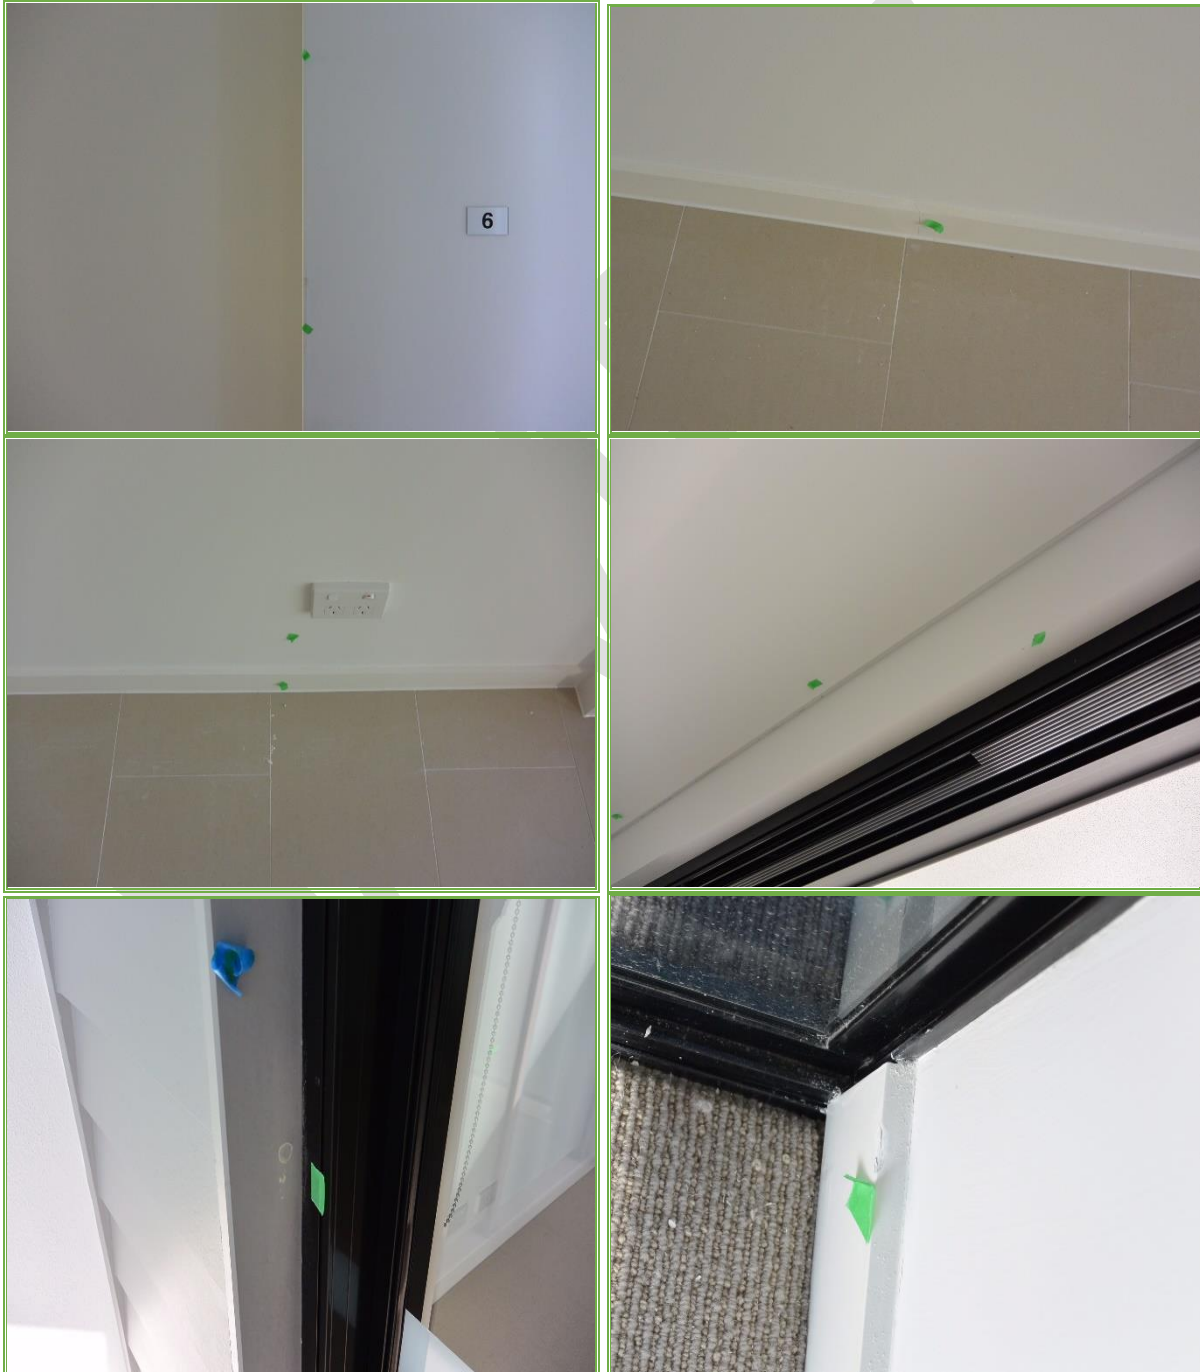
6. Paint touch-ups required as marked.

- starved/bare, incomplete areas, need to be done and finished
- patching/holes, to all be finished and completed before handover
- and some paint defects as marked all to be completed before handover.

Within the first 12 months after completion of the work, paintwork is defective if application defects or blemishes such as paint runs, paint sags, wrinkling, dust, bare or starved painted areas, colour variations, surface cracks, irregular and coarse brush marks, sanding marks, blistering, uniformity of gloss level and other irregularities are visible in the surface from a normal viewing position.
