(Defect Inspection) REPORT (hereinafter called the "Report")

ALL INSPECT
All Building & Termite Inspections

Inspection Date: 18/02/2021

Property Address: Sample drive

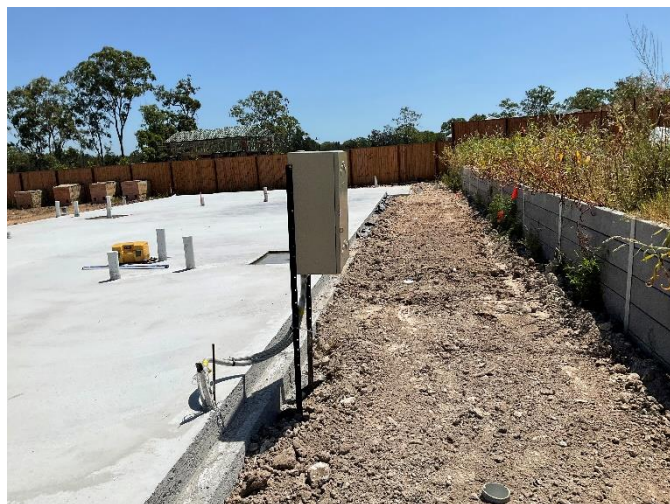
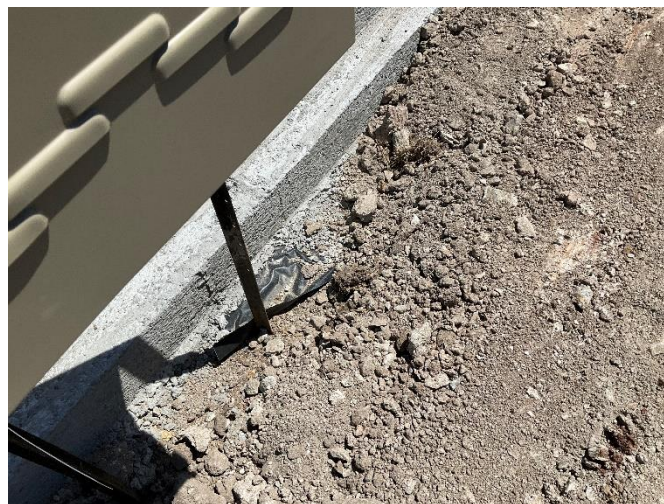
1. The polyethylene vapour barrier from beneath the concrete floor slab has not been turned up along the external side faces of the edge beams. It must be turned up prior to the slab edge being back filled. If not completed this will allow moisture ingress via slab edge dampness into the internal building wall skins and/or the floor coverings if not done. As per insert.

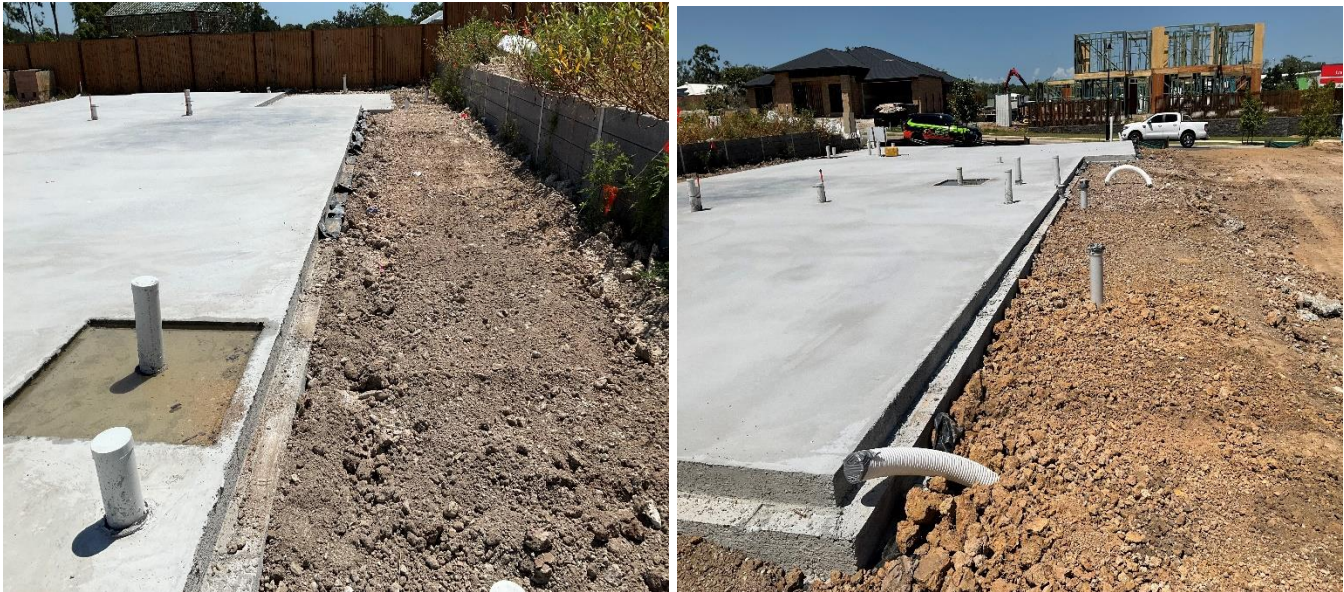
2. There are small areas of open concrete voids to the slab edge bonny slab edge. These areas are now showing the exposed reinforcement bars and that the slab has not been mechanic all compacted in areas as per the requirements of AS 2870. (Structural)

It is clear that the steel is not installed with the minimum concrete coverage area as per the mandated requirements of the BCA. We refer all to part 3.2.3.2. and AS 2870, part 6.4.7 that calls for the vibration.

- Seek engineering process and design for rectification of this defect
- Send a competent person back to site like the engineer for approval of the rectifications

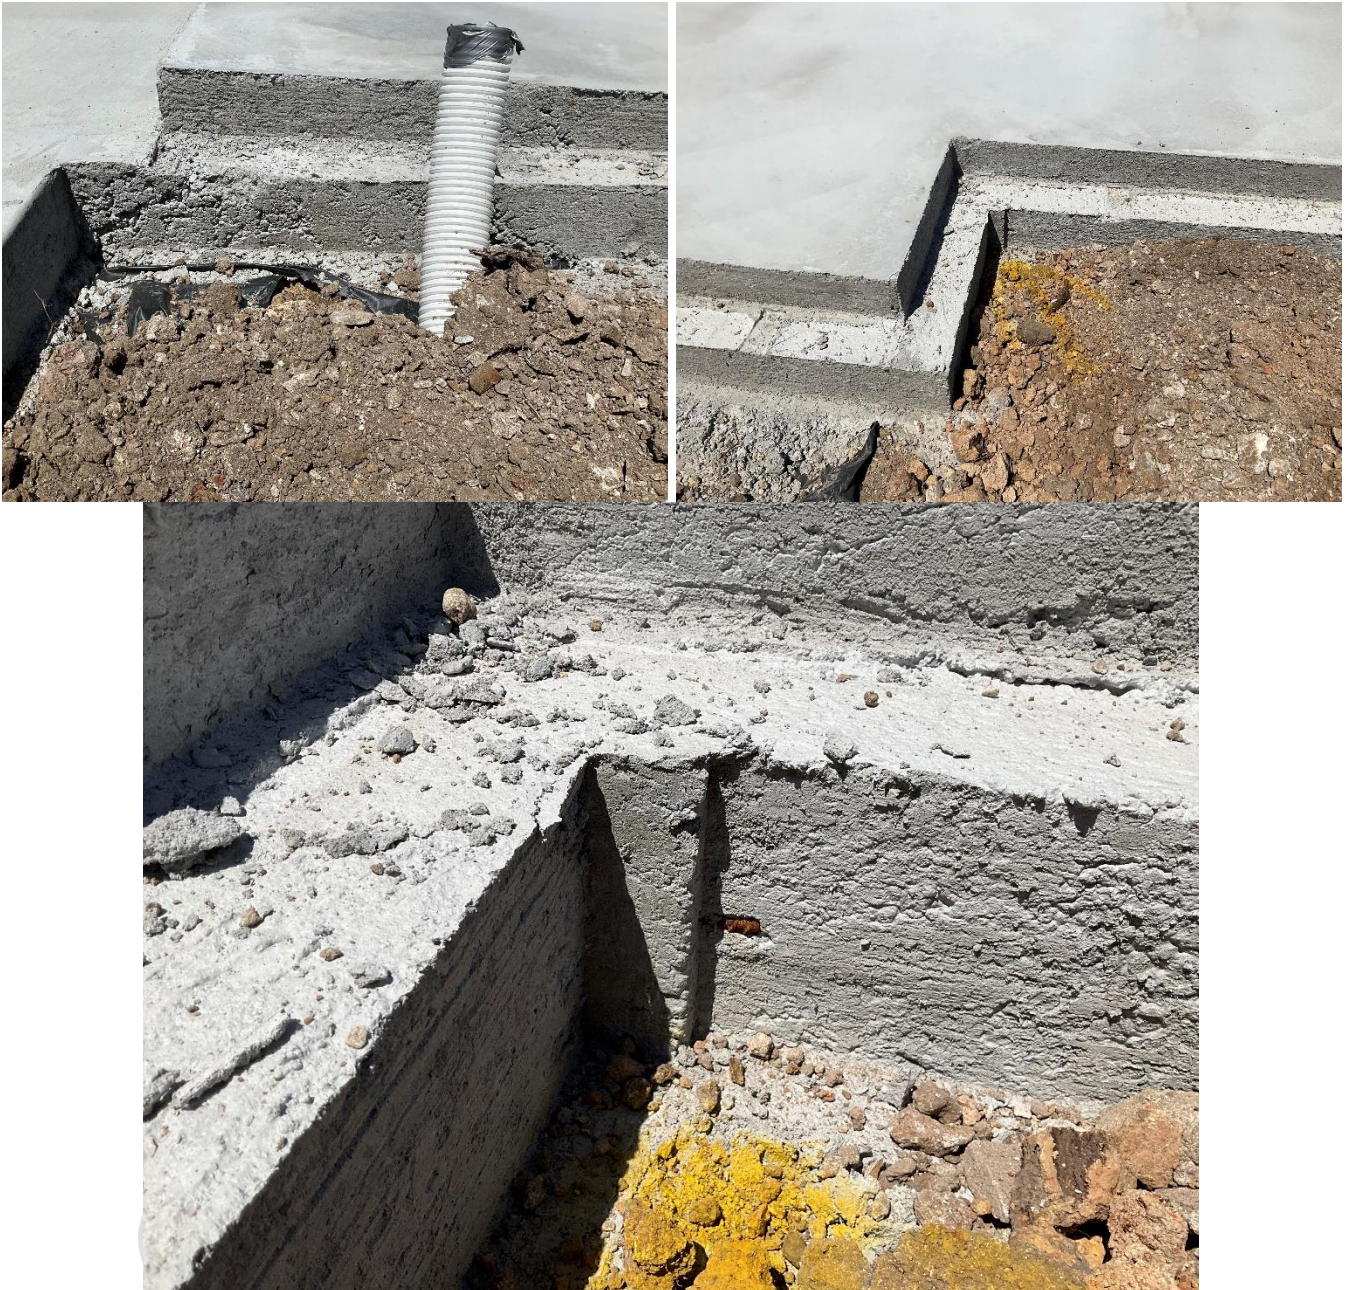
3. There are areas around the slab with concrete overpour.

Concrete overpour increases the effectiveness of the footing width and depth and decreases the bearing capacity required to support the external walls. This can result in lifted or more highly loaded areas. Concrete overpour below finished ground level allows water to accumulate on top of the footings and prevents normal evaporation drying of subsoil moisture. Concrete overpours can interfere with future site works or landscaping.

All footings in the NCC and AS 2870 are shown with edges of their footings vertical and without overspill. All excess concrete overpour from the house needs to be removed to allow the footing to work efficiently as designed.

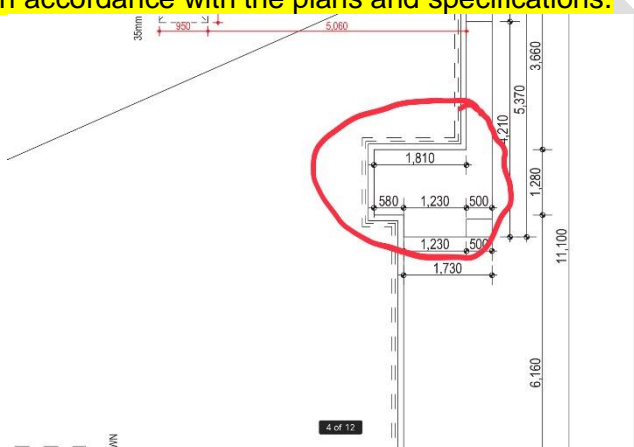
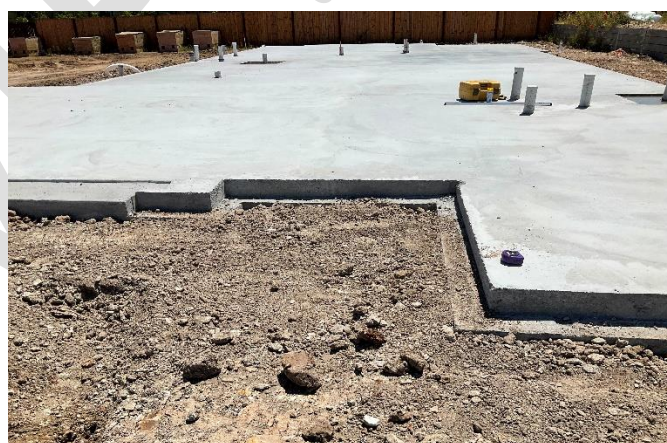
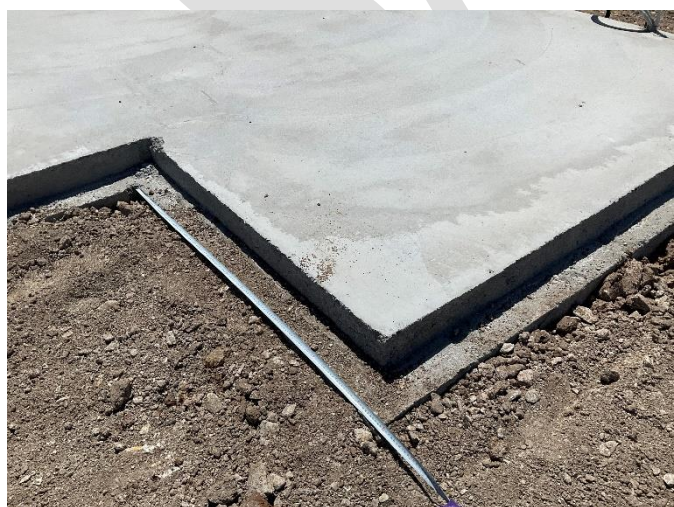
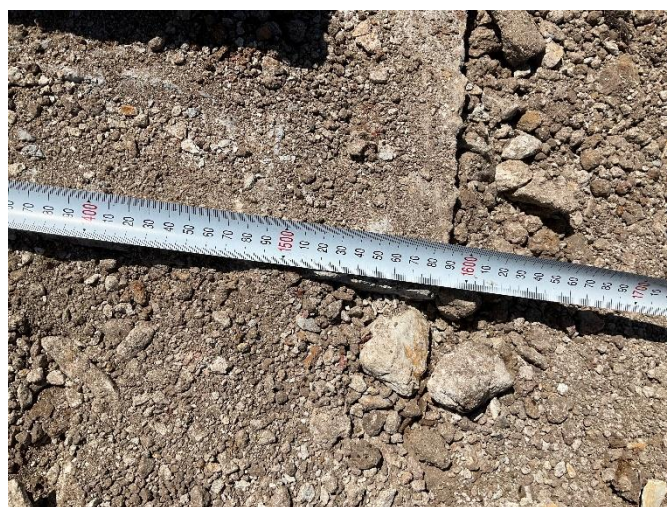
4. Some areas of the slab appear not to be as per plan, incorrect measurements, the slab is short this will need reworking to bring it up to a suitable standard that is acceptable before handover. Not in an appropriate, skilful way or with reasonable care and skill.
