This is a visual only Building Inspection & Report carried out in accordance with AS4349.0

Enclosed Defect REPORT (hereinafter called the "Report")

Inspection Date: 18/12/2019

Property Address: Sample

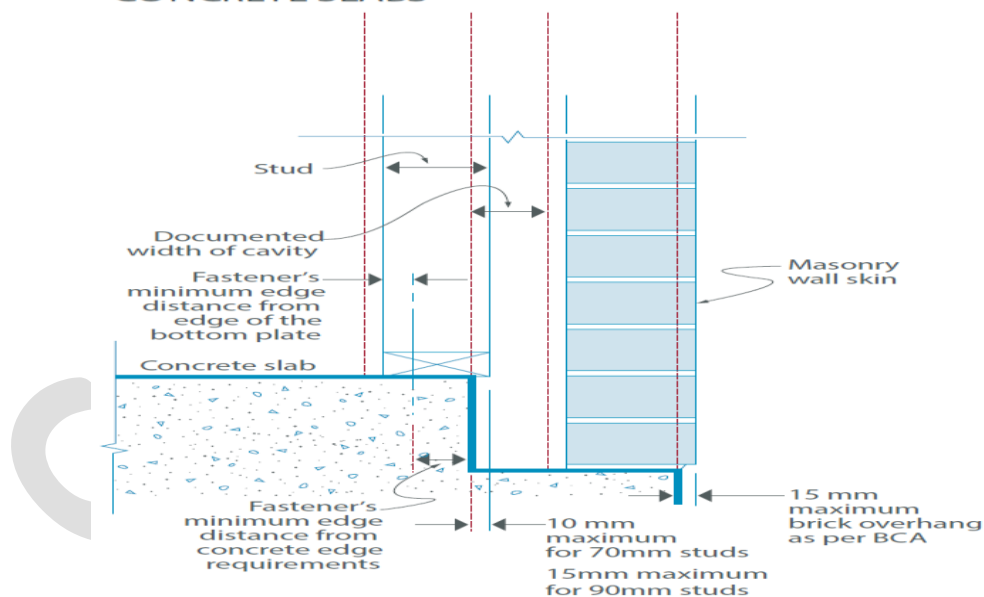
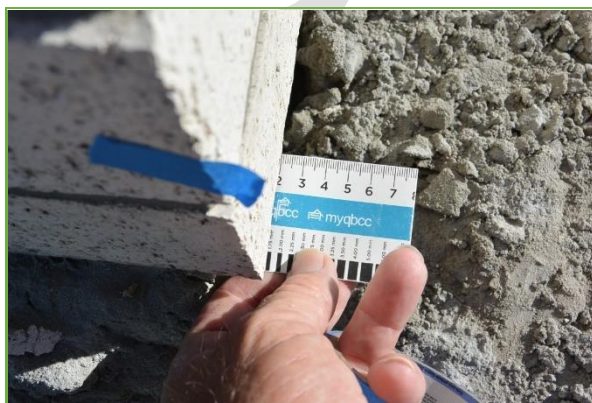
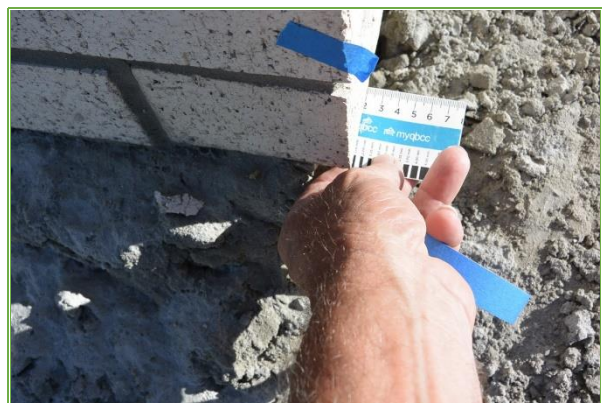
1. Brick over-hang. This will need to be rectified.

The brick over hang to the dwelling needs to be supported. The BCA, part 3.2.2.7 calls for a maximum overhang of 15 mm. All must be reworked and supported in accordance with AS 2870 prior to handover.

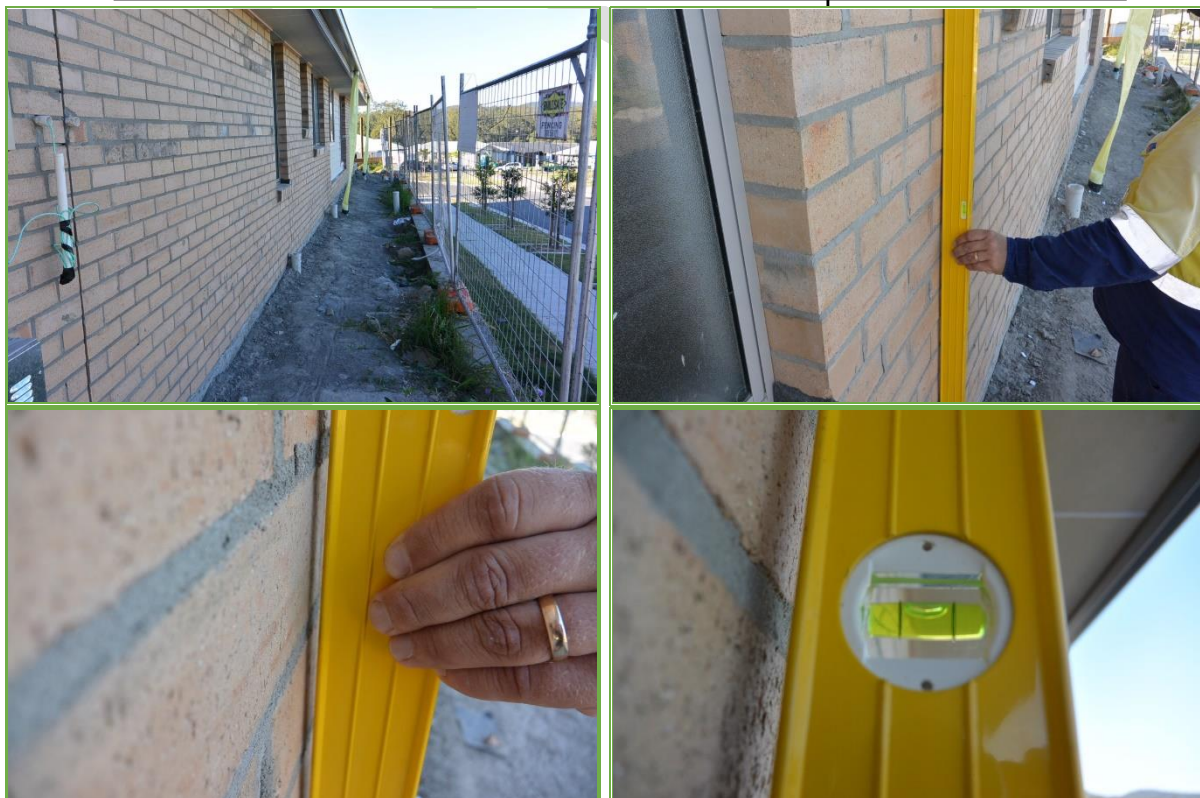
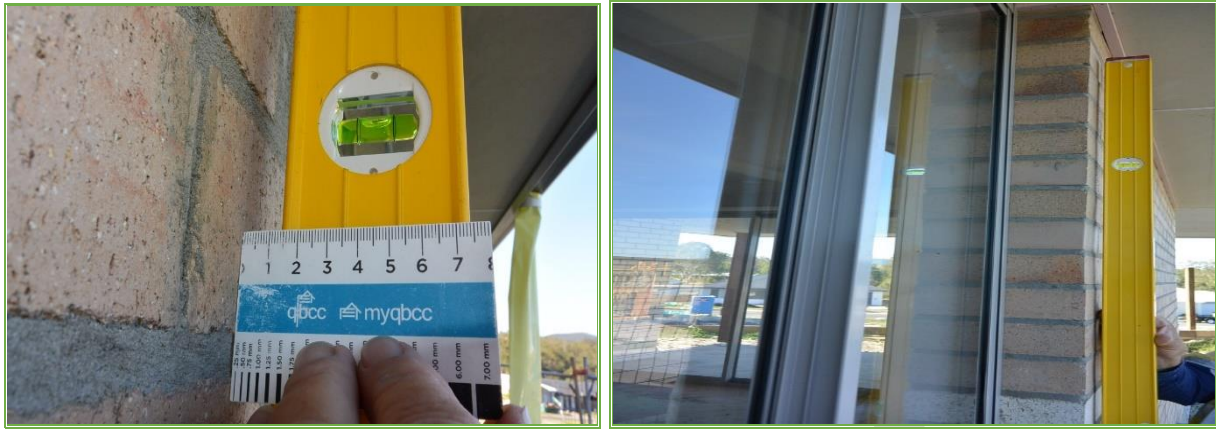
2. It noted at the time of in section that the brickwork is presenting with bowed walls. These are out of level, and are clearly discernible. Noted that the walls are going be render, but still not in an appropriate way or with reasonable care and skill as per below:

We refer the builder to AS 3700-2011, page 128, table 12.1, section (e). The maximum allowance is 5 mm. This installation exceeds this amount. This needs to be rework to comply with standard.

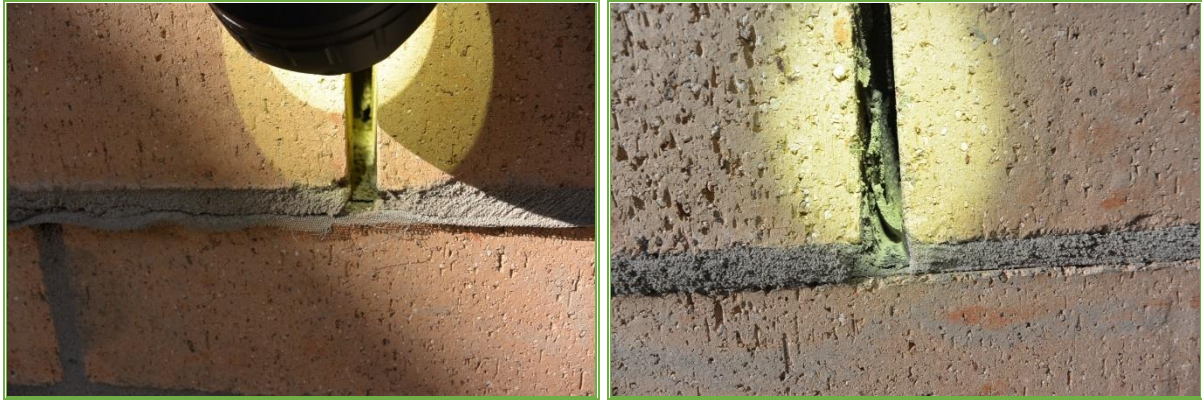
3. Weep holes Blocked. This will need to be rectified.

A number of weep holes on the dwelling appear to be blocked.
All weep holes must be clean and the hole “functional” as per AS4773.2-2010 clause 9.6.2.1 inserted below. **Please note that any damage to the flashings during the removal of the hardened mortar will require considerable reworks as the flashings cannot be breached.**

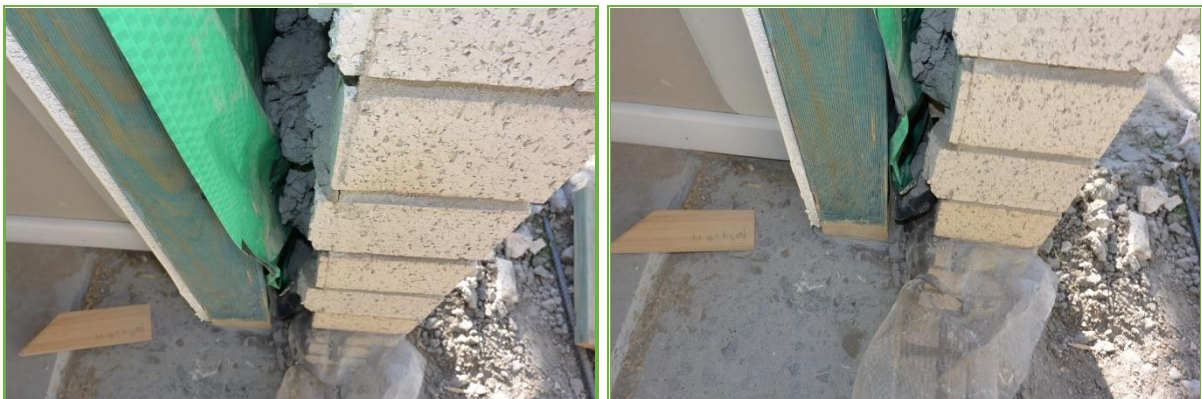
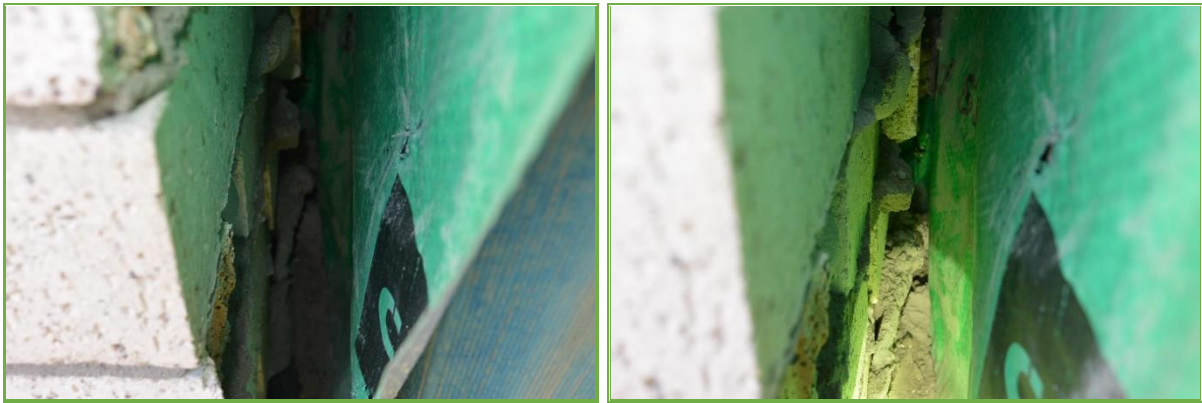
4. Brick Cavities Area garage, will need reworking.

The cavities have been breached with mortar. The BCA calls for 25 mm minimum opening between the back of the brickwork and any items installed onto the frame that could cause a bridge to form, thus allowing the transfer of water/moisture to the frame. There are numerous occasions on this dwelling where a complete bridge has been formed with mortar hard up against the frame/sisalation paper. Considerable rework needs to take place to ensure that the builder's comply with requirements of this BCA requirement.

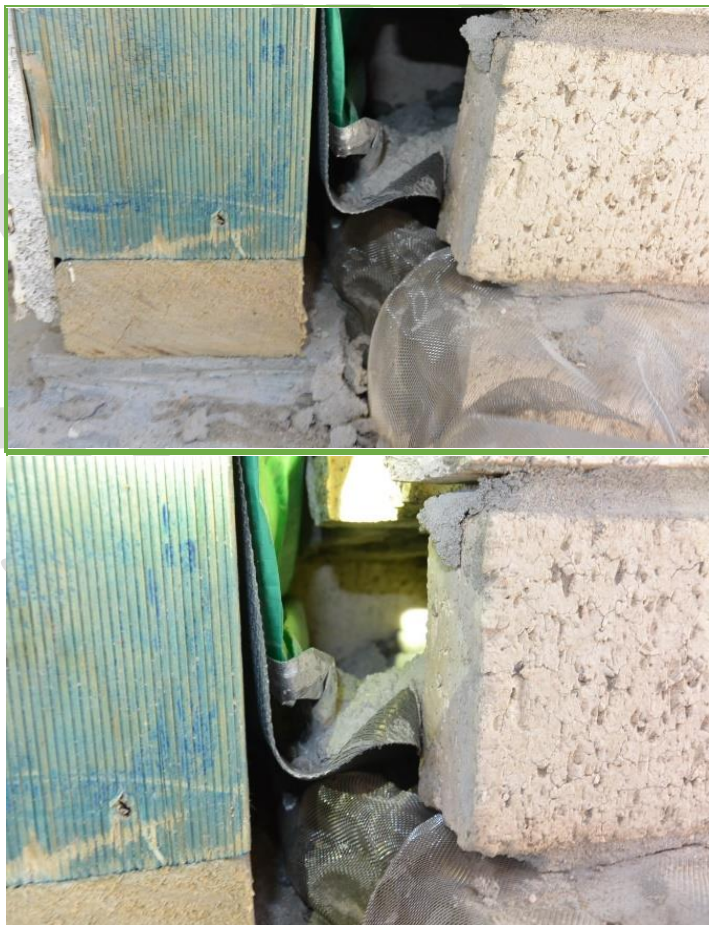
5. Area garage this will need rework.

We noted that the DPC was set at a height greater than the FFL of the garage.

As per AS 4773.1, part 14.8.2, the DPC must be installed into the rebate as low as possible however no case higher than the FFL of the internal floors.

The garage wall will need to be reworked to install two bricks to the underside of the internal wall thus lifting the bottom plate to a height greater than the installed DPC.

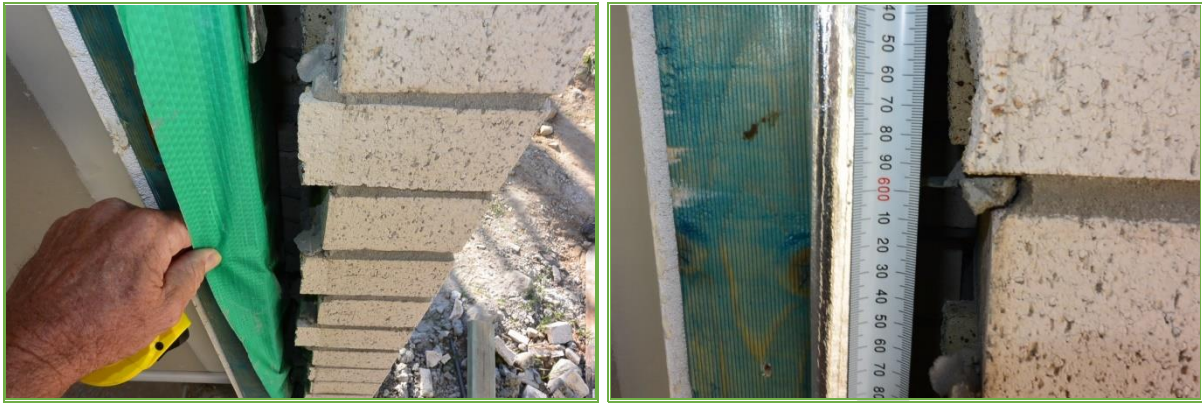
6. Garage and other area will need rework.

We noted that the brick ties do not comply with the minimums set out in the Australian Standards or the BCA/NCC. The BCA calls for compliance with AS 3700 and AS 4773.2. It is adopted by reference which means it makes up part of the BCA/NCC.

We noted on this dwelling that compliance was not present.

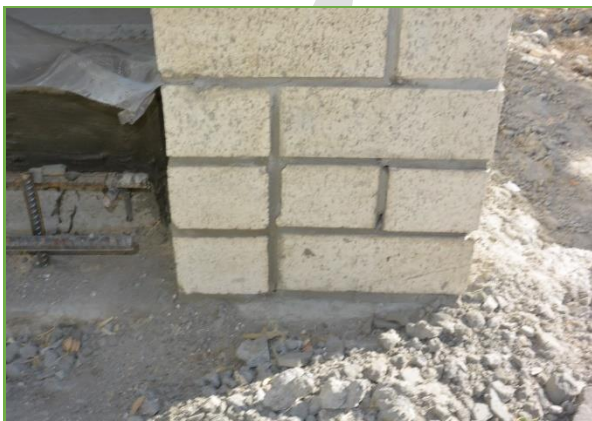
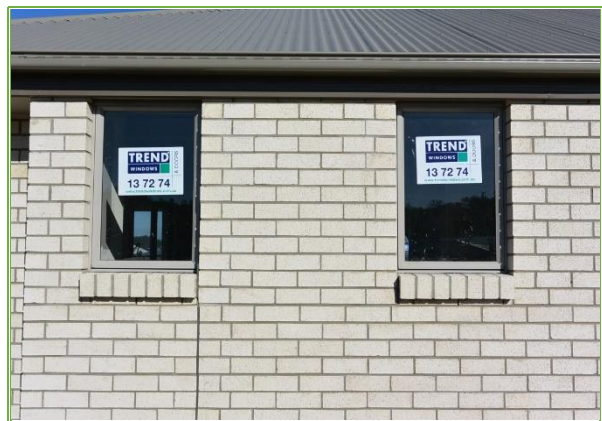
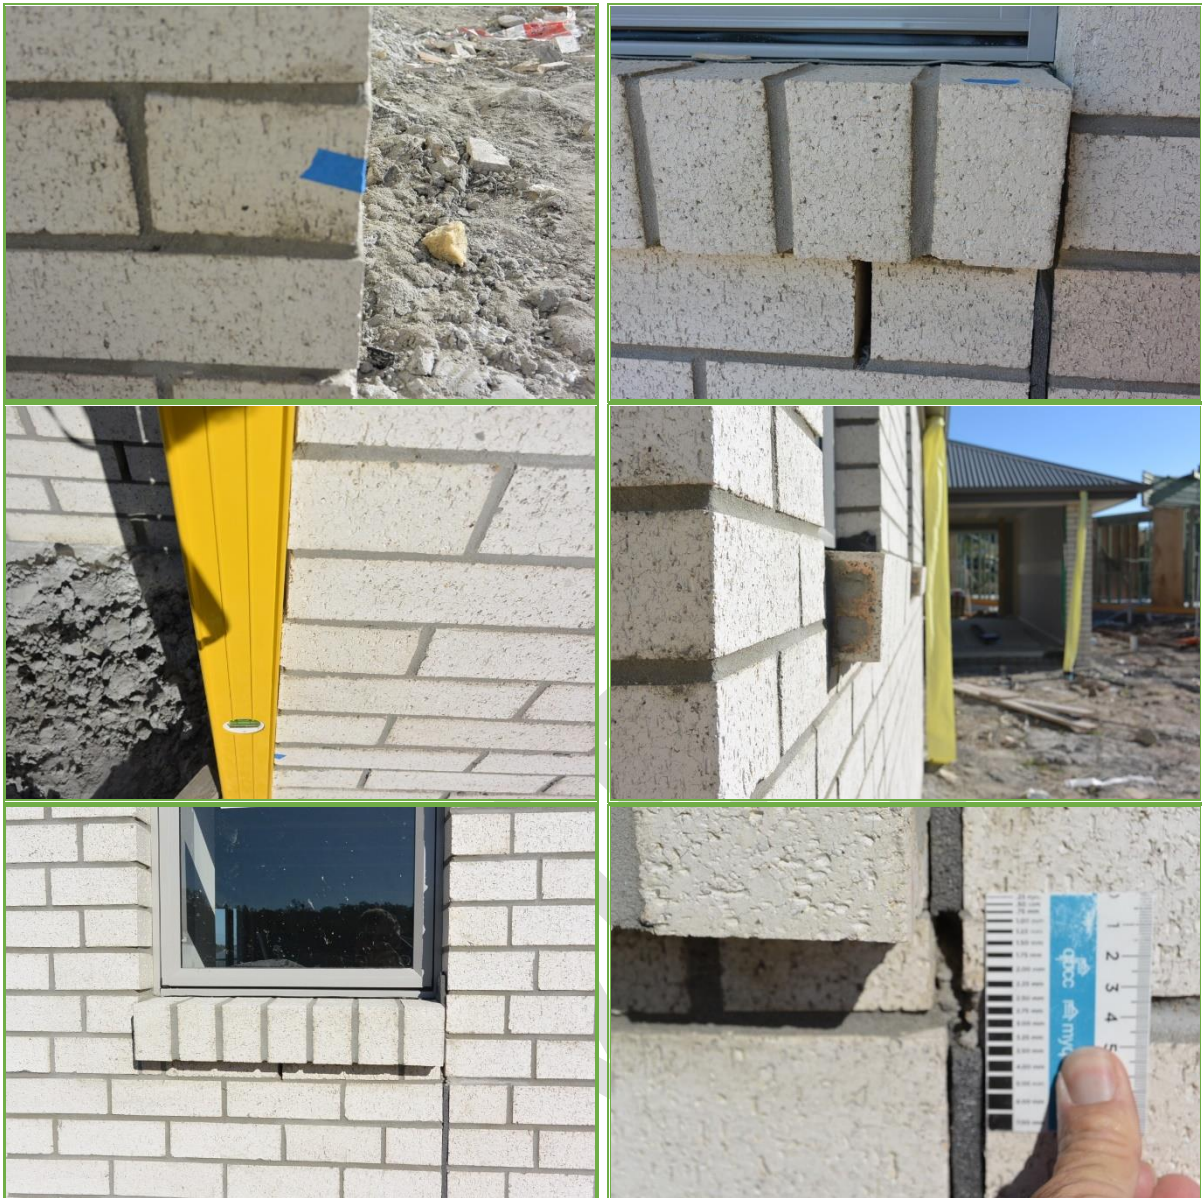
7. External Brickwork Defects Listed Below:

- Stack bond bricks garage
- Bricks lipping and twisted
- Brick sills not same lope
- Corners uneven and stepping
- Brick articulation joints not vertically inline

All will need to be rework to comply with below insert

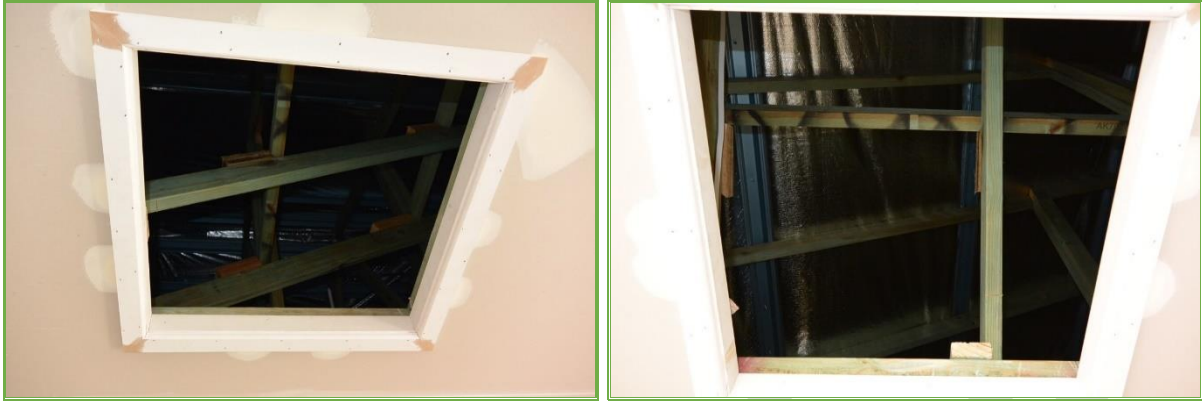
8. Garage

Manhole obstructed, this will need to be rectified.

The man hole is extensively obstructed. AS 5601, clause 1.4.1 calls for non- hazardous access to the heating unit. The manhole in its current position could be classed as hazardous. The manhole needs to be reposition to allow unrestricted access to service persons needing to access the ceiling space from time to time. Obstructing the access breaches AS 3000 electrical rules and AS 5601 Gas Installations.

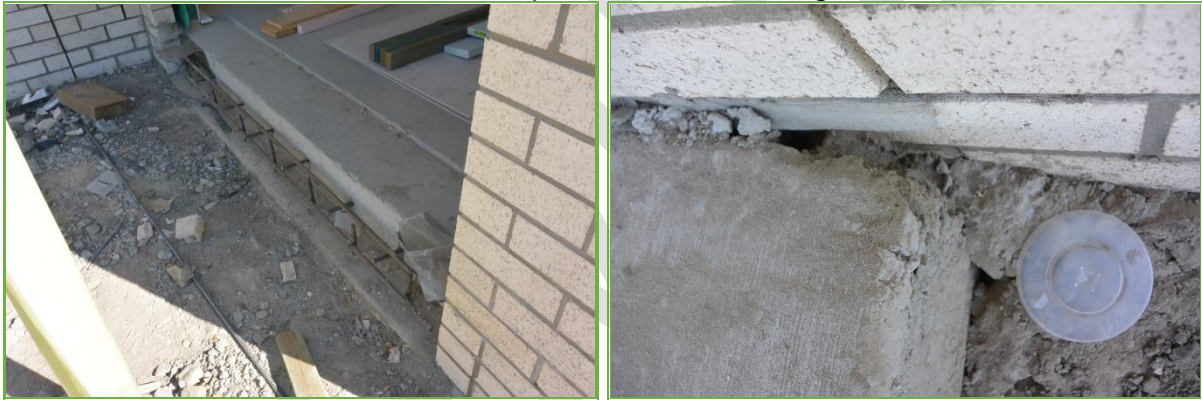
9. Slab rectification needs to be completed before moving forward with this build.

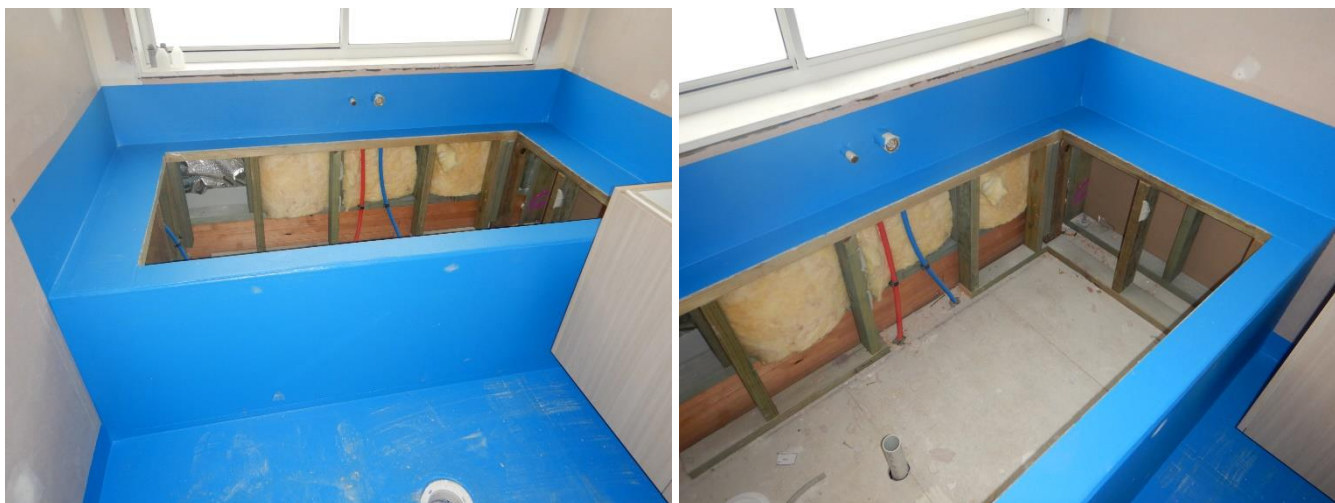
10. The main bath area waterproofing does not have at least a 25mm leg up above the bath frame, waterproofing to extend over the top, this needs to be reworked to comply with insert below:

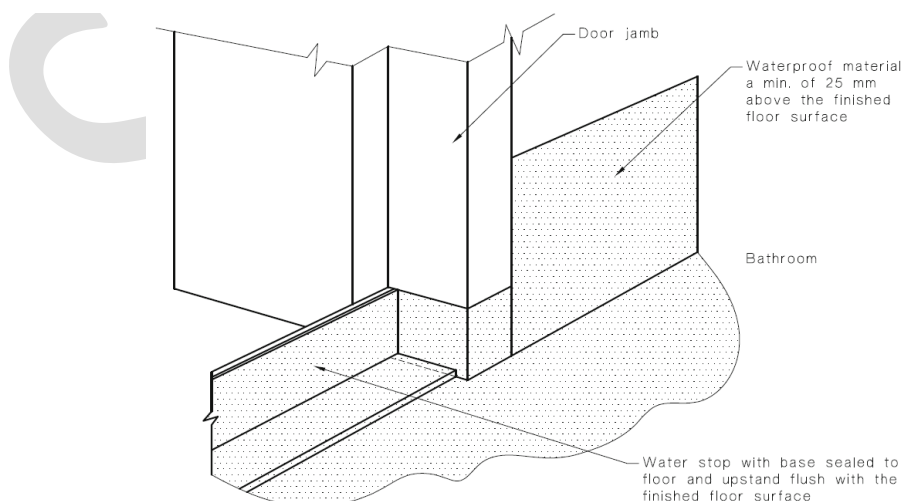
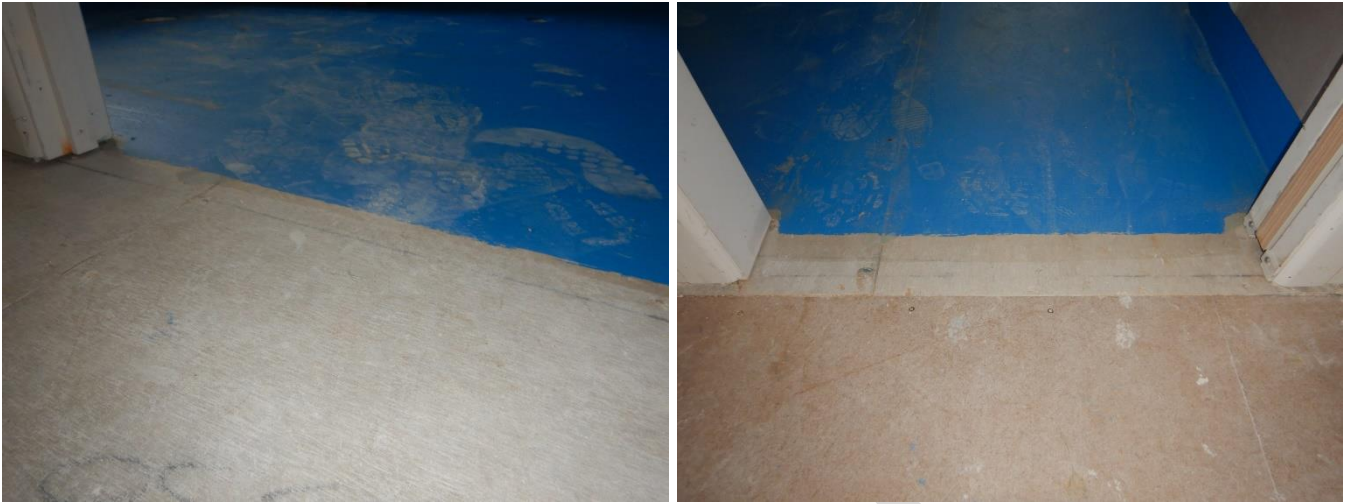
11. It was noted at the time of the inspection that it appears that there as been no water stop installed to the openings of some of the bathrooms, this will need to be rectified to comply with the minimum standard, refer to insert below.

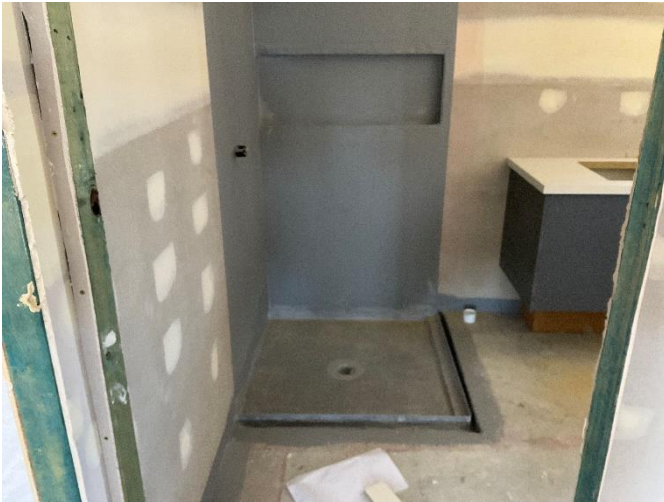
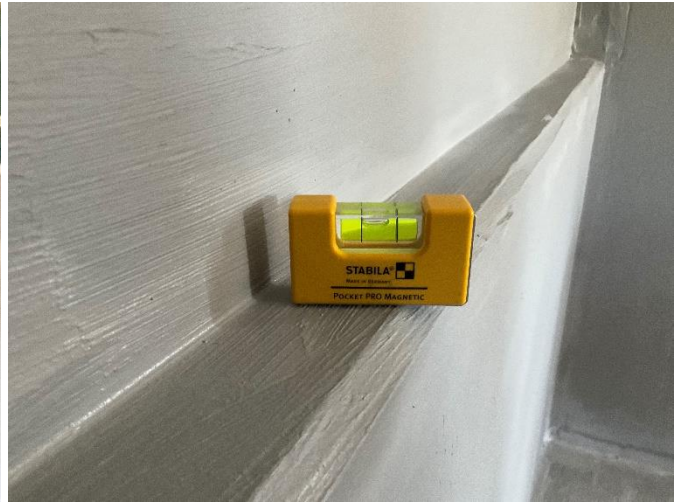
12. The niche sections to the shower have not been constructed with sufficient fall. The builder must rework these sections to comply with AS 3740.

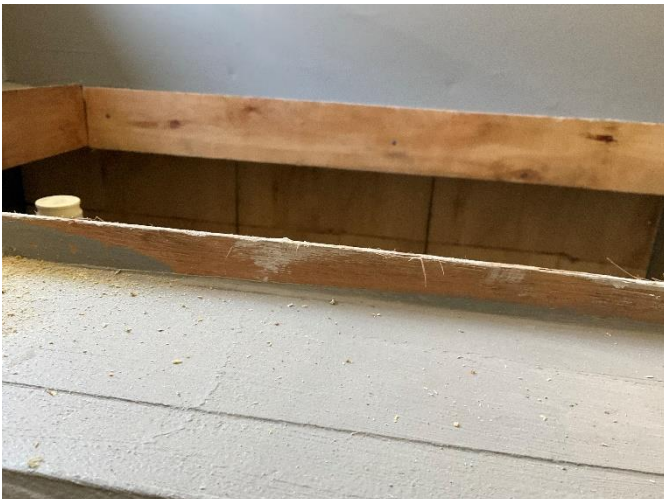
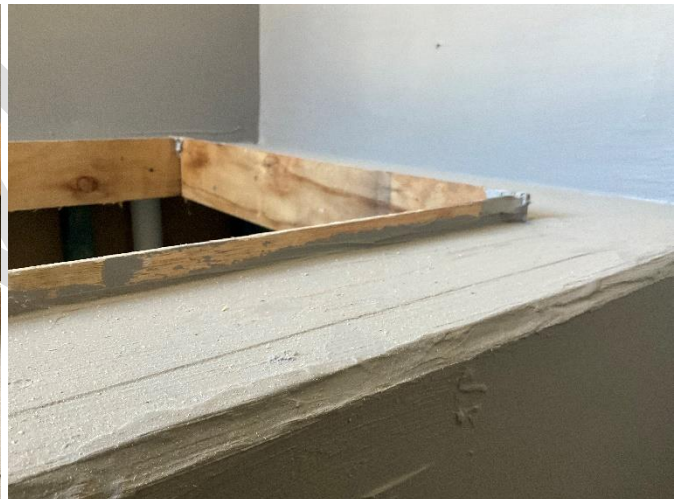
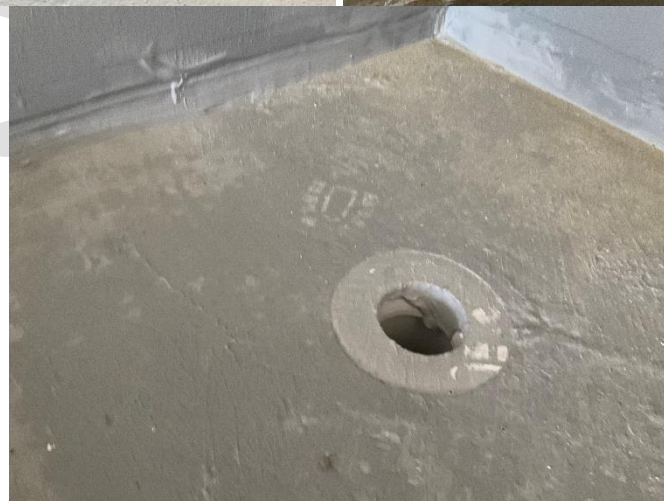
13. It appears the waterproofing is starved; this will need rectification to meet the manufacturers insulation manual.
