(Progress Inspection) REPORT (hereinafter called the "Report")

Report Number 01744

Inspection Date: 17/03/2023

Property Address: Sample street

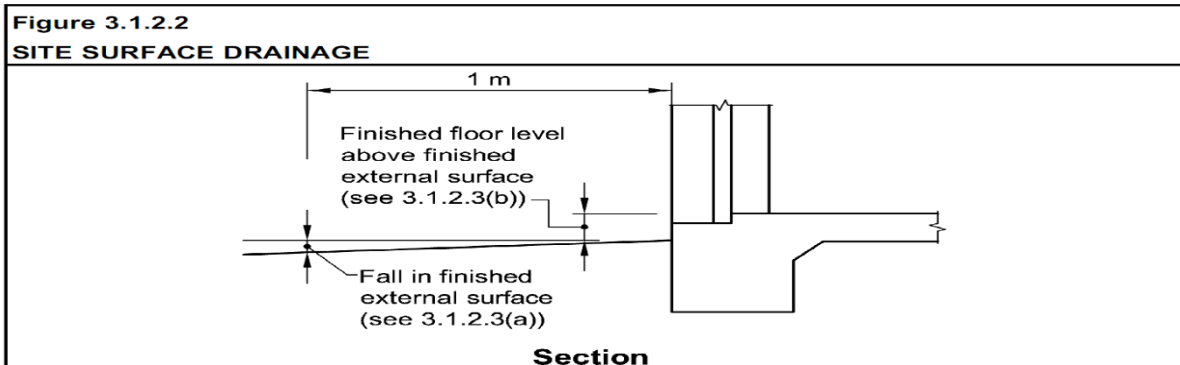
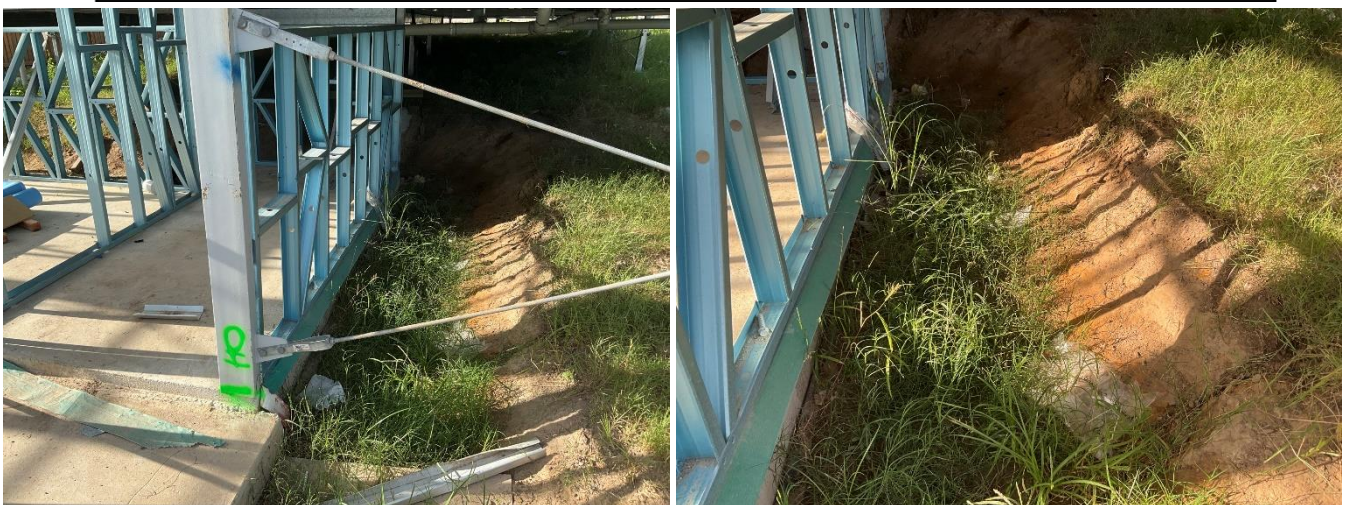
1. Ground levels, surface water drainage inadequate and temporary downpipes are not connected this can cause water to lay against the footings. This must be maintained throughout the build regardless of if the owner is doing the landscaping or not. As per 3.1.2.3 BCA and the QBCC Standards & Tolerances. We do acknowledge this is works in progress.

QBCC Standards & Tolerances 2.3 Site Drainage

Surface water is required to be directed away from the building and shaped to prevent ponding of water near or against the footings. Part 3.1.3.3 of the BCA provides minimum surface water drainage requirements. In Queensland AS 2870 *Residential Slabs and Footings* is widely used as an acceptable construction manual.

Site drainage requirements must comply with the AS 2870 provisions and any relevant engineer design. Site drainage will be defective if it is not in accordance with the above requirements.

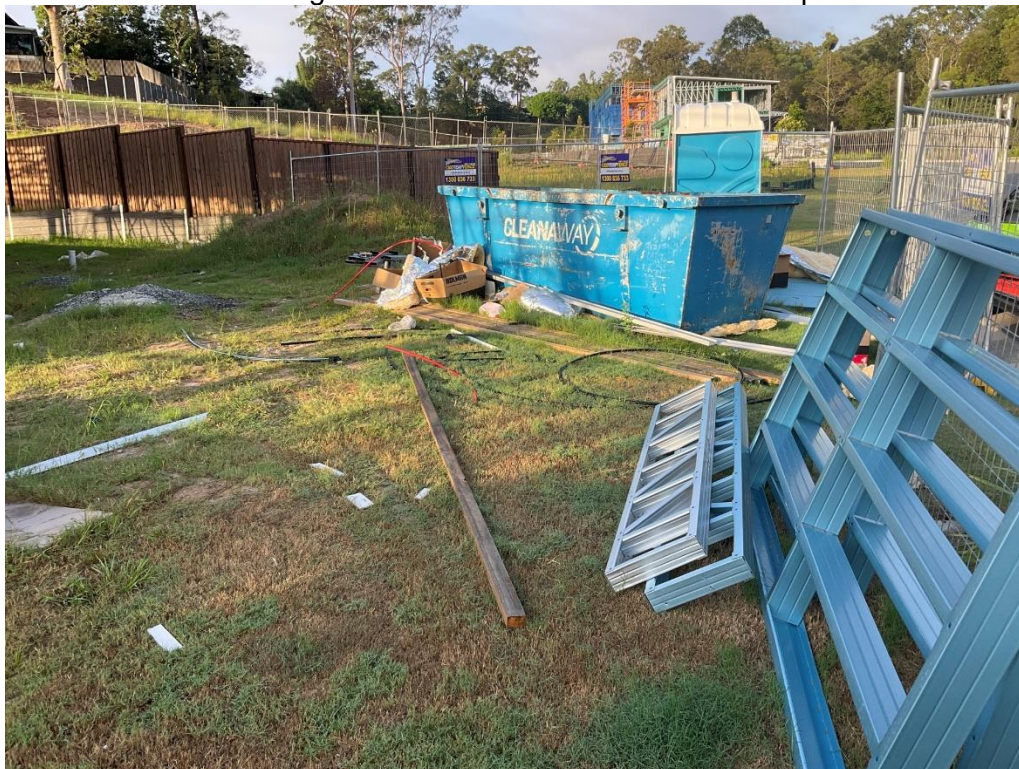
2. Poor housekeeping site rubbish unsafe. **Trip hazard.**

Many slips, trips and injury are the results of poor housekeeping, and this is often a sign of a lack of storage, maintenance and cleaning. This should be cleaned as soon as possible.

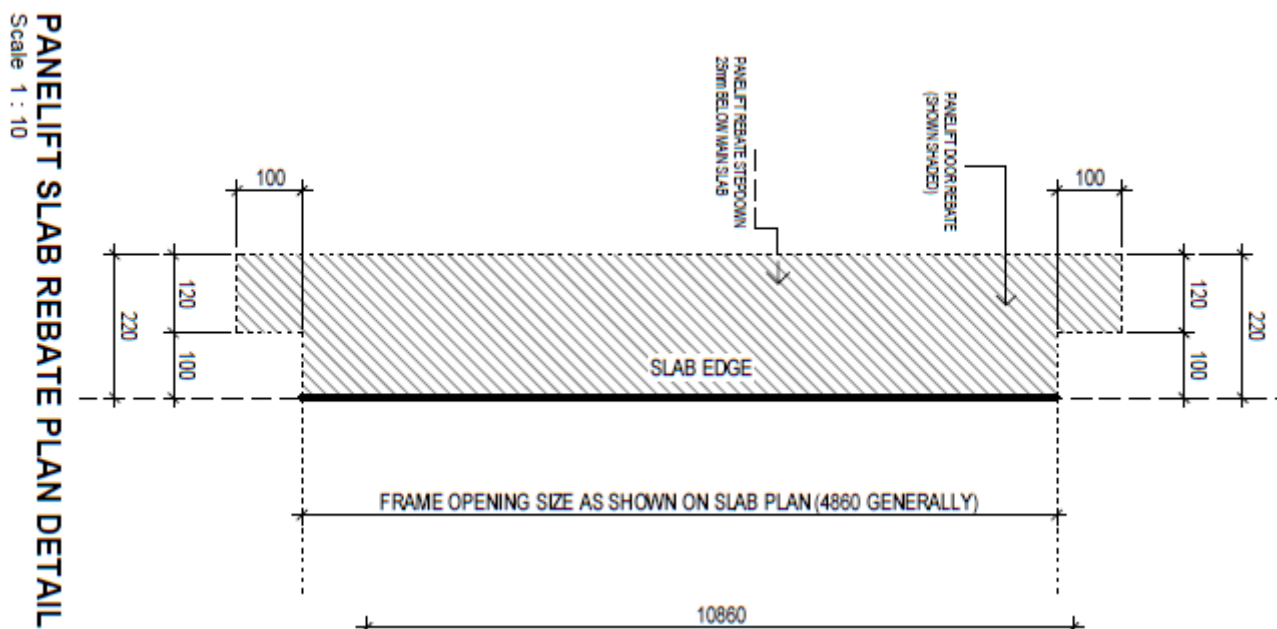
3. Garage slab missing stepdown rebate at the front and no slope, not as per plan, this will need to be rectified.

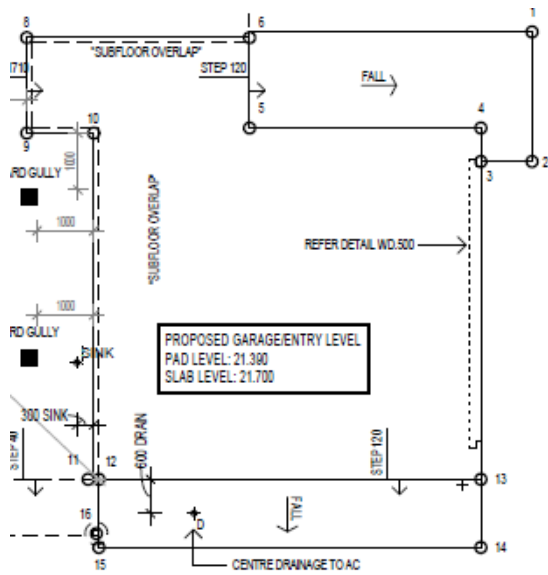
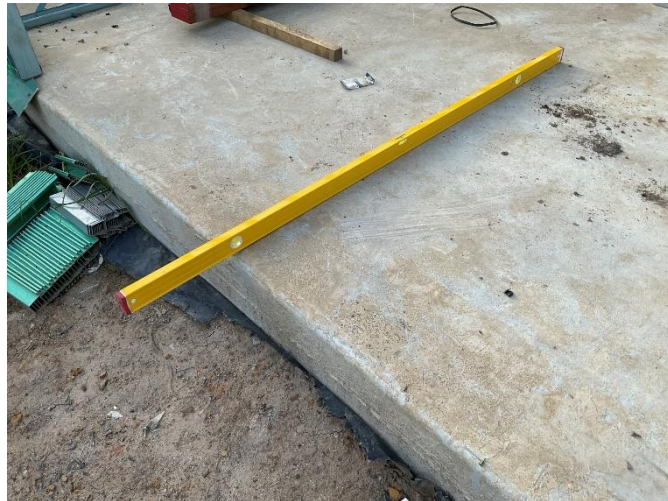
4. It was noted at the time of inspection that the concrete slab has rain damage the surface is dusting and soft/chalky this needs to be rectified. As per insert

QBCC Standards & Tolerances 3.12 Finish to concrete slabs

Within the first 12 months after completion of the work, the finish to a concrete slab is defective if it is not suitable for the documented applied finishes such as tiles, polished concrete, carpet or sheet flooring, including set downs where required.

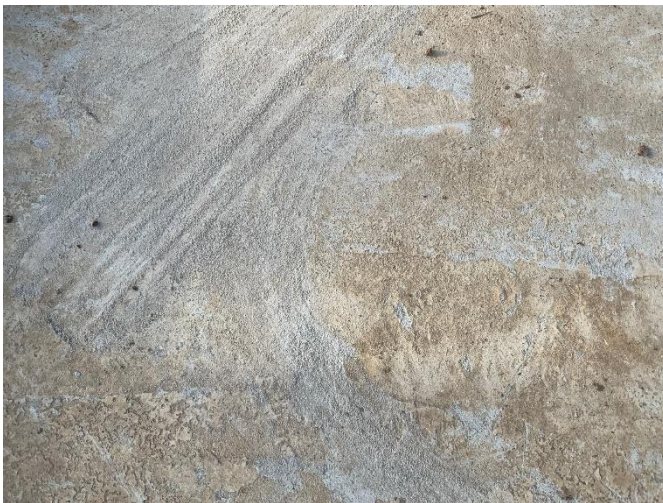
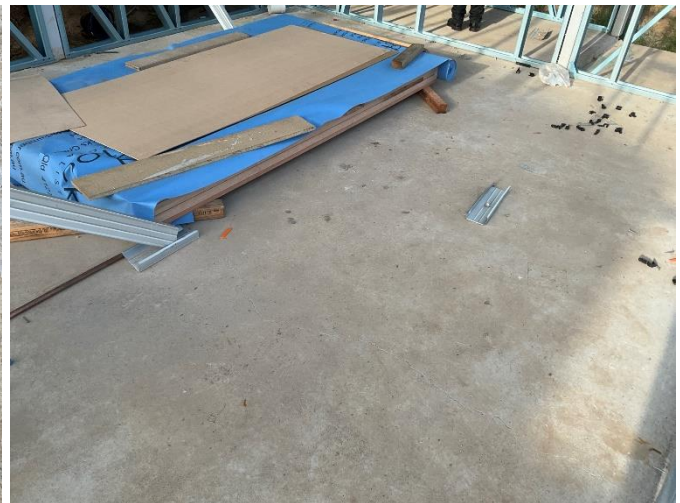
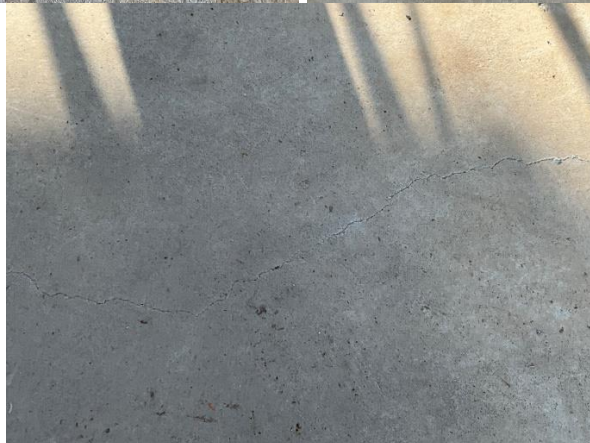
5. Fixings have gone into the garage slab this is a finish floor this is substandard workmanship; this will need to be rectified.

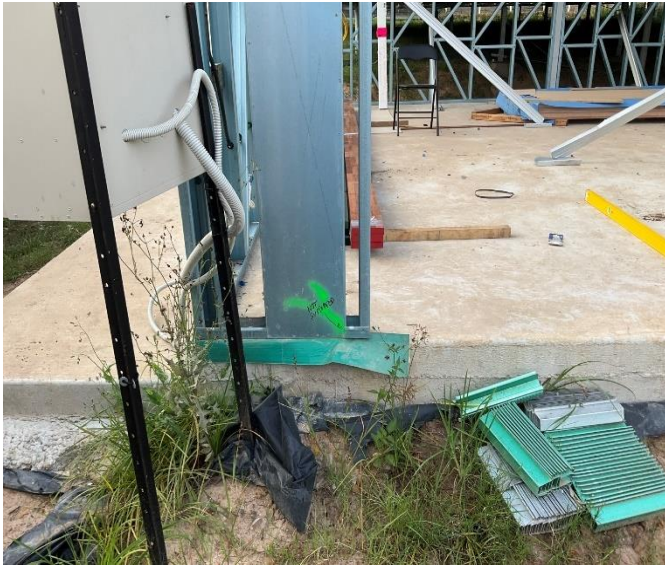
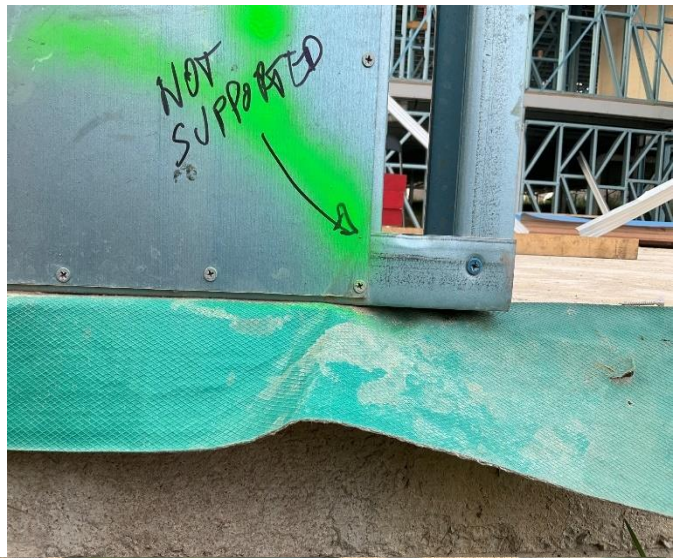
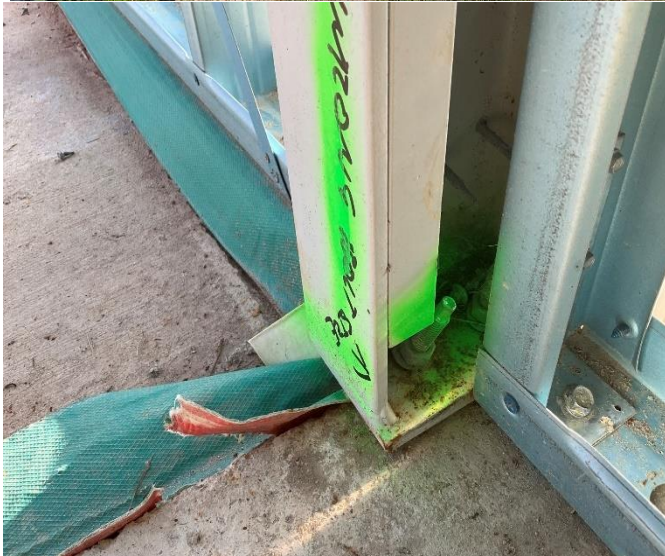
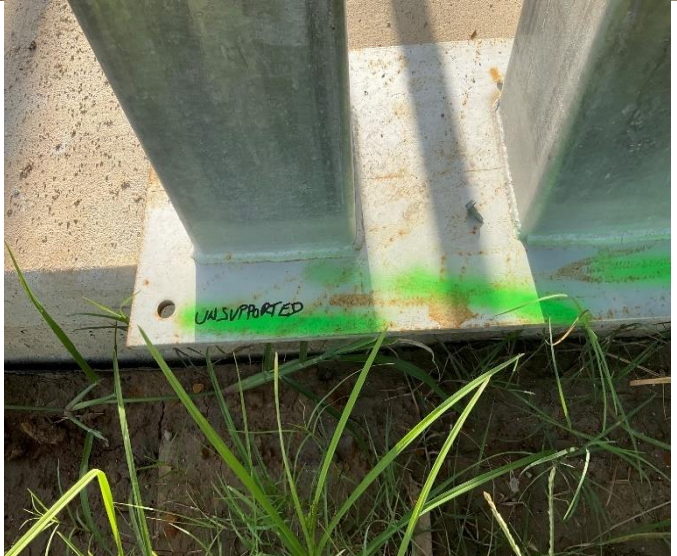
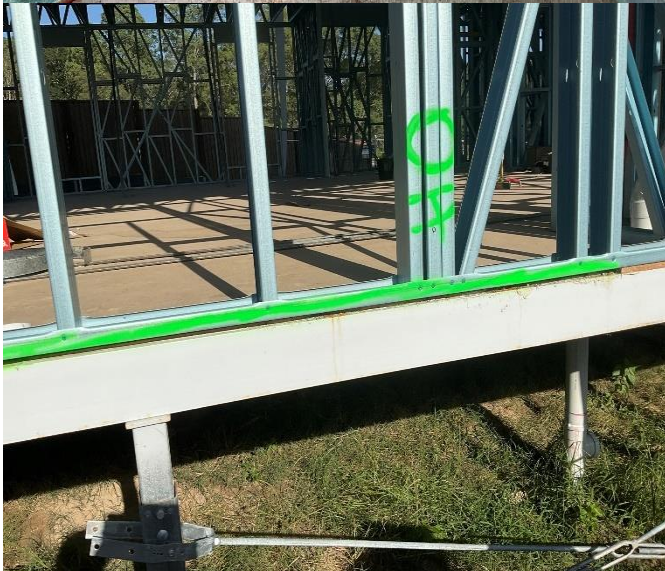
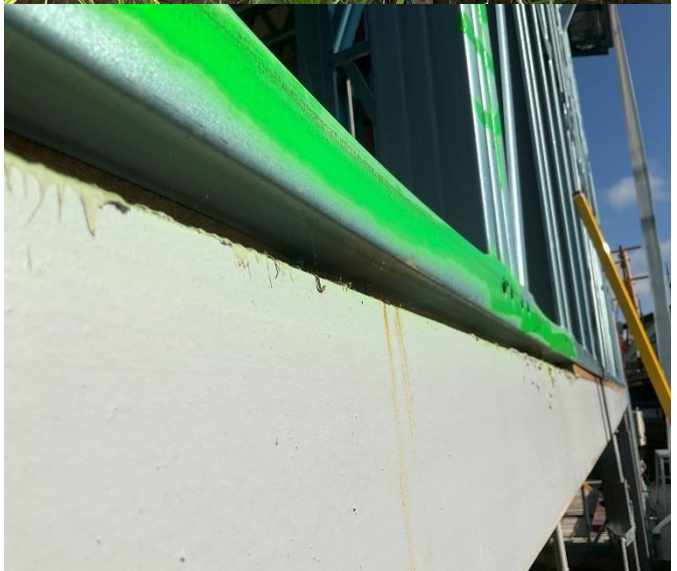
7. A number of wall intersection screw fasteners are missing and need to be installed prior to the installation of wall linings.

The National Association Steel-framed Housing (NASH) Standard – Part 2 calls for 2 x 10g screws at the top, bottom, and nogging level. Spacing cannot exceed 1350mm.

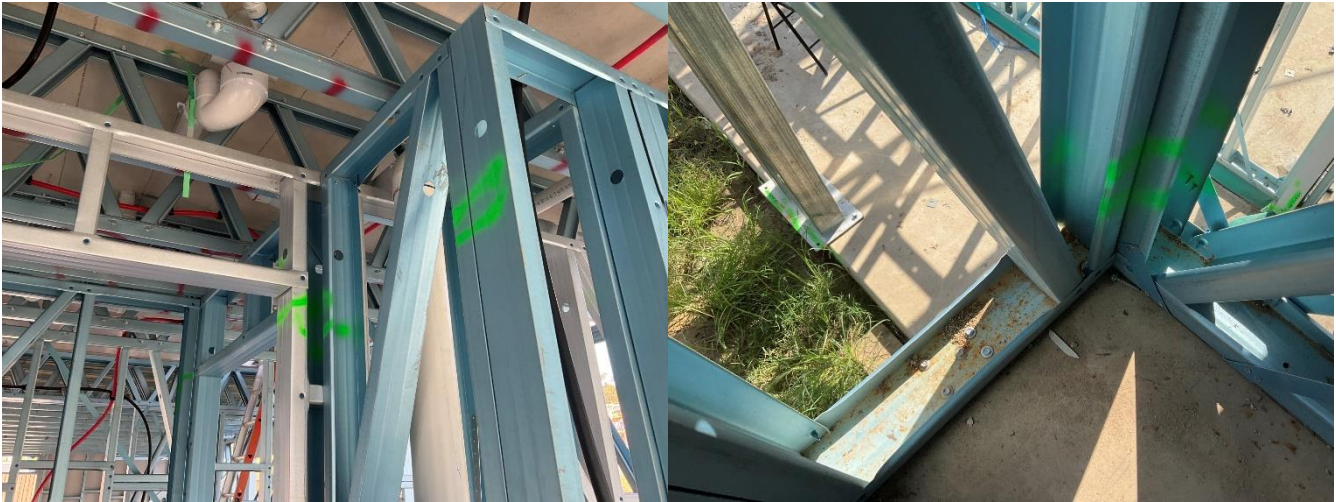
8. Frame out of plumb, this will need to be rectified.

NASH Standard Part 2; 2.2.3: - Walls shall be plumb to within $H/600$ or 3mm as detailed in Figure A1.

Steel wall frames to this building have not met this requirement.

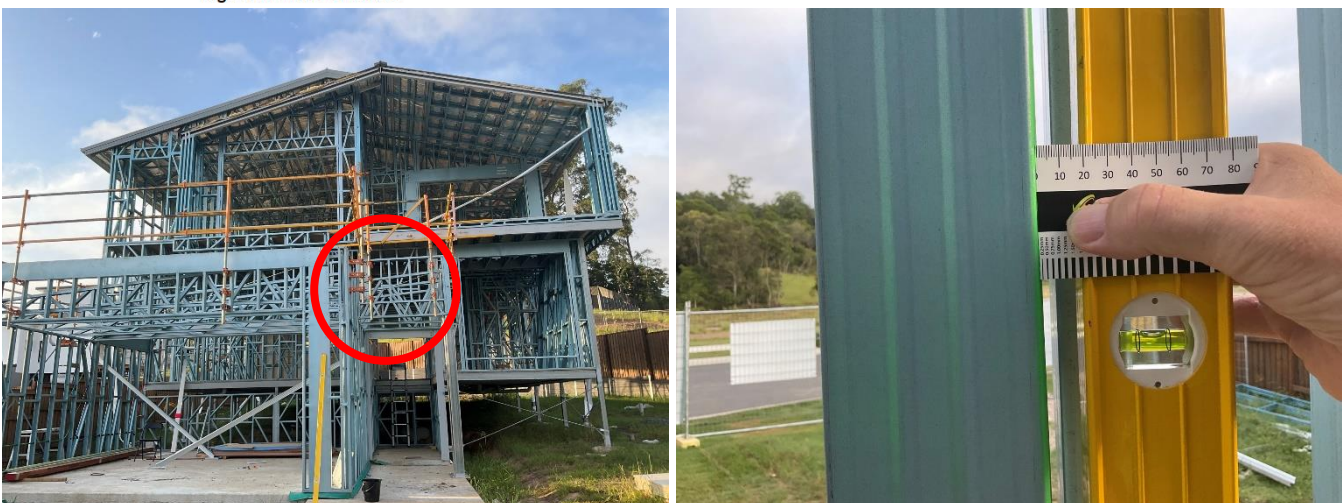
9. The frame has been damaged, substandard finish, this will need rework, not in an appropriate, skilful way or with reasonable care and skill need to be rectified.
As per NASH 1.13 insert

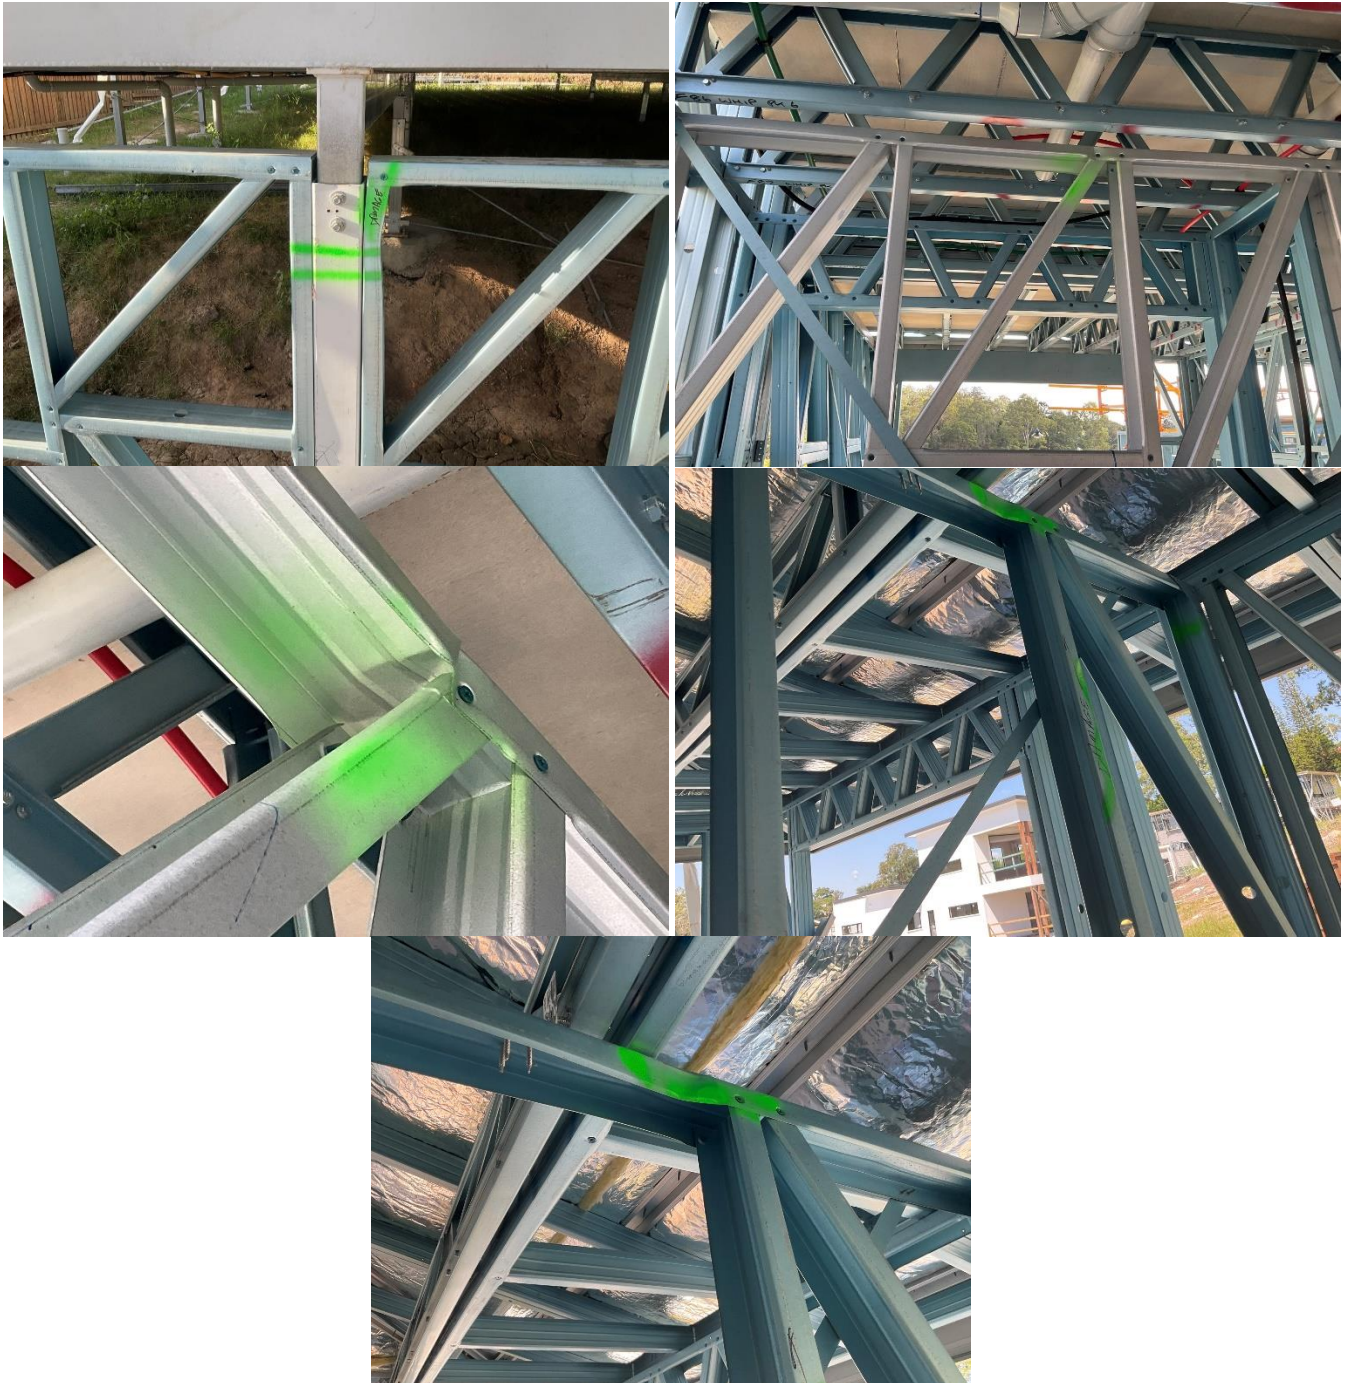
10. Back of garage wall where bearer meets first floor framing is way out of alignment, this will need to be rectified.

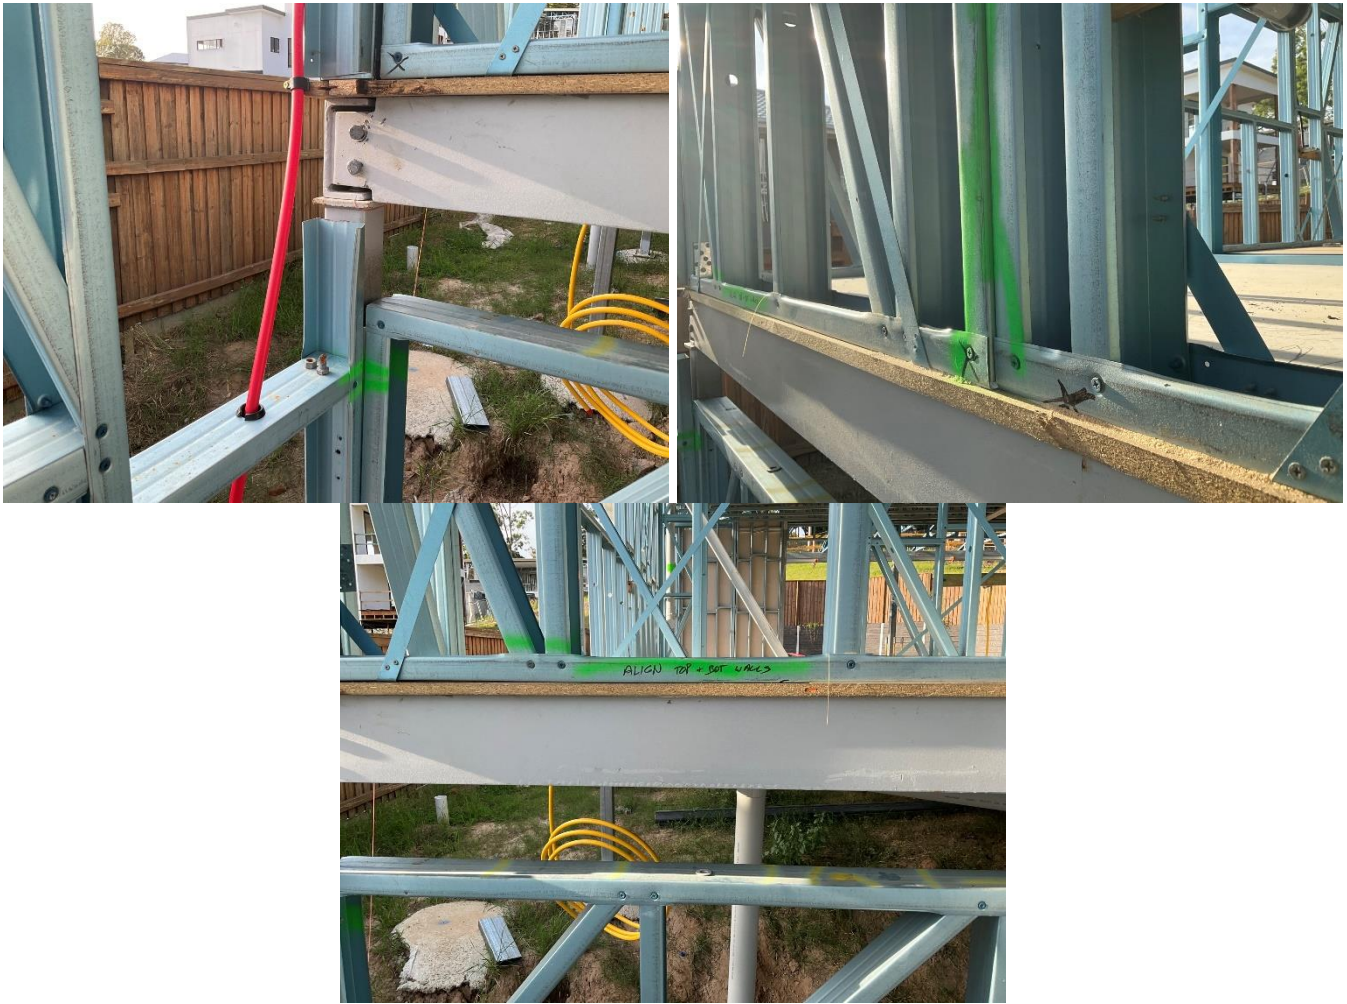
11. The cross bracing is loose, not screwed to each stud and are not the correct width apart as per the Nash Standard, see insert below, this will need to be rectified to comply.

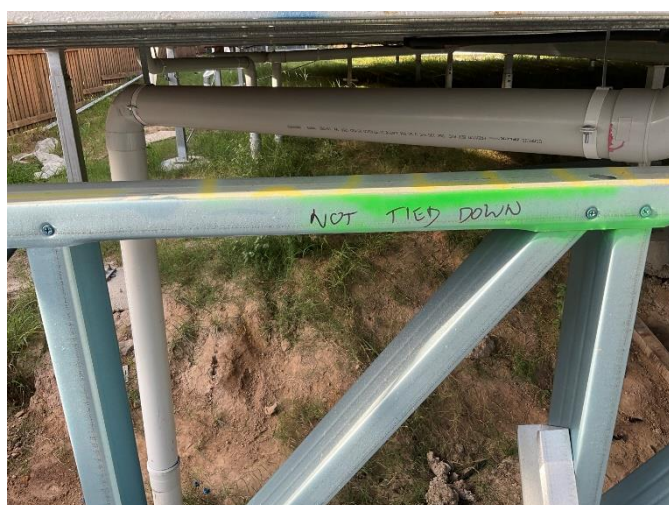
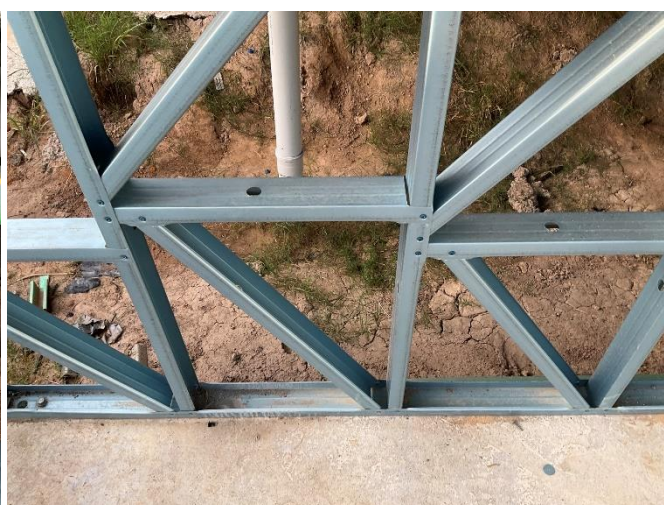
12. Bracing walls missing tie downs and are not in the correct location, not as per engineering/NASH.

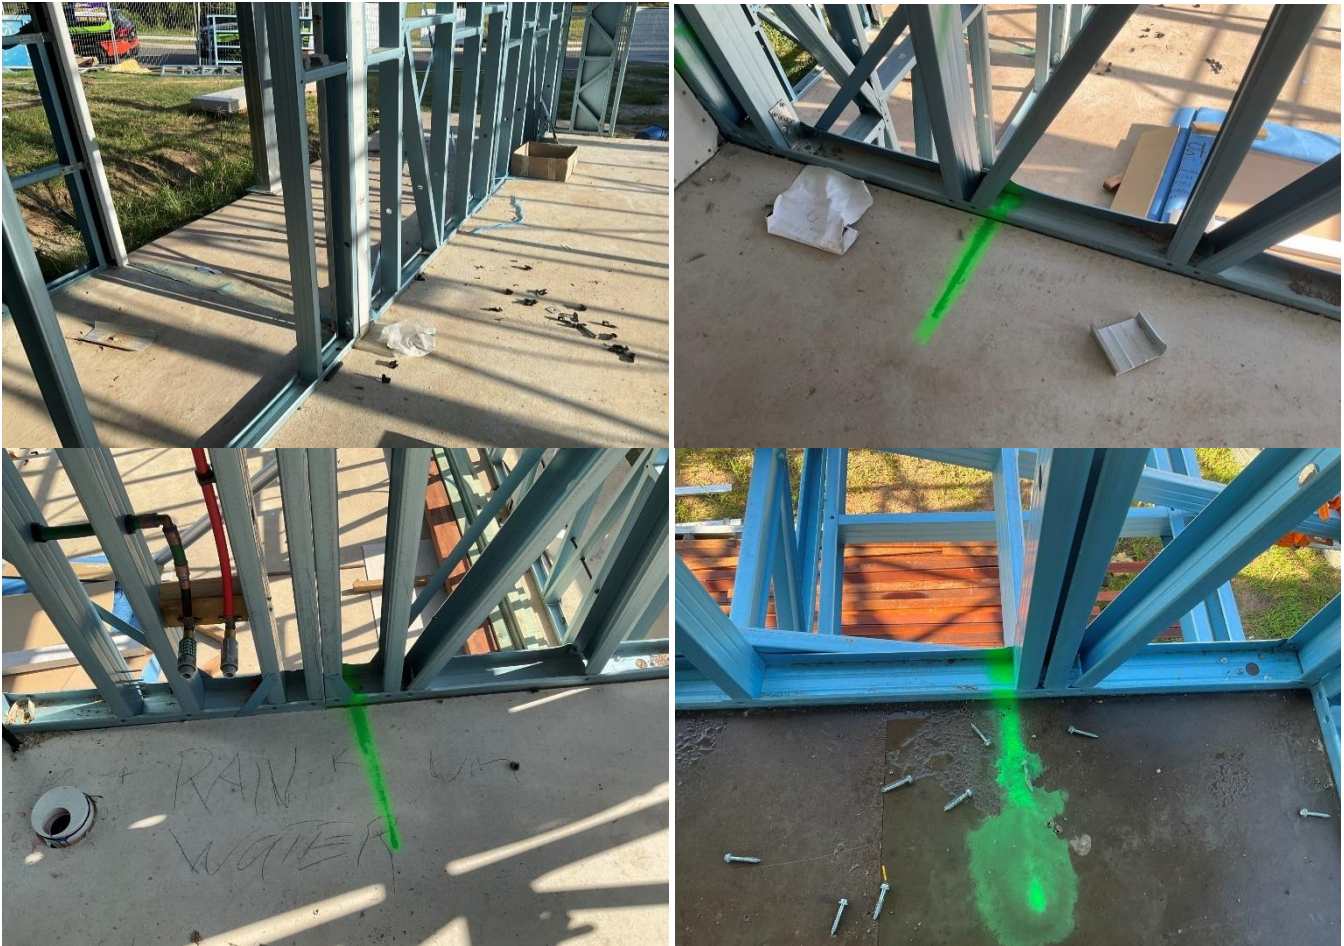
13. Bottom plate tie down bolts do not have any washers 50x50x3mm, not as per the engineering.

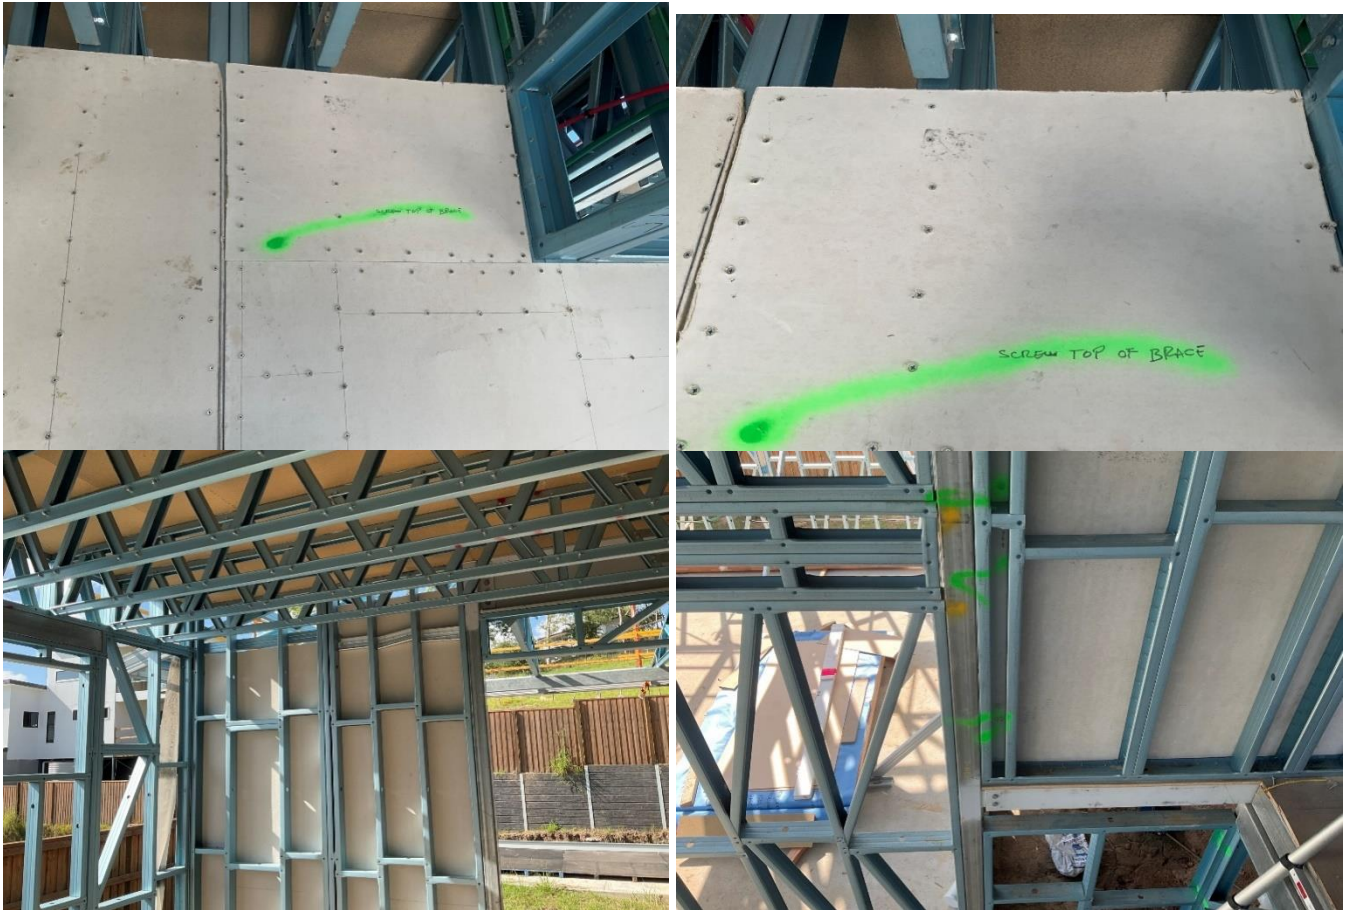
14. Fibro sheet, bracing has no screws to the top, no noggings to screw too, this will need to be rectified as per the engineering.

The bracing plan states that the screw spacing must be 150ctrs (the top isn't screwed off) M16 connections are missing.

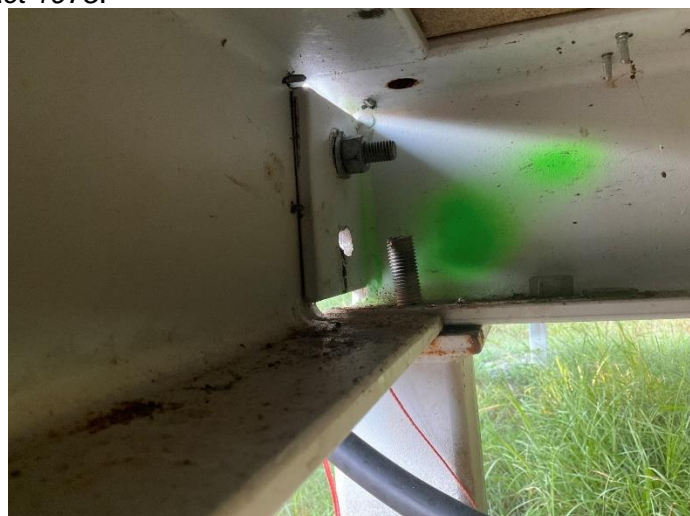
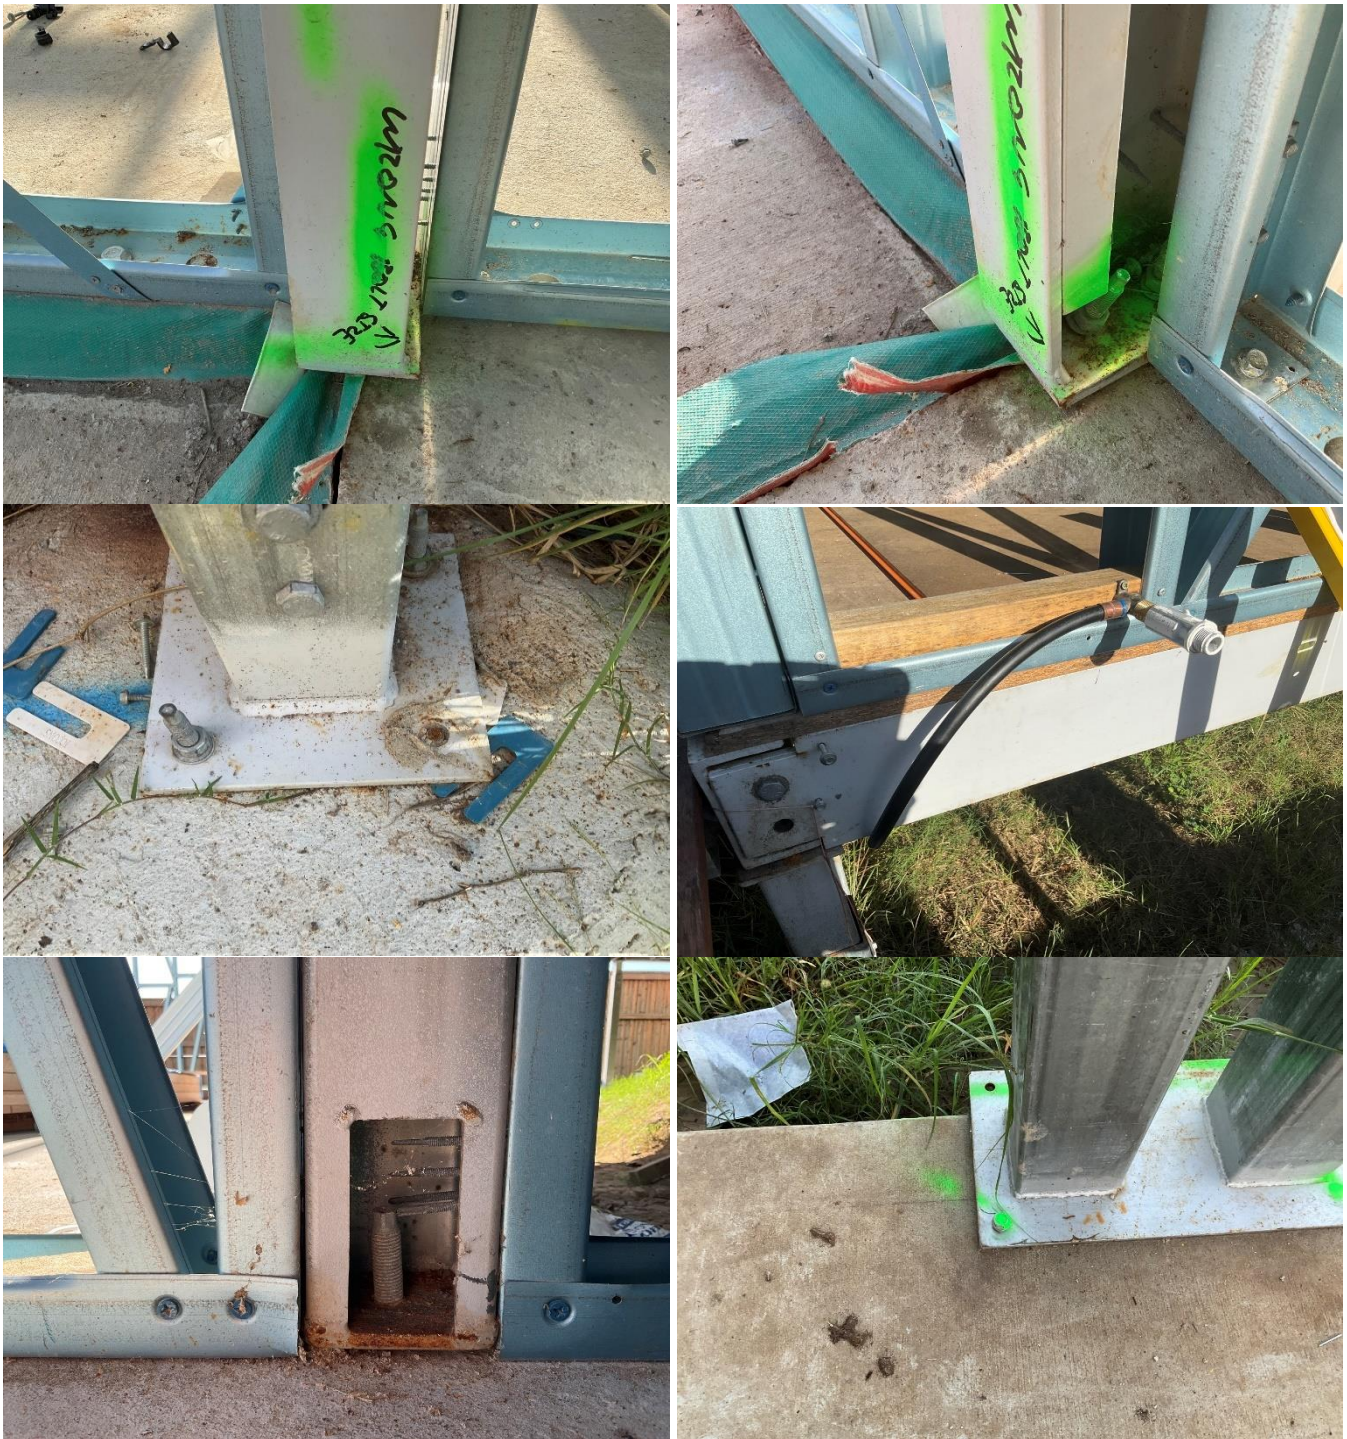
15. Tie down nuts are loose, missing bolts and incorrect sizing for steel posts, this will need to be rectified to comply with engineering.

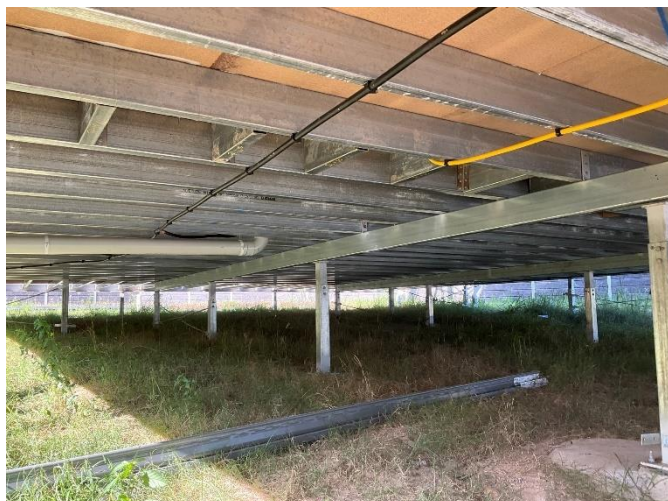
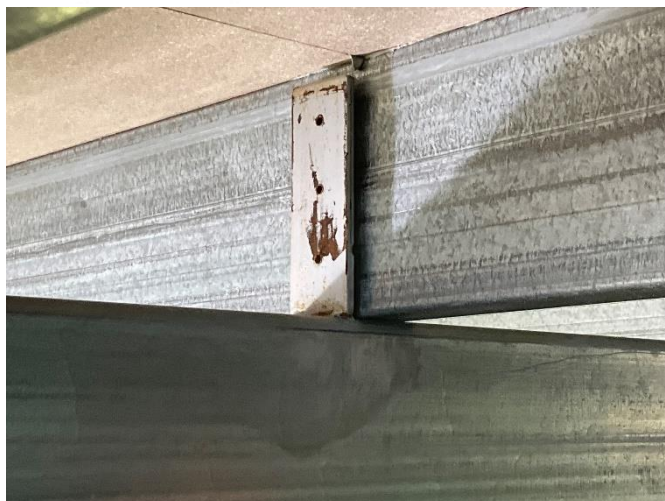
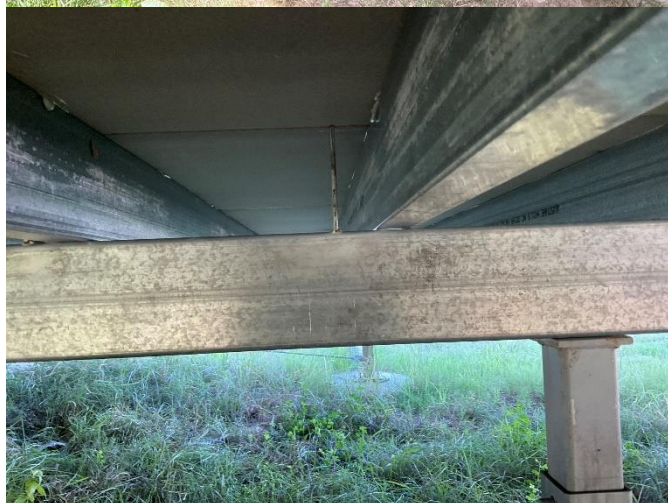
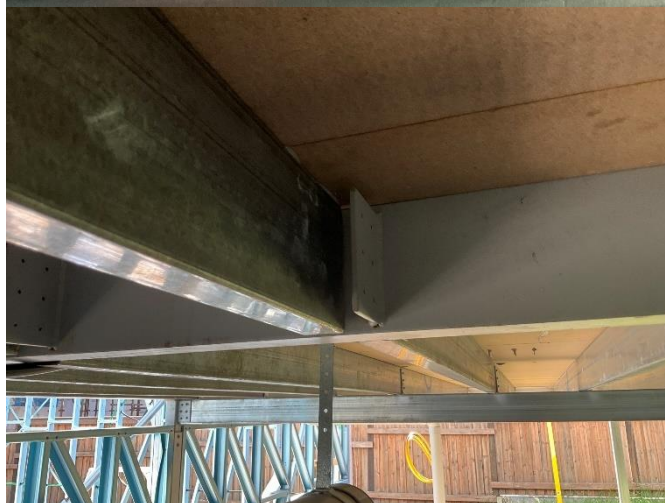
16. It appears that there are a number of joists that haven't been screwed off to the load bearing walls as marked, see insert below.

- A number of fixings to bearers to the joists have not been completed and are in the wrong location for fixings, the brackets for the floor joist are in the wrong location.
- Front entry, subfloor joist, not connected to bearers cantilevering, no connection to intermediate bearers PFC. This will need to be rectified.

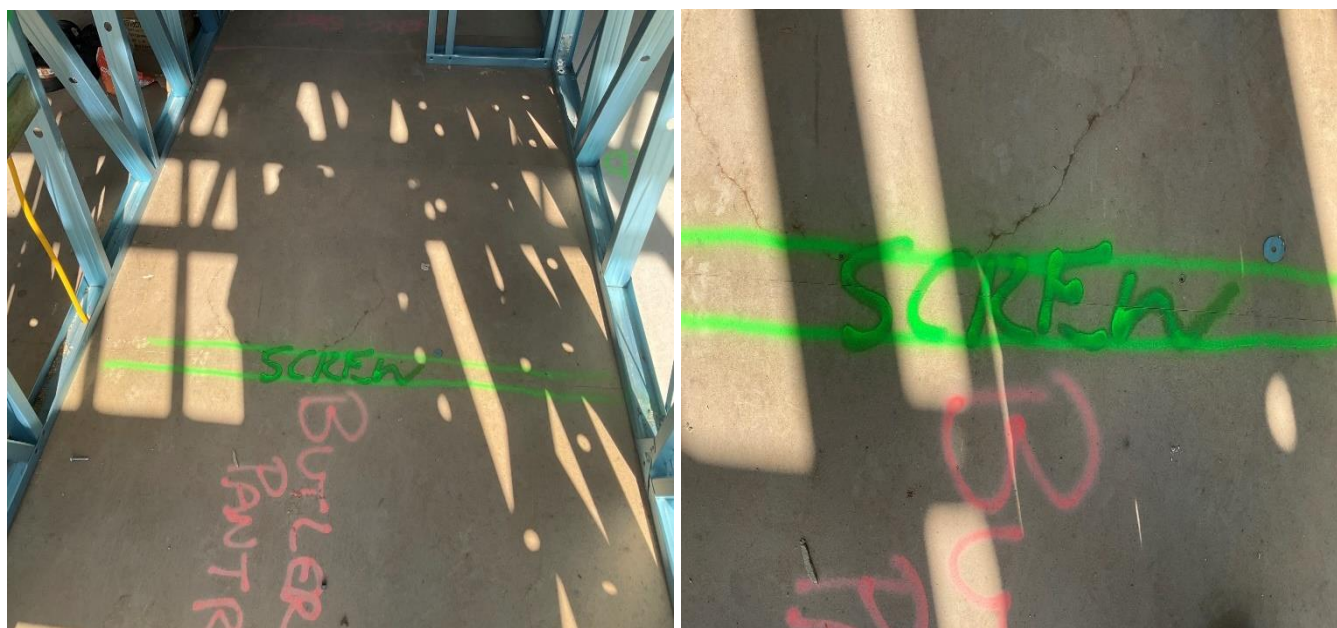
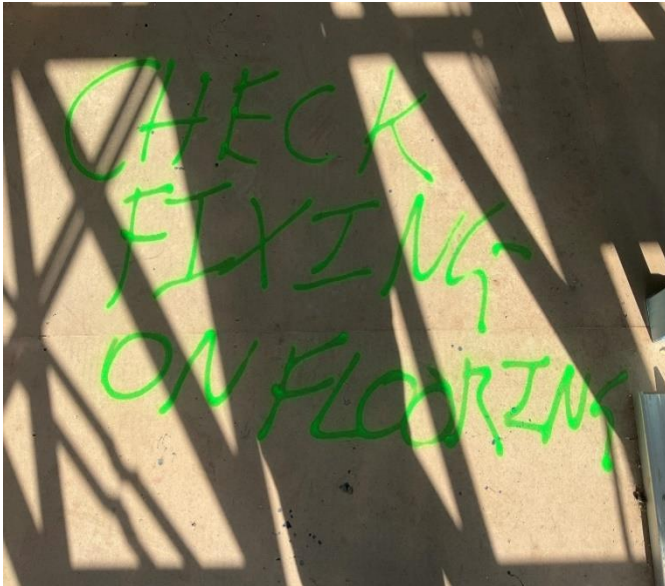
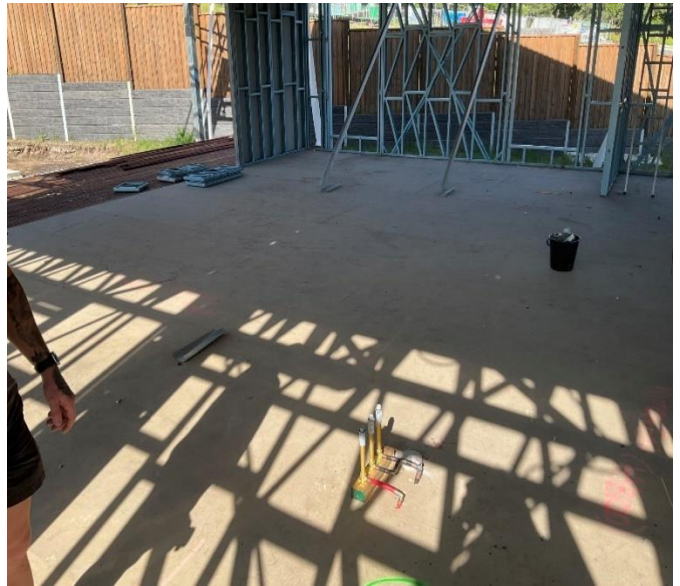
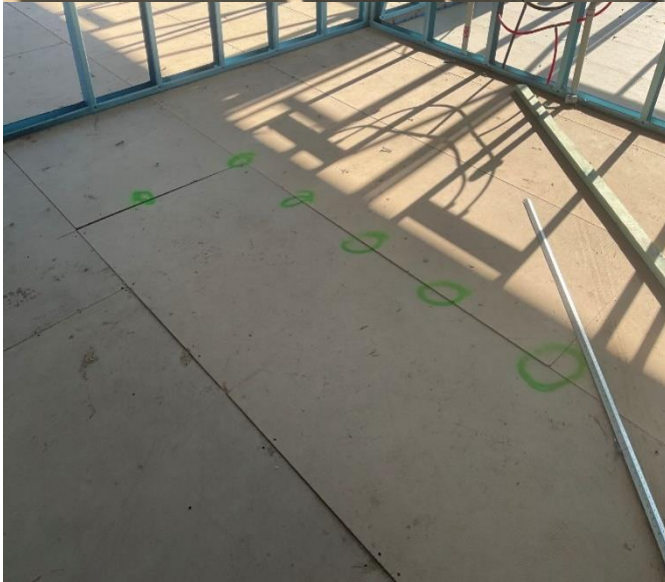
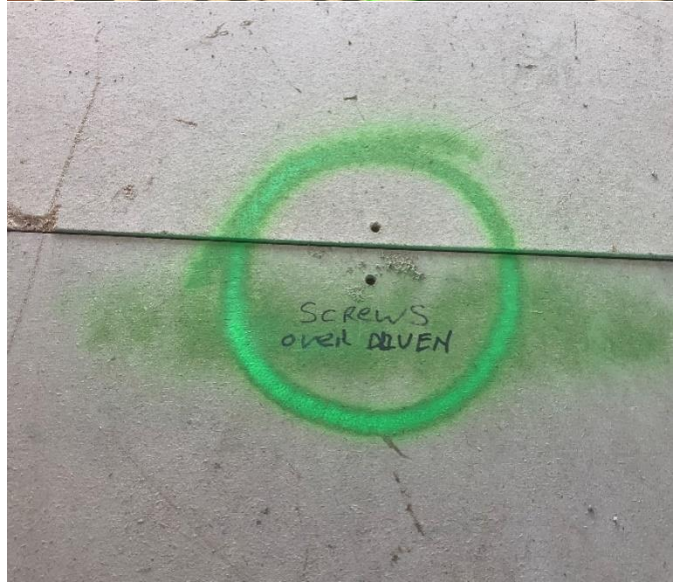
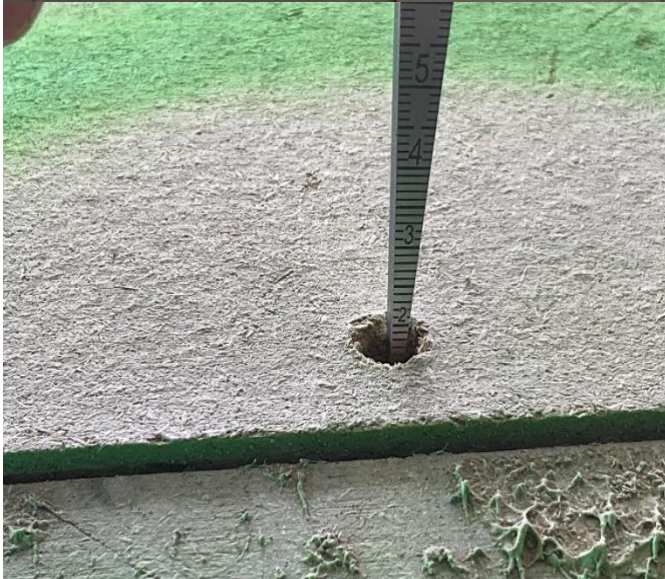
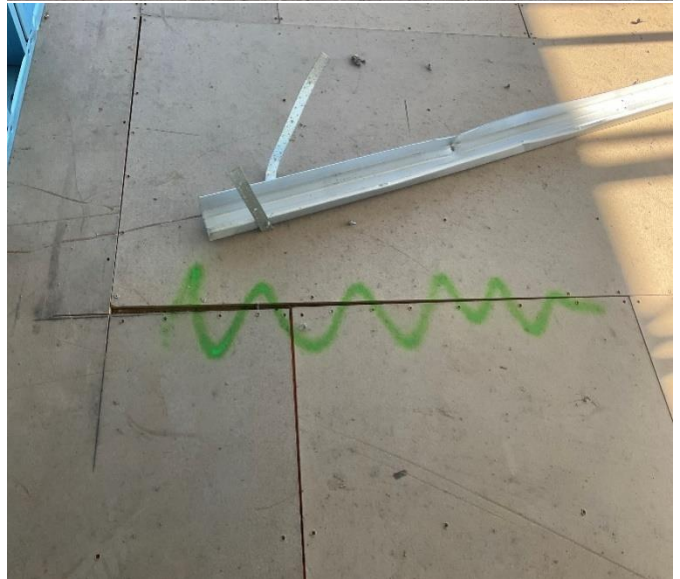
17. The particleboard flooring has not been installed as per the manufacturer & as per AS 1860.2

- Missing screws.
- Screws over driven.
- Close to the edge.
- Humps and dips/ out of level.
- Damage
- Excessive gaps.

AS 1860.2, 10.4 Screws; The screws over driven should be adjusted to drive the screw head 2mm to 3mm below the panel surface to allow for later sanding. Screws should not be driven more than 3mm below the panel surface.
