(Progress Inspection) REPORT (hereinafter called the "Report")

Report Number 01744

Inspection Date: 17/03/2023

Property Address: Sample street

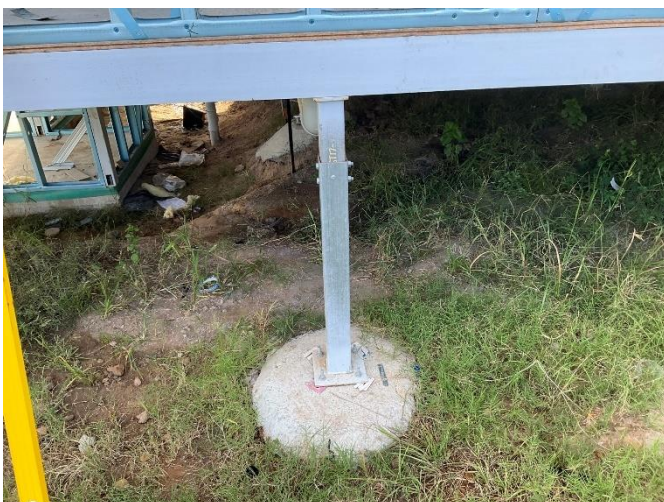
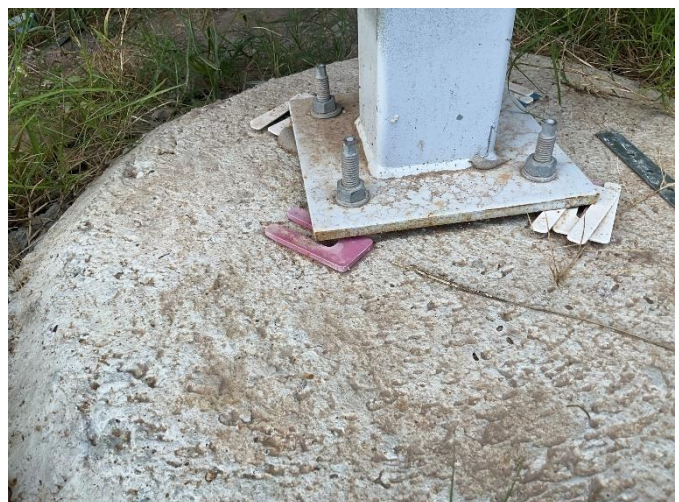
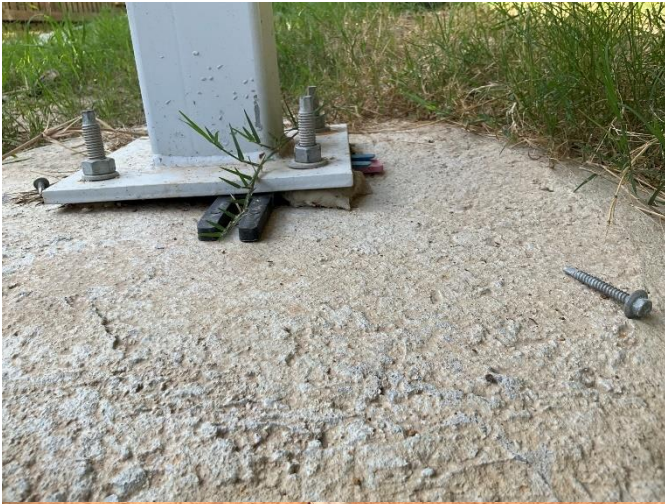
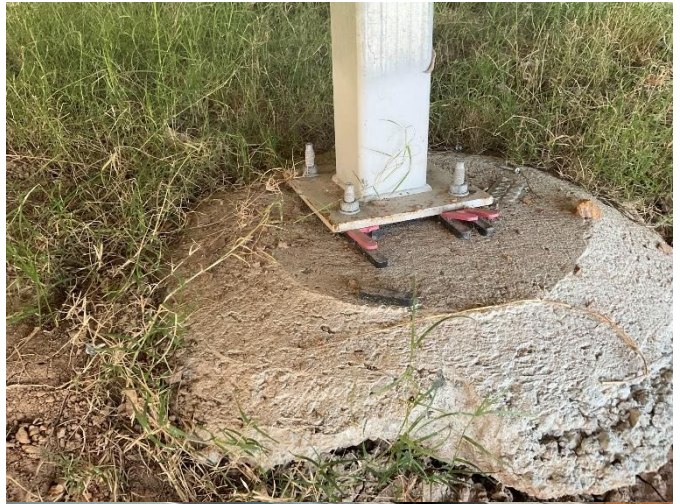
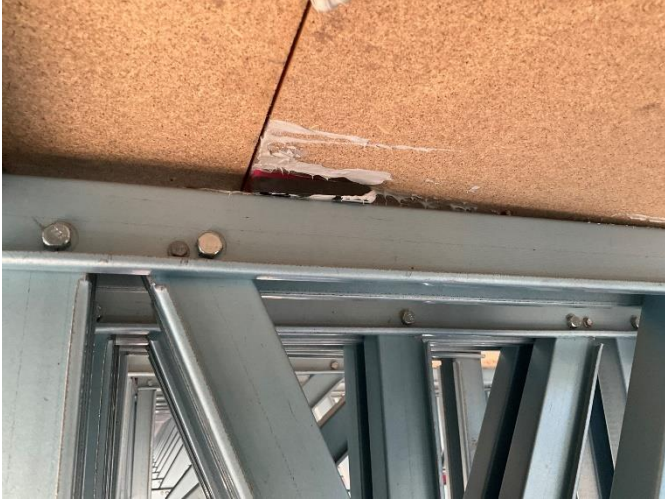
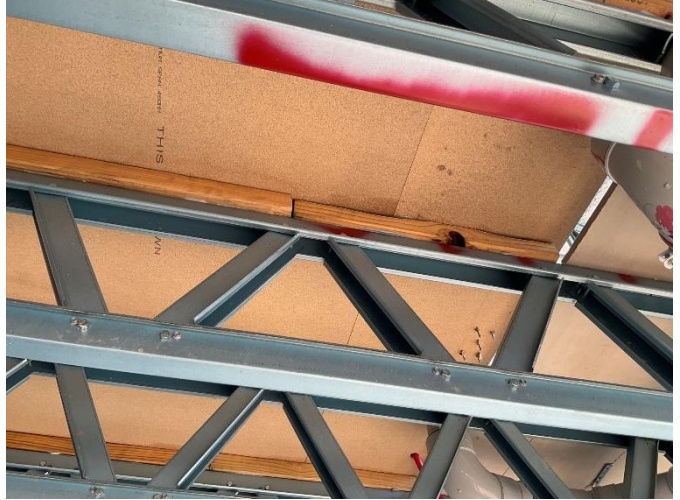
18. Subfloor and frames have used window packers for structural support, these may not be fit for this purpose; these structural members are not fully supported.

This will need rework, not in an appropriate, skilful way or with reasonable care and skill. All needs to be reworked to comply with the Nash standard as per insert:

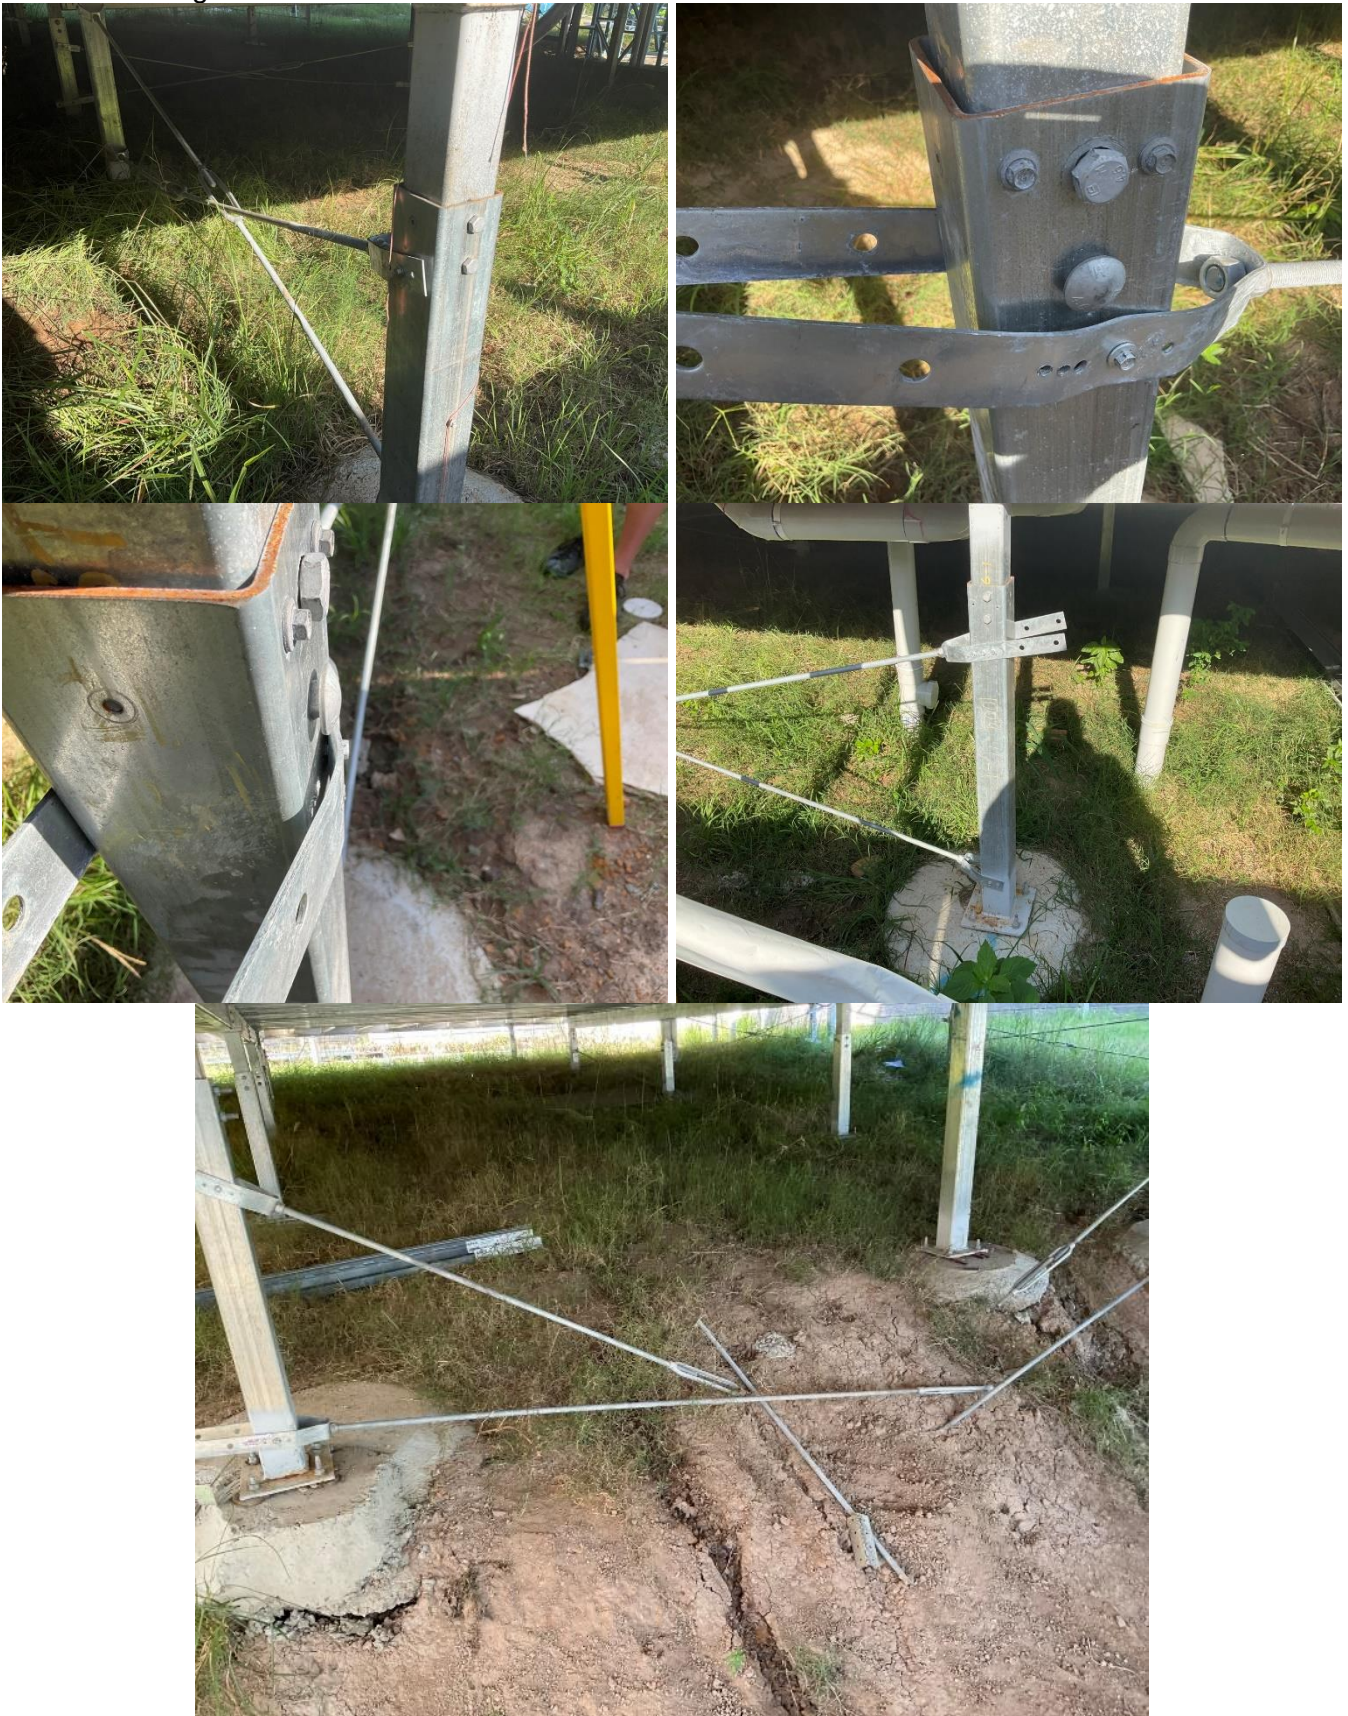
19. Subfloor cross bracing is incomplete, fixings are inconsistent this will need to be checked by an engineer.

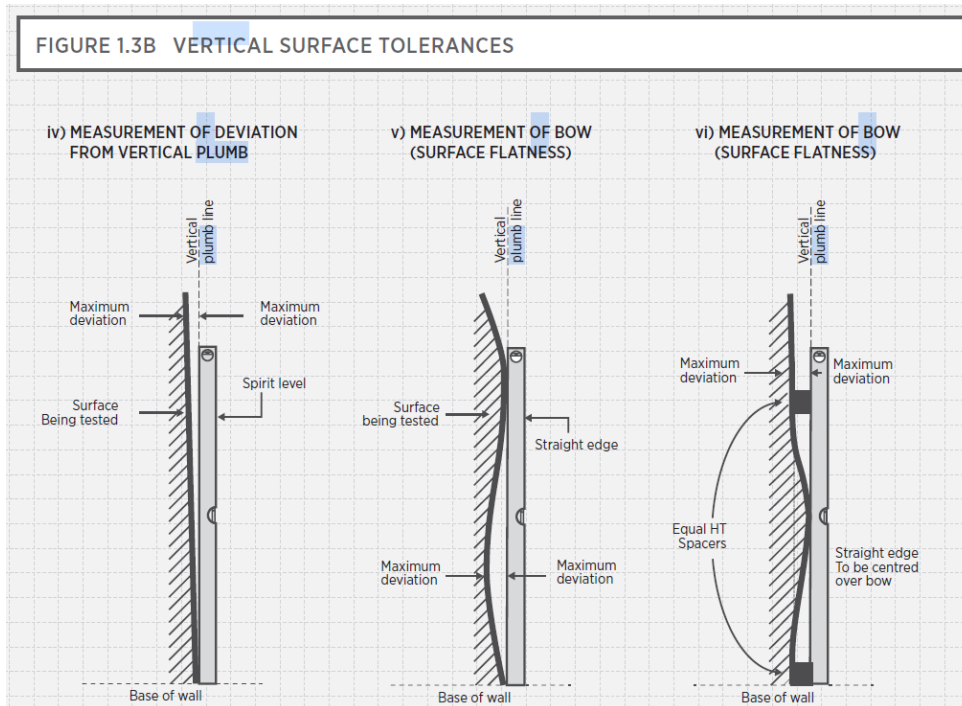
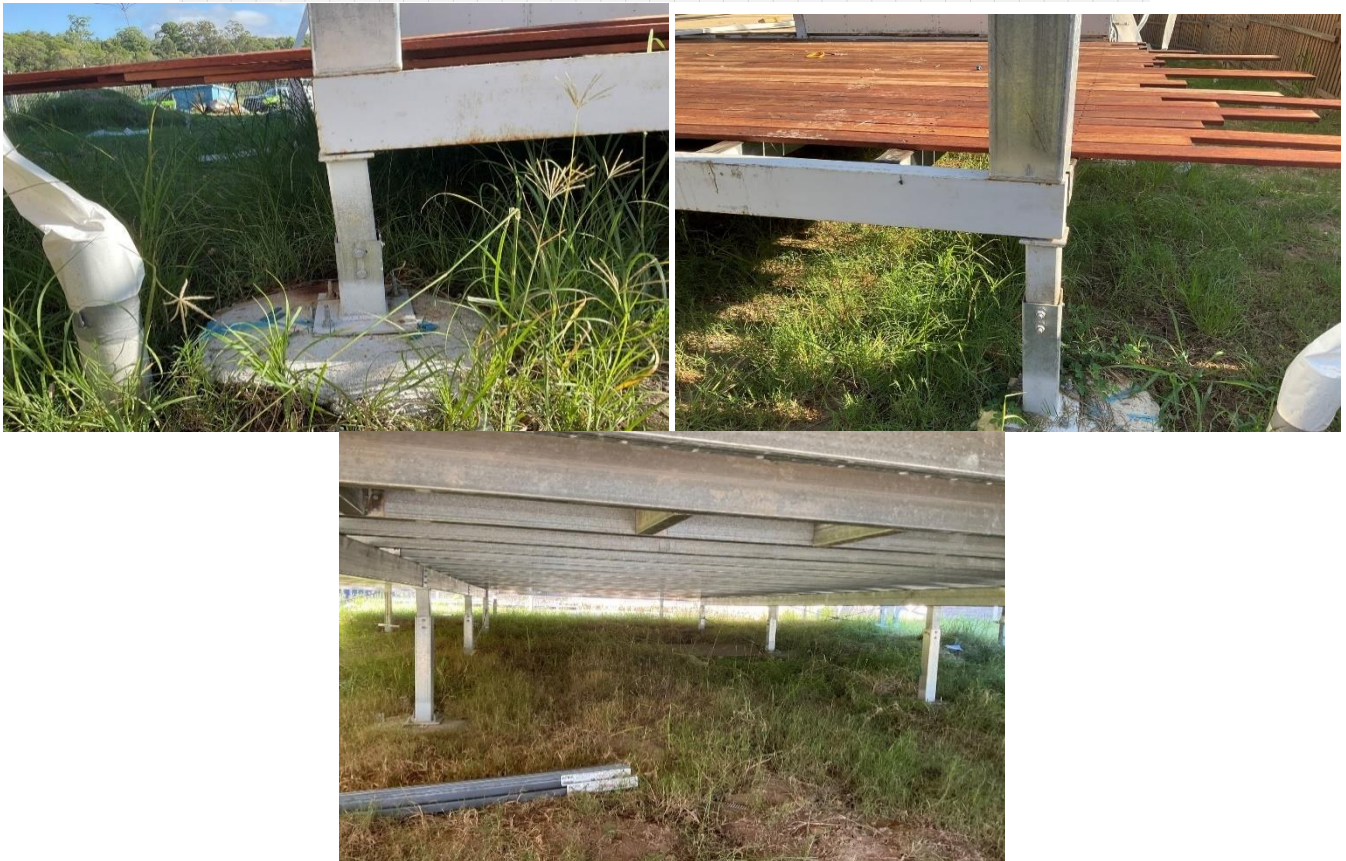
20. Subfloor post supports not plumb, this will need to be rectified.

Walls exceed the allowable allowance as marked; this will need to be reworked. We refer the builder to the insert below.

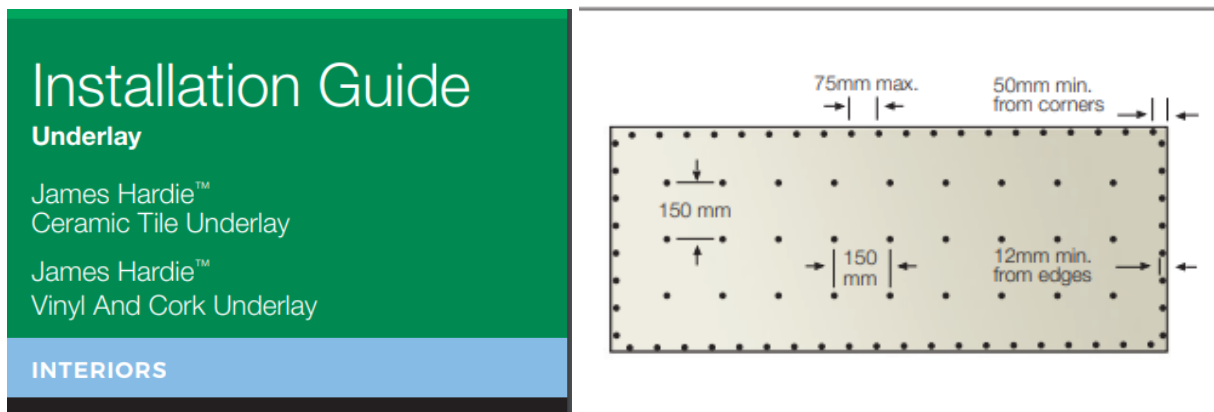
21. Tile underlay has not been fixed down, this will need to be rectified.

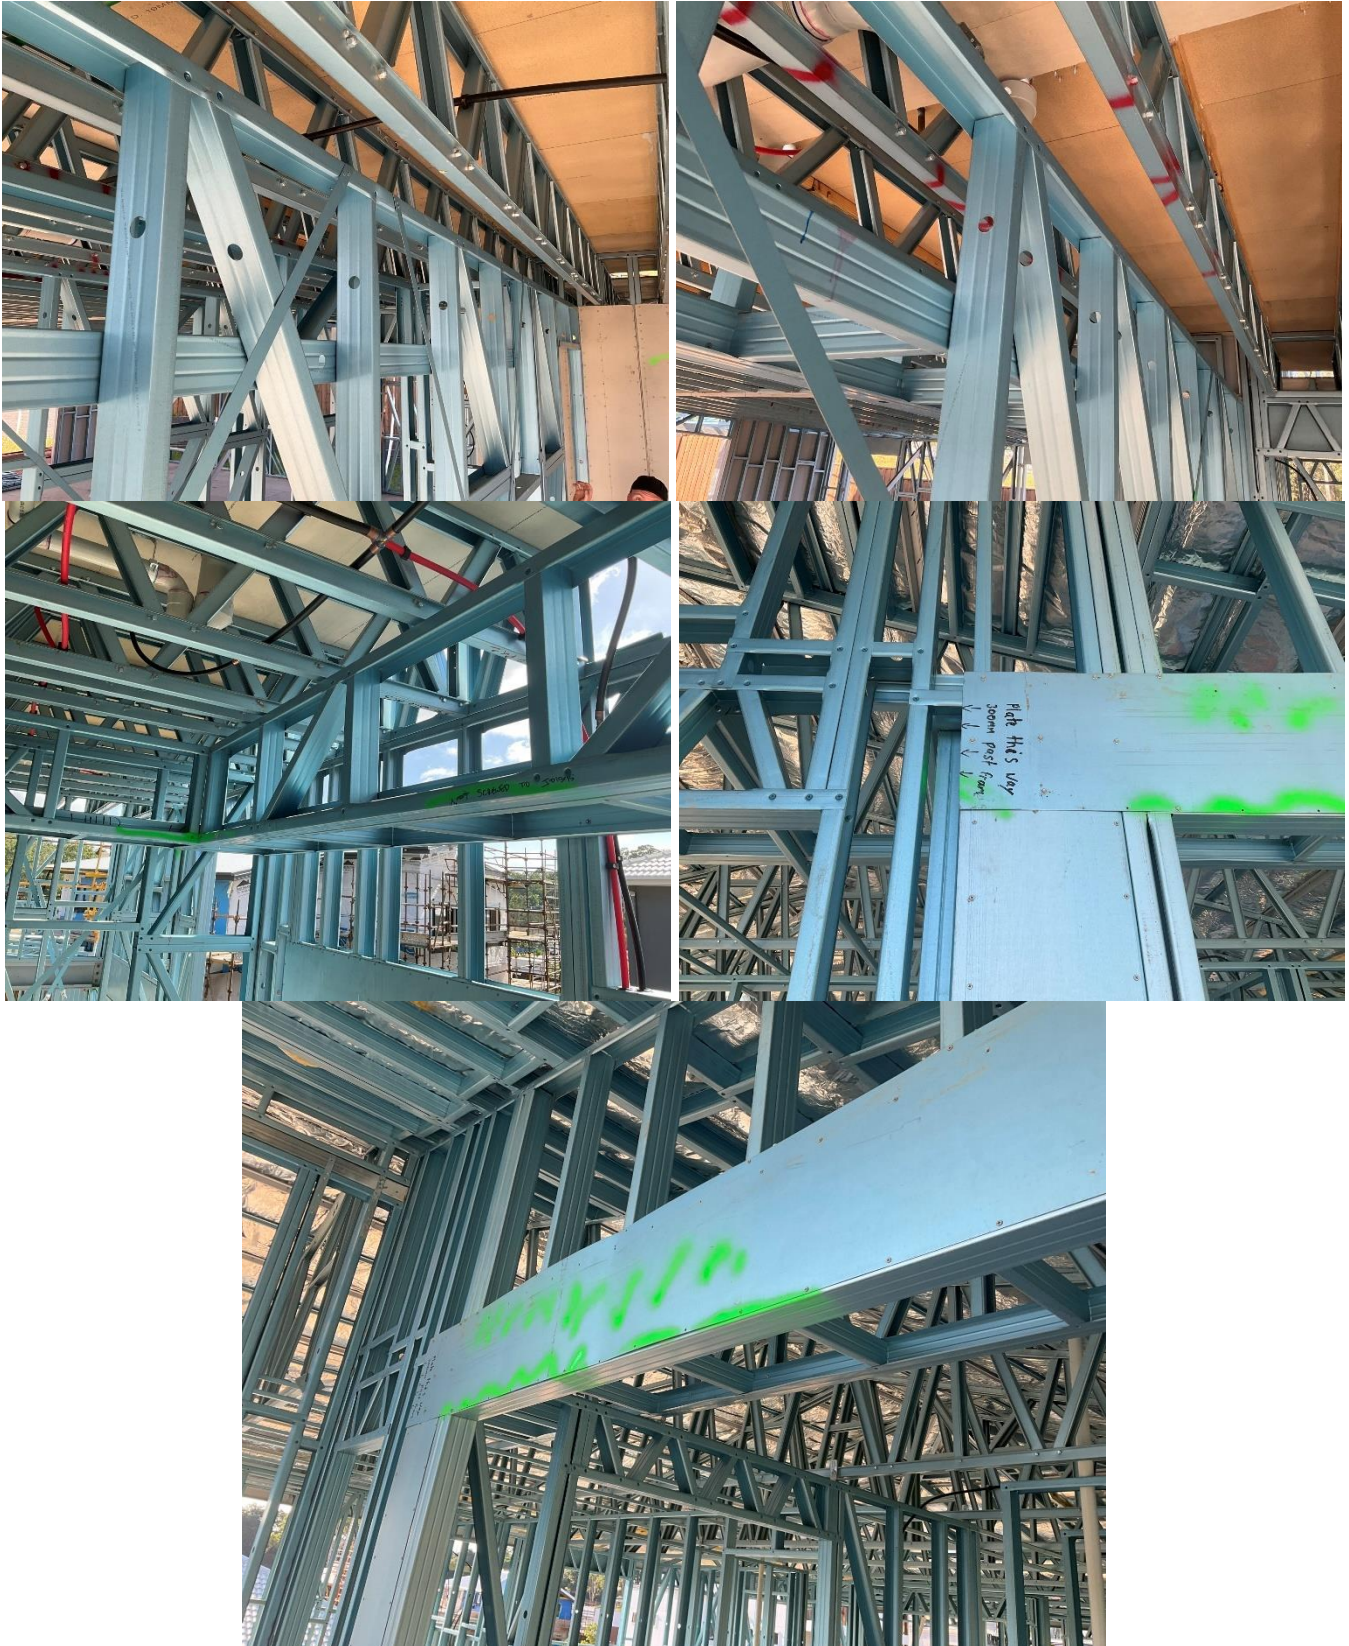
22. Non load bearing walls are missing wall brackets- This will need to be reworked.

As per the **3.3.3 NASH Standard; Mitek Manual**; Non load bearing walls must be kept a minimum of 15mm below the underside of the bottom chord of the roof truss, roof beams roof rafters, floor members or ceiling battens when used and fixed with vertically slotted wall brackets. Wall brackets also must be no more than 1800mm apart. This is a requirement also detailed in the 2014 Mitek roofing fixing and bracing guidelines. This will need to be reworked.

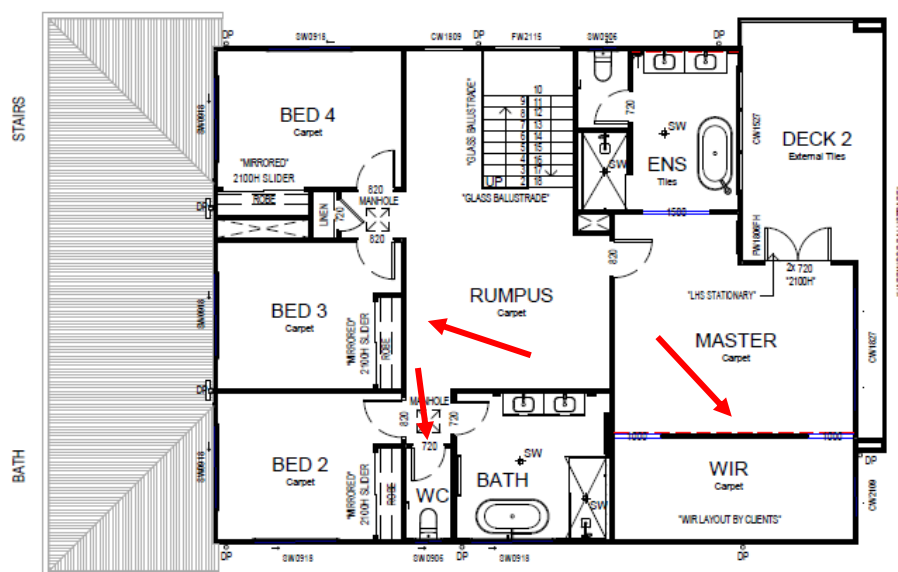
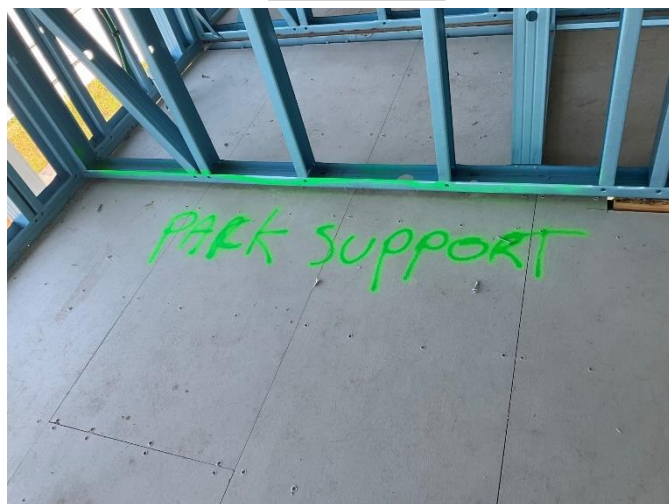
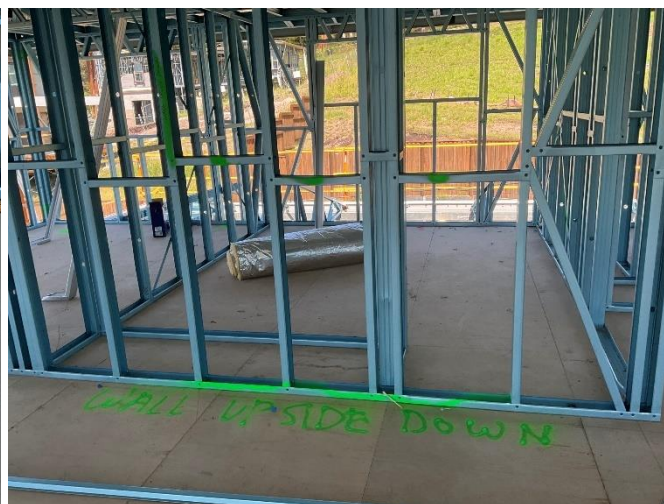
23. It appears that there are a few wall frame's in the incorrect location not as per plan.

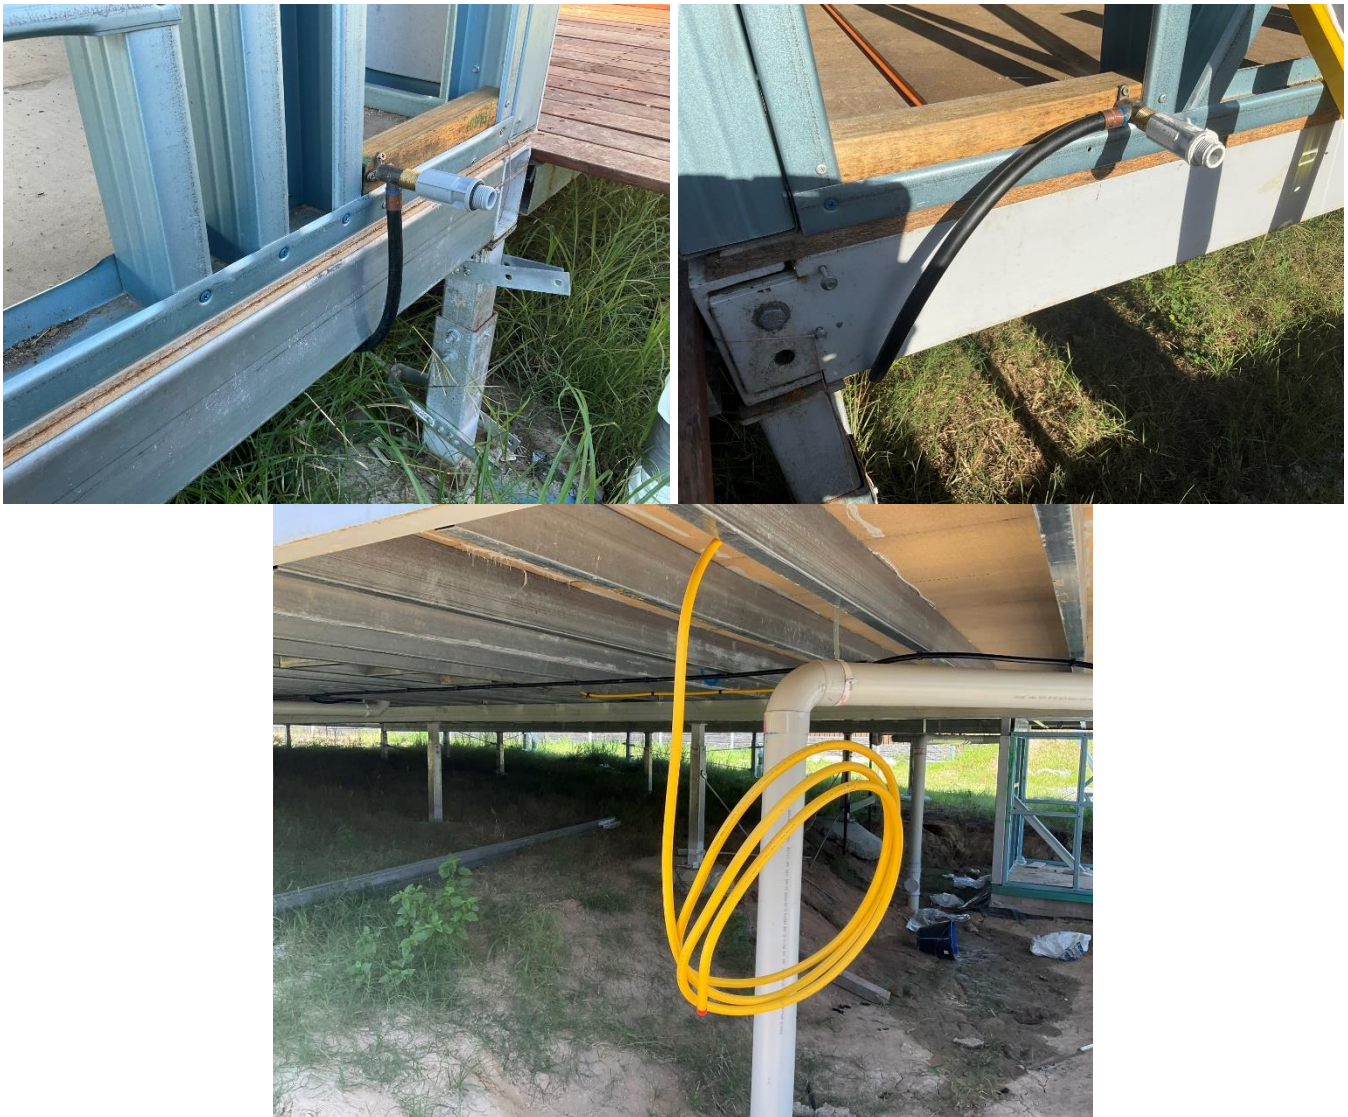
24. Pipes are to be metal not plastic the standard has not been achieved as per insert.

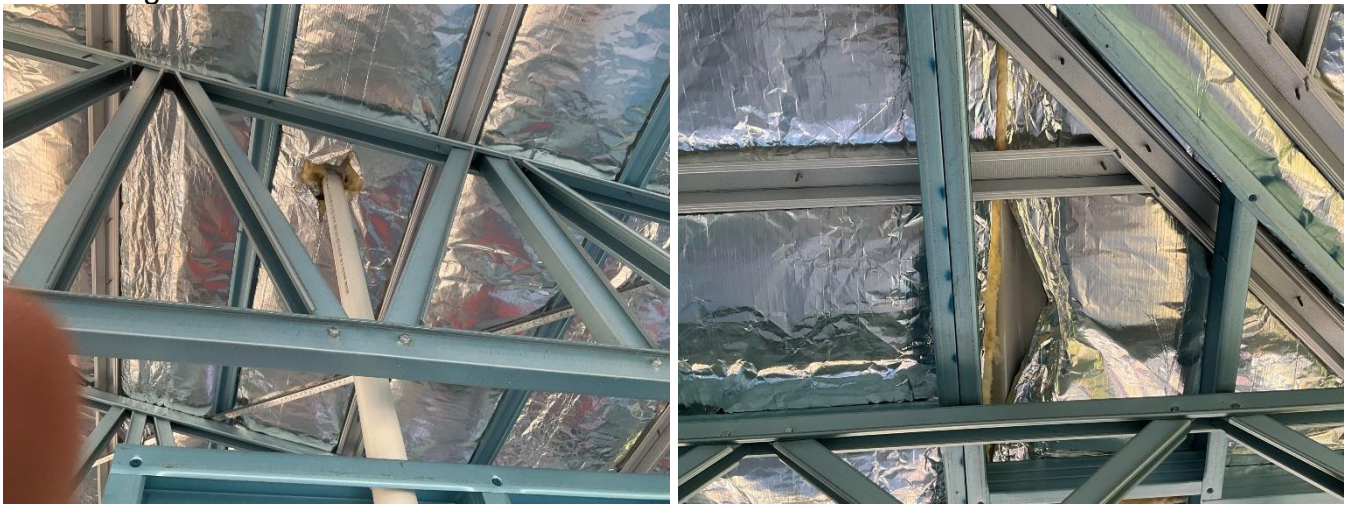
25. The anticon blanket in the roof void in has been installed in manner that doesn't comply with AS 3999 and AS 4200. The anticon blanket part missing and over cut around the penetration and the joints are coming apart, loose, not fix or tape into place, this needs to be rework as per insert.

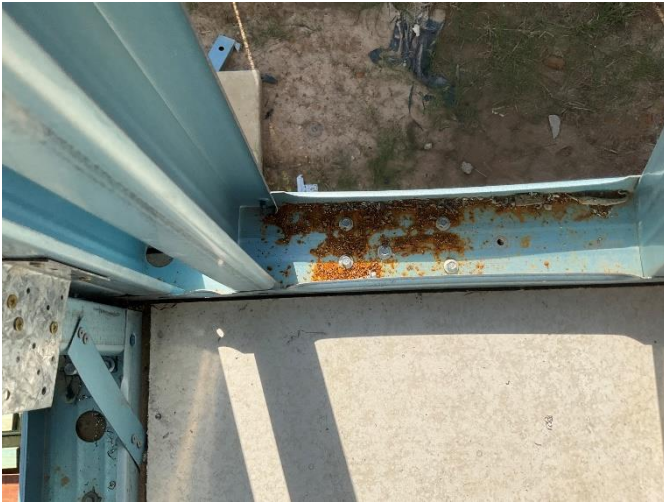
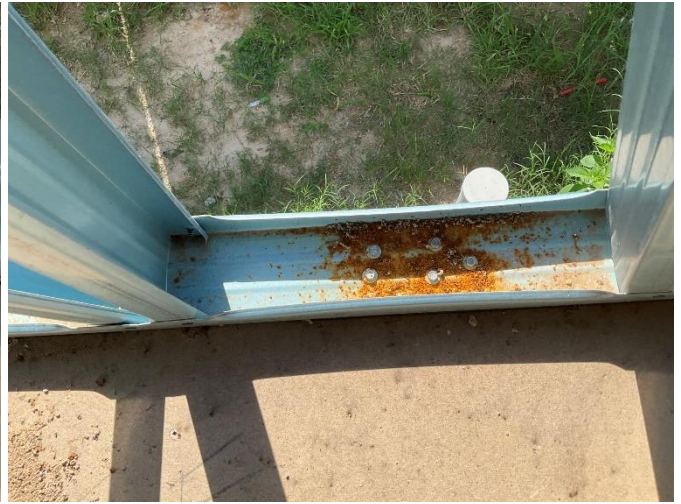
26. There are a number steel frames that have swarf metal filings the need to be clean as these areas have become rusty.
