Process REPORT (hereinafter called the "Report")

ALL INSPECT
All Building & Termite Inspections

Inspection Date: 19/01/2016

Property Address: 875 Sample Drive Sample 4300

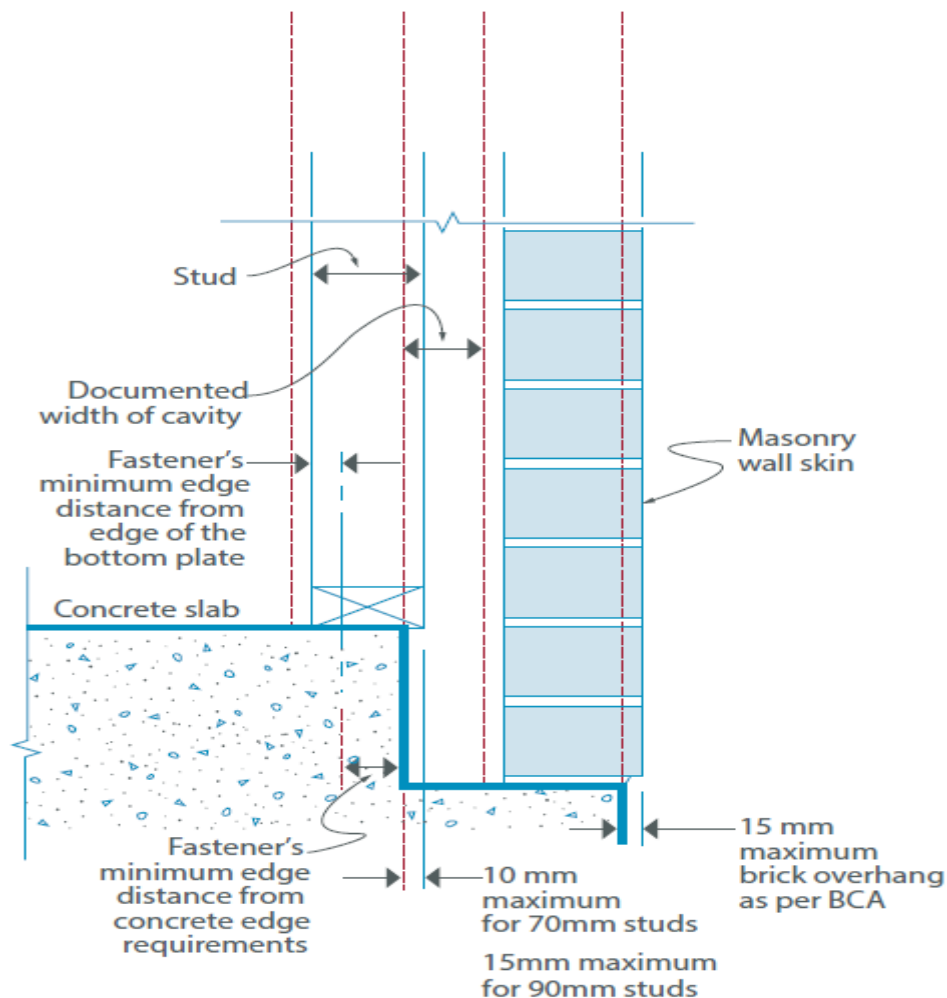
Refer Figure 4.11

The frame overhang is more than the allowance and needs to be supported in a manner that complies with As 1684.2, clause 6.3.3, and the BCA 15mm for a 90mm frame, and fixings have broken the edges the Standards & Tolerances allowance reference to the 4.11

4.11 Bottom plates that overhang concrete slabs Bottom plates that are at least 90 mm wide and overhang concrete slabs by in excess of 15 mm are defective and bottom plates that are 70 mm wide and overhang slabs by in excess of 10 mm are defective. In each instance, these permissible overhangs, are subject to the minimum edge distance for both the bottom plate and the concrete slab fixing locations being satisfied and minimum cavity widths as required by the Building Code of Australia also being maintained.

BOTTOM PLATES THAT OVERHANG CONCRETE SLABS

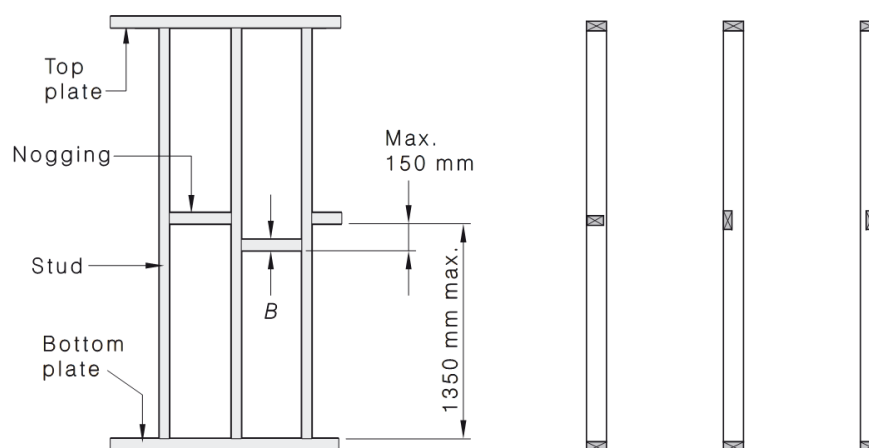
FIGURE 6.6 NOGGING

There are several noggings that need to be installed or in parts reinstalled.

Where required, wall studs shall have continuous rows of noggings, located on flat or on edge, at 1350 mm maximum centres (see Figure 6.6).

In other cases, noggings may be installed anywhere in the depth of the stud. Stagger in the row of noggings shall be not greater than 150 mm.

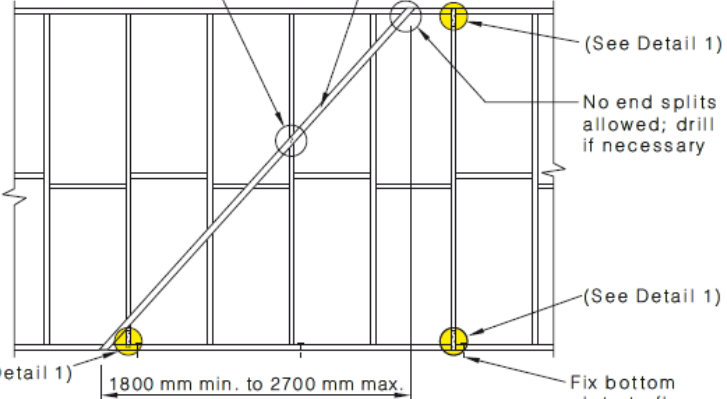
TABLE 8.18 (continued)

Results: The timber sheet bracing installation is a vital structural member in the overall build of the dwelling. It stops the house from moving when racking forces, such as wind, are applied to a dwelling. The installation of the timber sheet bracing on this house is defective for several reasons. The nails have been over installed or punched through a number of boards.

The outer sheet edge must be secured at a maximum of 150 centres. This dwellings installation fails that requirement. The central studs must all be nailed off at 300 mm centres maximum.

In simple terms, bracing stops the dwelling from falling over when forces such as wind are applied to the dwelling. The KN resistance capacity of the dwellings bracing resist these racking forces and stop any adverse effects that may cause damage or injury.
