This is a visual only Building Inspection & Report carried out in accordance with AS4349.0

Handover REPORT (hereinafter called the "Report")

Inspection Date: 10/11/2015

Property Address: 41 sample Circuit Sample QLD 4164

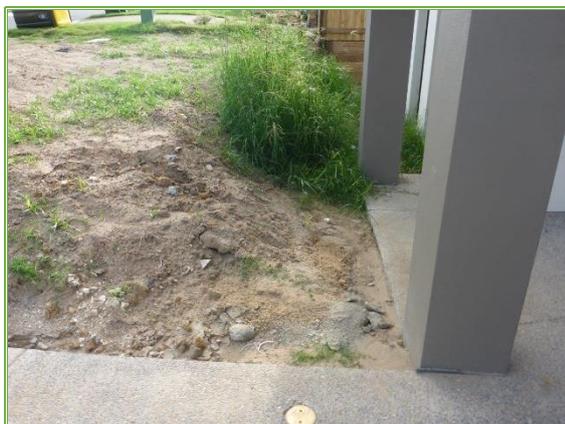
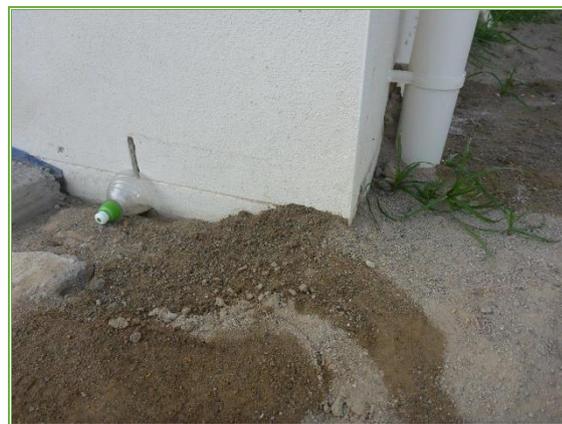
What it is: Ground levels inadequate.

Results: Ground levels are inadequate and can cause water to lay against the footings.

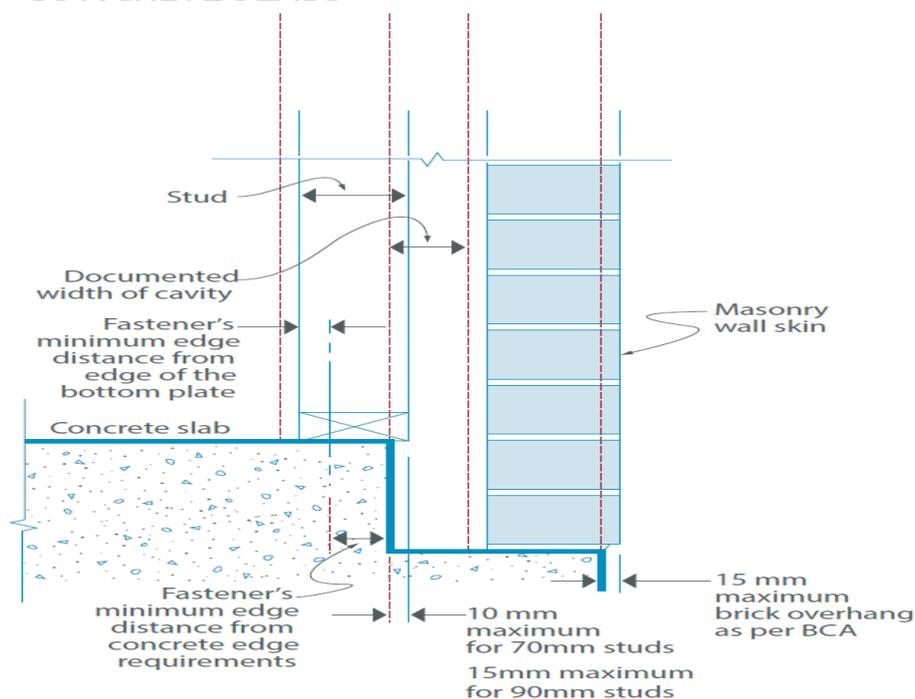
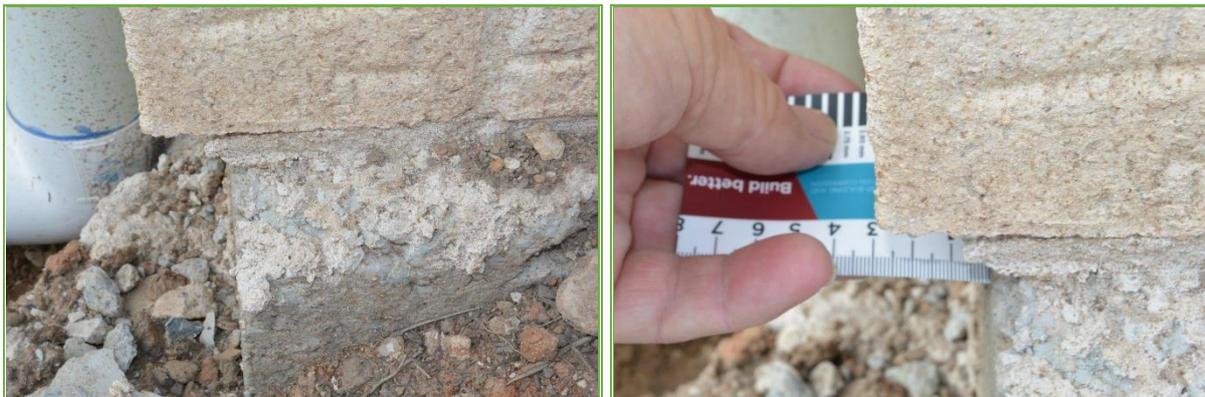
Where it is: External

What it is: Brick over-hang.

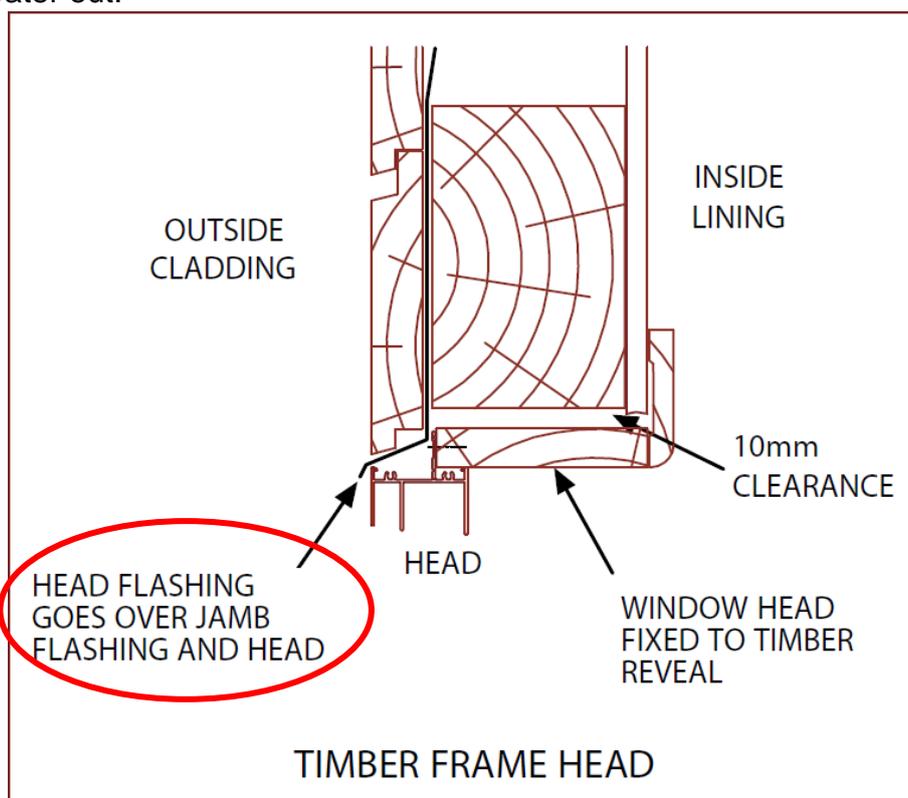
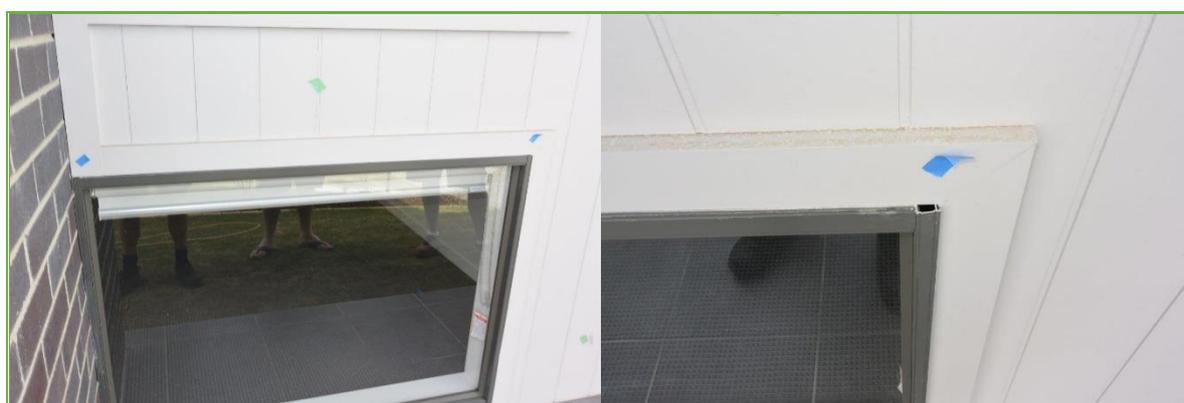
Results It was noted that windows don't have header flashing installed for weatherproofing. All needs to be reworked before handover and Deemed-to-Satisfy Provisions are an optional means of achieving compliance with the mandatory Performance Requirements of BCA/NCC. The Australian Window Association (AWA)

Provided to stop water wetting the inner skin by bridging across the window or door head.

Provided above any wall penetrations not specifically designed to stop water reaching the inner skin, ie; exhaust fans and ventilation ducts. Must project horizontally a minimum of 150mm both sides past the opening. Must be of approved materials to AS2904. Must be provided with weep holes to let the water out.

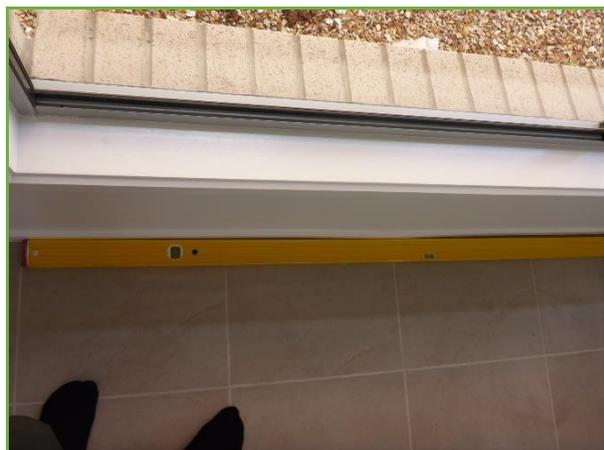
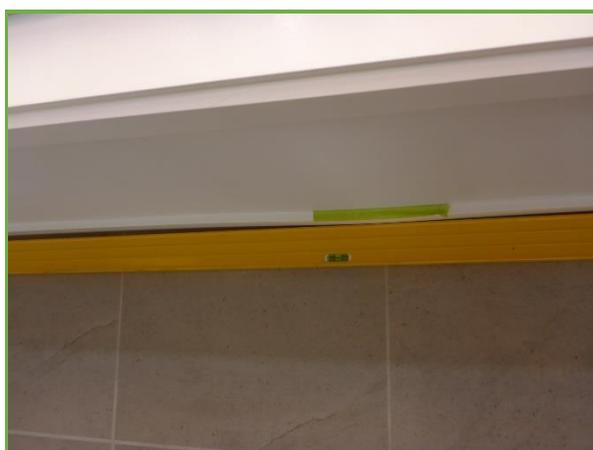
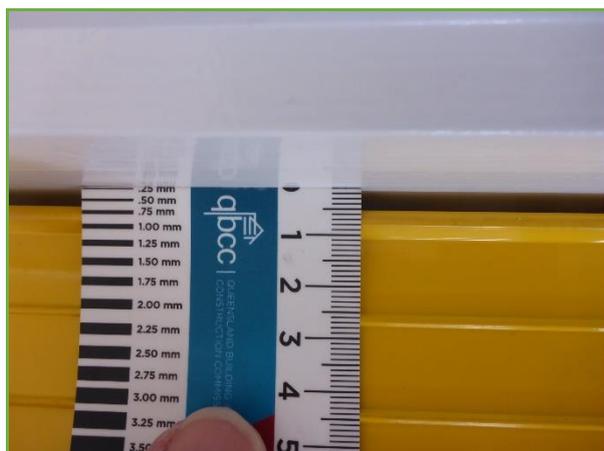
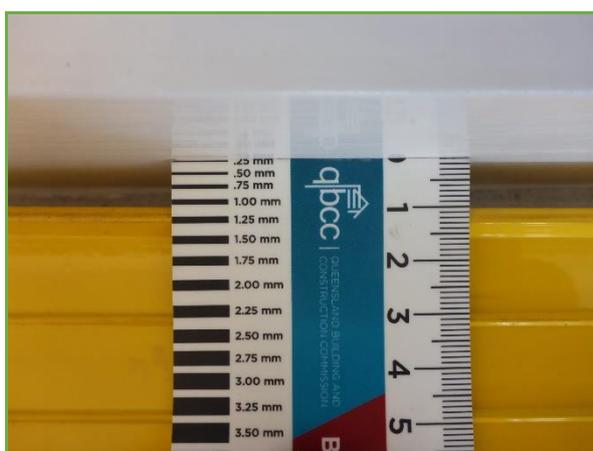
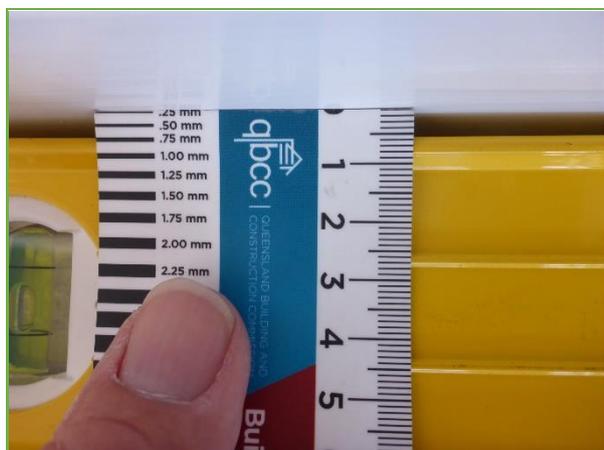
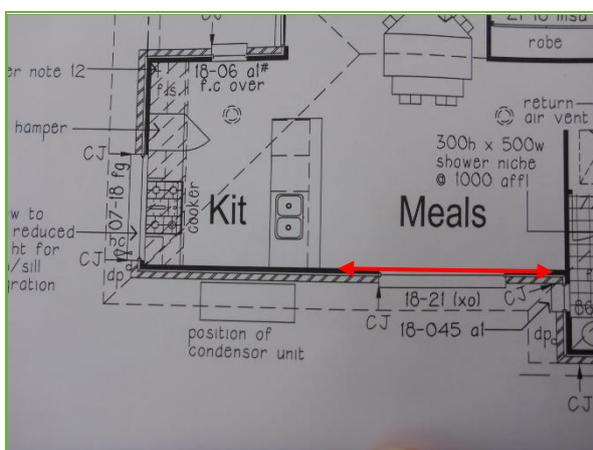
Where it is: Bathrooms

What it is: Shower nook not draining away and the waste is too high water will not drain away, and lippage more than the allowable rate.

Results: It was noted at the time of inspection after testing the shower, the nook and base appears to be holding water and there are tiles that are level and have some back fall to the wall and waste is too high, this is preventing the water from draining to the floor waste, this will need to be reworked to the minimum standard set out as per, I refer the Builder to, 103 AS 3958.1-2007 Appendix D FALLS IN FLOOR FINISHES D1 General.

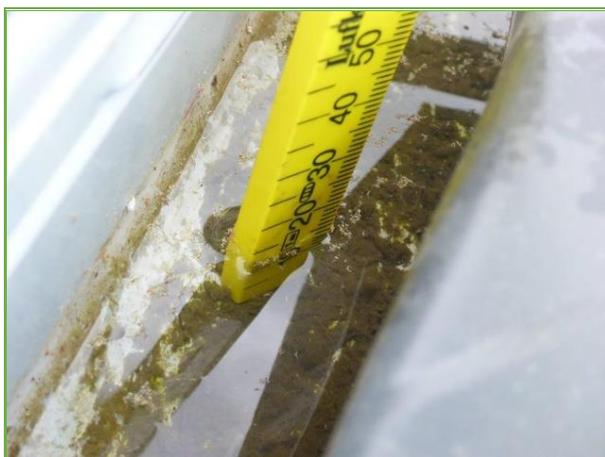
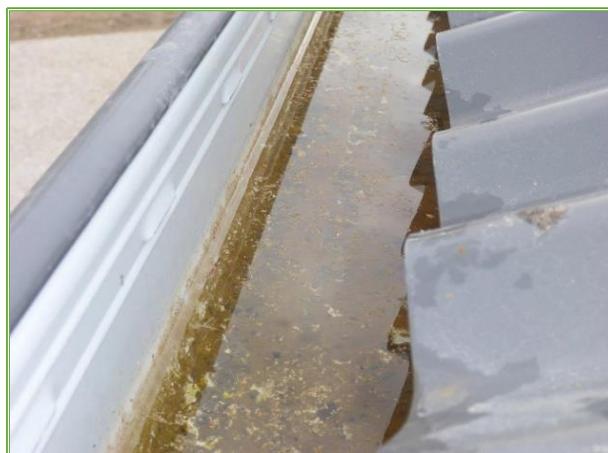
Results: The Colourbond gutter to the dwelling is defective and is holding water which needs to be reworked. The gutter is bowed to the side of the dwelling; this will need to be replaced as the manufacture did not make the guttering bow out of shape.

(b) Eaves gutters must be supported by brackets securely fixed at stop ends and at not more than 1.2 m centres.

All must be made as new prior to handover and fit for purpose.

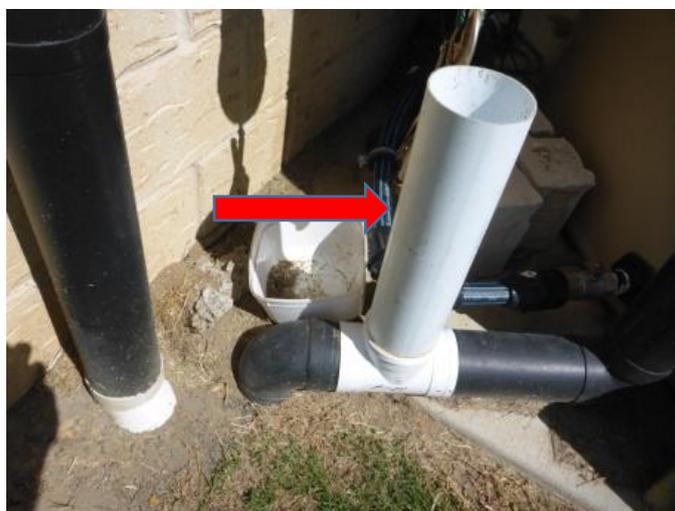
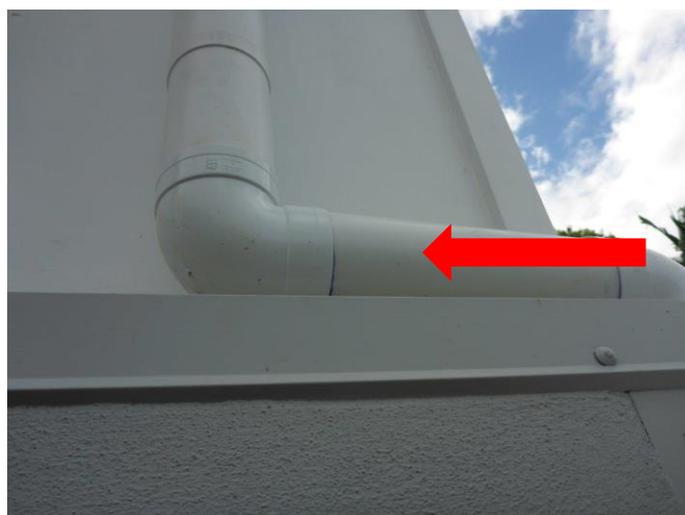
In section 2.3 and section 2.4.4 of this Australian Standard it clearly states that materials and products used in a plumbing and sanitary installation shall be selected to ensure satisfactory service for the life of the installation.

Note the requirements in section (c). Note section (a) in 2.4.4 The white PVC storm water pipes that are exposed to direct sunlight is not UV rated and MUST be protected from direct sunlight. The pipes must be painted in a UV rated paint in a colour that matches the downpipe. Polyvinyl chloride (PVC) pipes and fittings as specified in AS 1254, AS/NZS 1260, AS 1273, AS/NZS 1477 and AS/NZS 2179.2 (Int) shall where exposed to direct sunlight, have resistance to UV radiation or alternatively be protected in accordance with AS 2032. This Australian Standard is called for in the BCA and the NCC and is adopted.

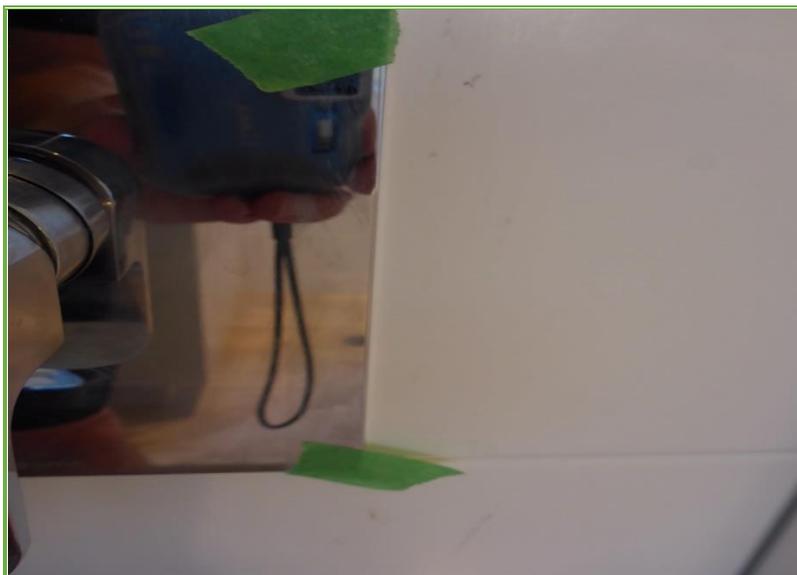
3 Main bathroom scratched tile.
