This is a visual only Building Inspection & Report **Defect REPORT** (hereinafter called the "Report")

Report Number 12663B

Inspection Date: 24/09/2018

Property Address: Sample street

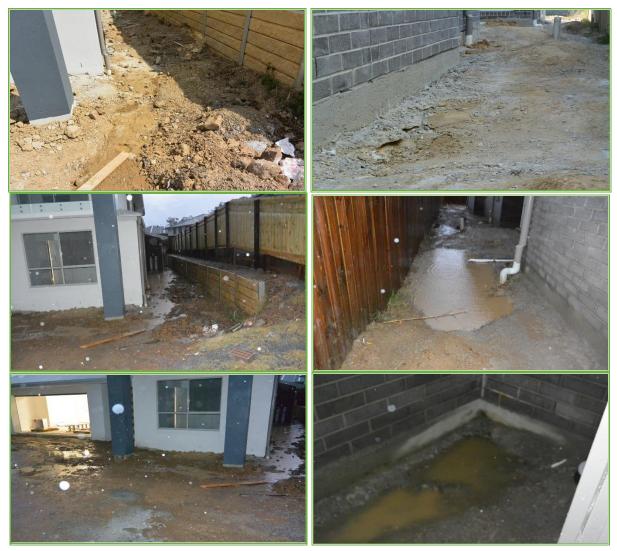
What it is: Ground levels, surface water drainage inadequate can cause water to lay against the footings. This will need rework before this reaches practical completion as it is clearly ponding to the footings. As per the engineering.

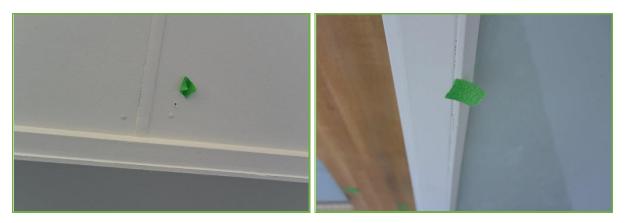
Beading is starved of paint this will all need to be repainted before practical completion.
