Frame (Defect Inspection) REPORT (hereinafter called the "Report")

Report Number 00024 Time:11:30 AM

Inspection Date: 17/03/2022

Property Address: LOT sample

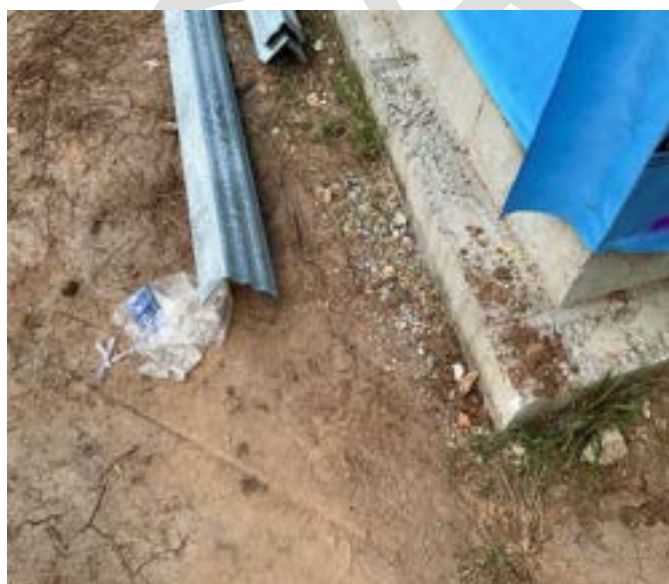
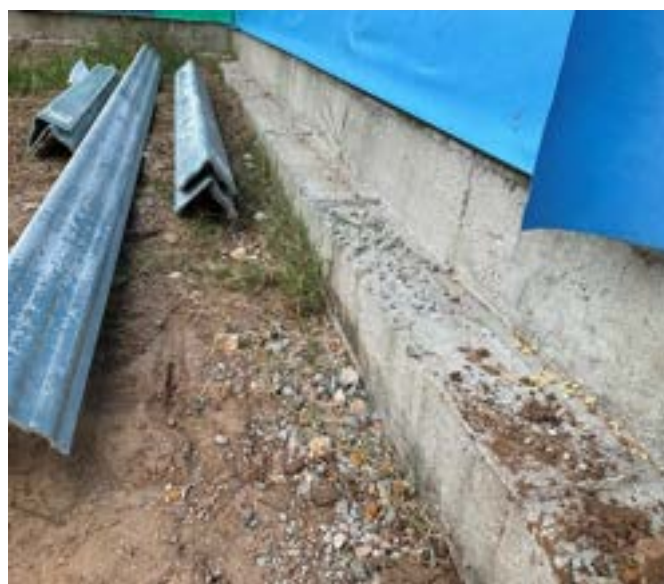
4. There are large areas of open concrete voids to the slab edge bonny slab edge. These areas are now showing the exposed reinforcement bars and that the slab has not been mechanic all compacted in areas as per the requirements of AS 2870. This must be reworked.

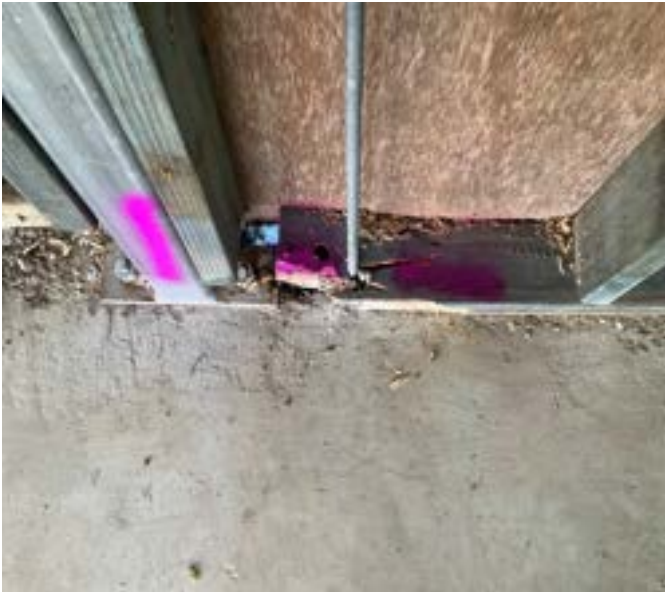
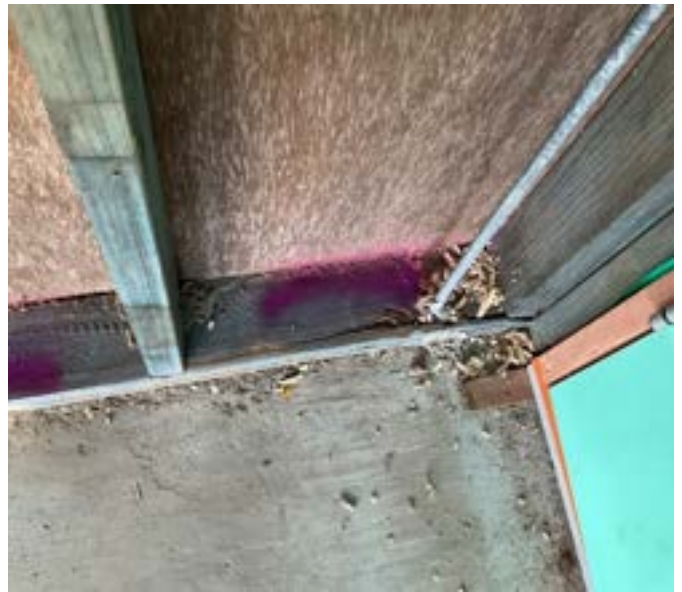
9. Bottom plate not nailed. This will need to be reworked.

The nailing of the bottom plates to the concrete slab requires the use of 75 mm masonry nails. bottom plates in the home at the correct maximum 1200mm spacing using 75mm masonry nails as per the AS1684 table 9.4 requirements.

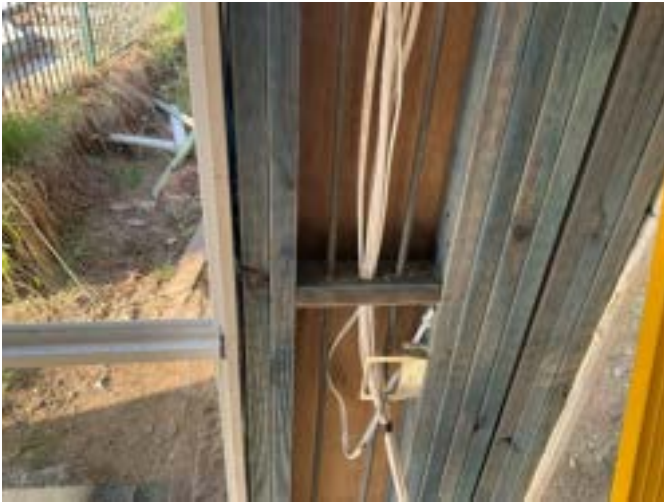
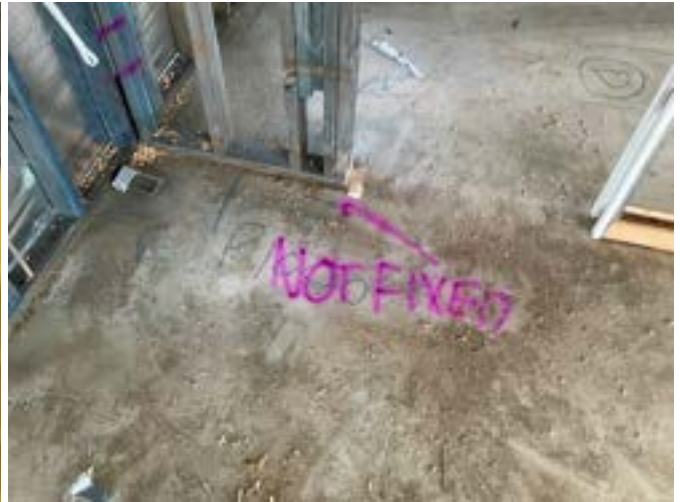
10. Poor substandard timber/materials used is bowed this will need rework, not in an appropriate, skilful way or with reasonable care and skill.

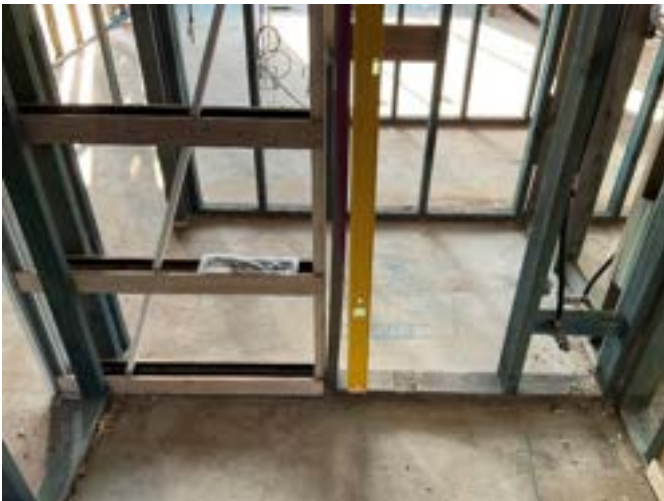
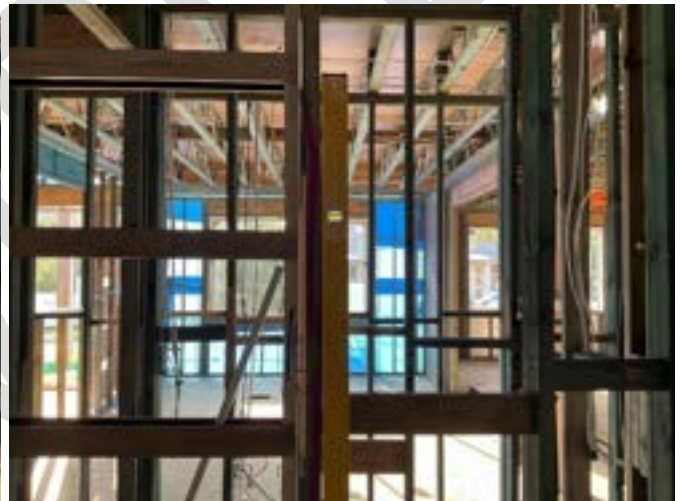
11. The load bearing studs are not supported, this will need rework, not in an appropriate, skilful way or with reasonable care and skill.

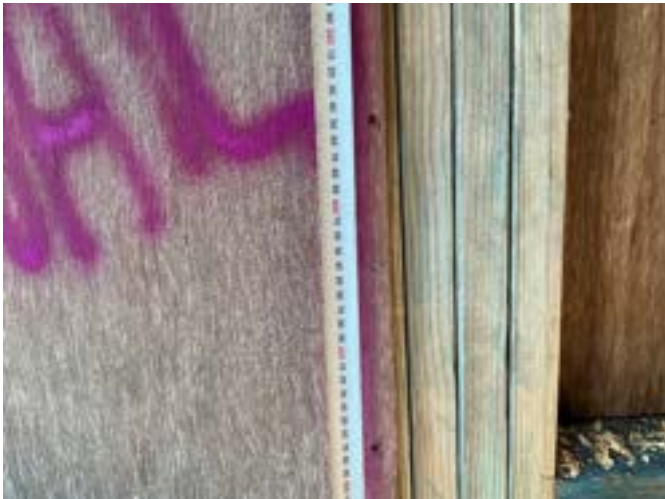
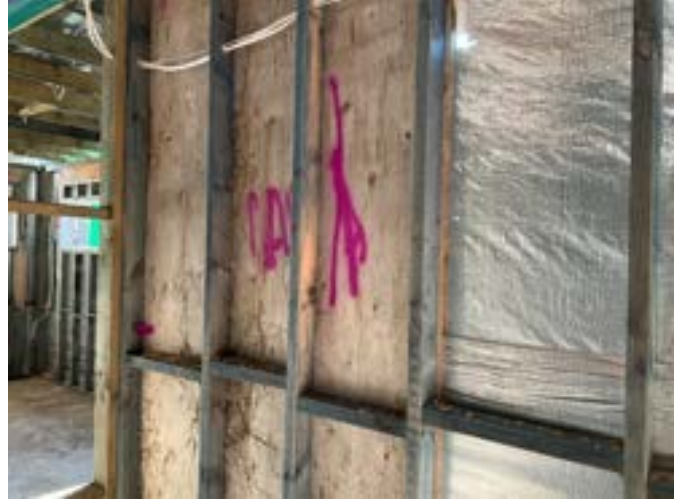
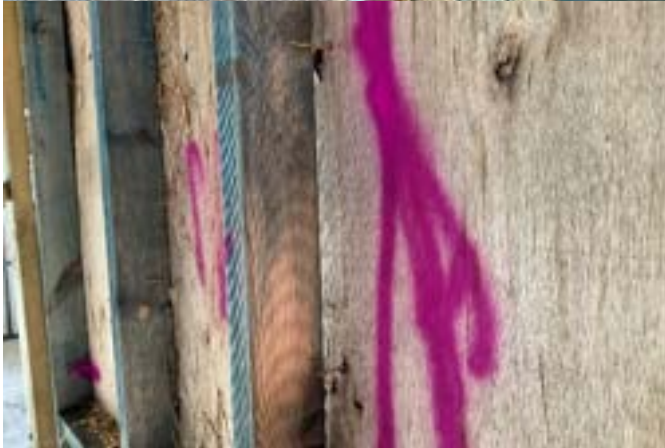
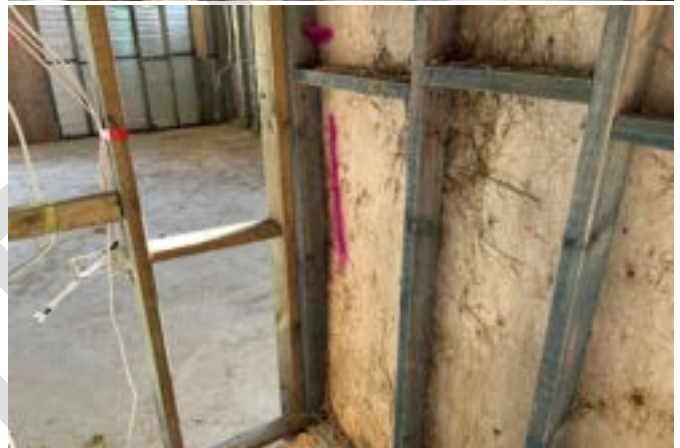
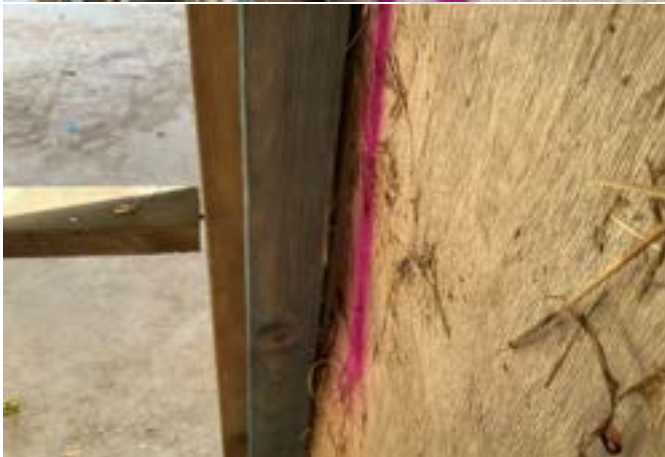
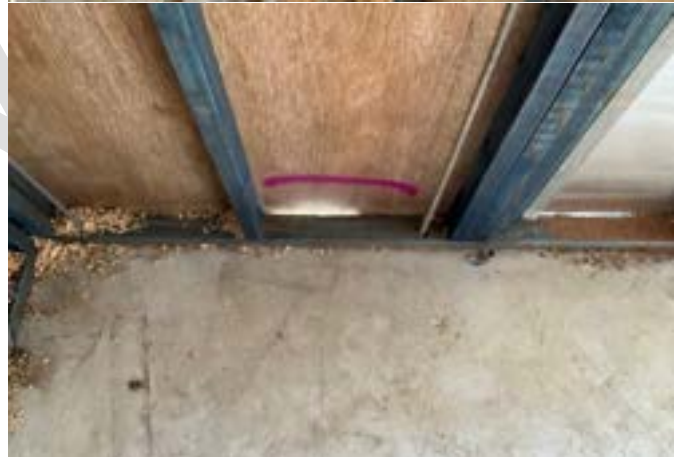
13. There are a number of sheets bracing, not as per plan and sheets have missing nails and loose bracing sheets therefore decreasing the function of the bracing and don't look new. This must be reworked.

The timber sheet bracing installation is a vital structural member in the overall build of the dwelling. It stops the house from moving when racking forces, such as wind, are applied to a dwelling. The installation of the timber sheet bracing on this house is defective for several reasons. The outer sheet edge must be secured at a maximum of top & bottom 50mm edges 150 centres. This dwellings installation fails that requirement. The central studs must all be nailed off at 300 mm centres maximum. We refer the builder to AS 1684.2, table 8.18 on page 143. The requirements stated above are clearly defined and must be rectified prior to moving forward with the dwelling.

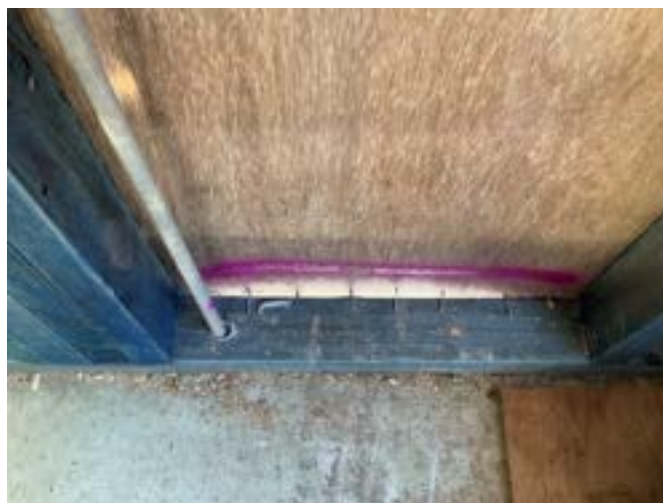
14. There are some bowed bracing sheets, this will need rework, not in an appropriate, skilful way or with reasonable care and skill.

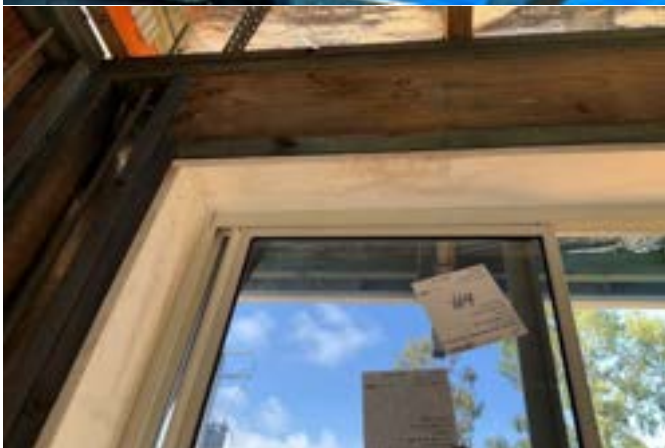
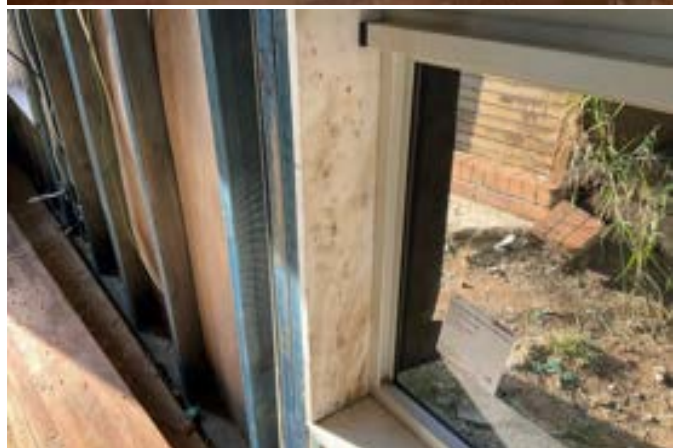
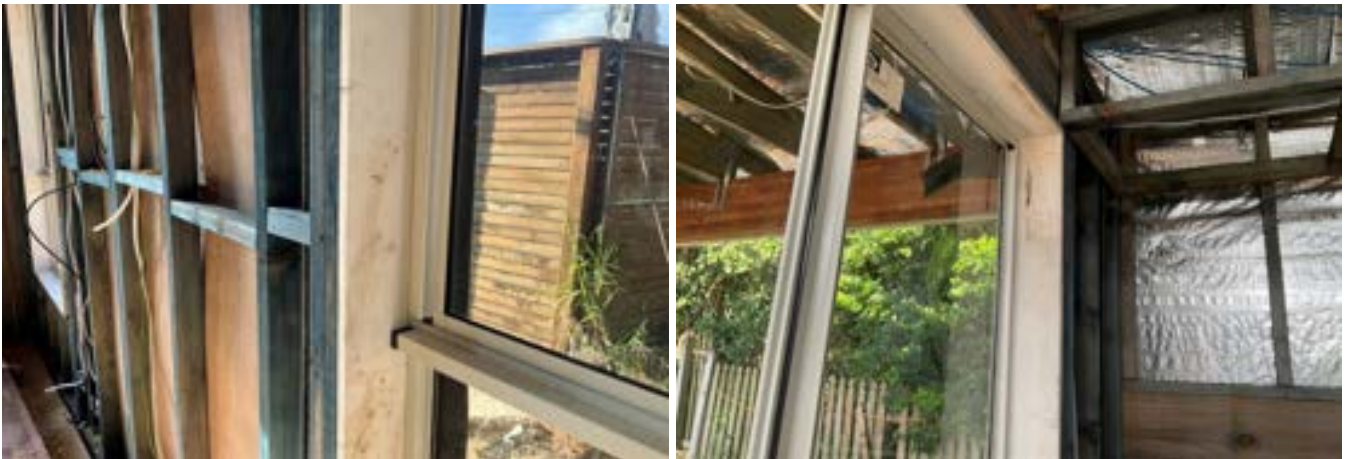
24. Windows/door openings, reveals are bowed, there should be suitable packing material to support the load of the window/glazer, and packing shouldn't deform the window in anyway.

We refer the builder to AS2047. Will need to be reworked.

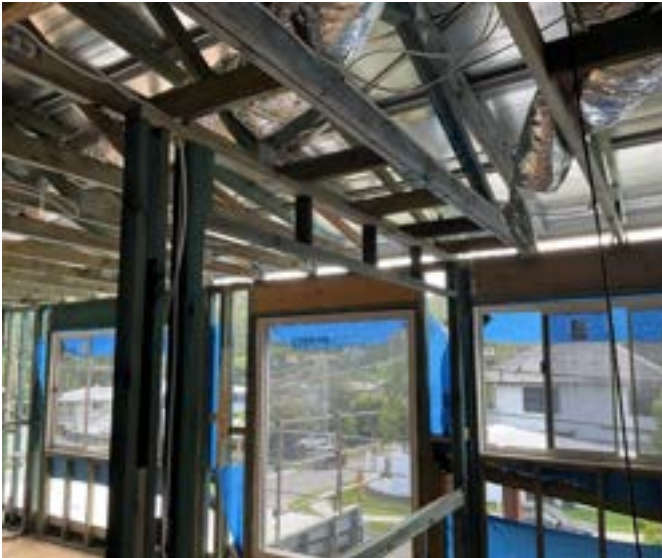
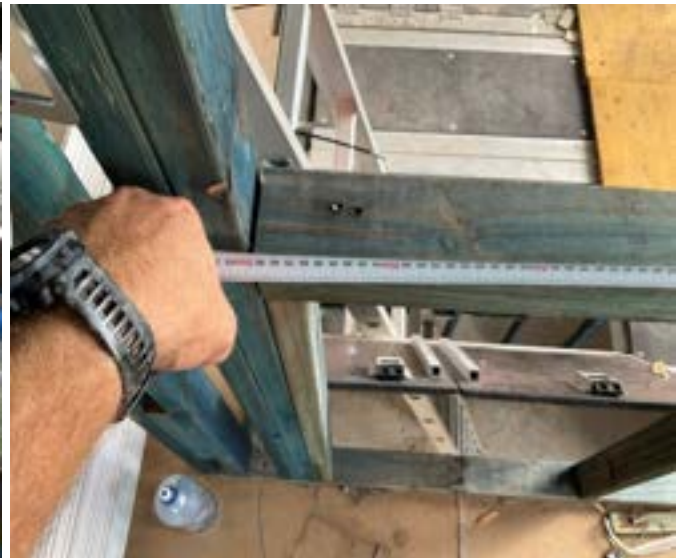
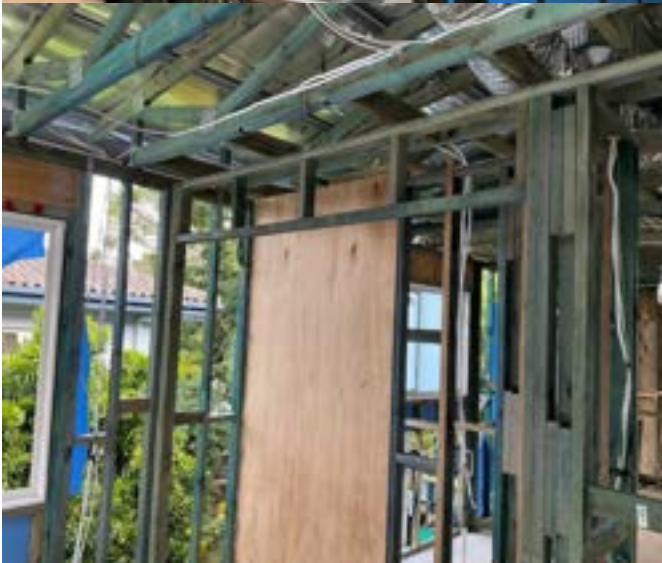
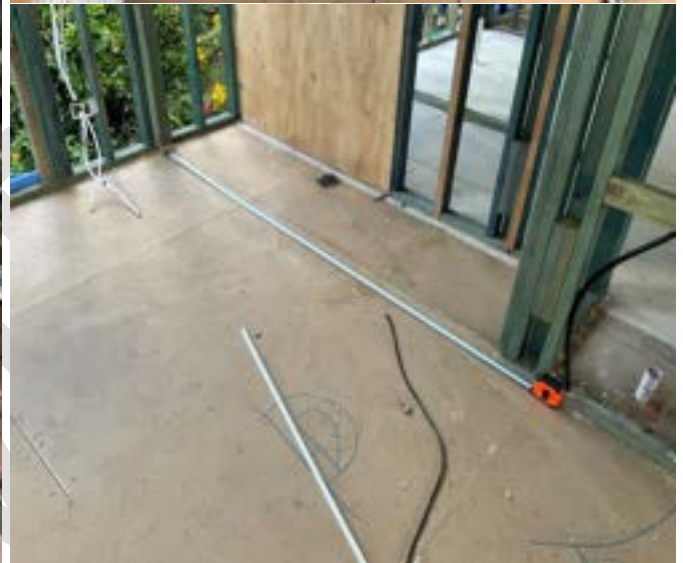
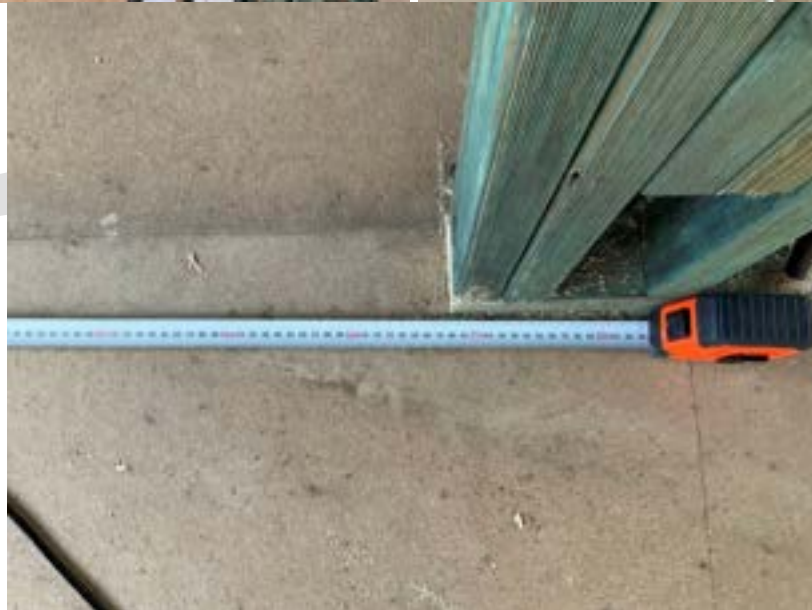
26. It appears that no strapping/ tie down for the top plate to lintel as been installed. As it states in table **9.20 Uplift capacity of beam/lintel tie down connections**, that top plate shall be fixed to lintel within 100mm of each rafter/truss or fixed to the lintel with a fixing of equivalent tie-down strength.

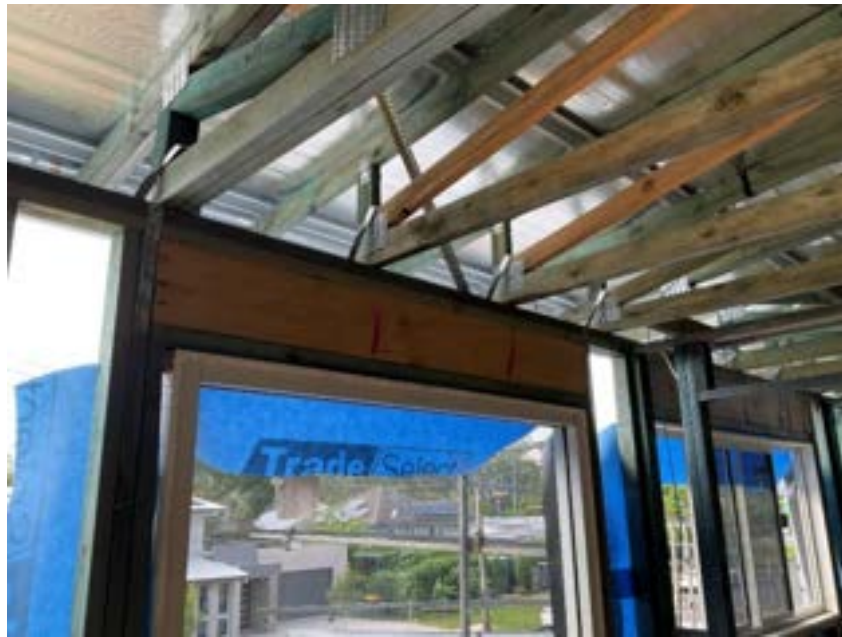
27. Some 'L' brackets have not been installed at the maximum 1800mm spacing. Some have not been nailed off throughout the non-load-bearing top plates.

AS 1684 framing requirements state these brackets must be installed no less than 1800 mm apart. This requirement is also detailed in the 2014 Mitek roofing fixing and bracing guidelines. We have attached the installation guidelines from the 2014 MiTek manual.

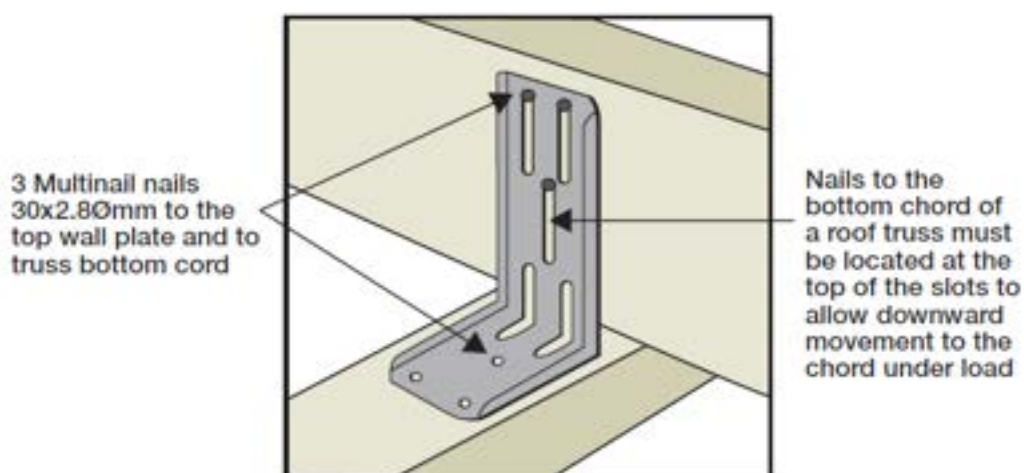
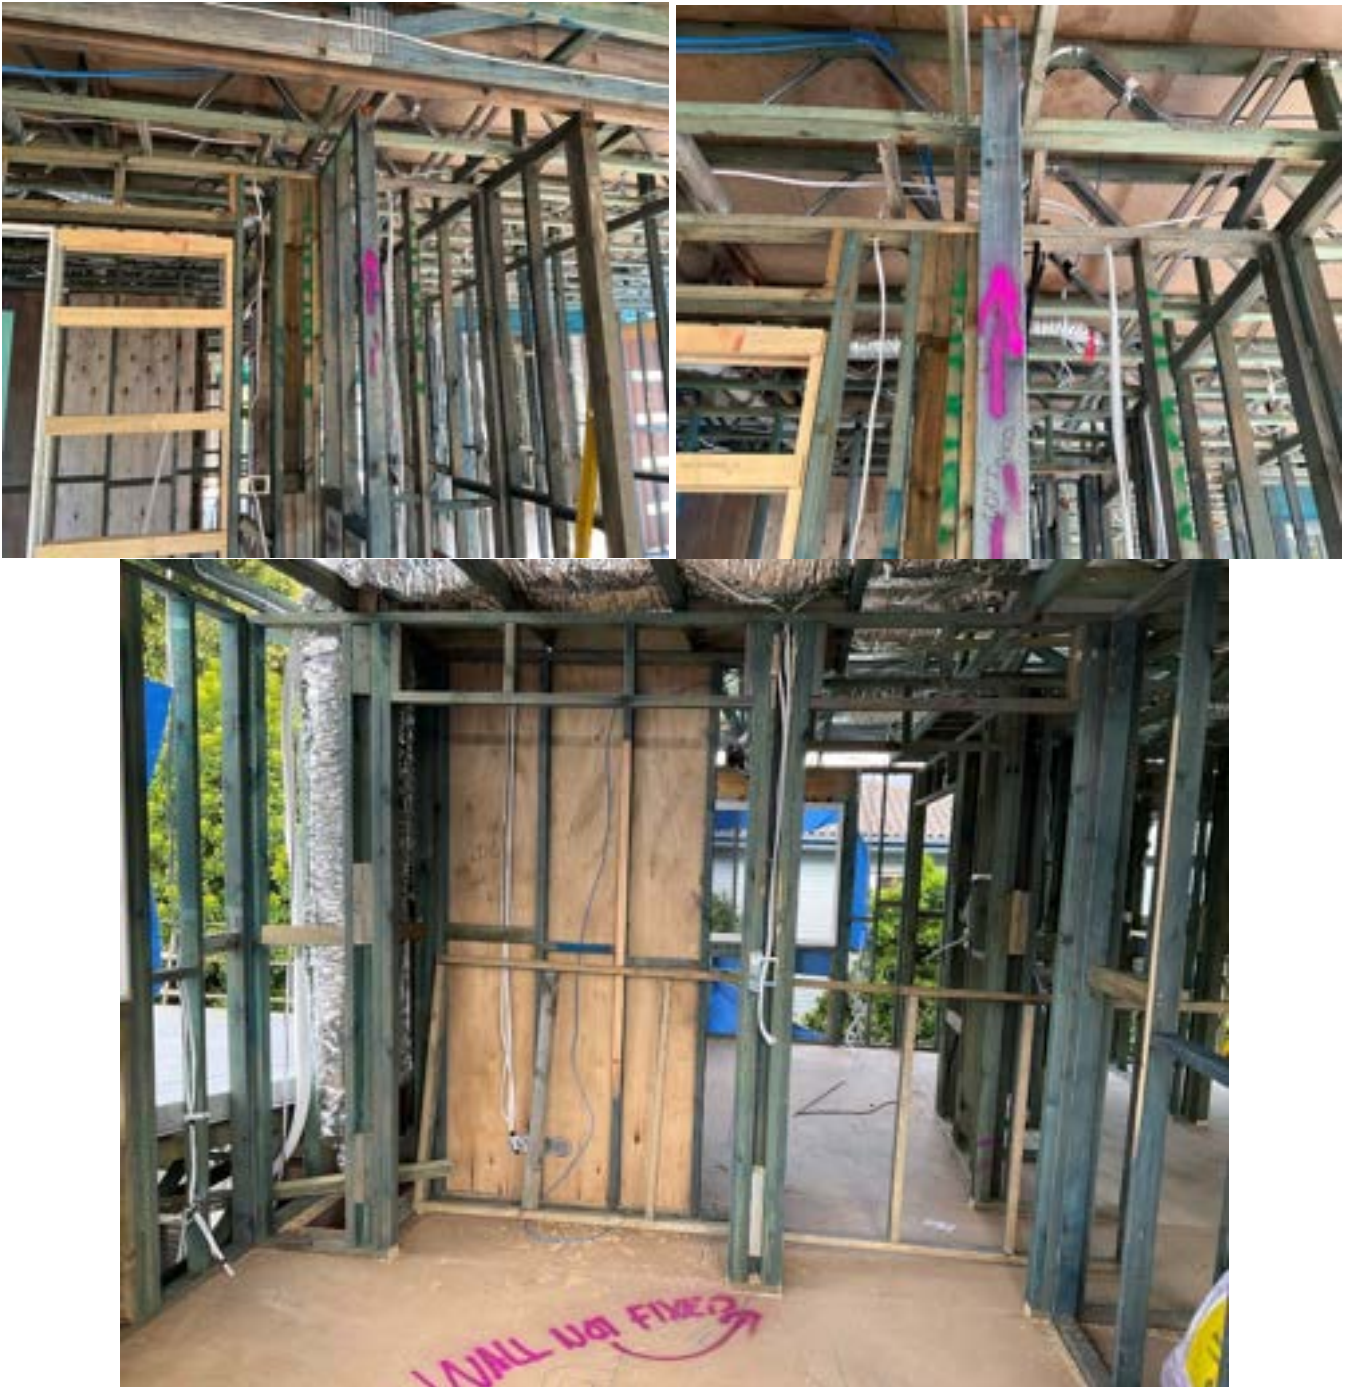
28. It appears that some of the L-brackets have been over driven, this doesn't not comply, see insert below for further information.

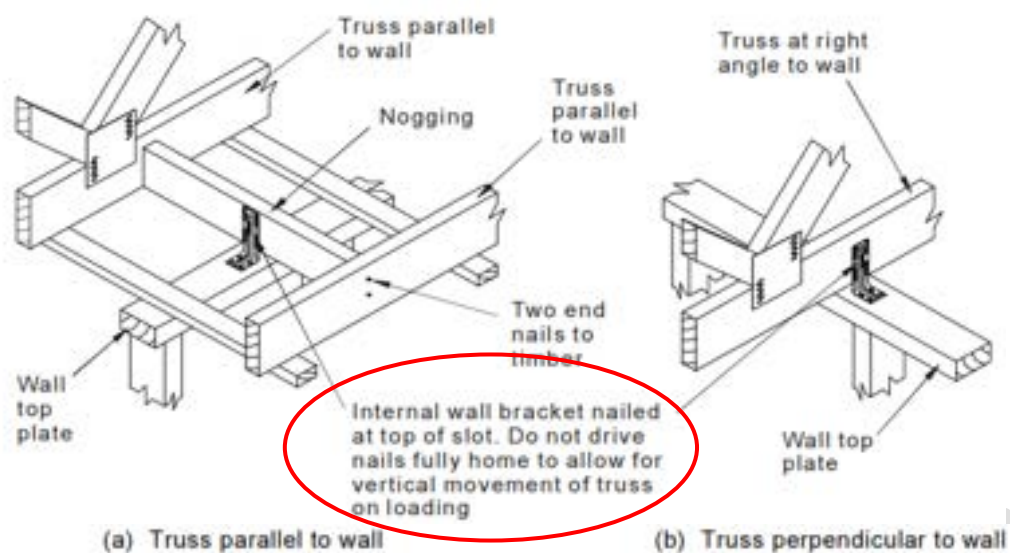
FIGURE 2.3 FIXING OF TRUSSES TO FREESTANDING NON-LOADBEARING WALL THAT IS NOT A BRACING WALL

- (c) *Non-bracing wall* For an internal non-loadbearing wall not designated as a bracing unit, stability of the wall shall be required to resist normal applied force, e.g., when closing doors. The top plate of the wall shall be stabilized at maximum 1800 mm centres. Where trusses are parallel to the wall, nogging shall be used in between the bottom chords and fixed to the bracket. Figure 2.3 gives an example of fixing details.

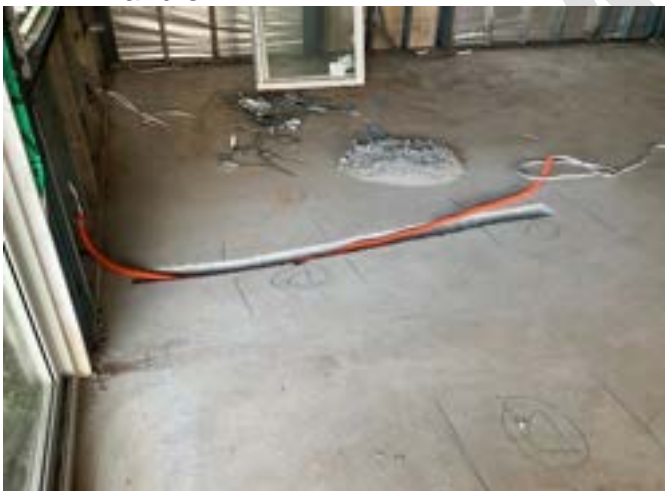
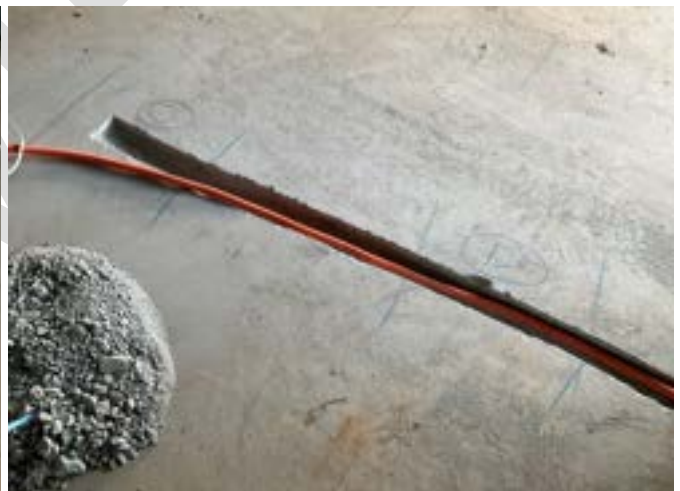
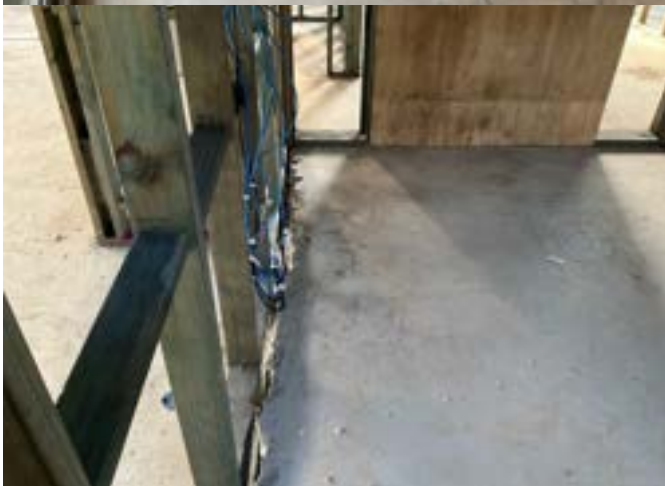
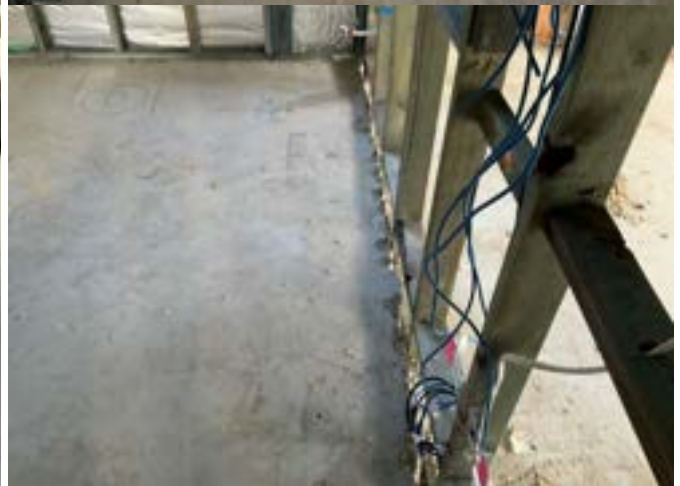
35. The concrete slab has been jack hammered substandard finish, steel Rio set back may be compromised, send a competent person like the engineer to the site for approval **form 12 for the rectifications**. As per part 9, Division 2, section 74 of the BR 2021: This will need rework, not in an appropriate, skilful way or with reasonable care and skill.
