This is a visual only Building Inspection & Report carried out in accordance with AS4349.0

Enclosed Defect REPORT (hereinafter called the "Report")

Inspection Date: 18/12/2019

Property Address: Sample

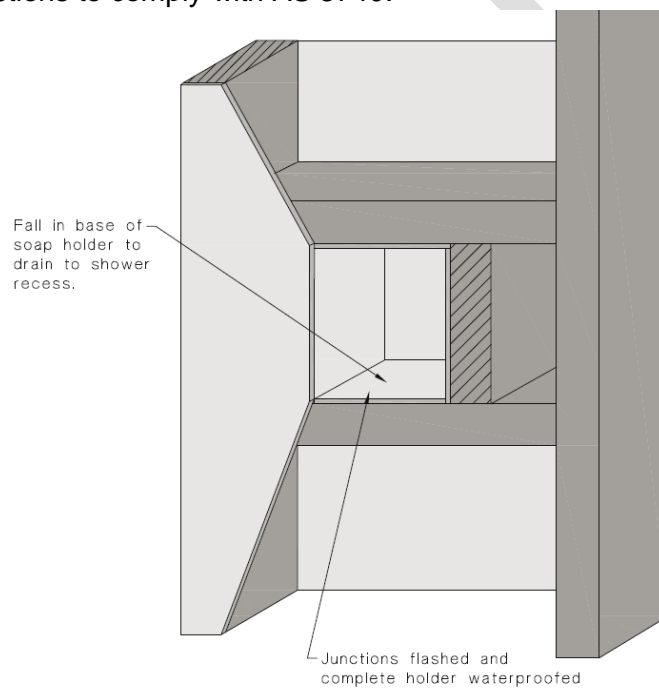
FIGURE 3.4 TYPICAL DETAIL FOR RECESSED SOAP HOLDERS

12. The niche sections to the shower have not been constructed with sufficient fall. The builder must rework these sections to comply with AS 3740.
