(Progress Inspection) REPORT (hereinafter called the "Report")

Report Number 01744

Inspection Date: 17/03/2023

Property Address: Sample street

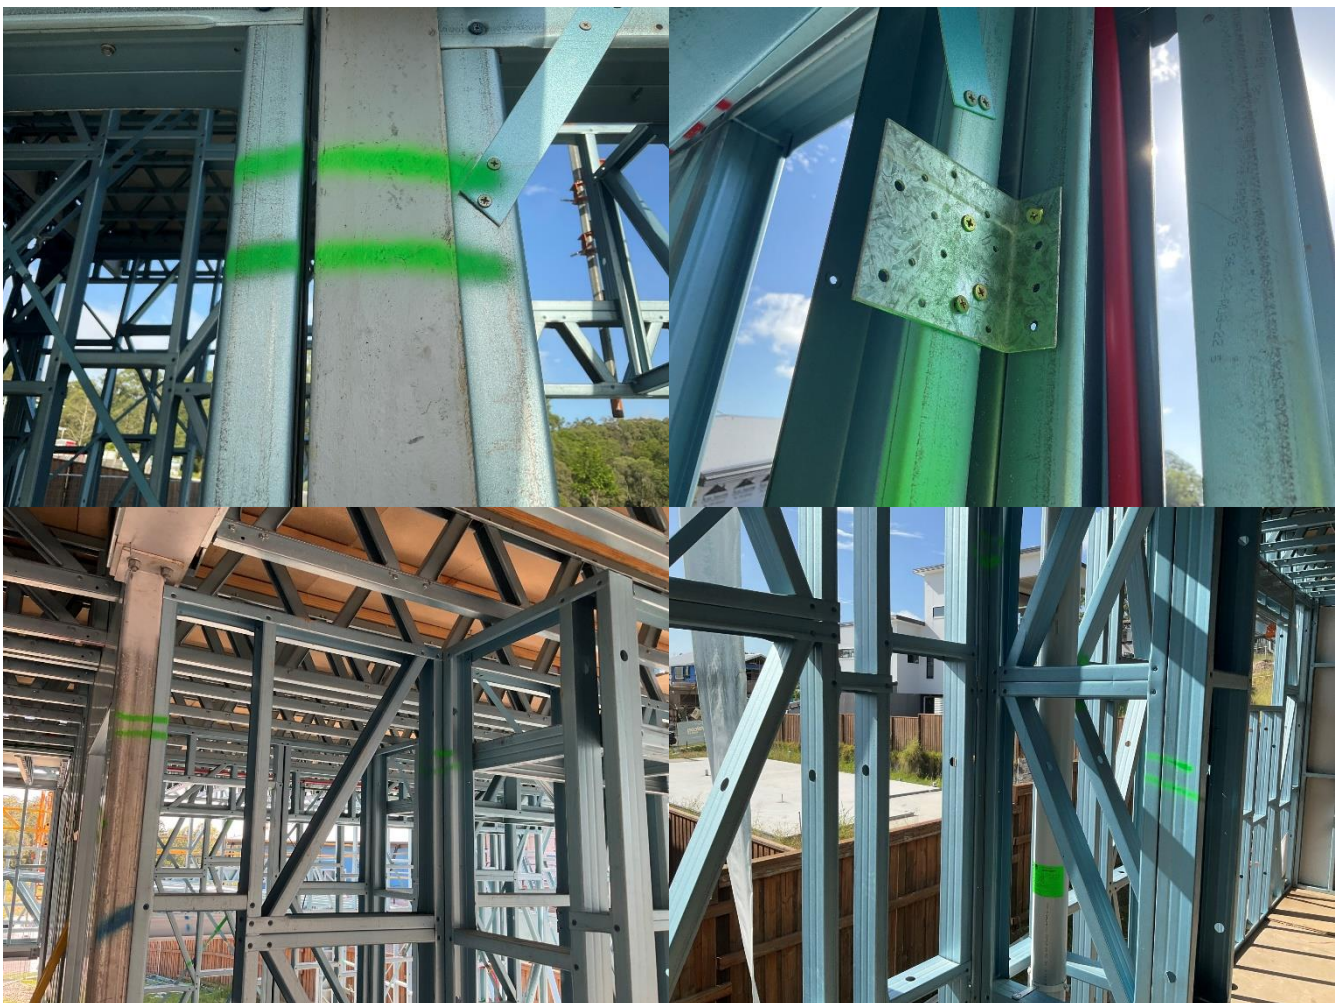
7. A number of wall intersection screw fasteners are missing and need to be installed prior to the installation of wall linings.

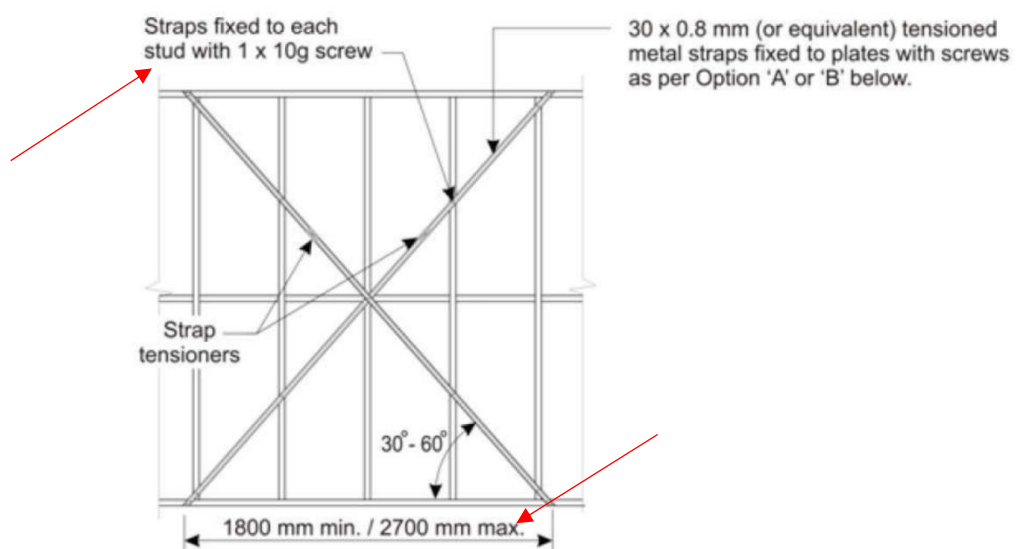
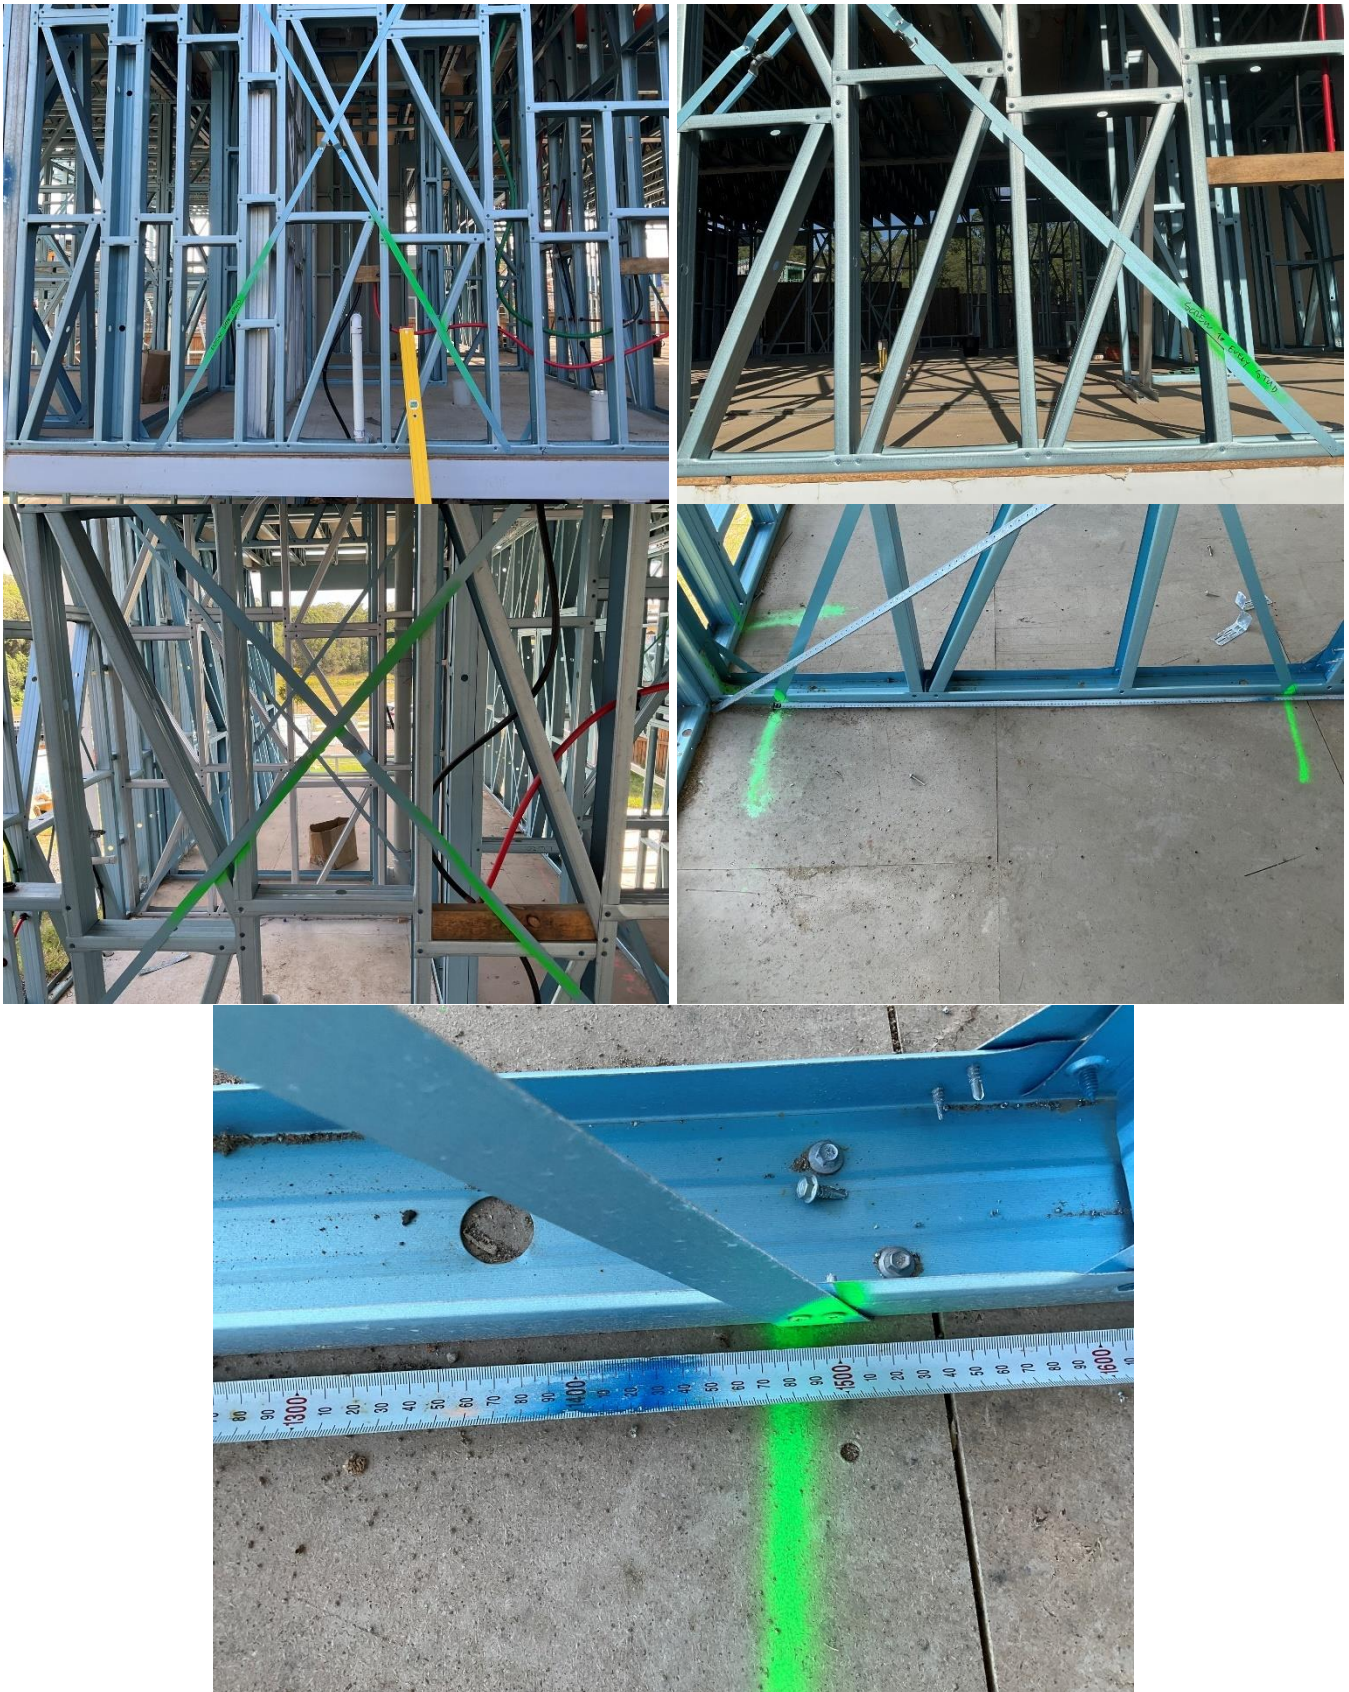
11. The cross bracing is loose, not screwed to each stud and are not the correct width apart as per the Nash Standard, see insert below, this will need to be rectified to comply.

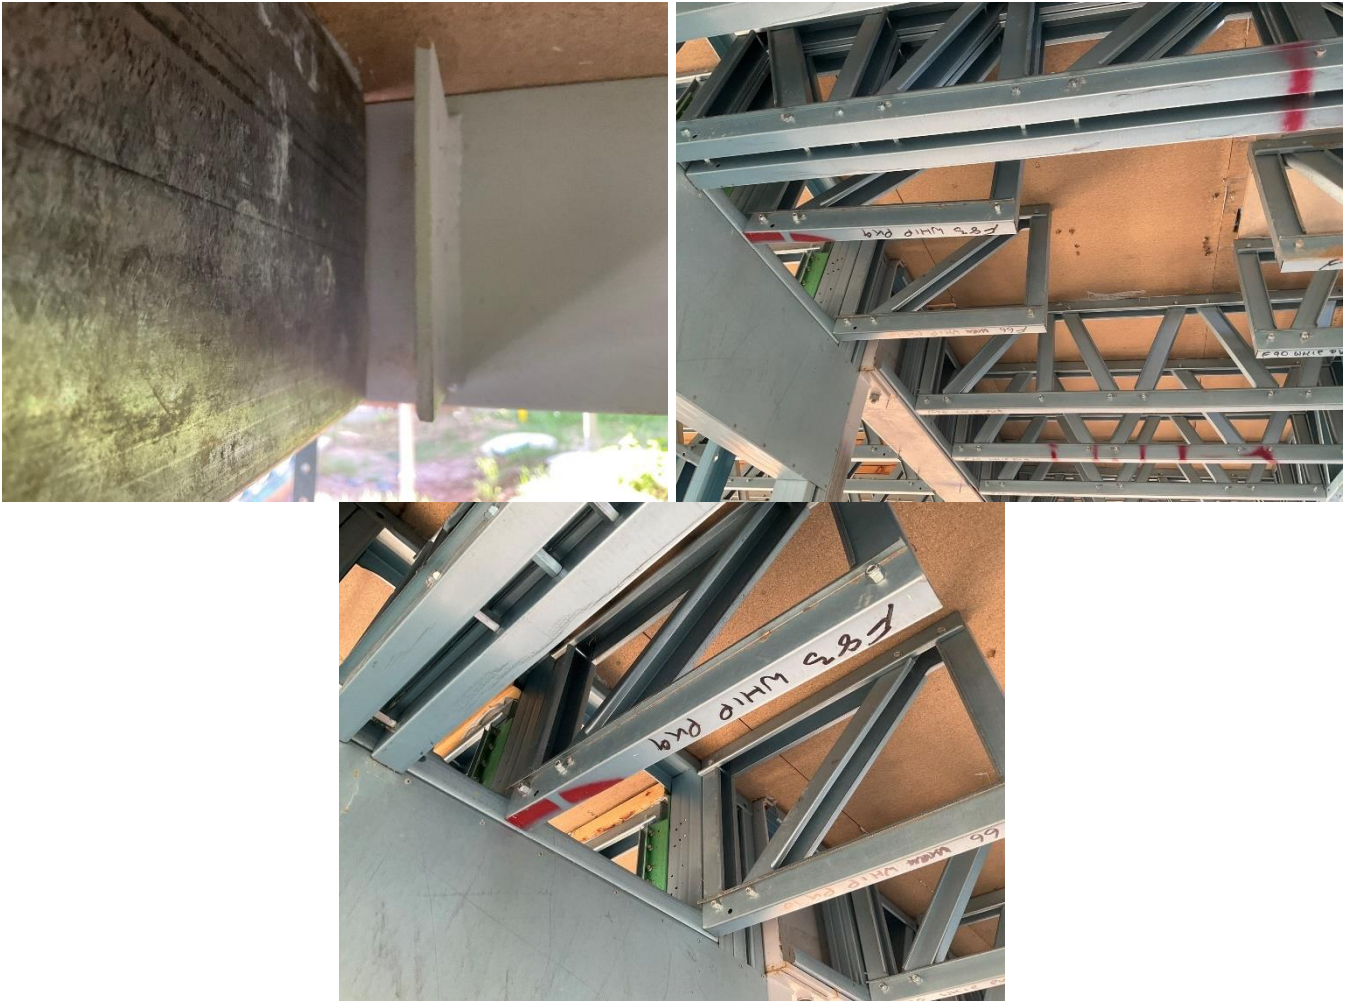
17. The particleboard flooring has not been installed as per the manufacturer & as per AS 1860.2

- Missing screws.
- Screws over driven.
- Close to the edge.
- Humps and dips/ out of level.
- Damage
- Excessive gaps.

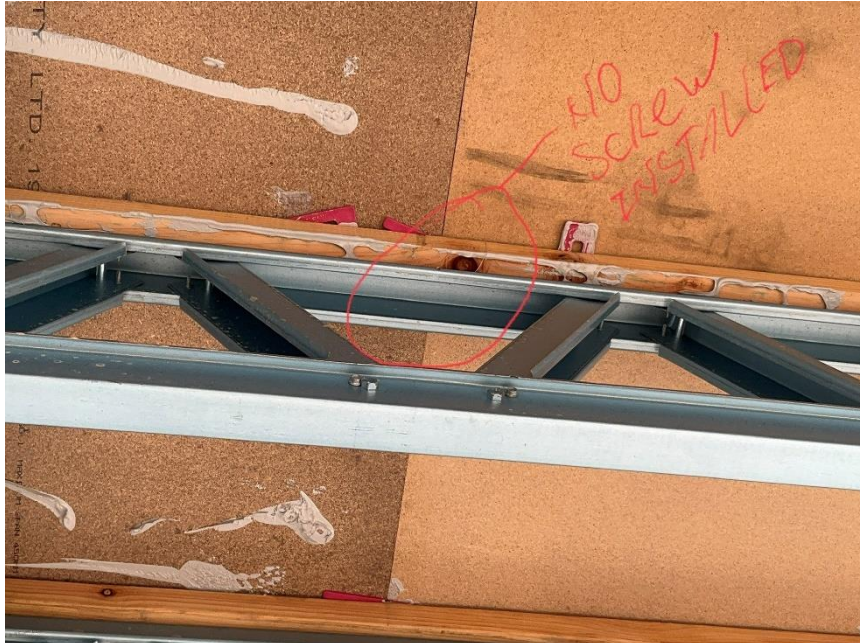
19. Subfloor cross bracing is incomplete, fixings are inconsistent this will need to be checked by an engineer.
